Investigation of bird induced outages on Montana Power Company's 500kV transmission lines
by David Robert Maehl

A thesis submitted in partial fulfillment of the requirements for the degree of Master of Science in
Electrical Engineering
Montana State University
© Copyright by David Robert Maehl (1996)

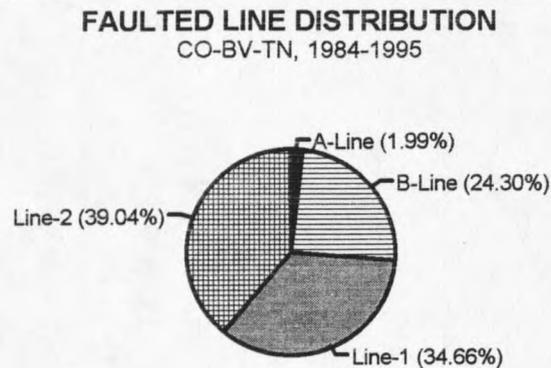
Figure 5. MPC Line Fault Activity

Figure 5 shows the fault activity on each MPC line and clearly, the A-Line is faulted less than all of the other lines. The BPA lines have experienced unexplained outage activity, although not as severe as MPC's B-Line and Lines 1 and 2.
