Investigation of contamination flashover as a possible cause for unexplained faults on the Montana Power Company 500kV transmission lines  
by Mark Grant Major

A thesis submitted in partial fulfillment of the requirements for the degree of Master of Science in Electrical Engineering  
Montana State University  
© Copyright by Mark Grant Major (1993)

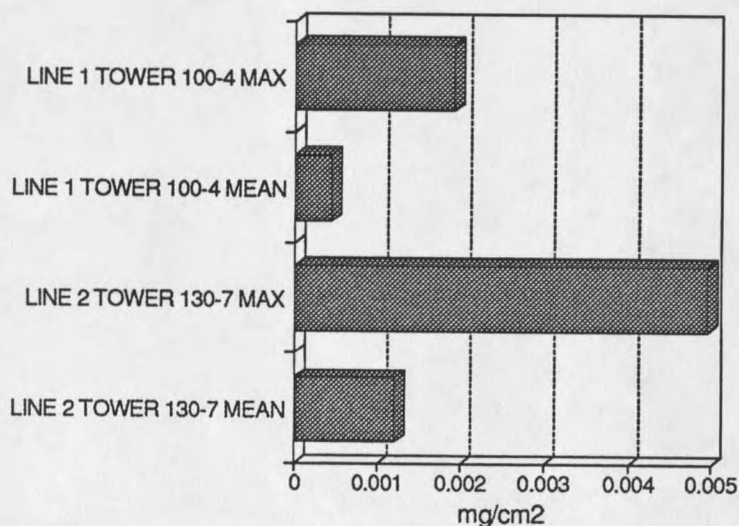
Figure 22

The April 1993 ESDD levels were found to be very light. Because these strings were removed in the spring, after periods of rain, it was not surprising to find only very light contamination levels. These ESDD levels are comparable to those measured on the three strings removed from service in May of 1992.

Tower 130-7 is a "dead-end" tower in which some strings were positioned at a 25° angle (angle from vertical), and some were positioned at 65°. During the ESDD sampling, noticeably more dust was observed on strings positioned at 25° than on strings oriented at more horizontal orientations. Vertically positioned insulator strings accumulate more contamination than horizontal strings because rain is more effective at washing horizontally oriented strings.

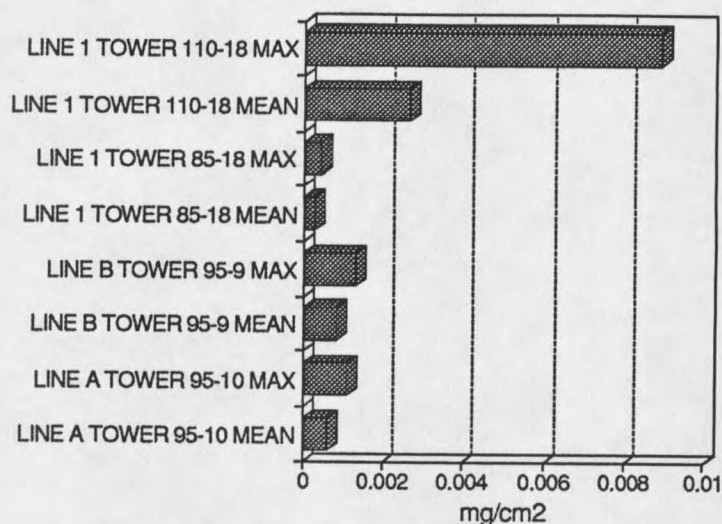
Figure 23

The August and September 1993 ESDD measurements revealed only very light levels of contamination. Normally, higher levels would be expected since these samples were taken during the late summer. However, since much higher than normal amounts of precipitation were observed the summer of 1993 in Montana, these low levels were not surprising.

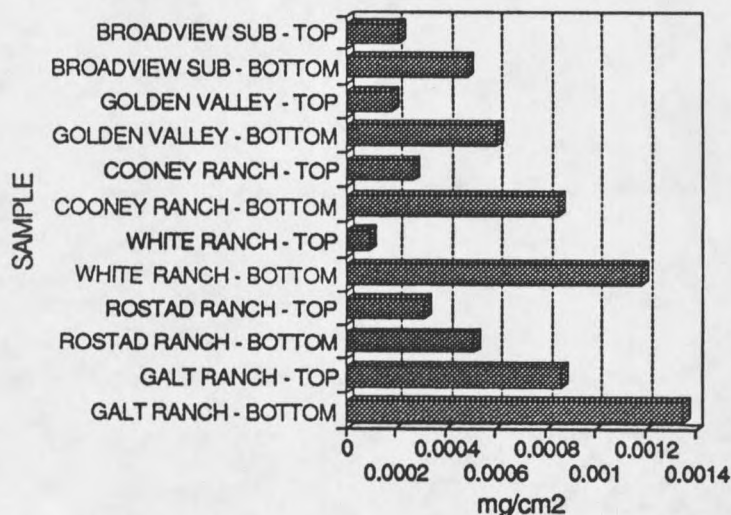
Figure 24

Each of these samples were found to have ultra-light levels of contamination, which is not very surprising since they were suspended only two months during a very rainy summer. Sampling of the test insulators was not repeated before this thesis was prepared, however, continued sampling of these test insulators is planned.

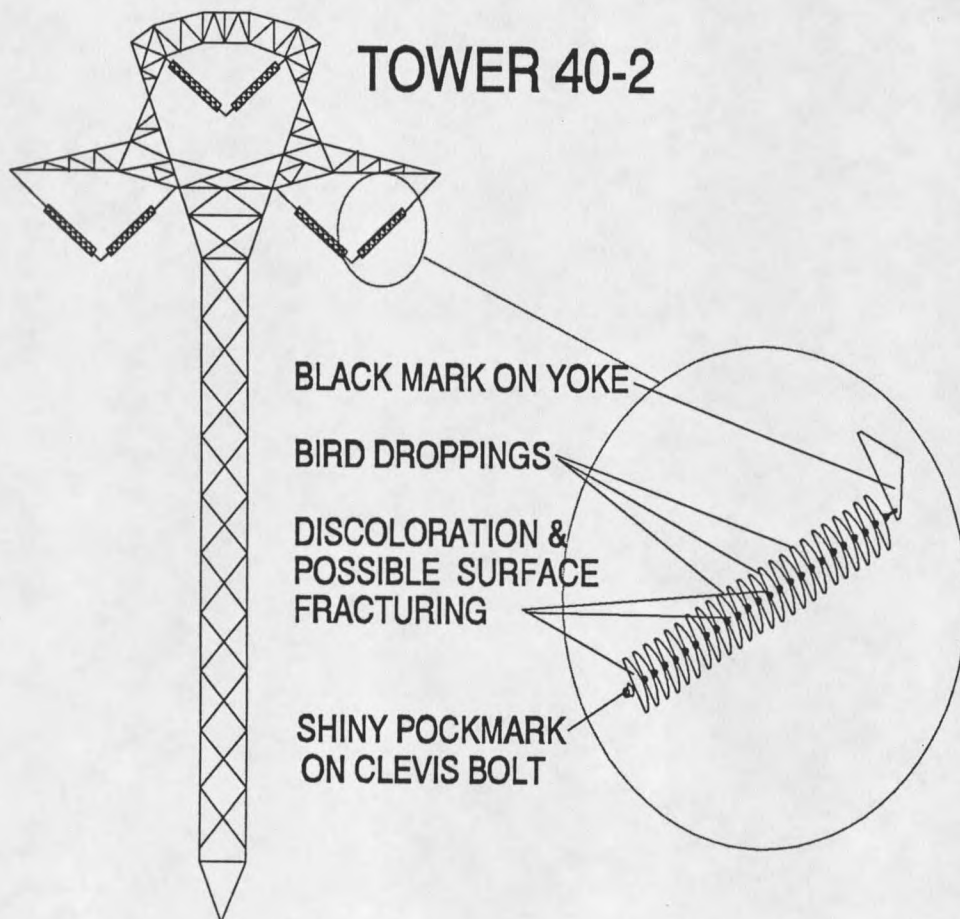
Figure 25: Markings on Tower 40-2

The fault discussed above was the only fault to occur within the areas of the line equipped with fault indicators prior to the preparation of this thesis.
