Investigation of bird induced outages on Montana Power Company's 500kV transmission lines  
by David Robert Maehl

A thesis submitted in partial fulfillment of the requirements for the degree of Master of Science in  
Electrical Engineering  
Montana State University  
© Copyright by David Robert Maehl (1996)

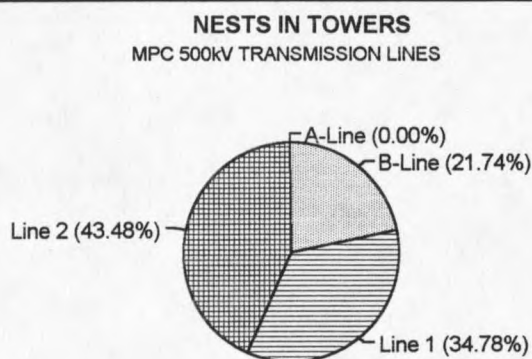
**Figure 16. Nests in Tower**

relative to the different 500kV lines. Nests were documented from land observations as well as helicopter surveys. A complete listing of the towers with nests located in them can be seen in Appendix B. Notice the striking similarities that exist between Figure 16 and Figure 5, Faulted Line Distribution. The percentage of nests in towers on each line is almost exactly the same as the percentage of faults on each line.

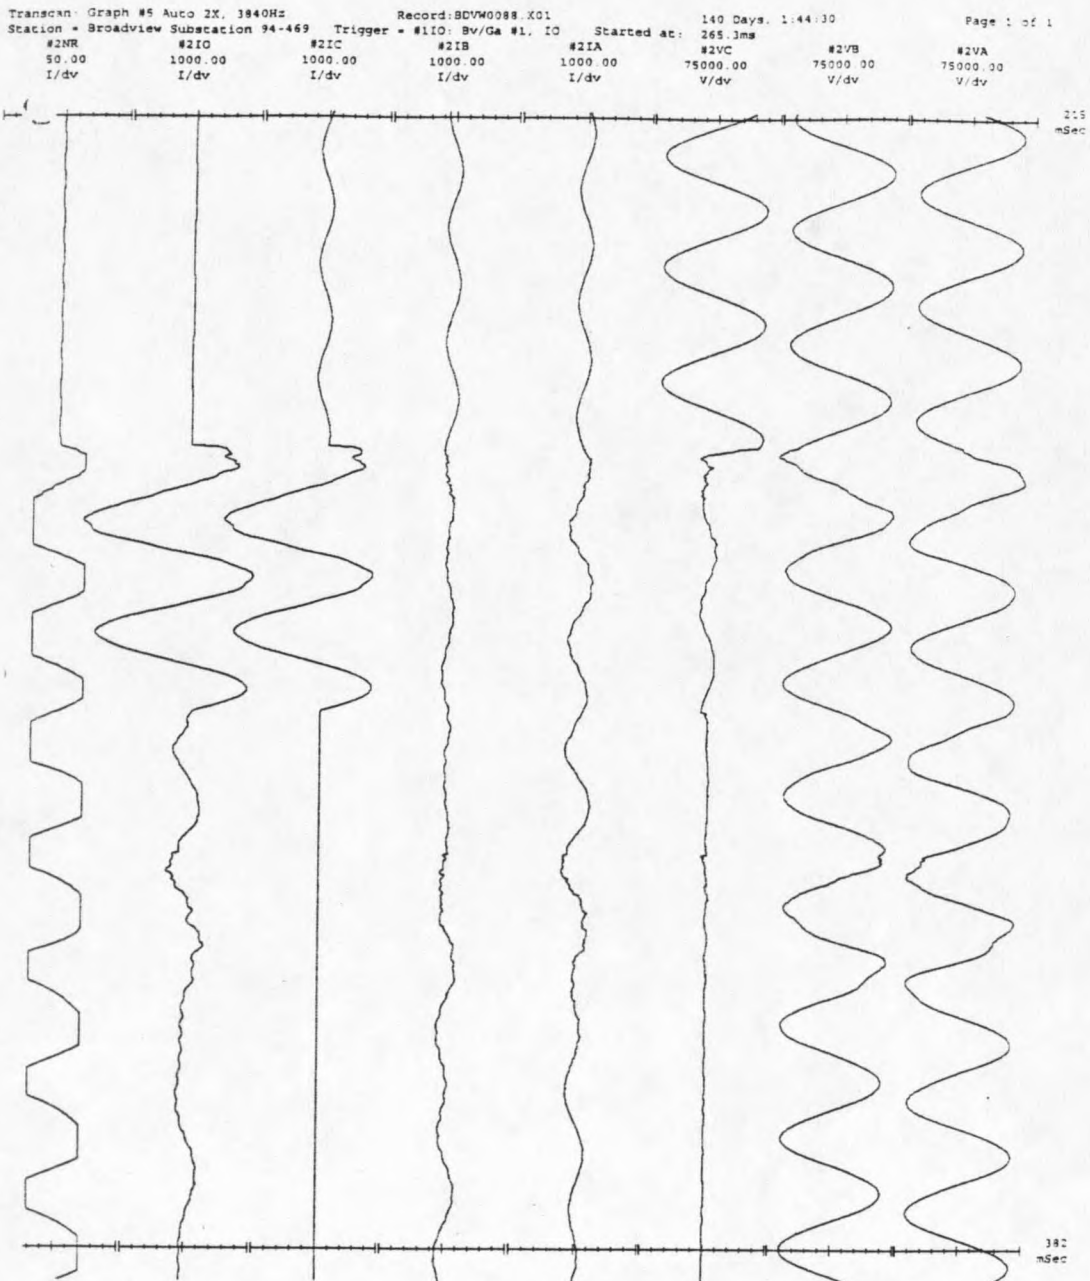
Figure 24. DFR Data for Fault on 5/20/95

Two faults that occurred on 5/20/95 and 5/27/95 were attributed to birds by MPC engineers because of an active nest with barbed wire hanging out of it located in a tower where the faults were suspected to have occurred. The fault on 5/20/95 occurred at 01:44 and the fault on 5/27/95 occurred at 12:29. Their DFR plots are very similar and can be seen in Appendix F, Figures 24 and 25. The faulted phase voltage occurs at a peak (+, -) and quickly goes to zero and stays at zero, even before the breaker is operated. The fault currents are high in magnitude, which may be due to the fact that both faults occurred close to the Broadview Substation. It appears as though the fault resistance was minimal and solid (constant). In other words, it may have been that there was a solid, conductive, connection between the phase wire and tower, such as barbed wire.

Suspected Cause; Birds, Foreign Object

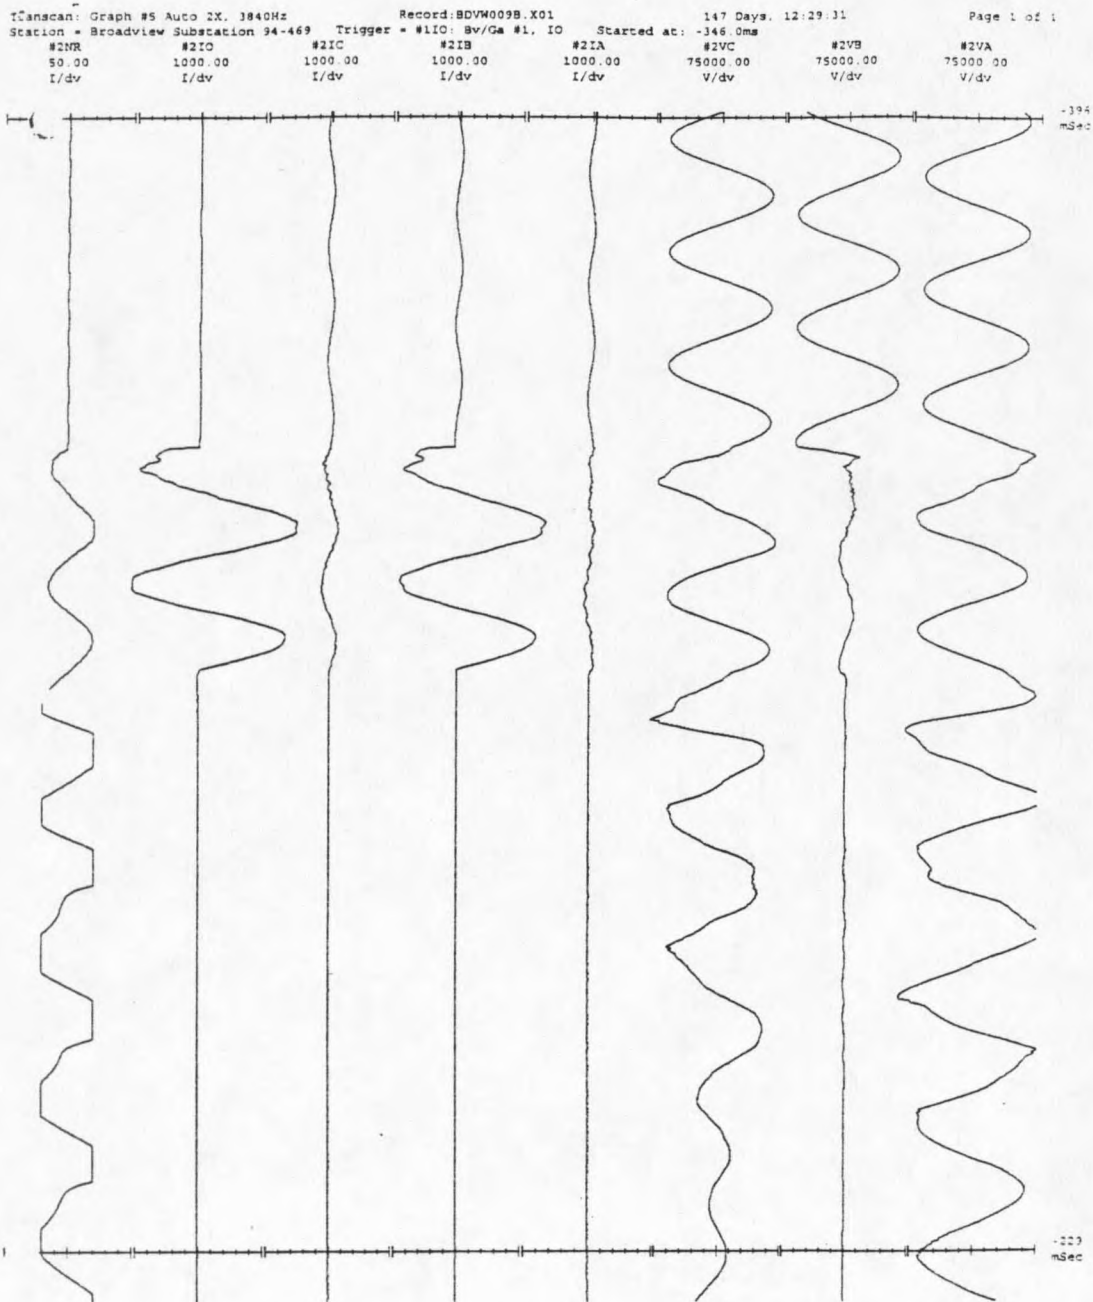
Figure 25. DFR Data for Fault on 5/27/95

Suspected Cause; Birds, Foreign Object

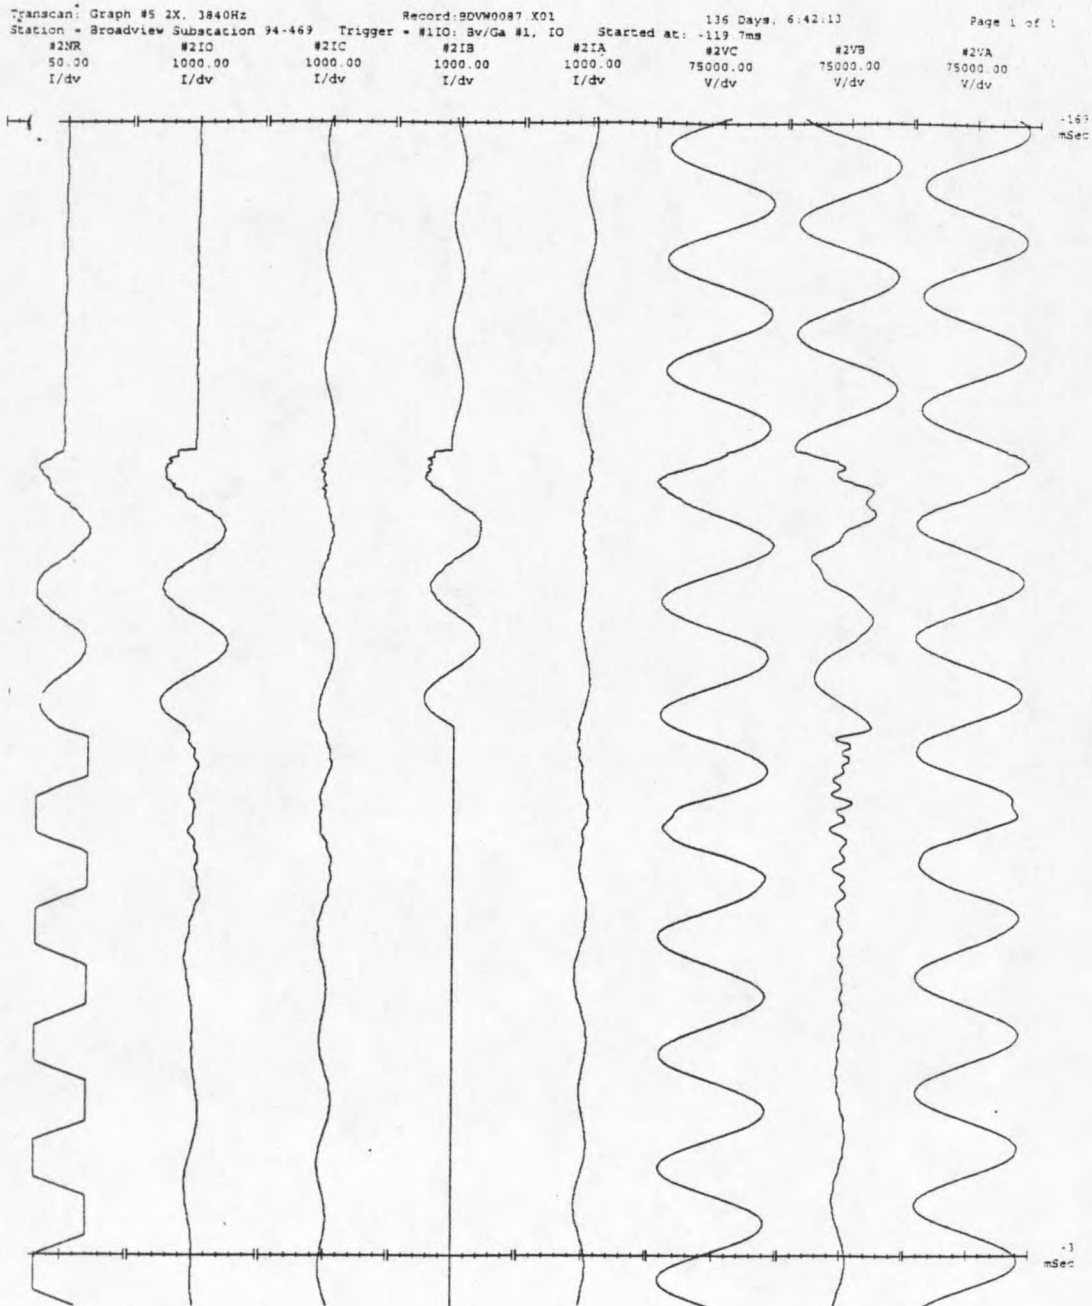
Figure 26. DFR Data for Fault on 5/16/95

Faults occurring on 5/16/95, 6/25/95, and 8/20/95 were also suspected to be bird caused because of nests that were located in neighboring towers. All of these faults occurred on the outside phases during the early morning hours (between 4:45 and 6:45) approximately 95 to 110 miles west of Broadview. The DFR plots are very similar to each other, although they are different from the DFR plots discussed in the preceding paragraph. The faulted phase voltage, as seen in Appendix F, Figures 26, 27, and 28 does not immediately go to zero after the fault, unlike the DFR plots for the "Faults Attributed to Birds, Foreign Object Caused". It is speculated that these faults may have been caused by mute. West (1971),[15]

Suspected Cause; Birds, Mute

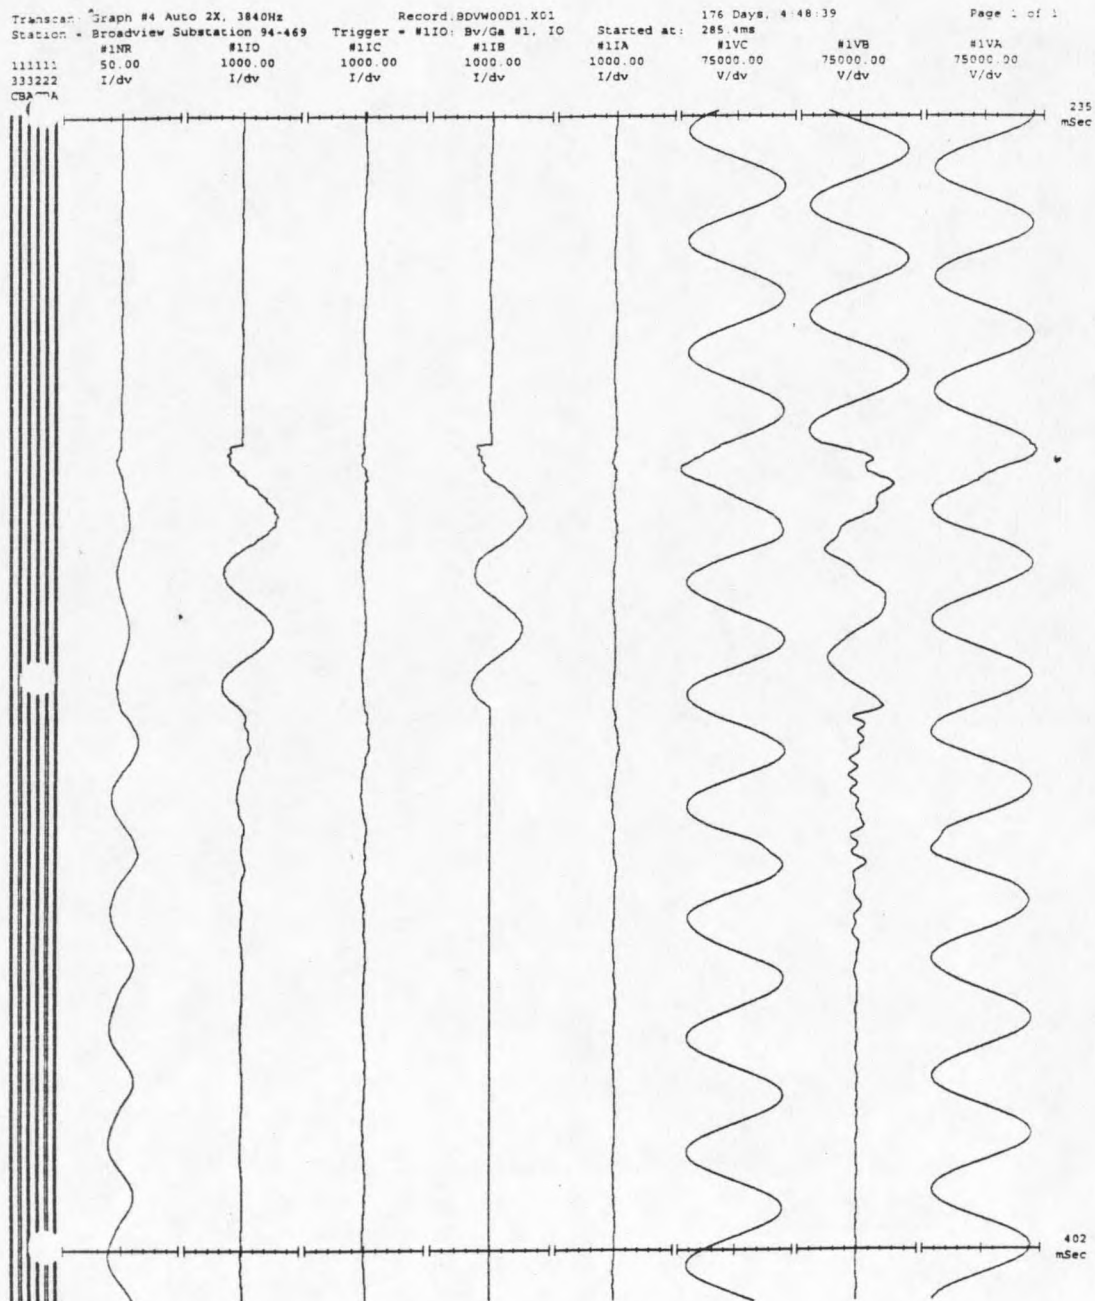
Figure 27. DFR Data for Fault on 6/25/95

Suspected Cause; Birds, Mute

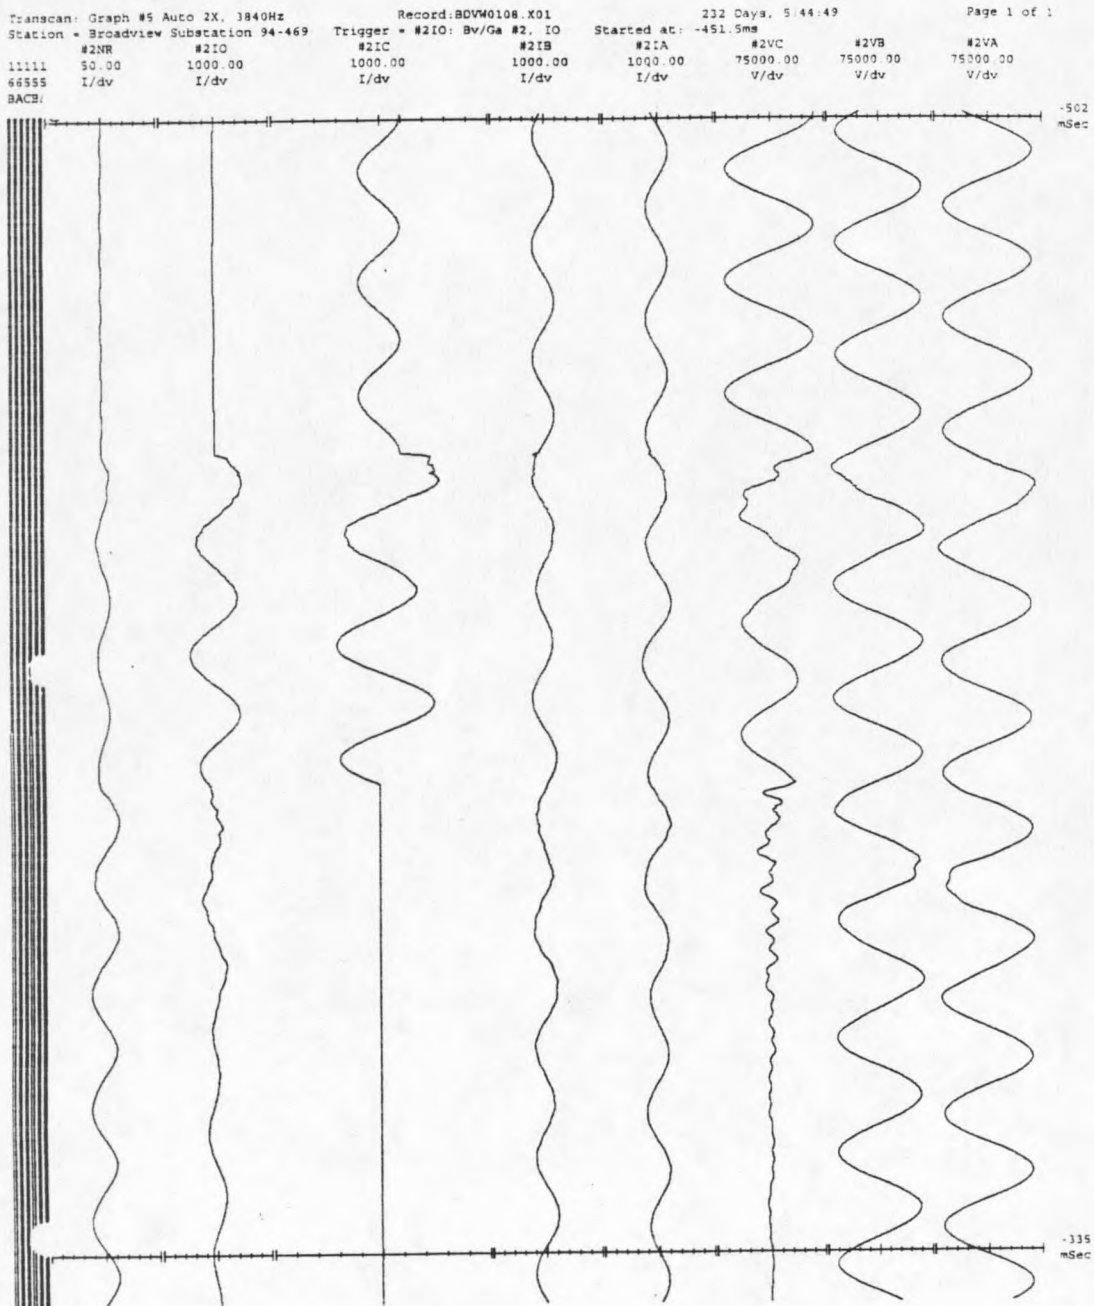
**Figure 28. DFR Data for Fault on 8/20/95**

Suspected Cause; Birds, Mute

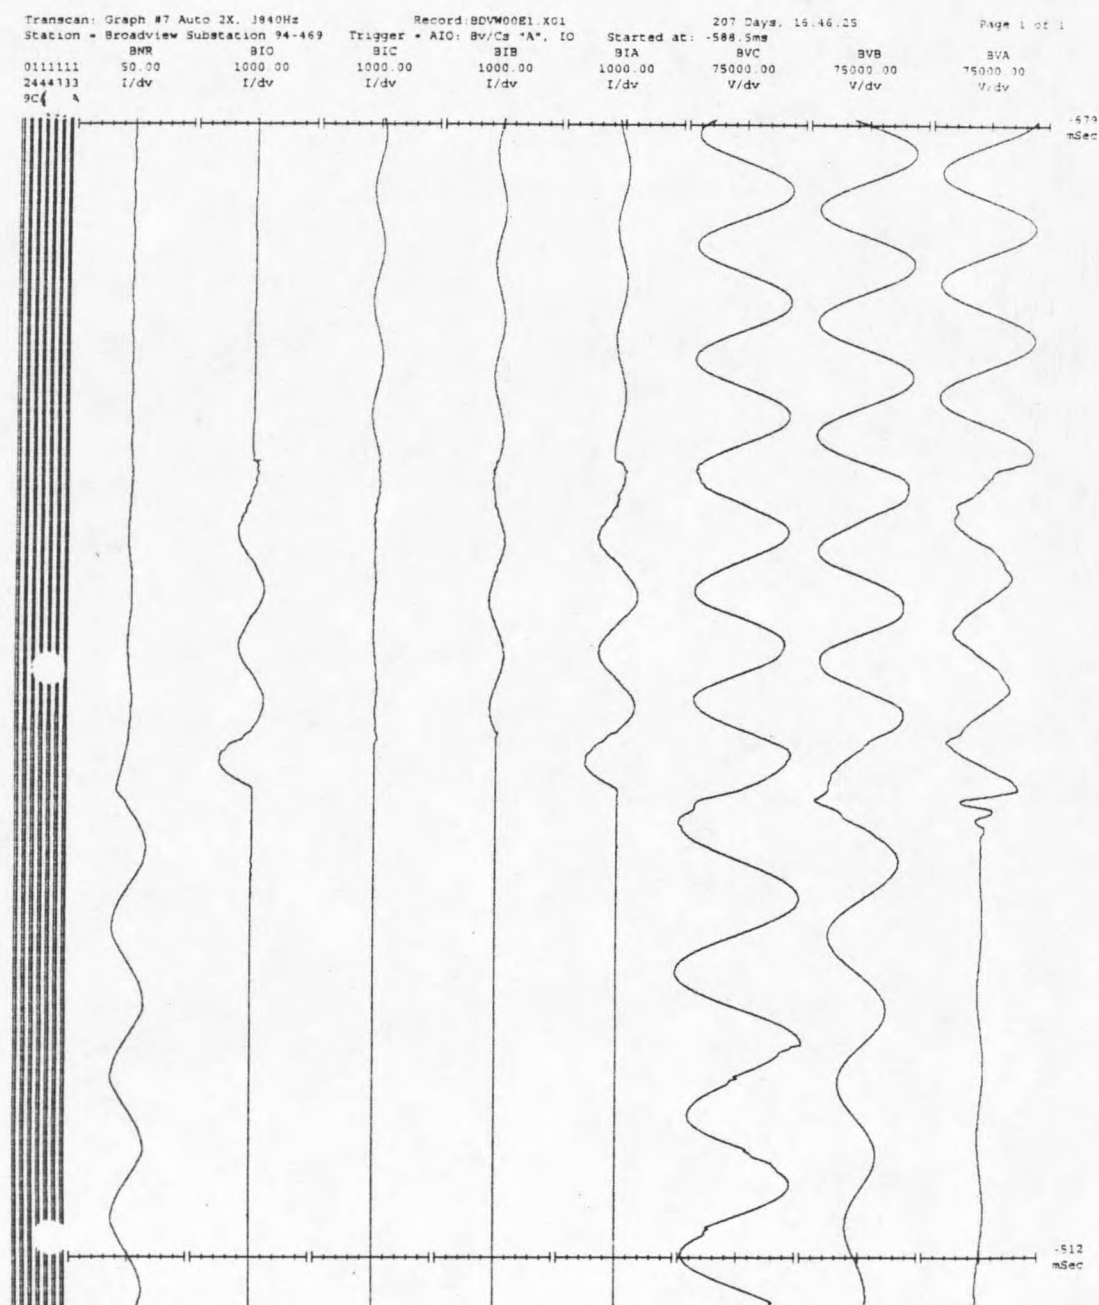
**Figure 29. DFR Data for Fault on 7/26/95**

**Known Cause; Line Sagging Into Tree**
