Investigation of bird induced outages on Montana Power Company's 500kV transmission lines
by David Robert Maehl

A thesis submitted in partial fulfillment of the requirements for the degree of Master of Science in
Electrical Engineering
Montana State University
© Copyright by David Robert Maehl (1996)

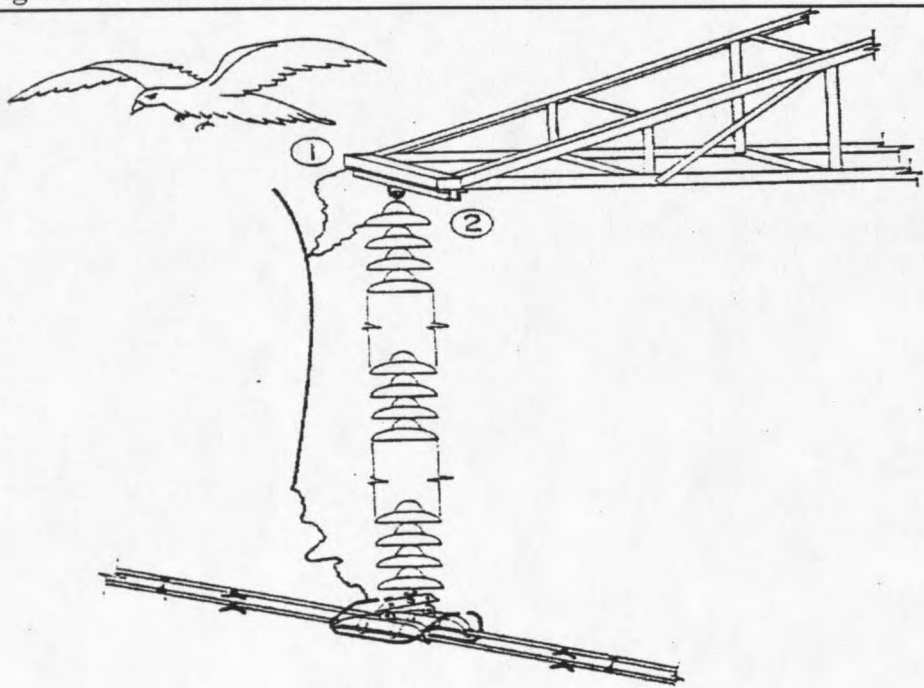
Figure 15. Bird Caused Fault

It is hypothesized that the birds perch on the tower angle iron above the hot phase wires (actually an observed fact) and excrete a long stringy mucus material (mucous) while perching or when leaving the tower. The mucus string has sufficient conductivity and length to reduce the gap between the phase wires and the tower to a distance where the air will ionize across the remaining gap and a single-phase-to-ground fault will occur. Raptors and

other large birds will regurgitate all of the solid matter they eat such that their excretions are only the mucus liquid left over (West et al. 1971),[15]. Figure 15 illustrates a bird caused fault (West et al. 1971),[15]. It is believed that the bird is usually not harmed in the scenario because no signs of dead birds have been found along the transmission line route.

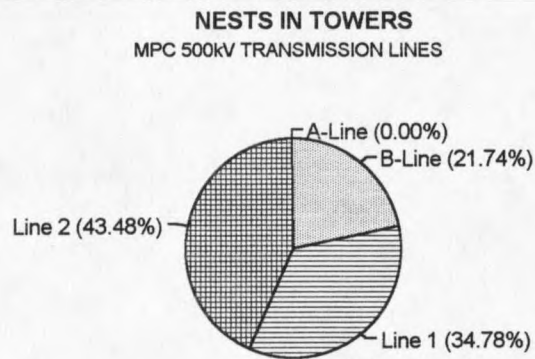
Figure 16. Nests in Tower

relative to the different 500kV lines. Nests were documented from land observations as well as helicopter surveys. A complete listing of the towers with nests located in them can be seen in Appendix B. Notice the striking similarities that exist between Figure 16 and Figure 5, Faulted Line Distribution. The percentage of nests in towers on each line is almost exactly the same as the percentage of faults on each line.

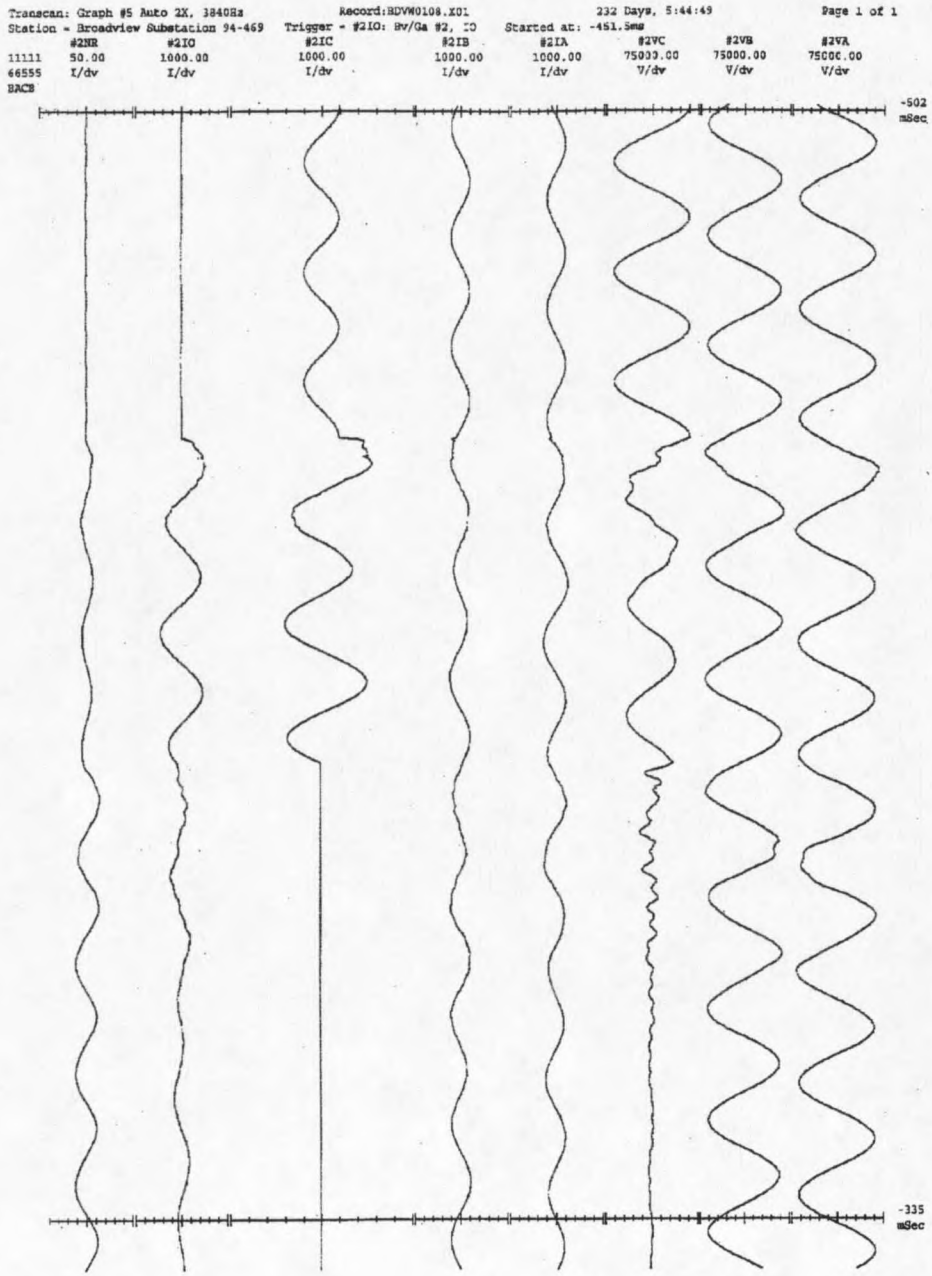
Figure 23. Digital Fault Recorder Data

As mentioned earlier, digital fault recorder (DFR) data have been available for faults occurring since 1995. The digital fault recorder allows for the generation of plots of the waveforms of each phase before, during, and after a fault. For illustration purposes, a DFR plot is shown on the following page in Figure 23 and the rest of the DFR plots discussed are shown in Appendix F.

Two faults that occurred on 5/20/95 and 5/27/95 were attributed to birds by MPC engineers because of an active nest with barbed wire hanging out of it located in a tower where the faults were suspected to have occurred. The fault on 5/20/95 occurred at 01:44 and the fault on 5/27/95 occurred at 12:29. Their DFR plots are very similar and can be seen in Appendix F, Figures 24 and 25. The faulted phase voltage occurs at a peak (+, -) and quickly goes to zero and stays at zero, even before the breaker is operated. The fault currents are high in magnitude, which may be due to the fact that both faults occurred close to the Broadview Substation. It appears as though the fault resistance was minimal and solid (constant). In other words, it may have been that there was a solid, conductive, connection between the phase wire and tower, such as barbed wire.

Faults occurring on 5/16/95, 6/25/95, and 8/20/95 were also suspected to be bird caused because of nests that were located in neighboring towers. All of these faults occurred on the outside phases during the early morning hours (between 4:45 and 6:45) approximately 95 to 110 miles west of Broadview. The DFR plots are very similar to each other, although they are different from the DFR plots discussed in the preceding paragraph. The faulted phase voltage, as seen in Appendix F, Figures 26, 27, and 28 does not immediately go to zero after the fault, unlike the DFR plots for the "Faults Attributed to Birds, Foreign Object Caused". It is speculated that these faults may have been caused by mute. West (1971), [15]

determined from the bird mute simulation tests that, "stream breakup occurred such that the mute would not drop in a continuous column", and thus a discontinuity was created in the arc flashover between the tower and conductor. This suggests that the fault resistance was not solid, which appears to be the case with these DFR plots. Furthermore, all of the faults occurred early in the morning which is the most likely time for a mute induced outage to occur because it is common for birds to mute a large quantity prior to commencing daily activity (Burnham 1995),[8].
