**Proceedings of CORROSION/2002  
Research Topical Symposium**

**Microbiologically  
Influenced Corrosion**

# **Chemical Characterization of Deposits Associated with Microbiologically Influenced Copper Corrosion in Potable Water Systems**

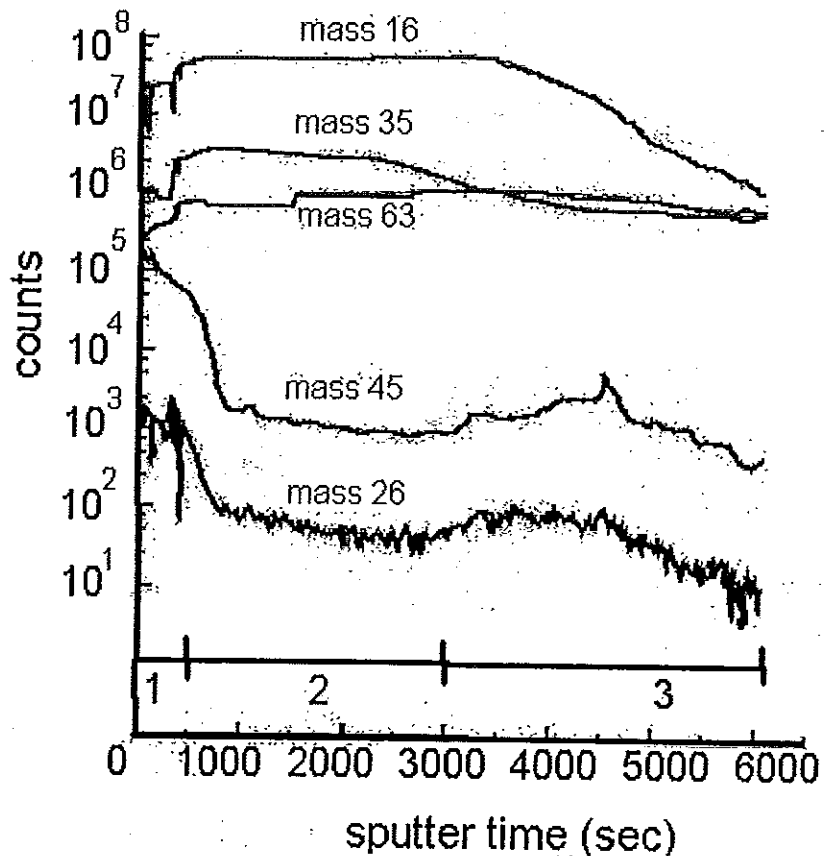
The parallel changes in abundance with depth of fragments  $m/e^-$  26 and 45, corresponding to  $\text{CN}^-$  and  $\text{COOH}^-$ , suggests they are derived from a similar source of organic carbon (Figure 3). Furthermore, the profiles identify an organic carbon-rich surface region (region 1), under which resides a region (region 2) that contained an organic carbon content that was 10-20% of that in the region 1 (Figure 3). At greater deposit depths, corresponding to region 3, organic carbon content increased slightly before decreasing to a minimum.

The change in elemental ratios of Cu, O, and Cl with sputter depth also identifies 3 chemically distinct regions (Figure 3). The approximately 5-fold increase in these elements at the boundary of region 1 and 2 corresponded to the depth at which organic carbon decreased an order of magnitude. Over the depth range that Cu abundance remained relatively constant, a 2-fold decrease in Cl abundance in region 2 was followed by a 10-fold decrease in O abundance corresponding to region 3 (Figure 3). Based on the previously described visual inspection results it is likely that regions 1 and 2 contained the yellow-green deposit, while region 3 contained the underlying blue and black deposits. From a cursory understanding of the nature of the different corrosion product layers, the sputter rate through the yellow-green layer is expected to be greater than that through the underlying blue and black layers. Thus, regions 1 and 2 may be 2-3 times thicker than region 3. Since region 2 had lower Cu/Cl and Cu/O ratios than region 3, the former likely contains  $\text{CuO}$ ,  $\text{Cu}(\text{OH})_2$ , and  $\text{CuCO}_3 \cdot \text{Cu}(\text{OH})_2$ , while the latter likely contains  $\text{Cu}_2\text{O}$ , supporting assignment of  $\text{Cu}(\text{OH})_2$  and  $\text{CuCO}_3 \cdot \text{Cu}(\text{OH})_2$  to the yellow-green corrosion deposit, and  $\text{Cu}_2\text{O}$  to the underlying black corrosion deposits, respectively, on the HV tube surface.

Figure 3. Negative ion SIMS depth profile of  $^{16}\text{O}$ ,  $^{35}\text{Cl}$ ,  $^{63}\text{Cu}$ ,  $^{12}\text{C}$ ,  $^{45}\text{COOH}$ , and  $^{26}\text{CN}$  through the yellow-green deposit on the HV tube surface.
