Effects of wildfire on first order stream channel morphology Yellowstone National Park, USA
by Kim J Ernstrom

A thesis submitted in partial fulfillment of the requirements for the degree of Master of Science in
Earth Sciences

Montana State University

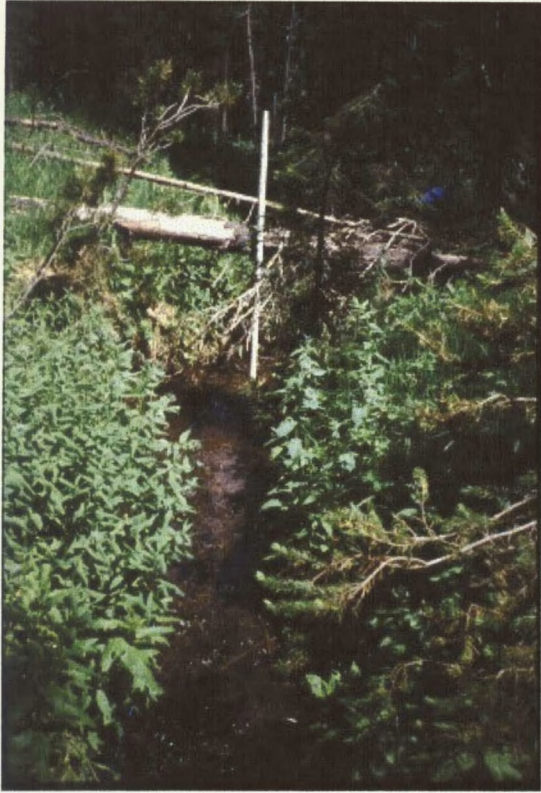
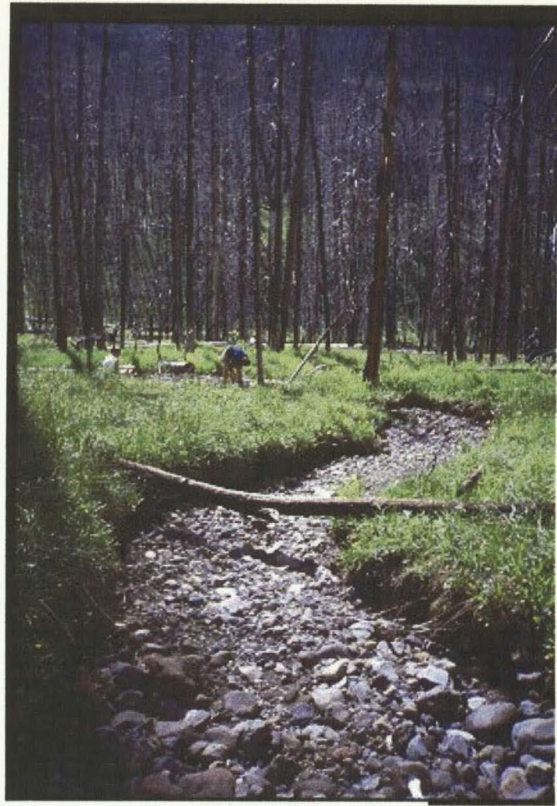
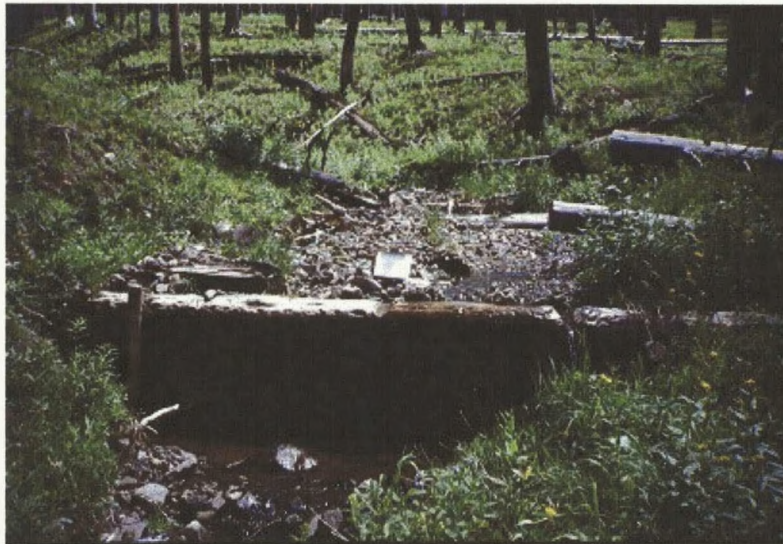
Unburned Stream

Burned Stream

Dammed Stream

Figure 3. Photographs of representative streams from the Pebble Creek (unburned), Cache Creek (burned), and upper Cache Creek (dammed) watersheds.

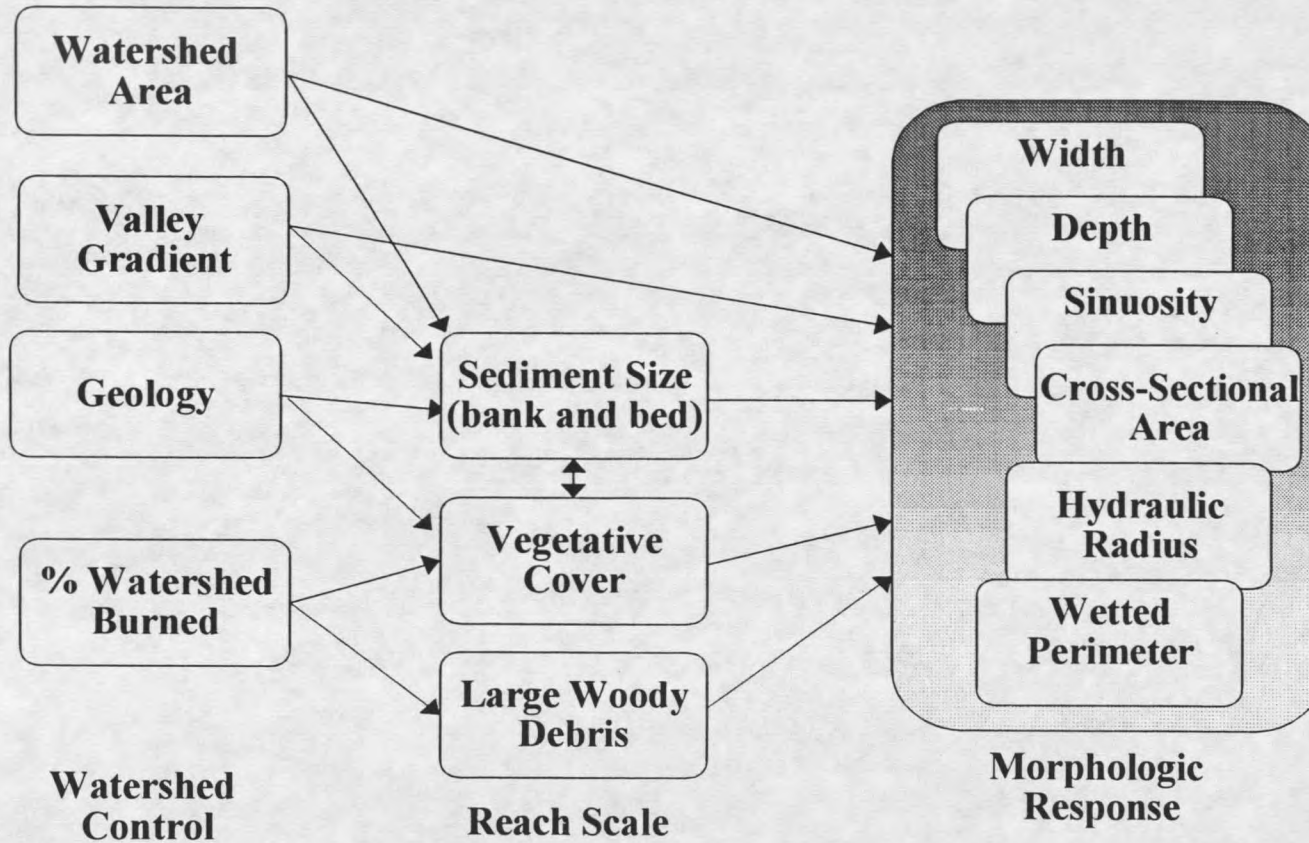
Figure 4. Schematic diagram showing association of watershed controls, reach scale variables and morphologic response variables. Reach scale variables both respond to the watershed controls while also affecting the morphologic response variables. Diagram is specific to spatial scales covered in this study.

Watershed scale variables, which included watershed area, percent watershed burned, geology and stream gradient, were landscape level variables that had not changed since the 1988 fires. Reach scale variables - percent cover, amount of large woody debris, substrate size (d50 and d90), and silt-clay ratios of bank and bed material can be affected by fire and in turn can influence stream morphology. The morphologic response variables were stream width, depth, cross-sectional area, hydraulic radius, wetted perimeter, and sinuosity. Changes in the watershed and reach scale variables influence these response variables at different spatial and temporal scales.

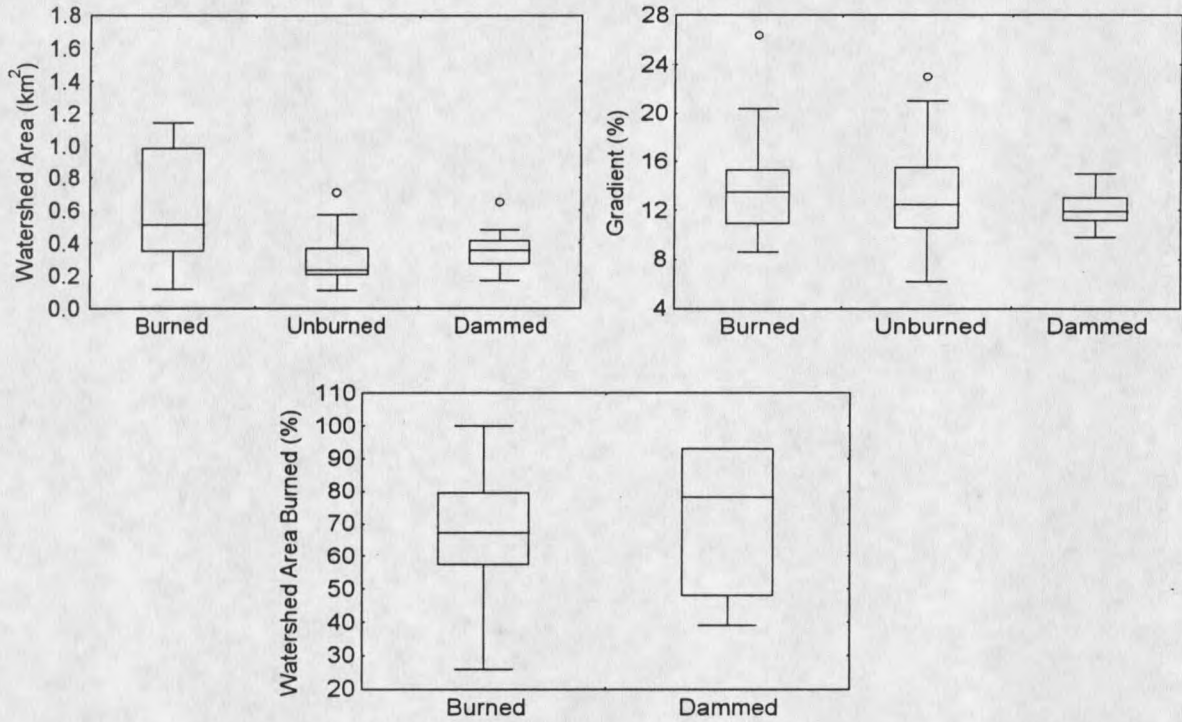
Figure 5. Box-plots of watershed control variables: watershed area, percent watershed burned and stream gradient. The top and the bottom of the box represent the 75th and 25th percentiles, the horizontal line is the median, the whiskers show the data range within 1.5 times the interquartile range, and outliers are represented by circles. All unburned watersheds had zero percent area burned.

Box plots of the watershed, reach scale, and morphologic variables for all three treatments are presented in figures 5 through 8. The boxplots indicated several general relationships among the three treatments. Watershed area for streams located in burned catchments was more variable and appeared to be larger than for the other two treatments (Figure 5). Stream gradient was similar among all stream types. Percent watershed burned was comparable between the burned and dammed streams.

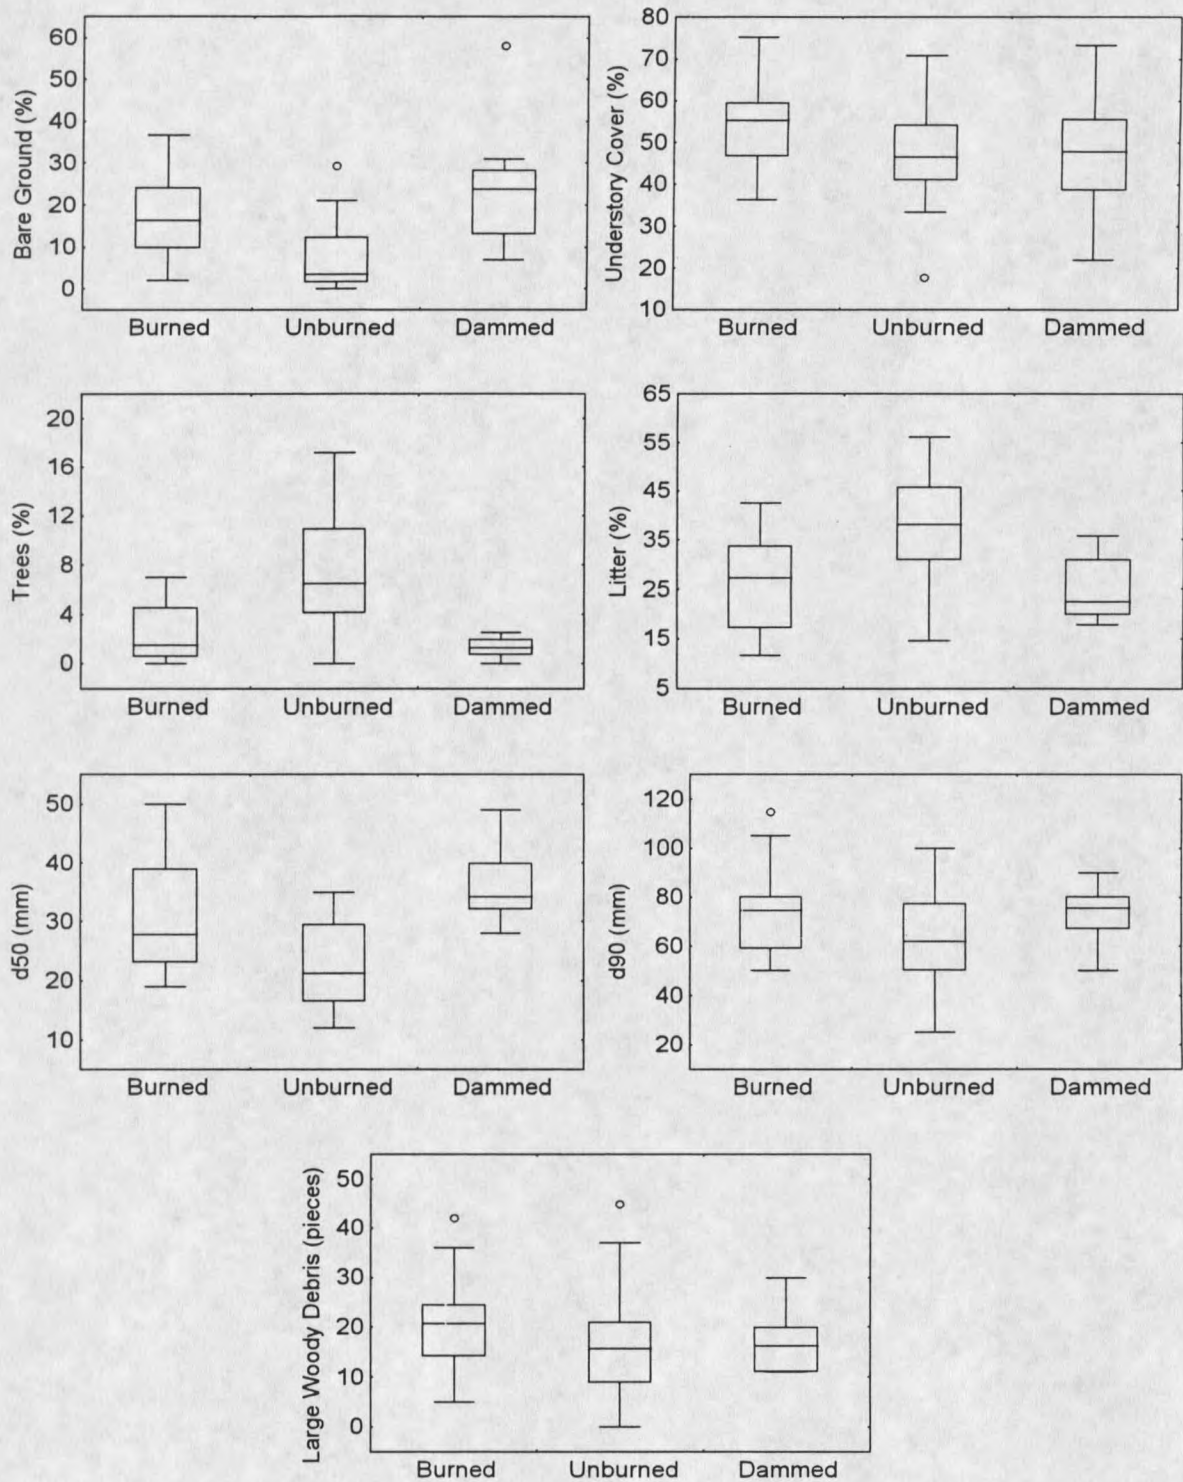
Figure 6. Box-plots of reach scale variables: cover (percent bare ground, understory cover, trees, and litter), substrate size (d50 and d90) and large woody debris.

Reach scale variables exhibited some variability among treatments. Burned areas had fewer trees, less litter and had higher percentages of bare ground than the unburned streams (Table 4 and Figure 6). Understory cover (shrubs, forbs and grass) was similar for all treatments, although burned streams had a slightly higher median value than the other two treatments. D50 and d90 indicate the 50th and 90th percentile of substrate size in millimeters and are shown in Figure 6. In general, the channel substrate appears to be smaller for the unburned watershed, with d50 having a greater variability between treatments than d90.

The amount of large woody debris within all three treatments was generally the same (Figure 6). The distribution of sand, silt and clay for both the bed and bank material for all treatments is also generally similar as indicated by the ternary diagram in Figure 7. Compared to the reach scale variables, the morphologic response variables show much

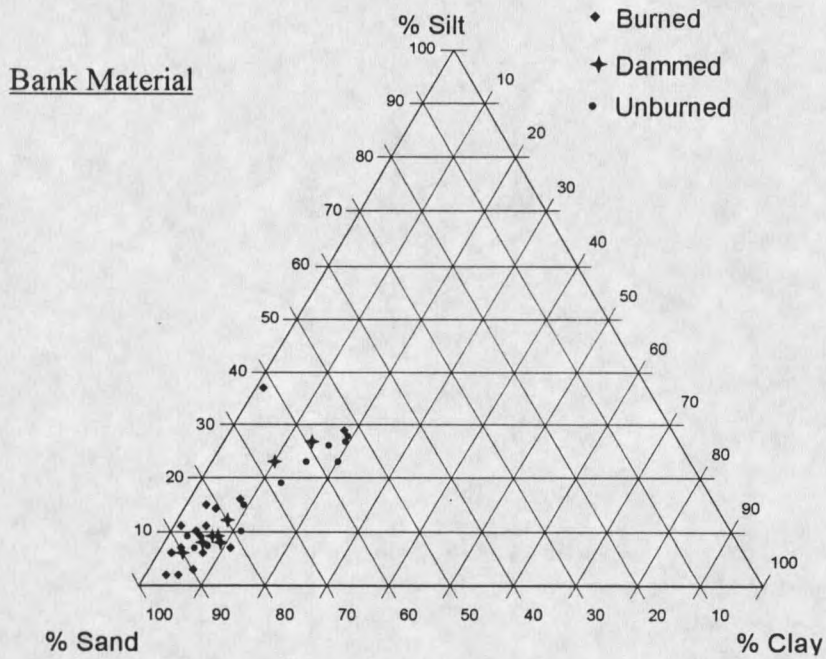
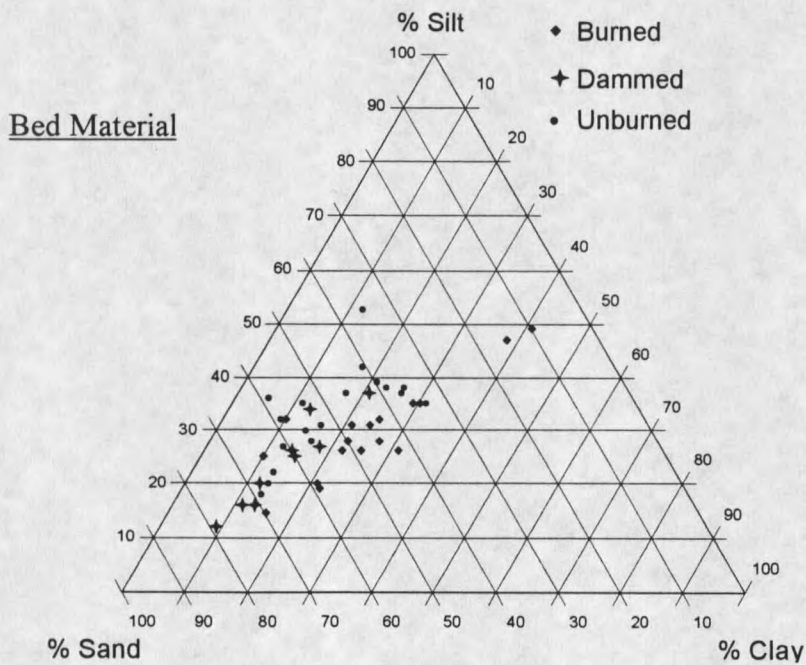
Figure 7. Ternary diagram of percent sand, silt, and clay in the bank and stream bottom material of unburned, burned and dammed streams.

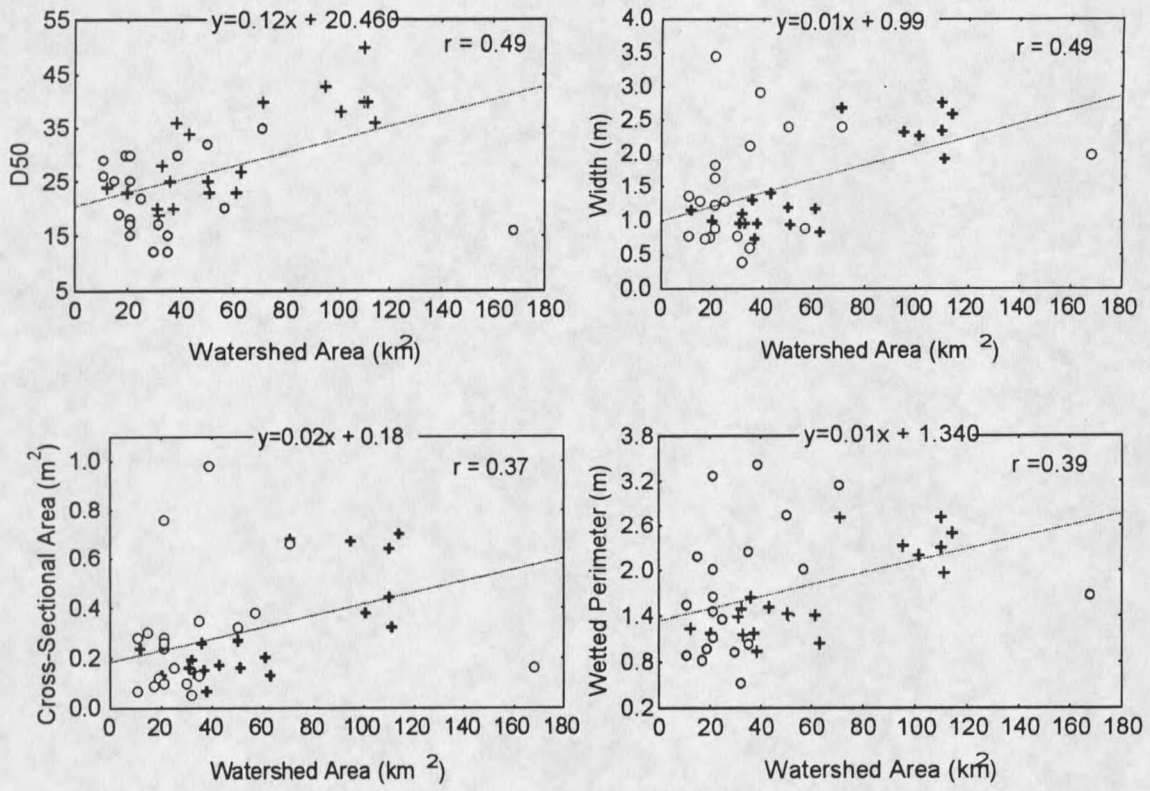
Figure 9. Scatterplots showing significant correlations at the 0.05 level between watershed area and d50, width, cross sectional area and wetted perimeter. Burned streams are indicated by a cross and unburned streams are shown with a circle.

The only significant correlations between watershed scale variables and morphologic response variables were between watershed area and d50, width, cross-sectional area and wetted perimeter (Figure 9). Stream gradient was not significantly correlated with any variable. Percent watershed burned was not included as a variable because the many zero values in the unburned streams rendered scatterplot correlation analysis useless.

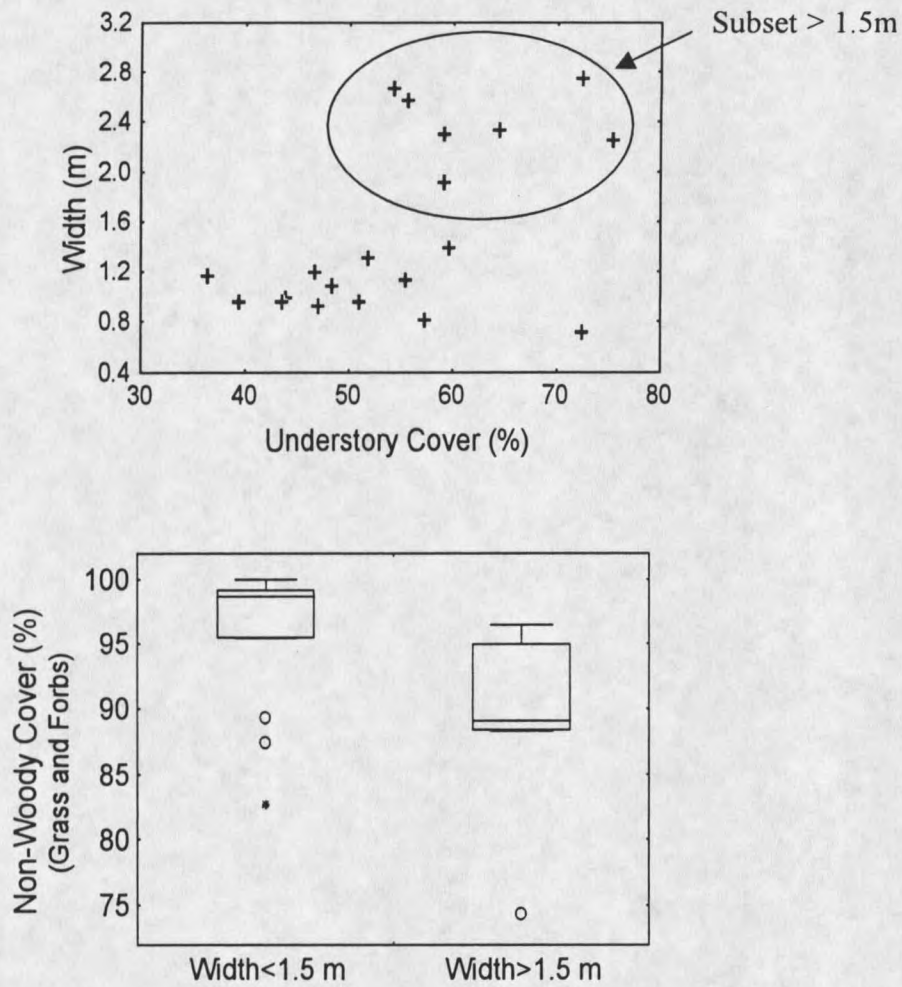
Figure 13. Scatterplot and boxplot of understory cover in streams from the burned Cache Creek watershed. Comparison indicates that non-woody cover (grass/forbs) is significantly less for streams with widths greater than 1.5m. P-value = 0.002, $\alpha = 0.05$

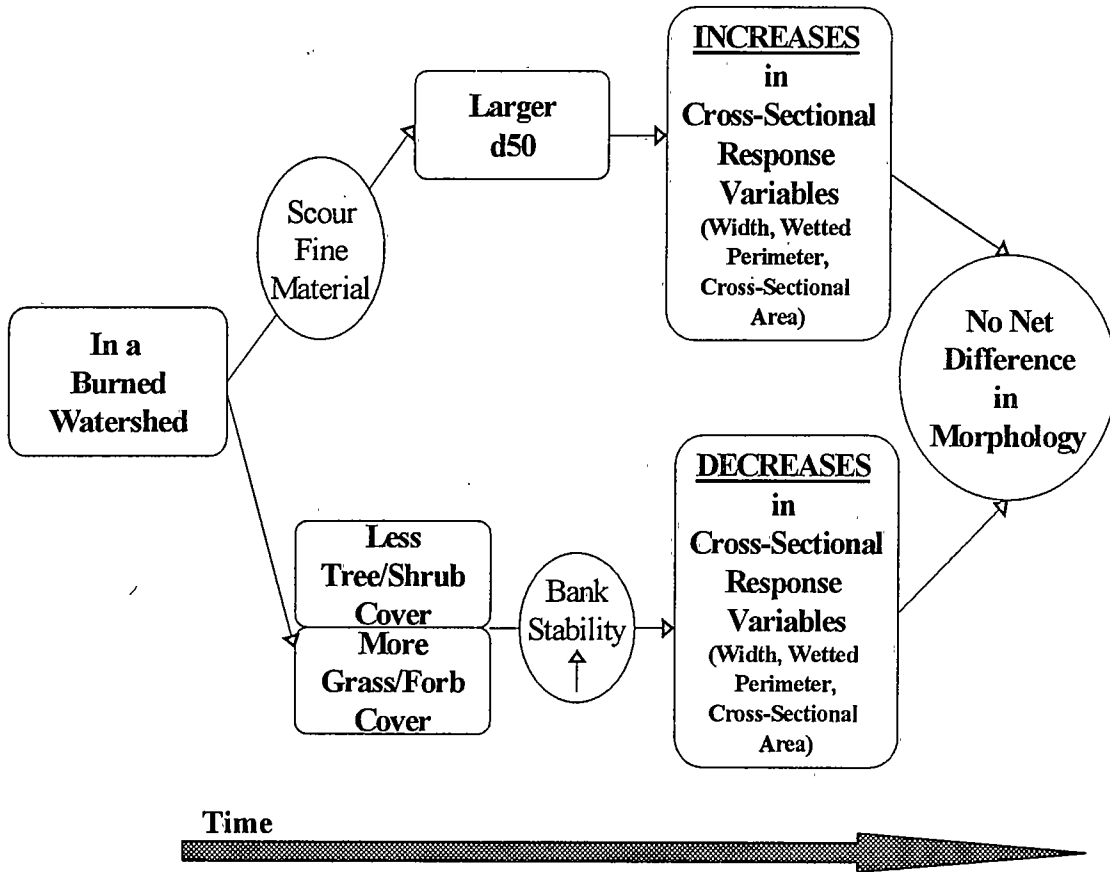
Figure 14. Schematic diagram representing relationships between a burned watershed, d50 and cross-sectional morphologic measurements and the same burned watershed, vegetative cover and cross-sectional morphologic measurements. These relationships operate in a counter-acting manner suggesting a reason that no differences are seen in stream morphology between burned and unburned streams.

Counter-acting processes may explain why no significant differences in stream morphology were detected between burned and unburned streams nine years after the fires (Figure 14). Immediately following the fires, fine-grained sediments enter the streams from burned areas and reduce median substrate size. Over time, this fine-grained material is excavated from the channel bottom leaving larger pebbles and cobbles. This larger substrate tends to promote increases in width, cross-sectional area and wetted perimeter. Initially, woody vegetation (trees and shrubs) are removed, but over time grass and forb cover is reestablished which stabilizes banks and decreases width, cross-sectional area and wetted perimeter. Therefore, larger median substrate sizes tend to promote increases in cross-sectional measurements, while greater amounts of grass and forb cover and less woody vegetation decrease cross-sectional variables. The net effect

of this combination of counter-acting relationships could cause morphologic characteristics of burned and unburned streams to appear similar nine years after the fires.
