THE EFFICACY OF BEAVER MIMICRY RESTORATION TECHNIQUES ON RIPARIAN  
VEGETATION VIGOR IN CENTRAL OREGON

A professional paper submitted in partial fulfillment  
of the requirements for the degree

MONTANA STATE UNIVERSITY  
Bozeman, Montana

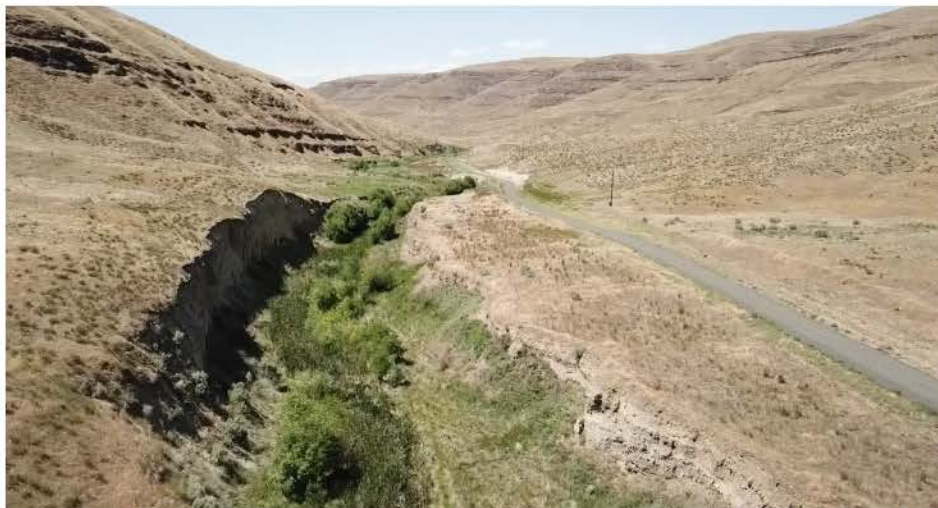
Figure 1. Drone aerial showing a narrow corridor of vegetation productivity along Hay Creek, an upper reach of the John Day River in Eastern Oregon. Photo by Allison Law.

Beaver habitat modifications, such as the construction of natural beaver dams, contributes to lower stream velocities, water impoundment, and flow resistance (Castro 2017). As a result, expanded water availability in riparian areas facilitates the growth of emergent vegetation, thus dominating pre-existing upland shrubs and trees. Furthermore, surface water flow into floodplains promotes the development of successional wetland communities. Micro- and macro-invertebrates benefit from boosted productivity in ponds and wetlands (Francis et al., 1985). In arid ecosystems, a narrow corridor of vegetation productivity occurs along streams (Figure 1) and supports a wide array of biodiversity and habitats (Fesenmyer et al., 2018).

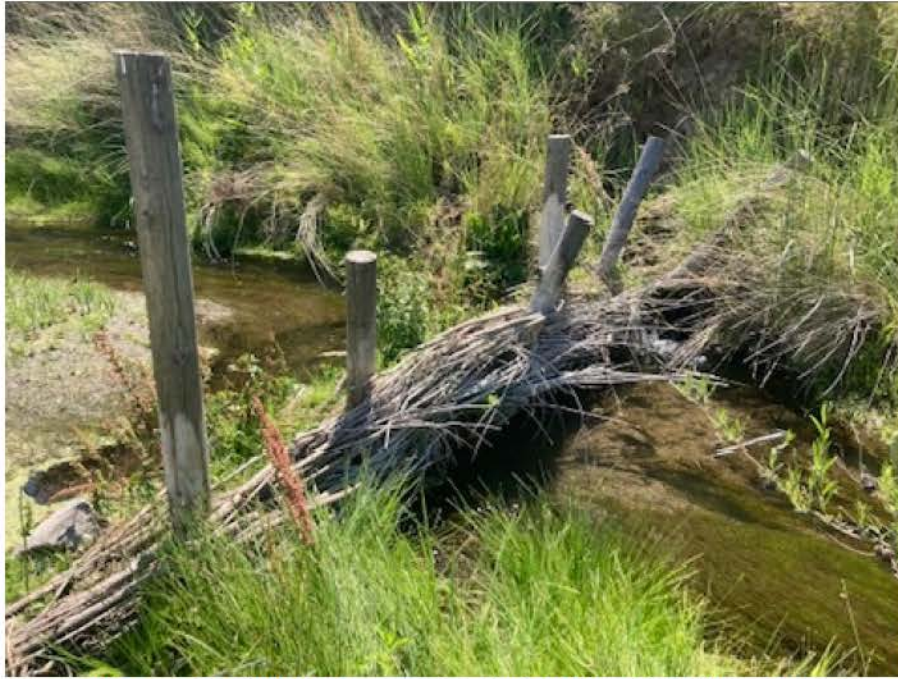
aiming to facilitate natural processes, using semi-porous wooden post structures traversing the stream channel to mimic a natural beaver dam (Figure 2.)

Figure 2. Typical BDA restoration design. Photo by Allison Law.

Castro et al. (2017) describe general recommendations for building BDA complexes comprised of a primary dam with additional structures downstream to decrease stress on the main dam to reduce the likelihood of failure in the event of peak flows. BDA complex structure is generally determined by stream gradient and geomorphology as dam failure is commonly associated with steeper gradients (Wheaton et al., 2019). Published protocols emphasize using willow branches, depending on availability, woven in between vertical wooden posts driven into the ground far enough to reduce the risk of structural failure. Additionally, fill material consisting of mud and vegetation is placed upstream and in between posts to facilitate water retention.

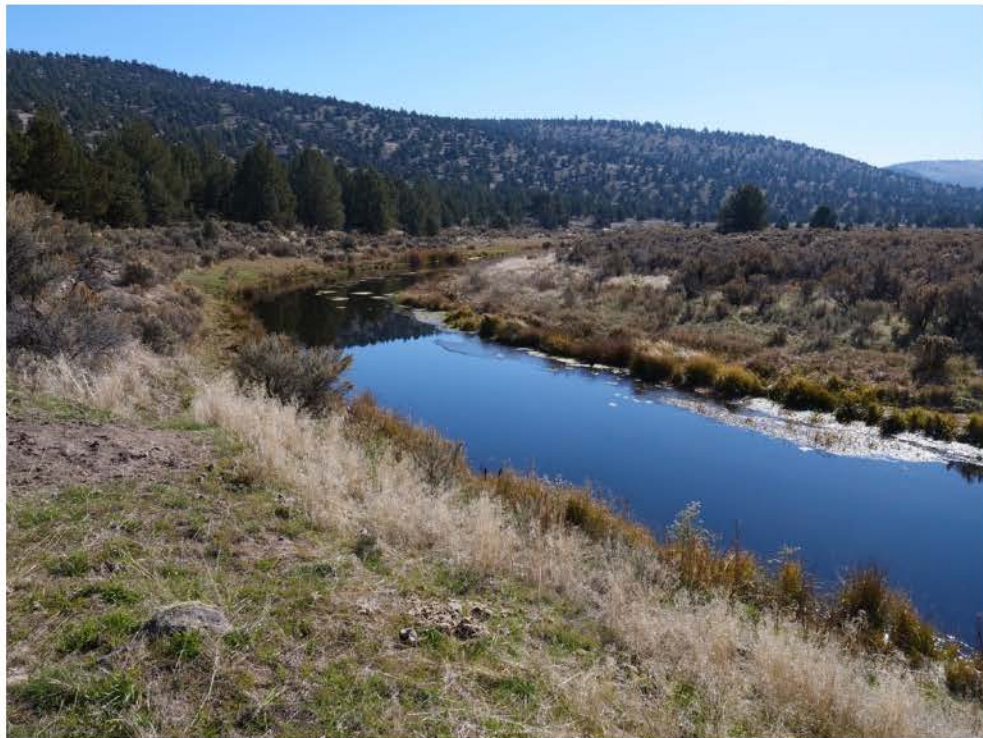
Figure 4. South Fork tributary of the Crooked River near Paulina, Oregon. Photo by Allison Law.

I chose sampling locations based on Orr et al. (2020) where pre-existing BDA restoration projects have occurred. This area of approximately 4,856,228 sq. meters in central Oregon (Figure 4) was purchased by a private landowner in 2003 with the intent of removing grazing and prioritizing conservation. Five BDAs were installed by Orr et al. (2020) and monitored during a one – to two-year period for sediment transportation, streambed aggradation, BDA structural integrity, water temperatures, and the response of restoration plantings in areas lacking woody vegetation.
