RESPONSE OF CHANNEL MORPHOLOGY AND RIPARIAN VEGETATION  
FOLLOWING RESTORATION AND LAND USE CHANGES,  
ADOBE CREEK, CALIFORNIA

A professional paper submitted in partial fulfillment  
of the requirements for the degree

Master of Science

Land Resources and Environmental Sciences

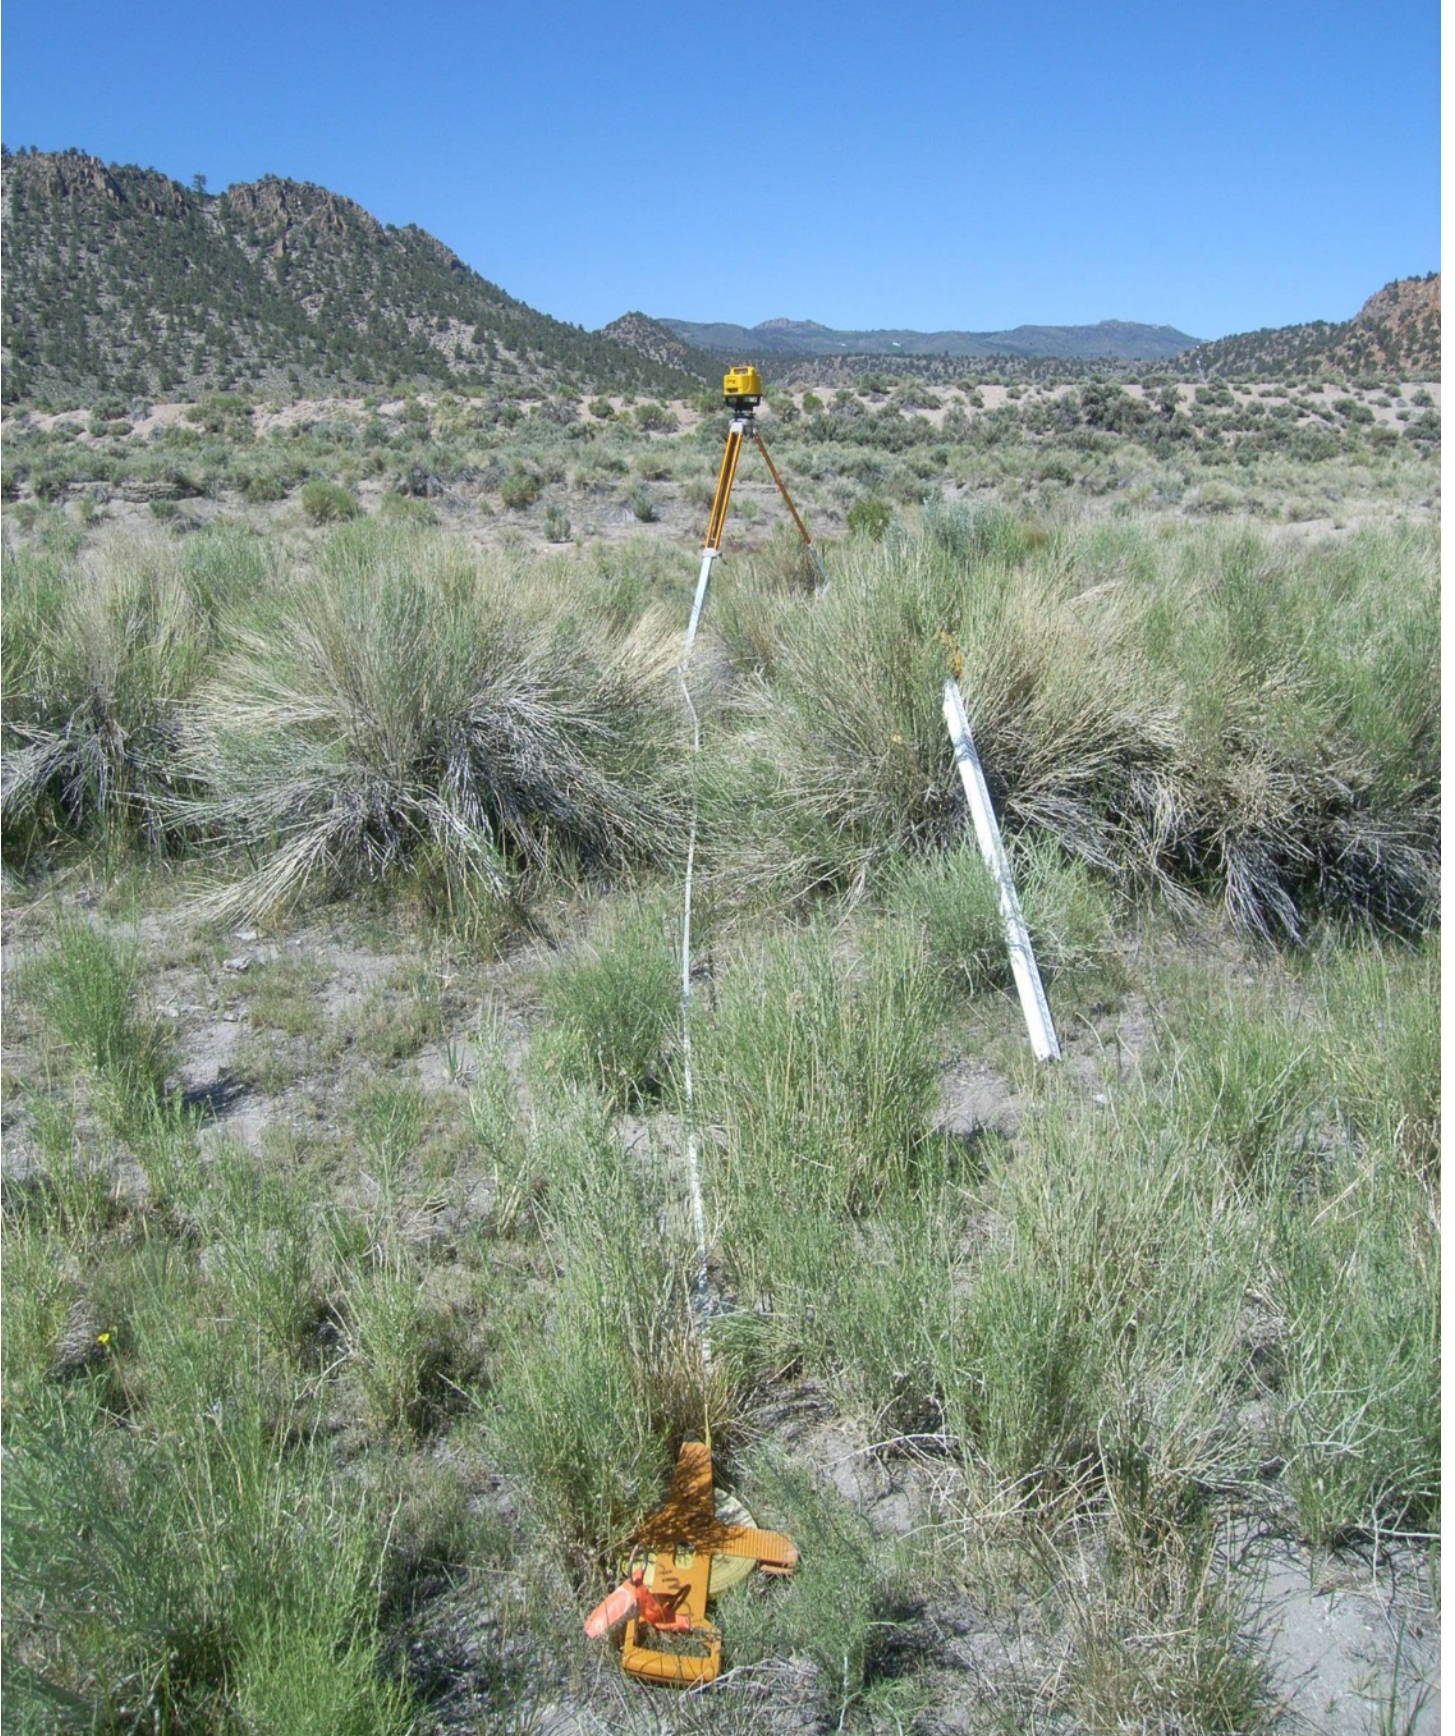
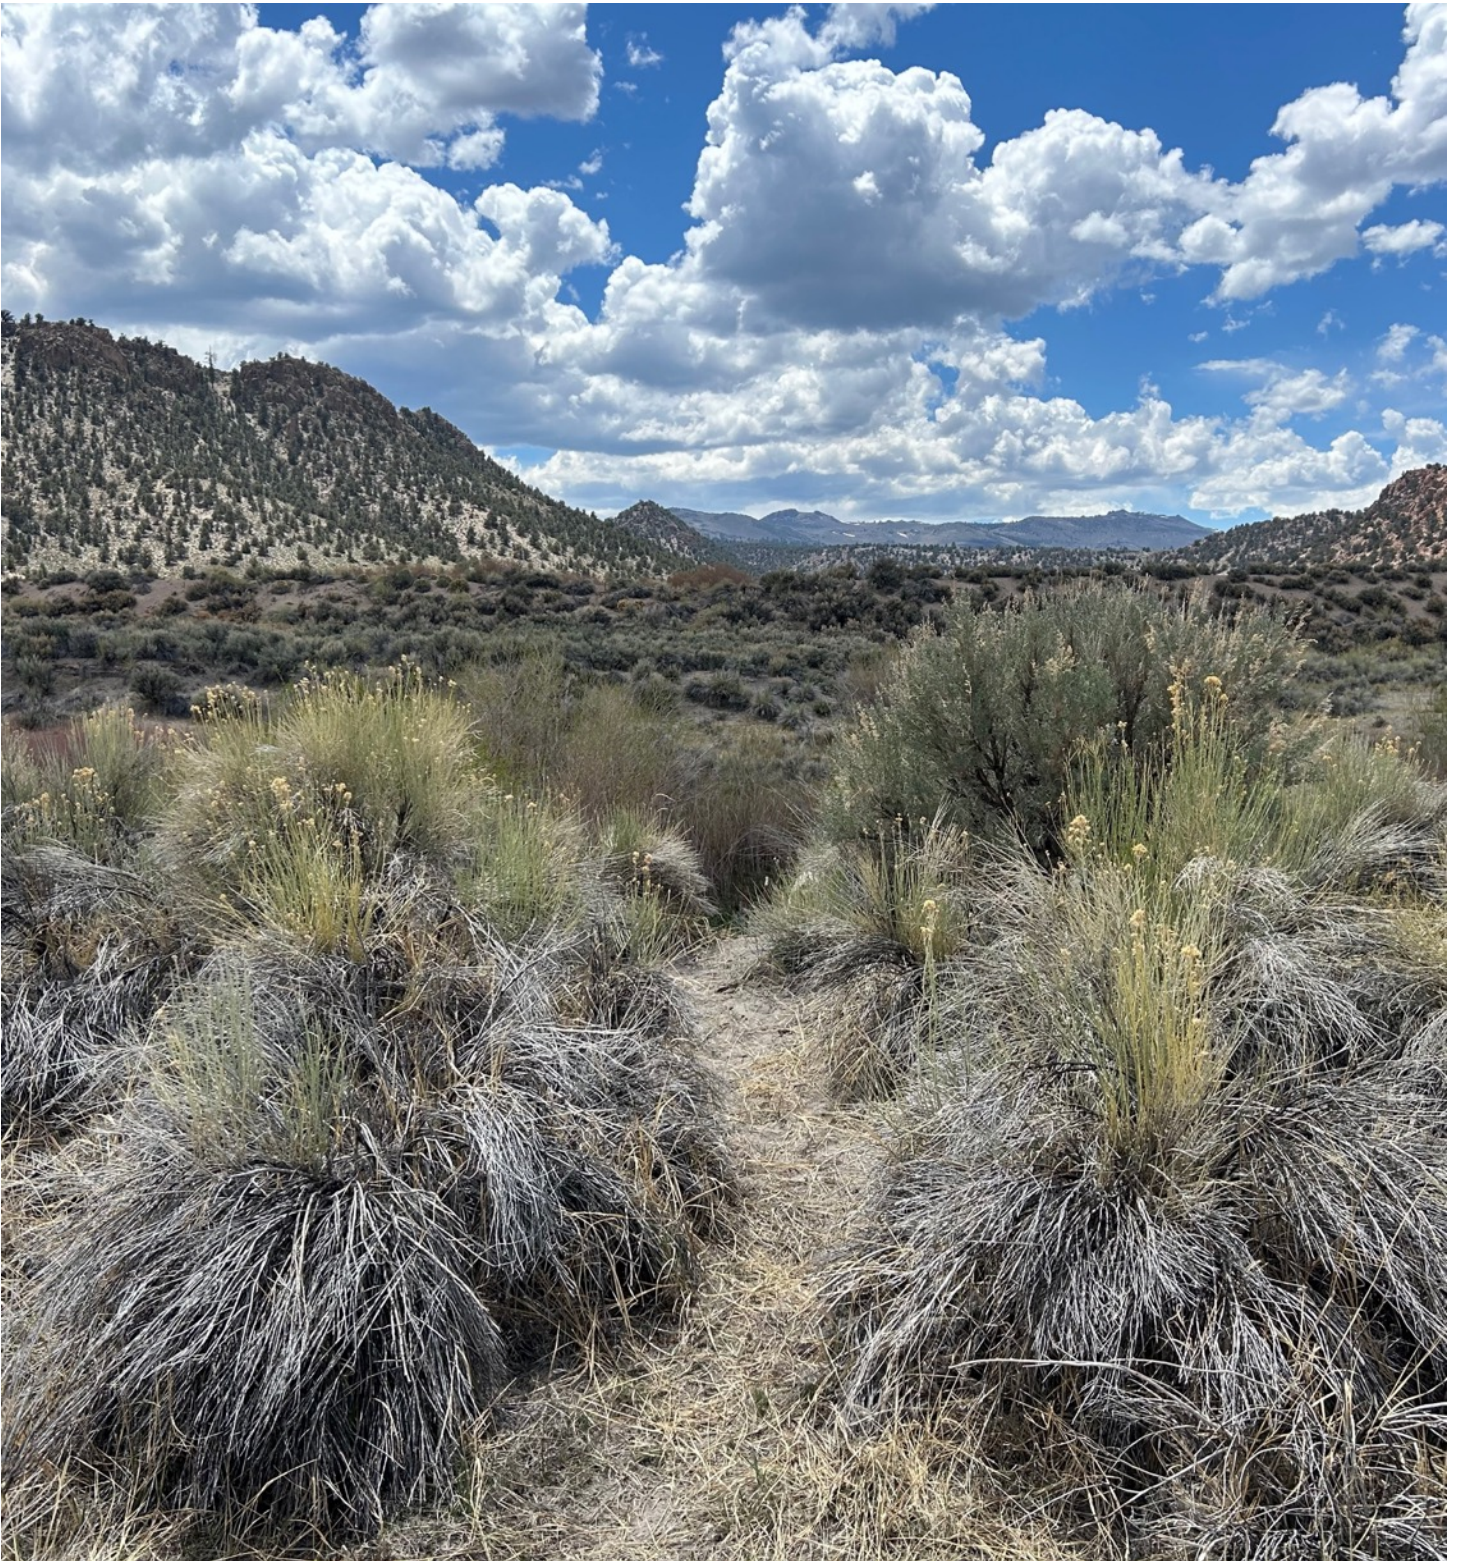
2011 - Cross-Section 1 - Right side of bank, top of slope

2024 - Cross-Section 1 - Right side of bank, top of slope

I compared available photos of Adobe Creek and the cross-sections to photos taken in 2024 (Appendix A). There are photos from 2006 and 2007, taken during the restoration, both physical and land use change, which are focused near the site of the stream breaching the dam. The cross-section photos from 2011 occur after physical restoration and grazing management had been implemented for several years. As such, the photos do not represent pre-restoration conditions; however, the evidence of vegetative change is dramatic.

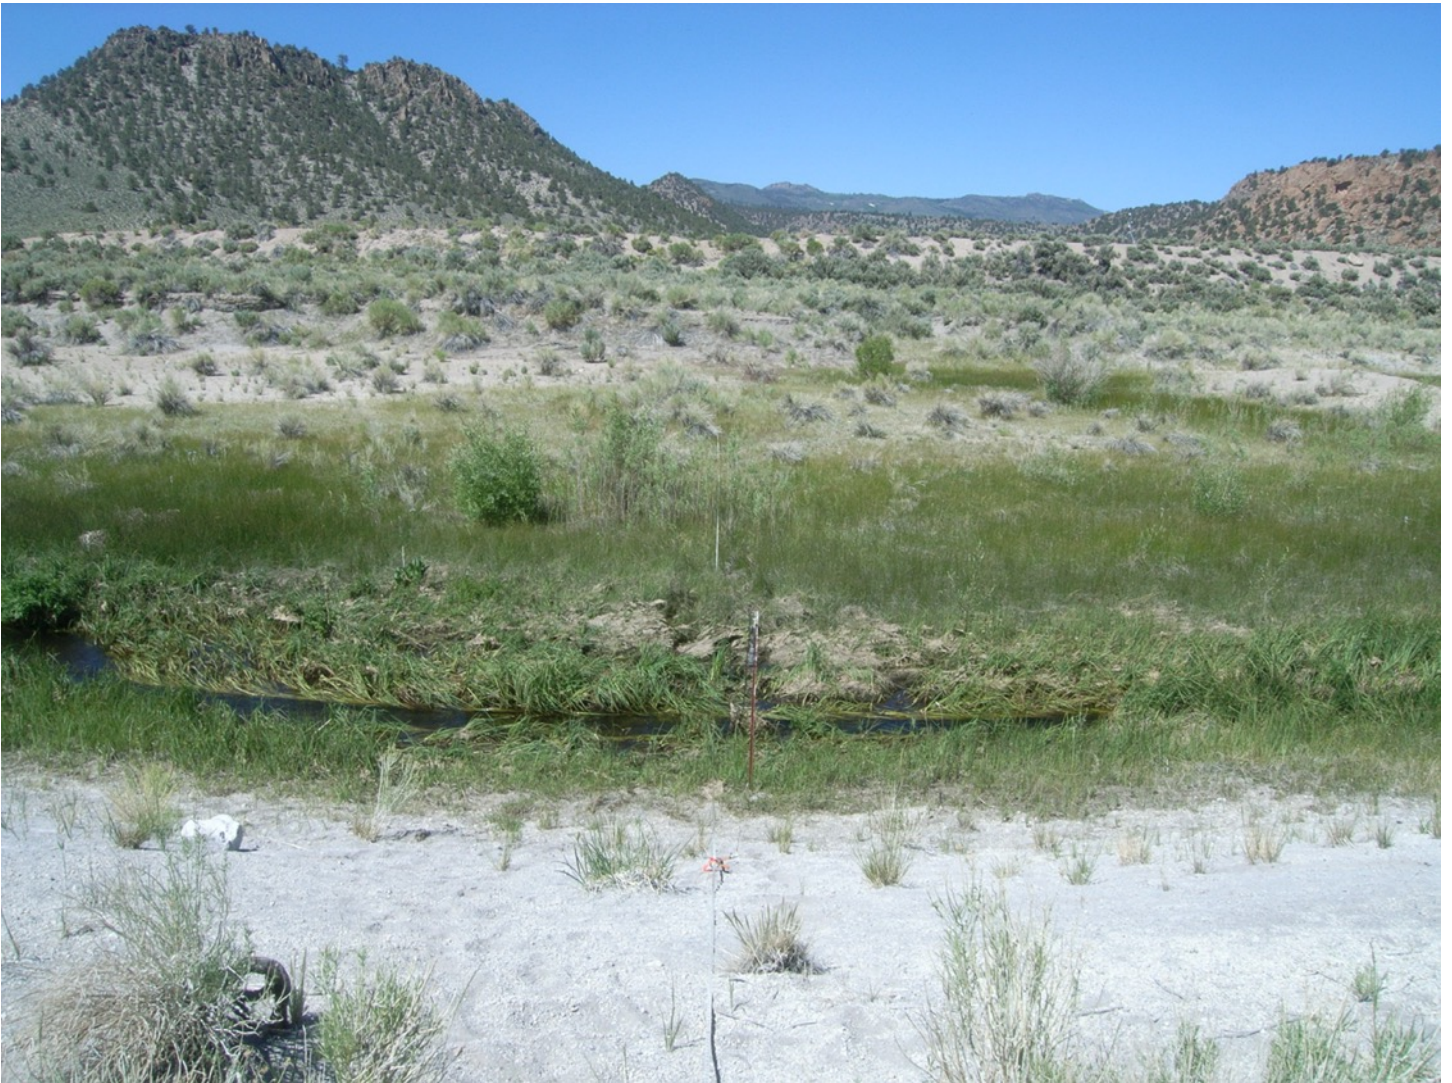
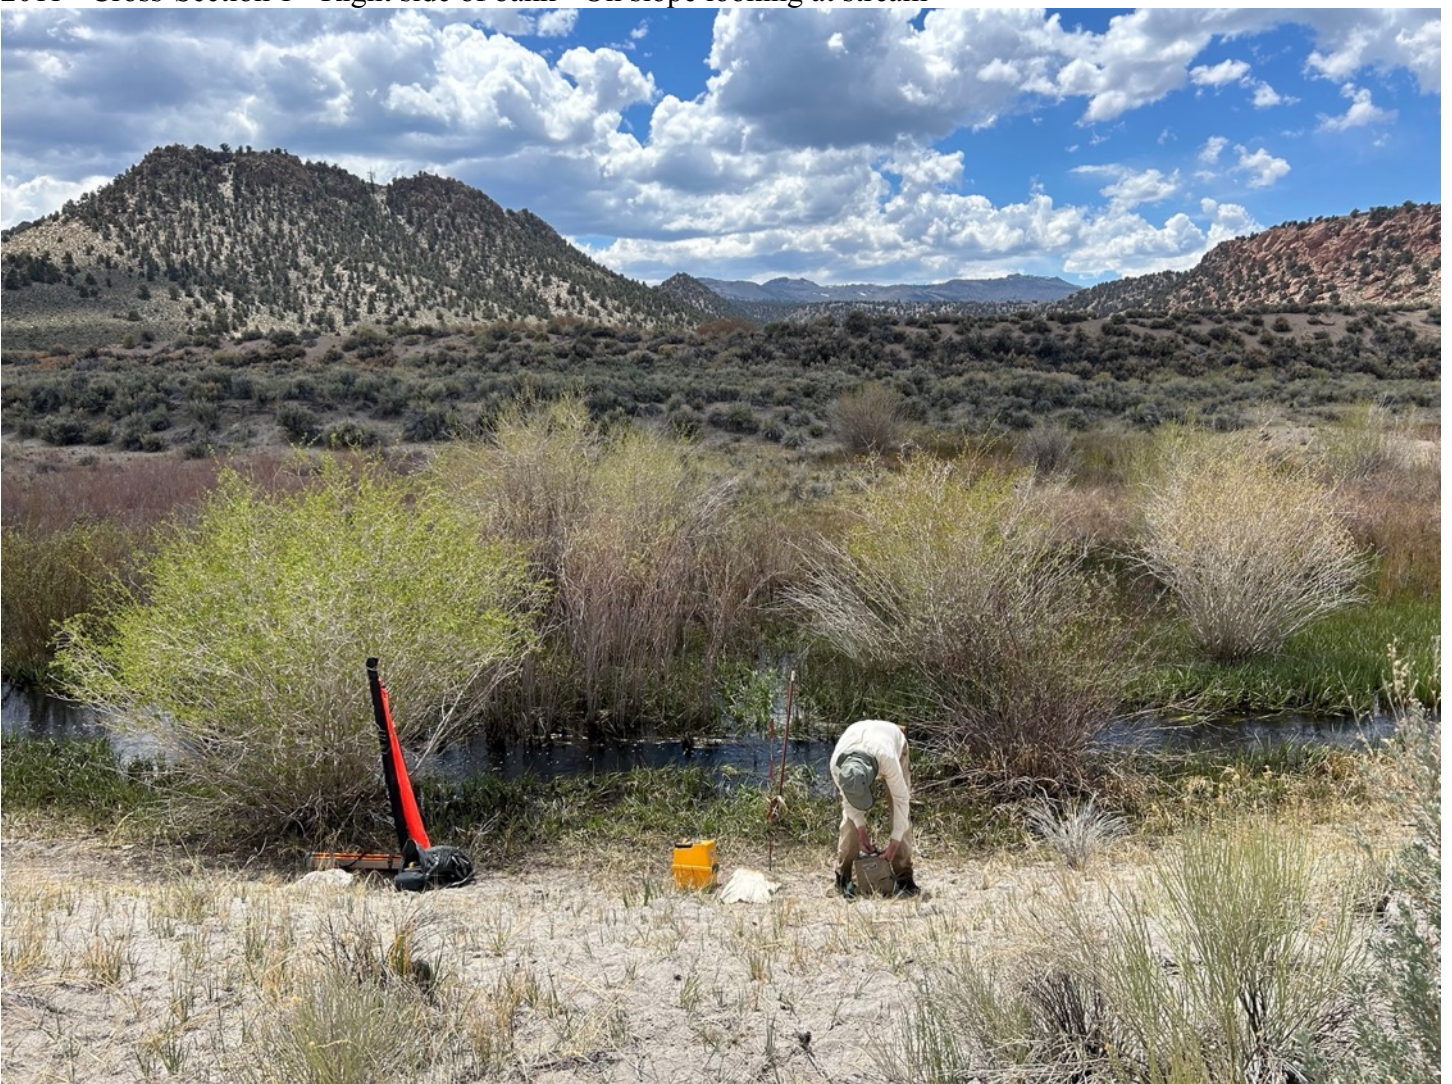
2011 - Cross-Section 1 - Right side of bank - On slope looking at stream

2024 - Cross-Section 1 - Right side of bank - On slope looking at stream

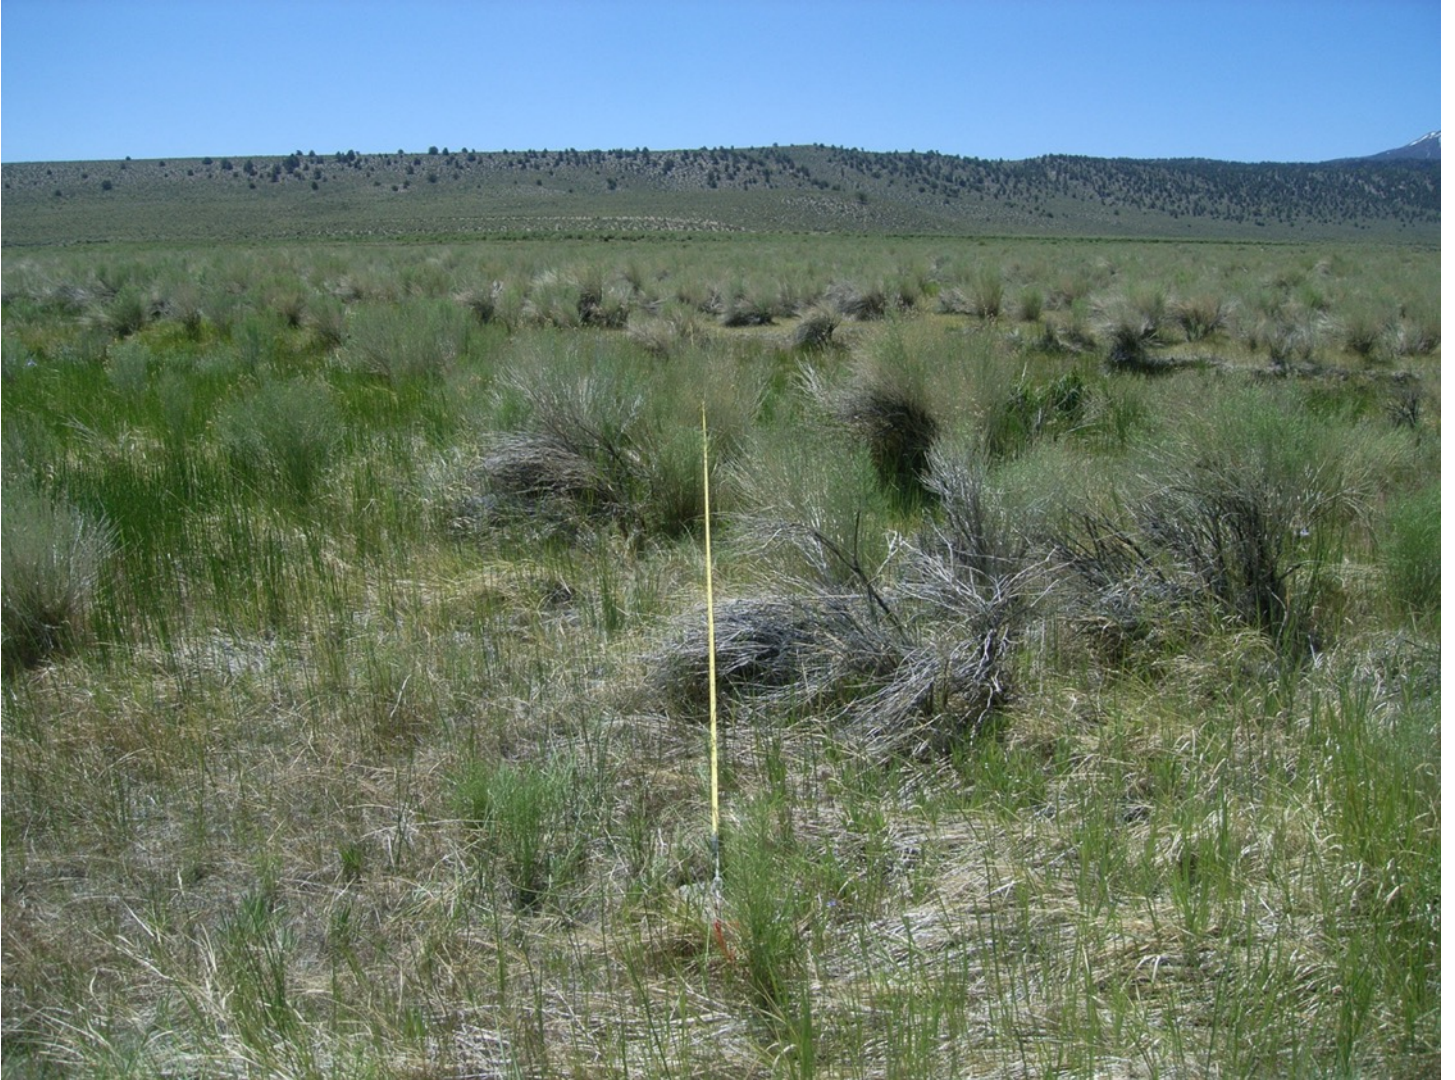
2011 - Cross-Section 2 - Left side of bank

2024 - Cross-Section 2 - Left side of bank

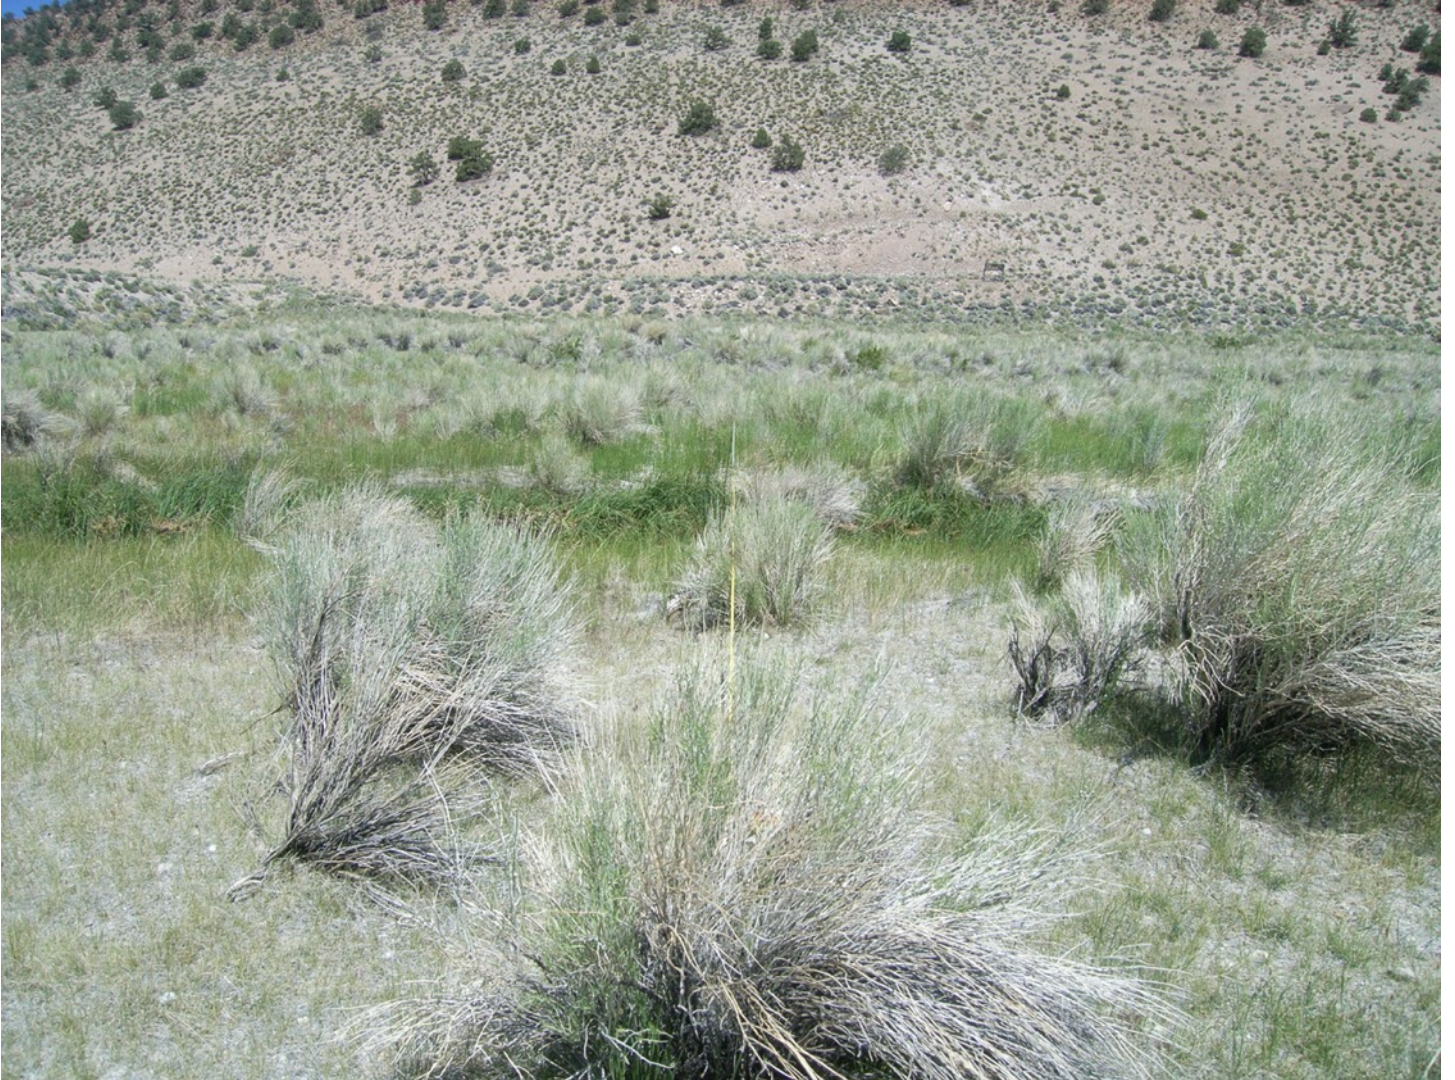
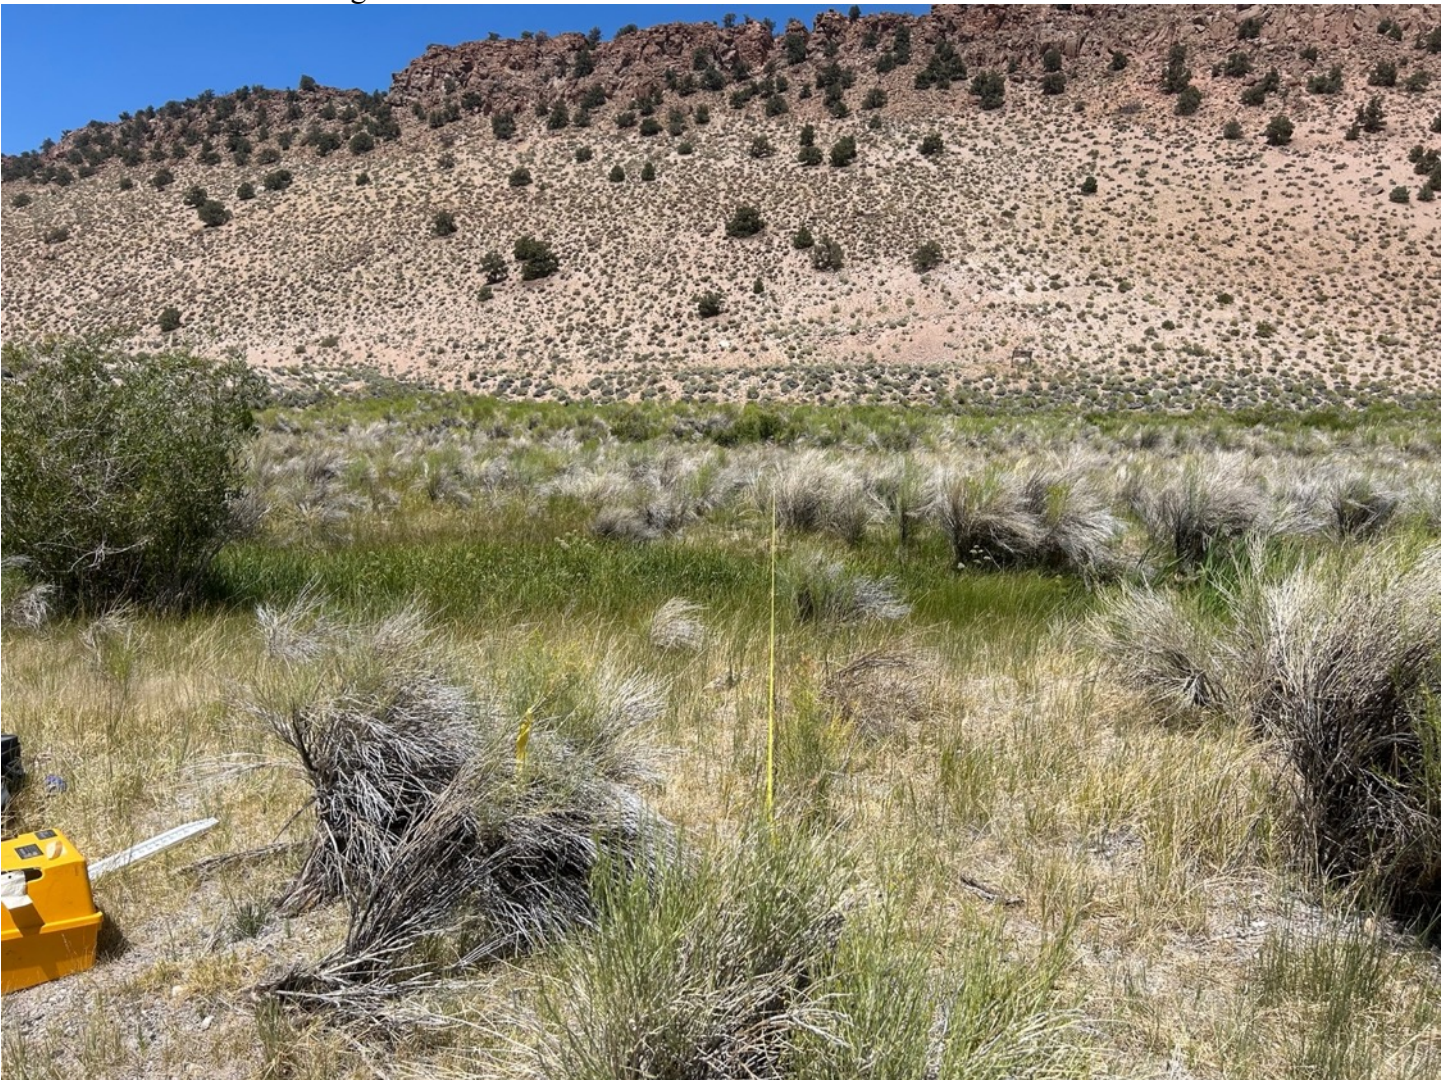
2011 - Cross-Section 2 - Right side of bank

2024 - Cross-Section 2 - Right side of bank

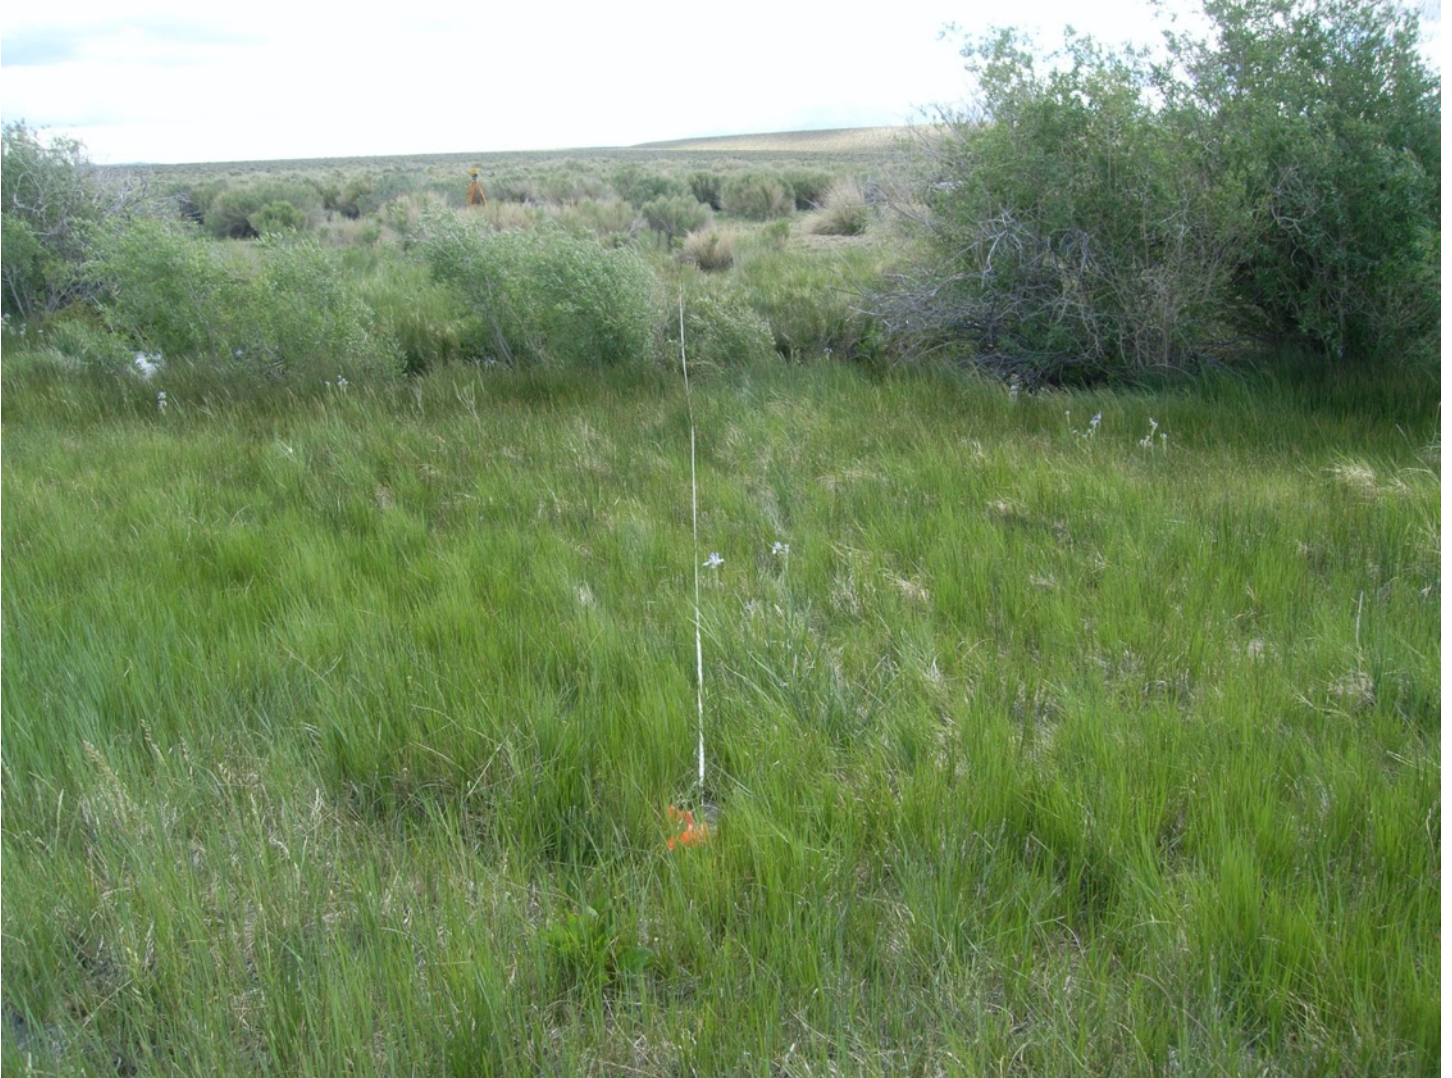
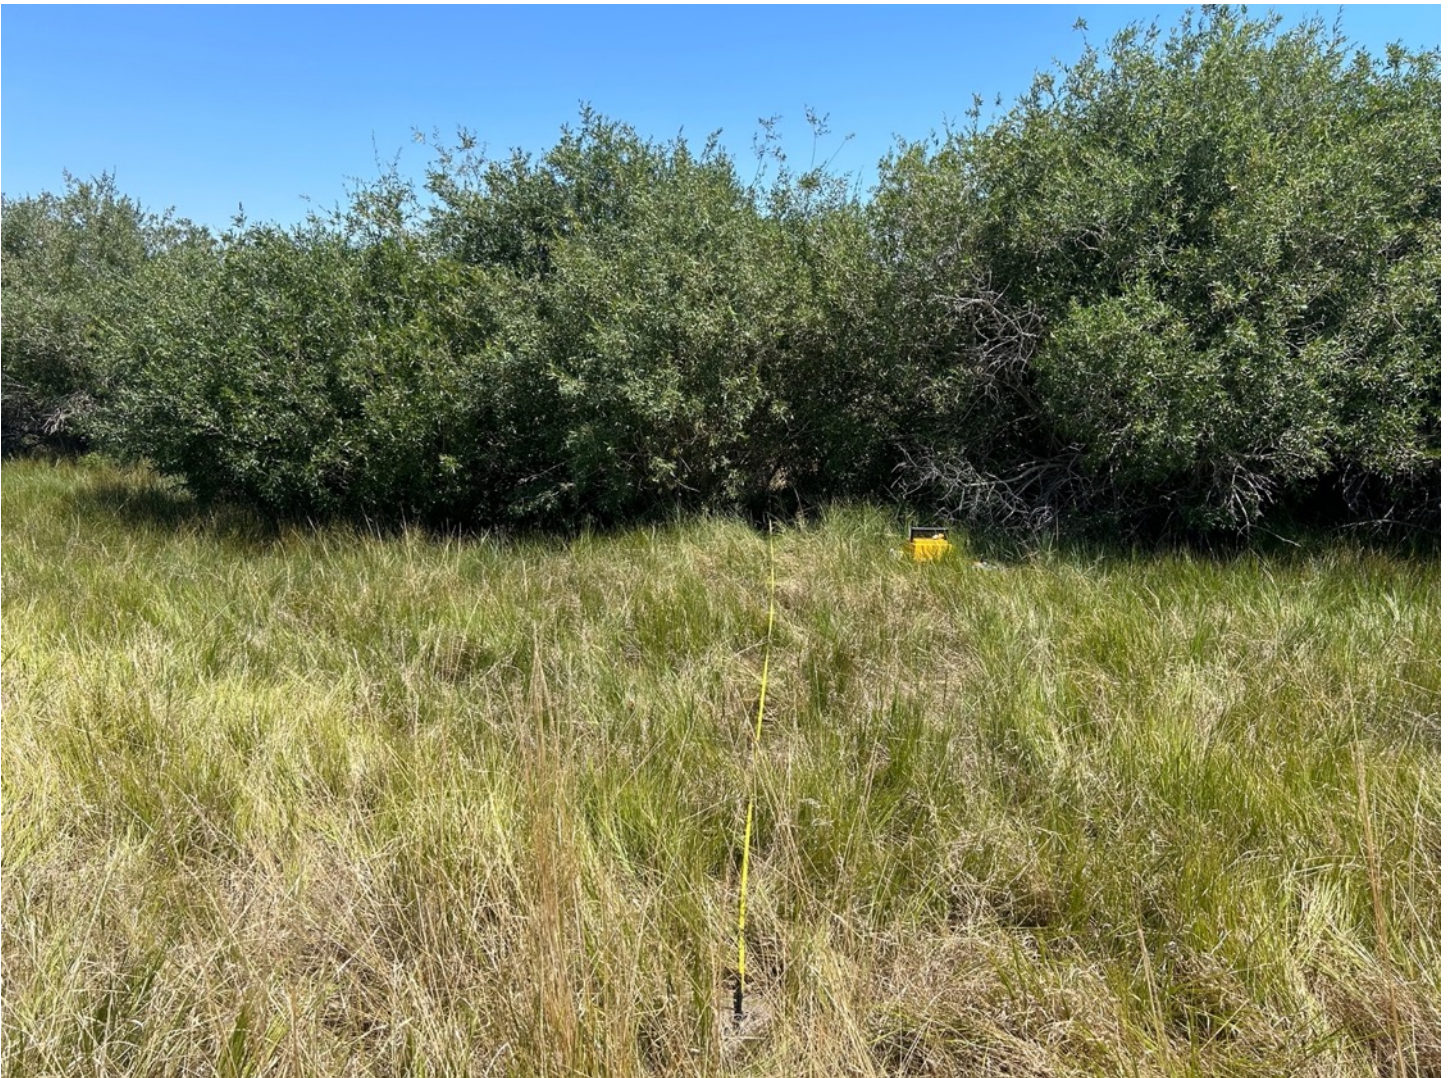
2011 - Cross-Section 3 - Left side of bank

2024 - Cross-Section 3 - Left side of bank

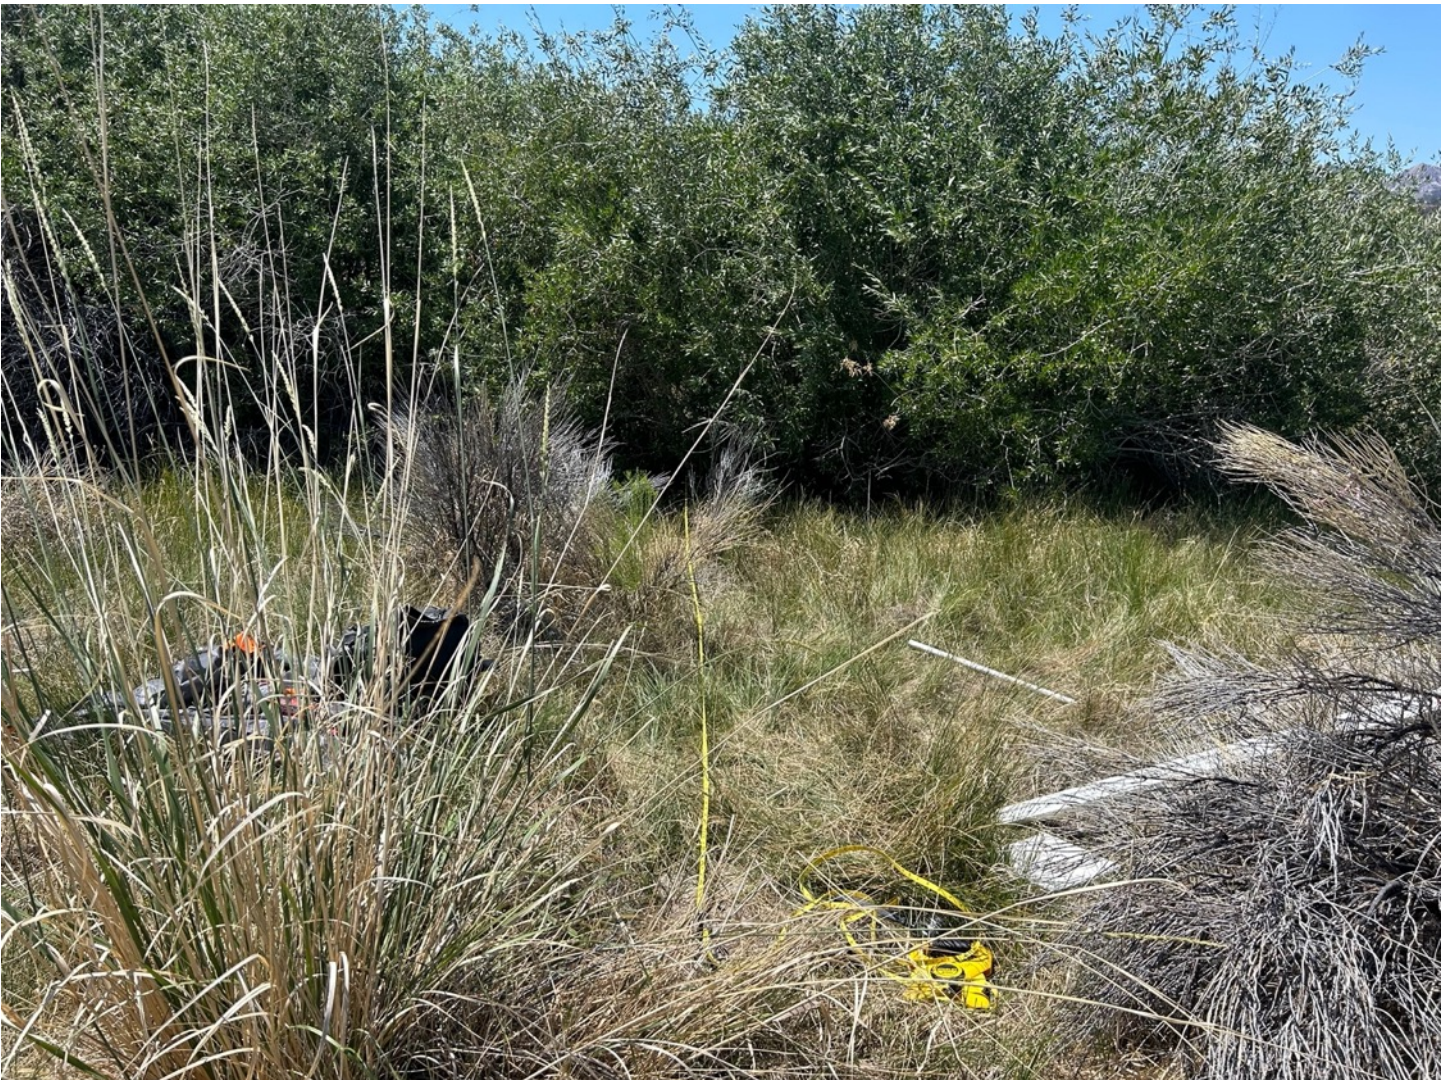
2011 - Cross-Section 3 - Right side of bank

2024 - Cross-Section 3 - Right side of bank

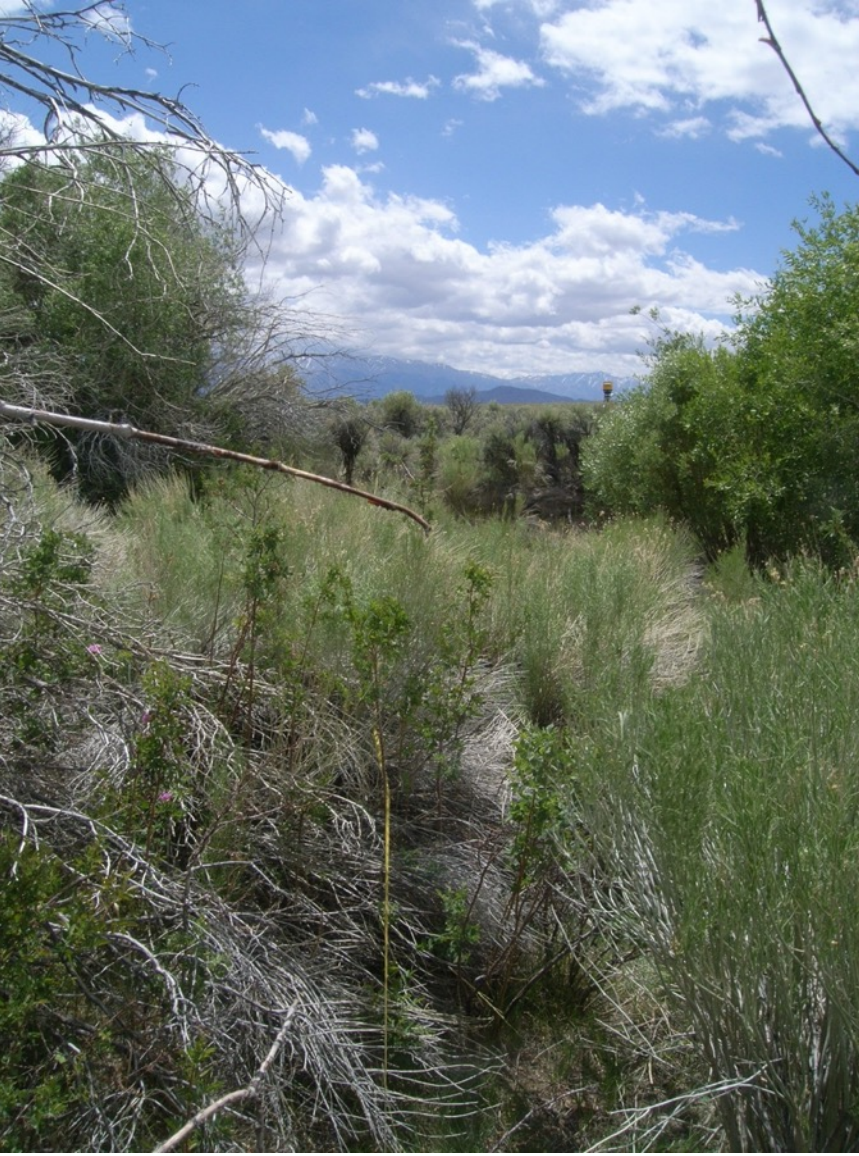
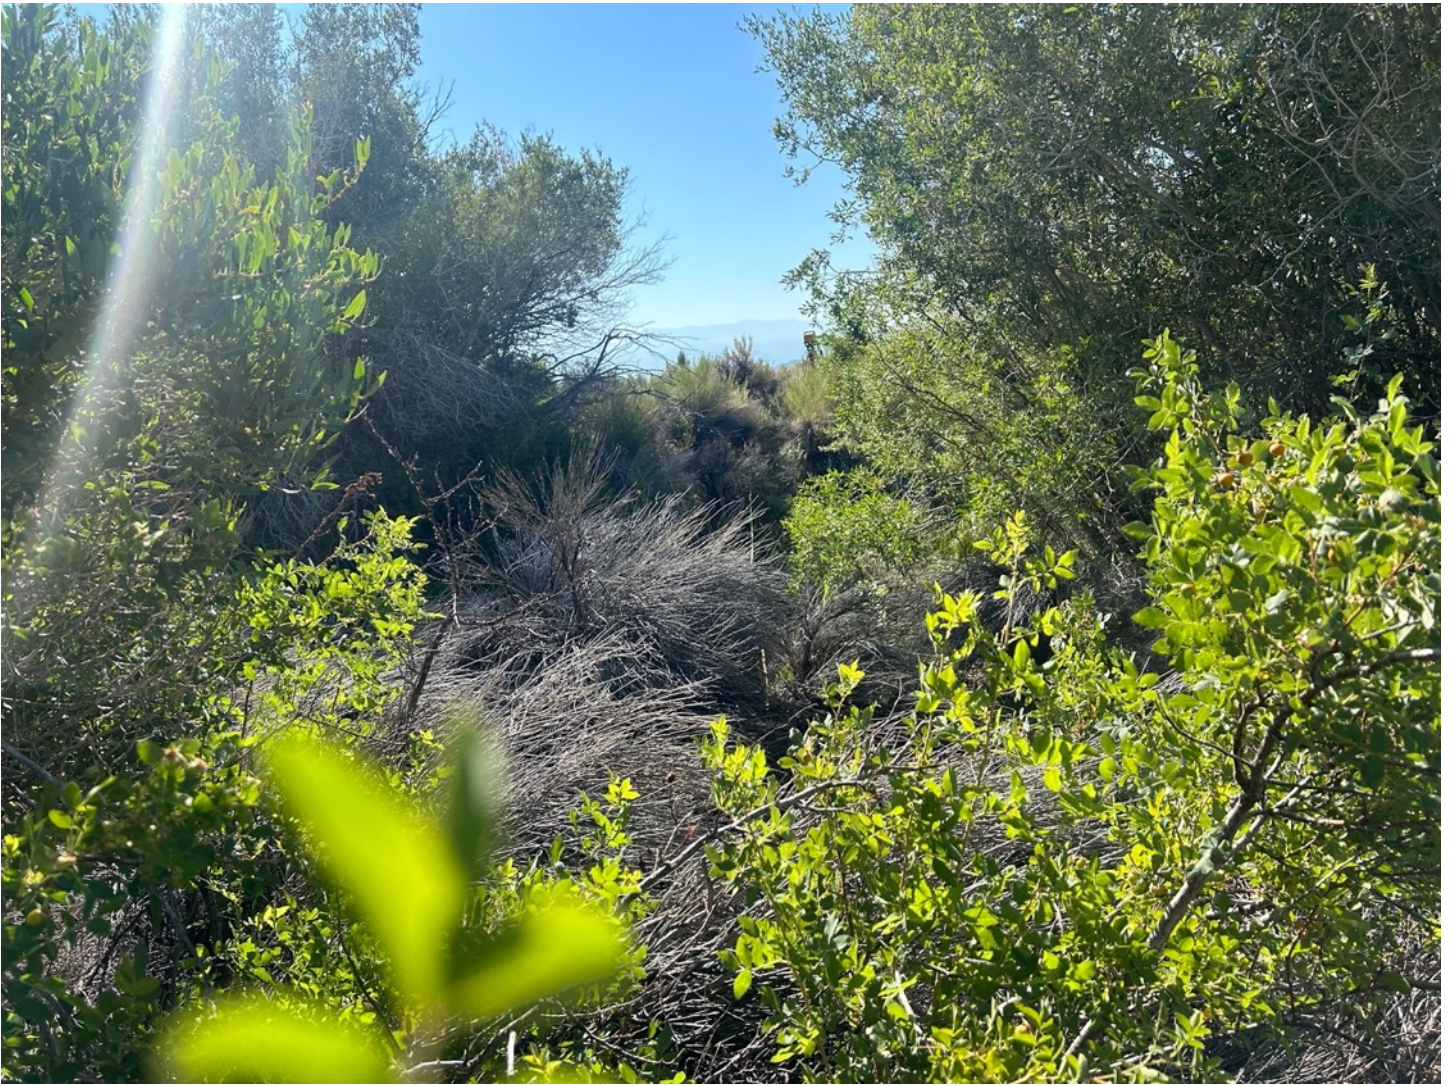
2011 - Cross-Section 4 - Left side of bank

2024 - Cross-Section 4 - Left side of bank

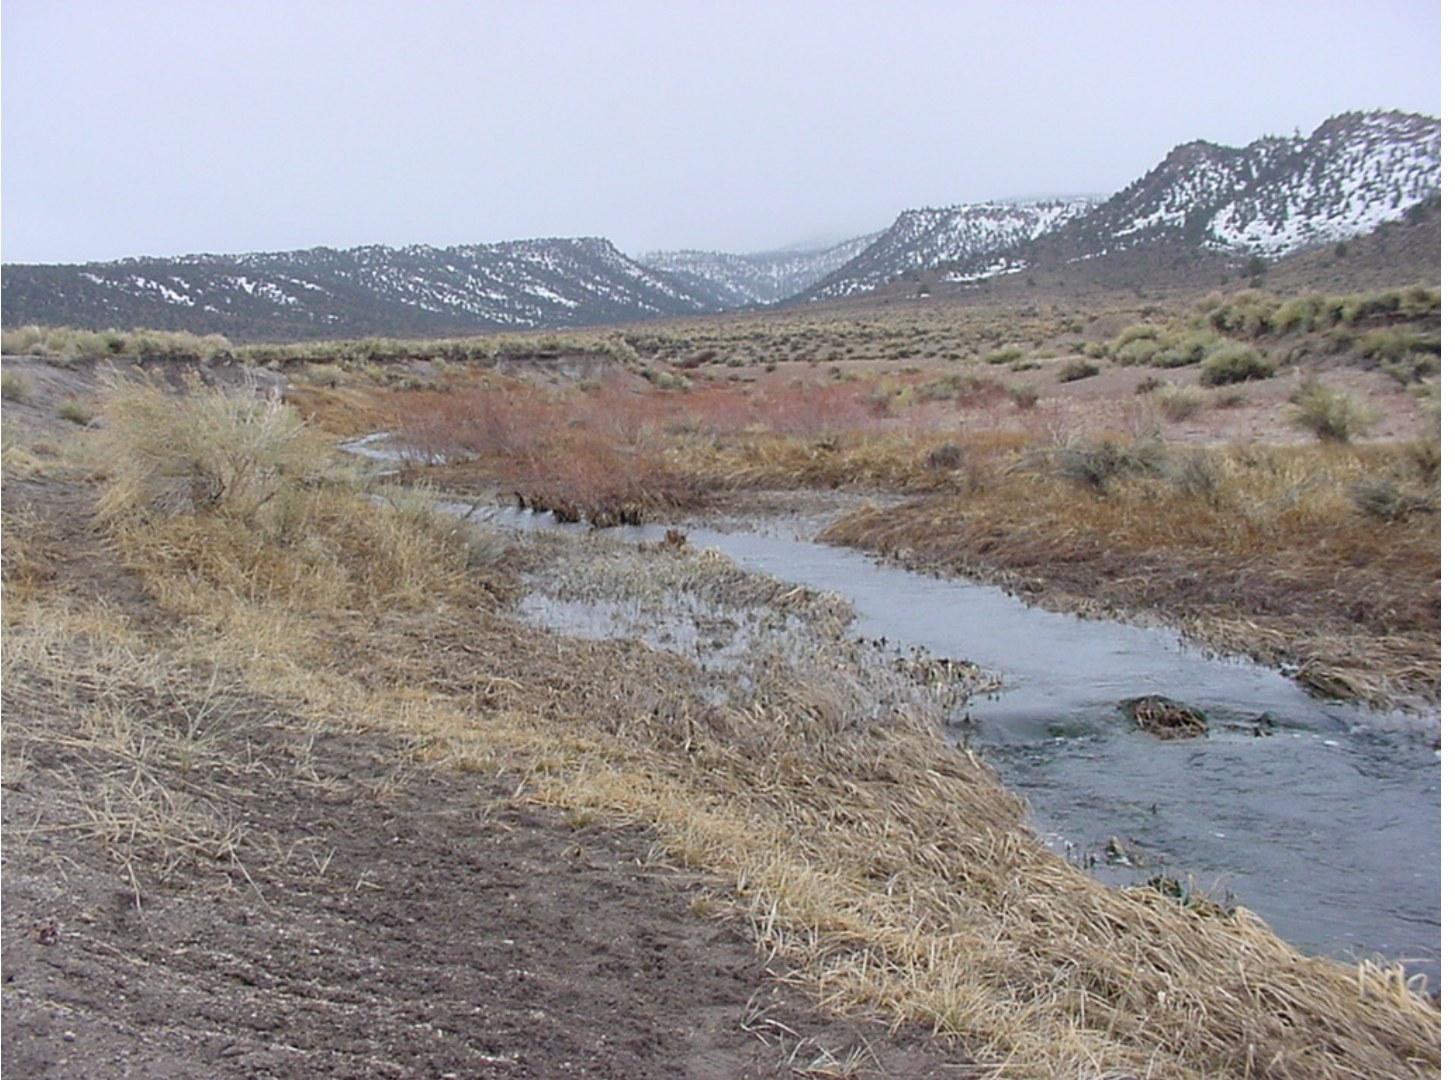
2006 – Slightly upstream from cross section 1 – Right side of bank, looking upstream and at Taylor Canyon with Glass Mountain (covered in cloud) in the background.

While this is an observational study with no statistical analysis, all the photo comparisons indicate an increase in the woody riparian vegetation across all stream reaches. The height and bulk of *Salix spp.* (willow) increased in all the photo comparisons, specifically those directly adjacent to and in the stream channels. With the removal of grazing pressure from cattle, studies found an increase in vegetation cover (including woody vegetation), as well as bank stability (Kauffman and Krueger 1984). Woody riparian vegetation was particularly connected to improvements in channel form and ecological conditions (Magilligan and McDowell 1997). A literature review found that channels that have vegetated banks are narrower and deeper compared to those that did not have vegetation on the banks, and, additionally, the reviewed studies found that the removal of riparian vegetation increased channel width and decreased depth (Opperman and Merenlender 2004). At Maggie Creek in Nevada, it was found that riparian vegetation likely was the source of streambank stabilization.
