RESPONSE OF CHANNEL MORPHOLOGY AND RIPARIAN VEGETATION  
FOLLOWING RESTORATION AND LAND USE CHANGES,  
ADOBE CREEK, CALIFORNIA

A professional paper submitted in partial fulfillment  
of the requirements for the degree

Master of Science

Land Resources and Environmental Sciences

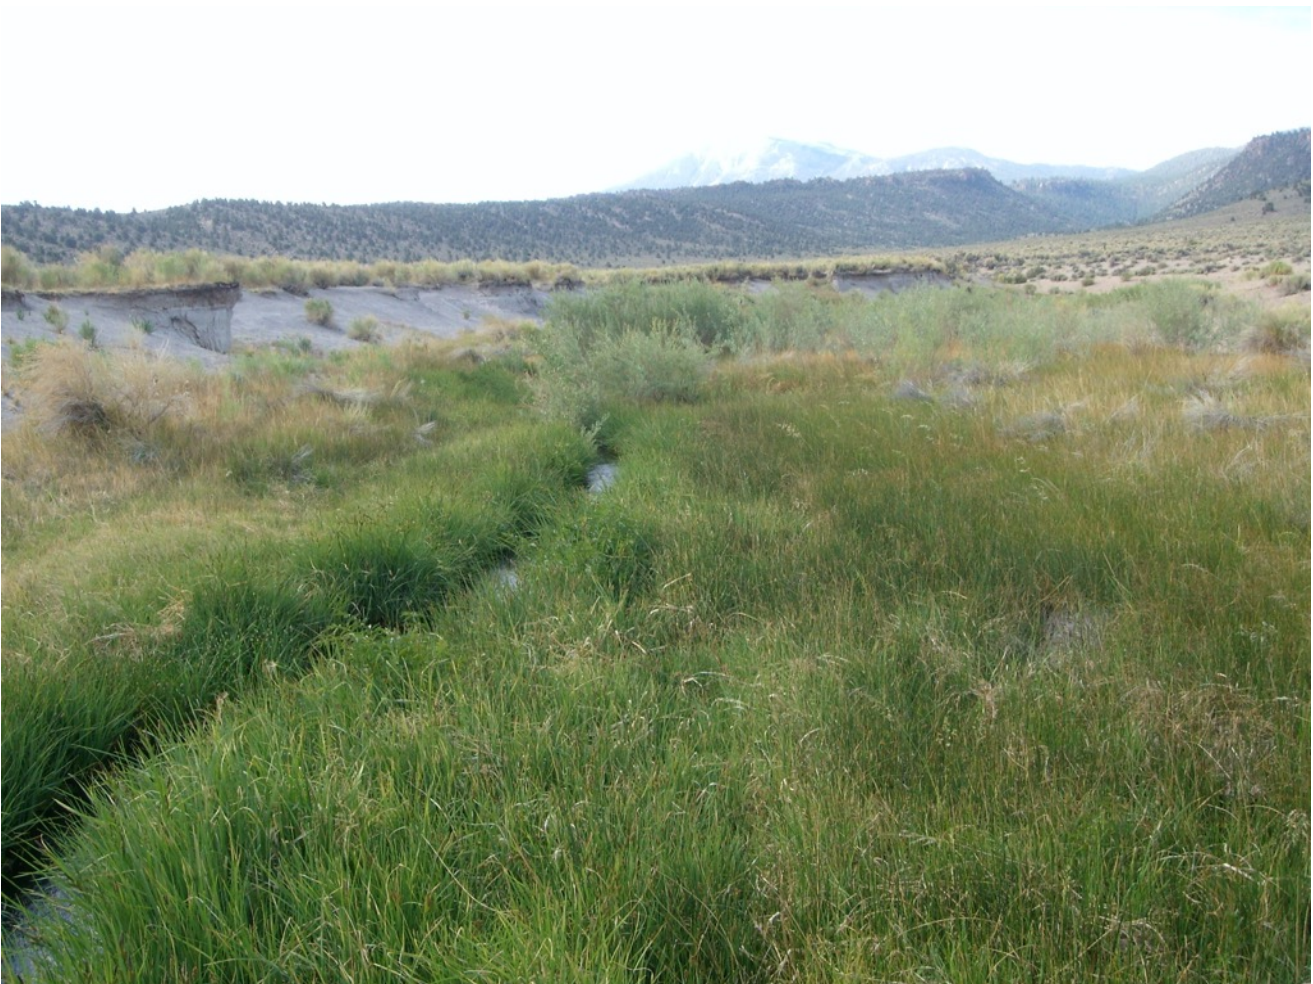
2007 - Slightly upstream from cross section 1 – Left side of bank, looking upstream and at Taylor Canyon with Glass Mountain in the background.

While this is an observational study with no statistical analysis, all the photo comparisons indicate an increase in the woody riparian vegetation across all stream reaches. The height and bulk of *Salix spp.* (willow) increased in all the photo comparisons, specifically those directly adjacent to and in the stream channels. With the removal of grazing pressure from cattle, studies found an increase in vegetation cover (including woody vegetation), as well as bank stability (Kauffman and Krueger 1984). Woody riparian vegetation was particularly connected to improvements in channel form and ecological conditions (Magilligan and McDowell 1997). A literature review found that channels that have vegetated banks are narrower and deeper compared to those that did not have vegetation on the banks, and, additionally, the reviewed studies found that the removal of riparian vegetation increased channel width and decreased depth (Opperman and Merenlender 2004). At Maggie Creek in Nevada, it was found that riparian vegetation likely was the source of streambank stabilization.

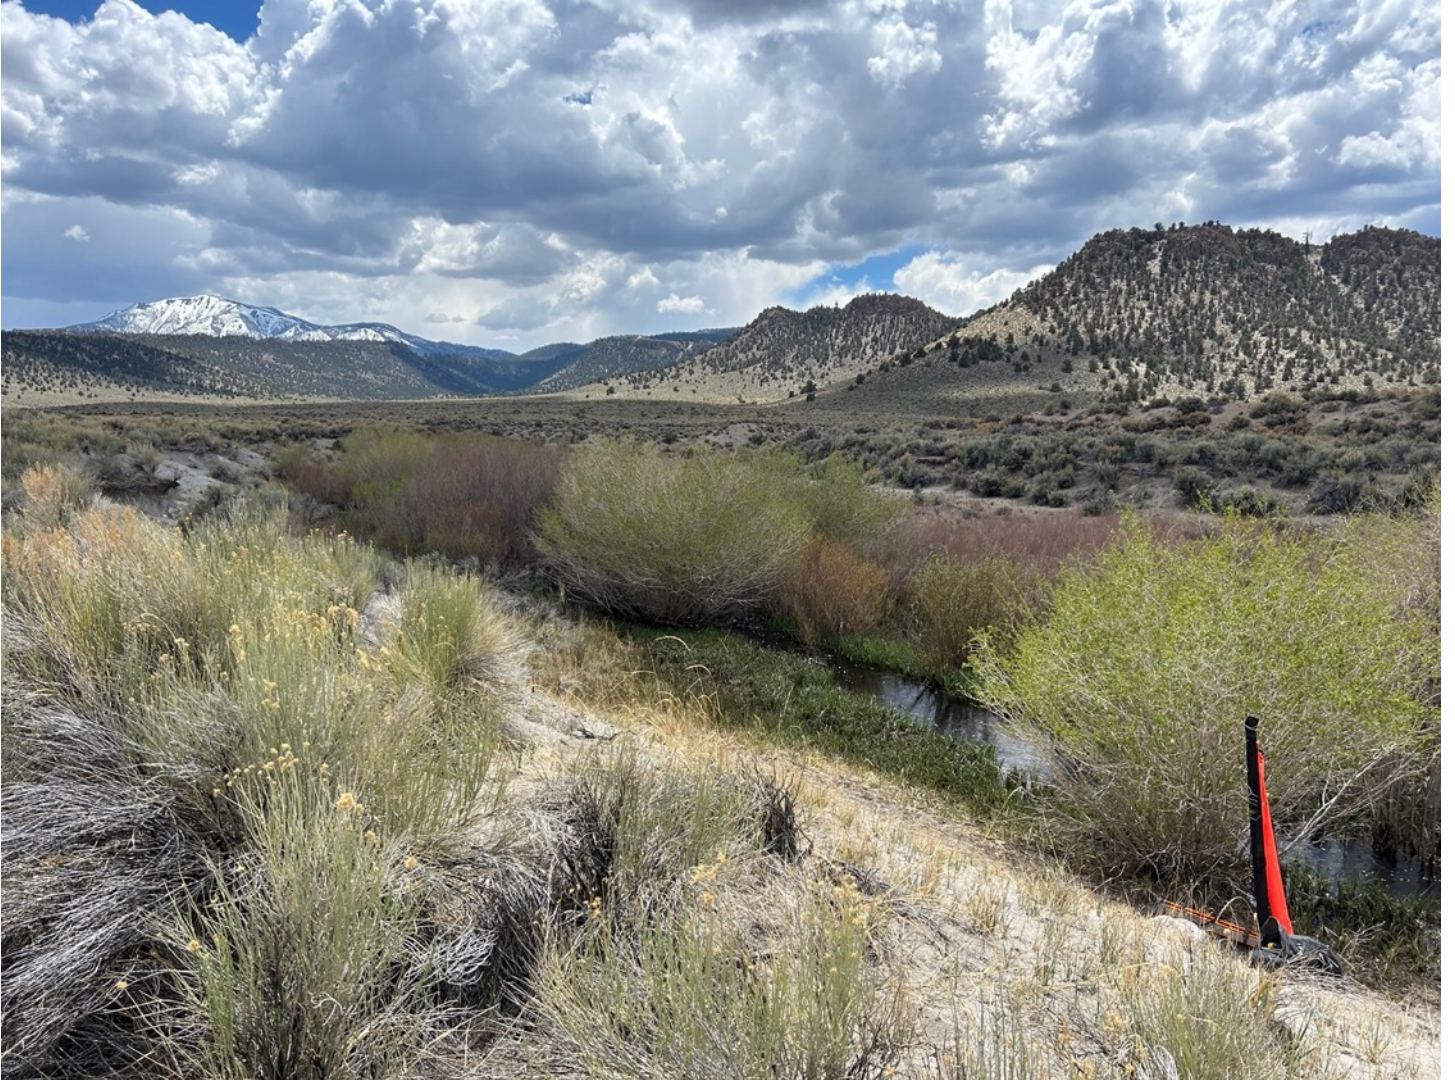
2024 – Cross section 1 – Right side of bank, looking upstream and at Glass Mountain.

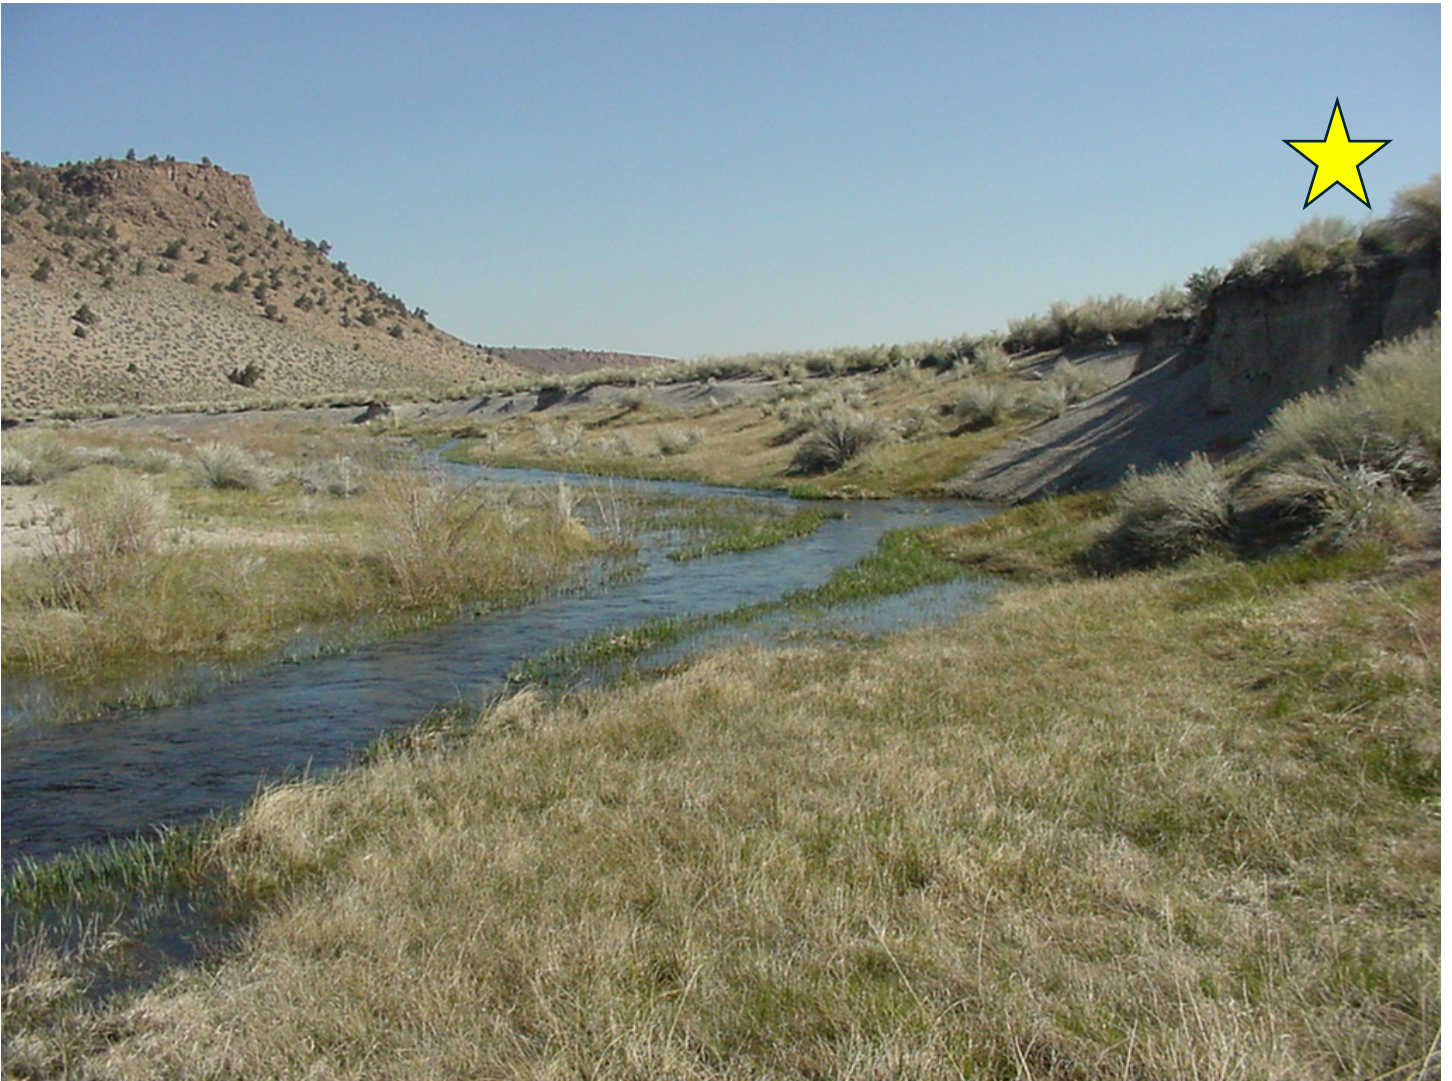
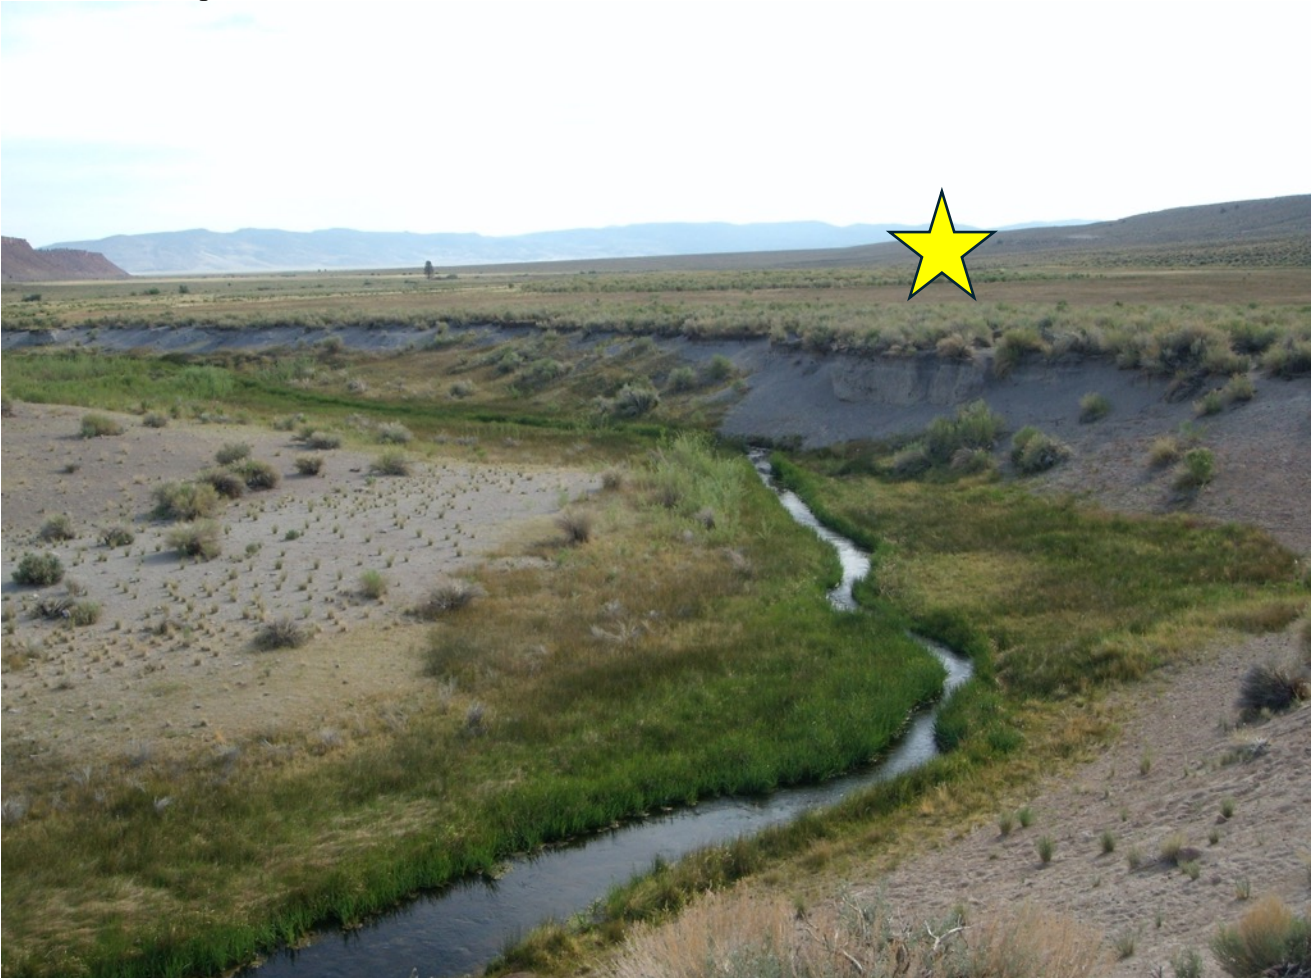
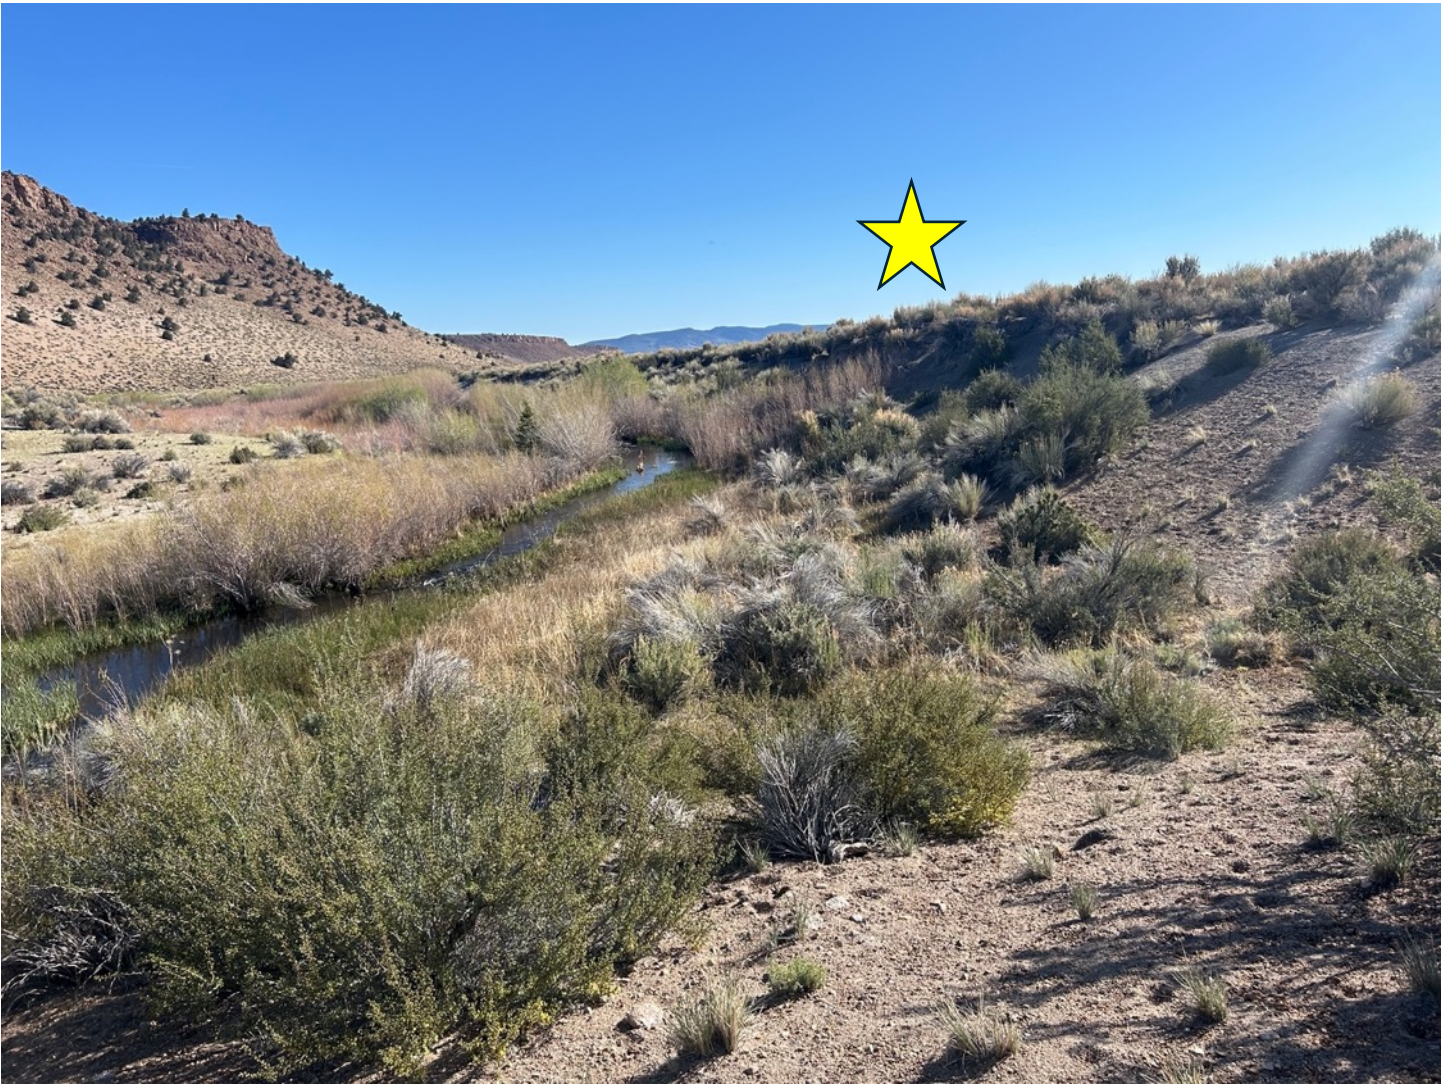
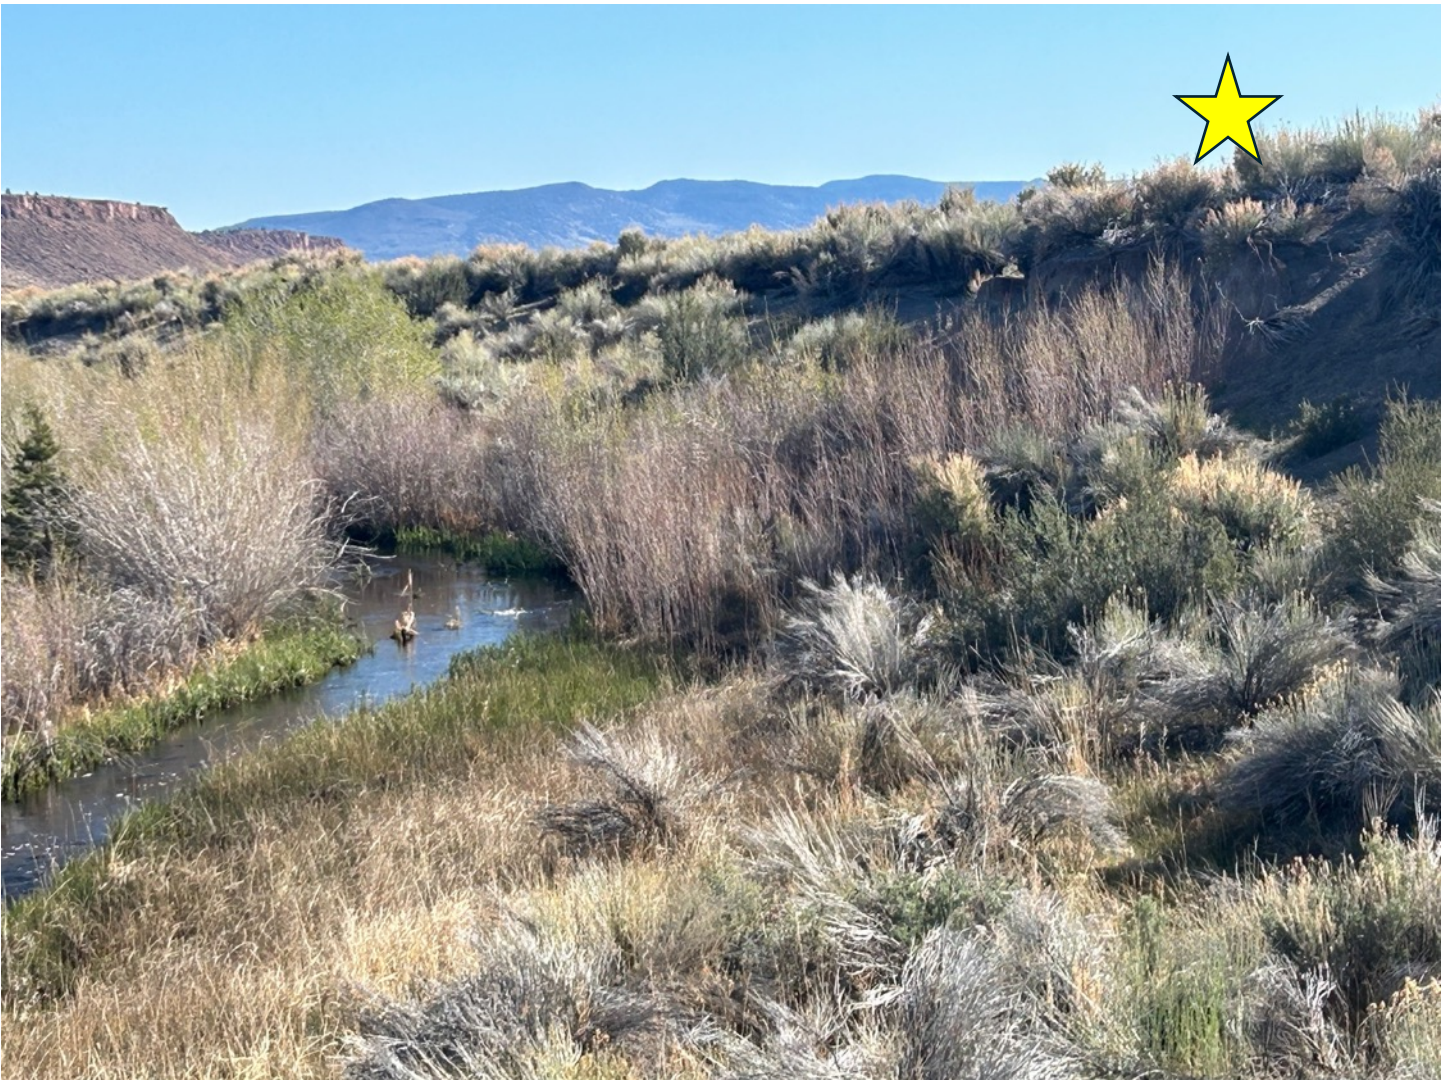
2006 – Dam cut – Right bank, looking downstream at future Brush mat restoration site – Star indicates same location across photos

2007 – Dam cut – Right bank, looking downstream at future Brush mat restoration site

2024 – Dam cut – Right bank, looking downstream at brush mat restoration site
