CHARACTERIZING THE MECHANICAL AND STRUCTURAL  
PERFORMANCE OF HYDRAULIC-LIME CMU  
WALL COMPONENTS AND ASSEMBLIES

A thesis submitted in partial fulfillment  
of the requirements for the degree

Civil Engineering

MONTANA STATE UNIVERSITY  
Bozeman, Montana

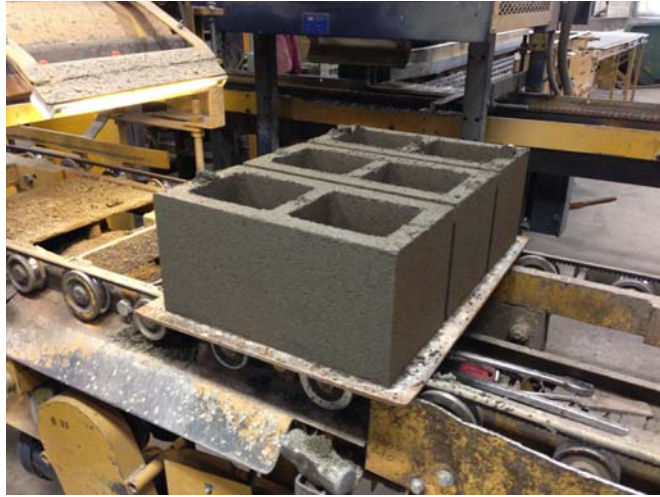
until it reaches a standard height, at which time they exit the machine (Figure 1). Before the blocks are palletized, they are given time to gain strength, either through steam curing in a kiln or left to air dry.

Figure 1. Freshly cast lime CMU block

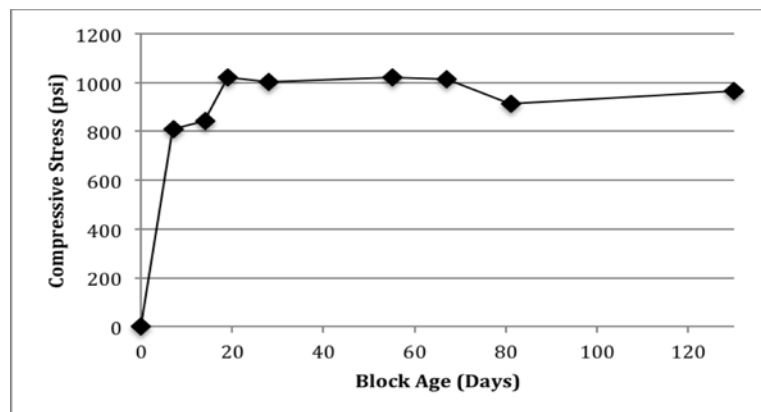
The standard blocks were tested in substantial accordance to ASTM C140 (ASTM International, 2013) over the course of 130 days, and the results of this testing are shown Figure 4.

Figure 4. Compressive strength of standard block vs time

This block design saw significant strength gains over the first three weeks, at which time the strengths plateaued at approximately 1000 psi. This is about half the strength that is required in the ASTM C90 for standard CMU. As stated previously, a modified block was pursued in an attempt to increase this strength.

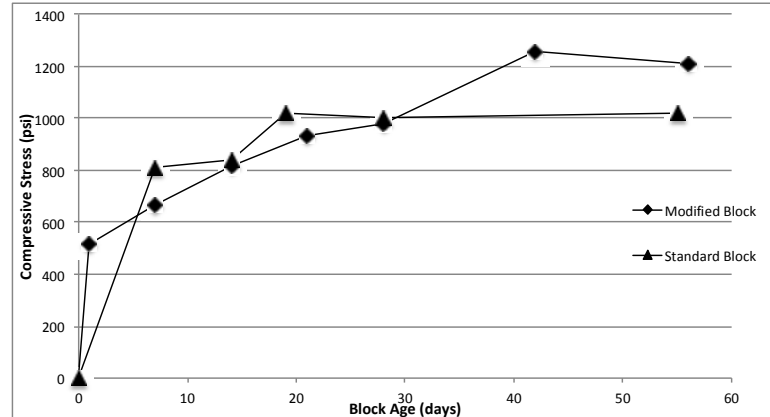
Standard Block vs Modified Block The effect of block design can be isolated by comparing the modified dry-cured Wisconsin block strengths to the standard block strengths from the previous section (which also used Wisconsin lime and were dry cured), as is done in Figure 5.

Figure 5. Standard block and modified block vs time

Referring to this figure, the modified block strength is less than the standard block initially; however, its strength surpasses the standard block at 28 days and remains higher throughout the testing period. At 56 days the modified block had a strength of approximately 200 psi higher than the standard block. There were a limited number of modified blocks for this study, therefore modified blocks could not be tested after the 56 days shown above. However, the standard blocks were tested as far out as 130 days (Figure 4), and these strengths were still hovering around 1000 psi. These results indicate that the modified normal-weight block design may be more appropriate for future projects, as it resulted in higher strengths.

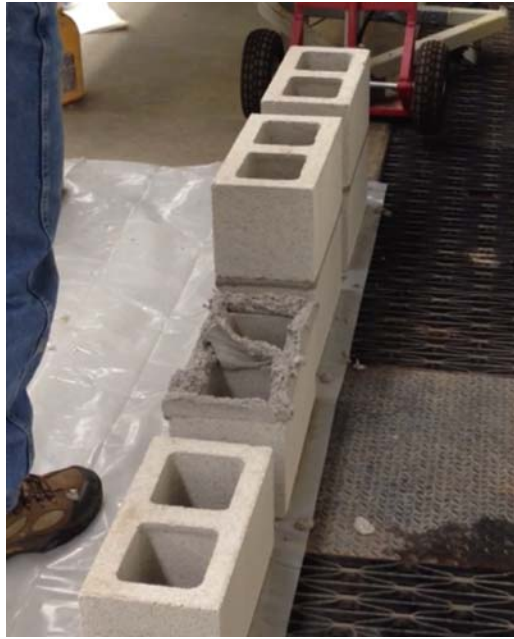
The compressive response (strength and modulus) of two types of fully-grouted two-block prisms were tested in this research. The first type of prism was grouted with the structural grout discussed in a previous section, while the second was grouted with the perlite grout. These prisms were constructed by experienced masons at the same time as the wall specimens discussed in the following chapter. A picture of the construction process is shown in Figure 10. They were also cured alongside the wall specimens at room temperature without added moisture.

Figure 10. Construction of prisms

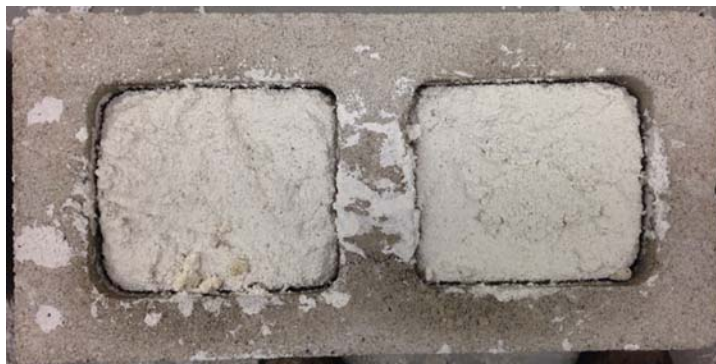
It should also be noted that both the structural and perlite grout had a tendency to shrink when placed in the CMU blocks, although it was significantly less in the structural grout. A perlite-grouted specimen is shown in Figure 11.

Figure 11. Shrinkage of perlite grout in prism

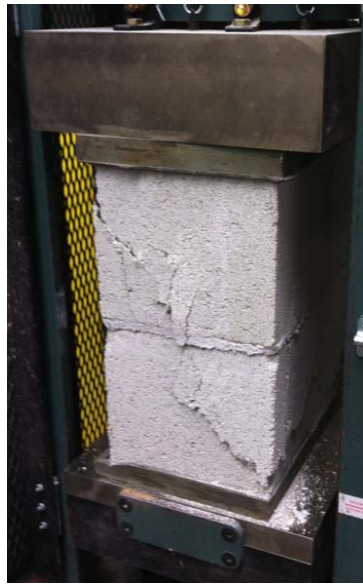
Figure 13. Typical prism failure

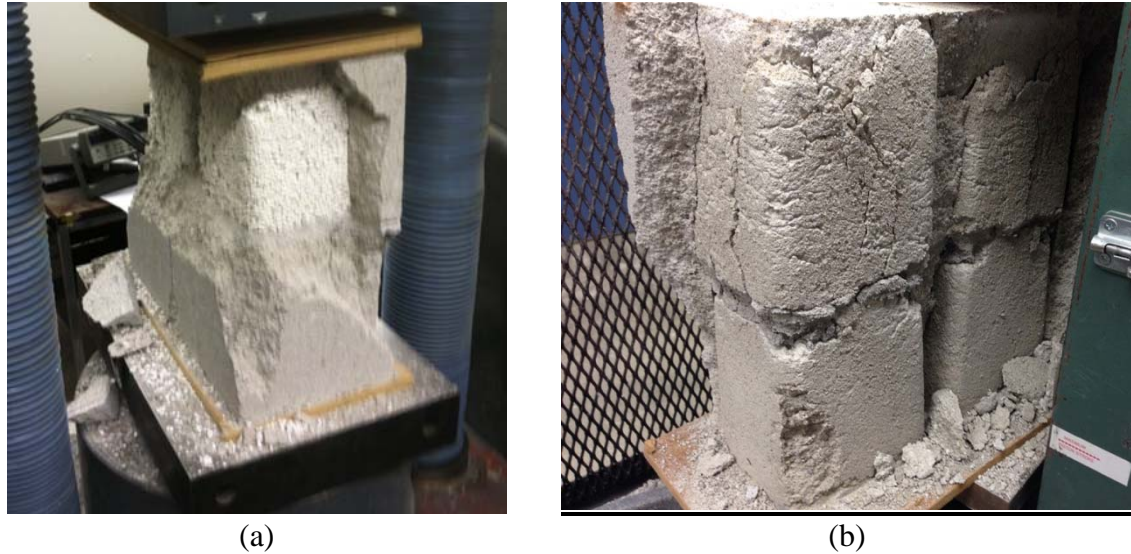
Three prisms from both grouting methods were tested in compression, in substantial accordance with ASTM C1314 (ASTM International, 2013), over one year. The resultant average compressive strengths for the two grouting methods are shown in Figure 12. In this figure, the compressive strength is taken as the ultimate load divided by the gross cross-sectional area of the block, which was approximately 119 in<sup>2</sup>. For reference the standard design value for a portland cement CMU is 1500 psi. In the structural- and perlite-grouted specimens, the failure mechanisms of the blocks were similar and initiated with a failure in the mortar joint and progressed through the block shell (Figure 13), and culminated with the CMU shell falling off and the grouted core remaining (Figure 14).

Figure 14. Ultimate failure of (a) perlite prism and (b) structural prism

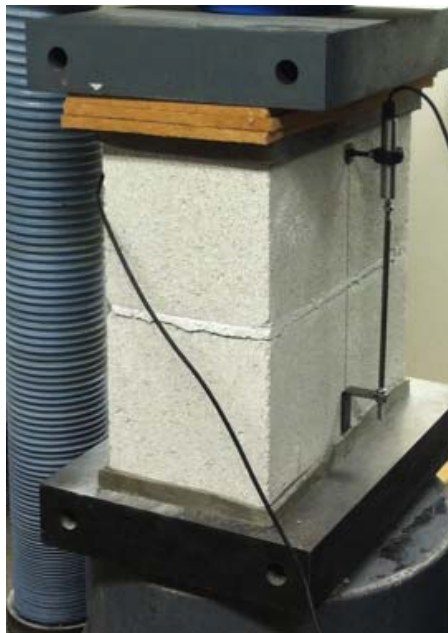
The modulus of elasticity of the prisms was determined in substantial accordance to ASTM E111 (ASTM International, 2013) by loading the specimens to 33 percent of their expected capacities while recording the applied load and the resultant deflection of the prism, as observed in Figure 15. The deflection was monitored with two potentiometers attached to the top and bottom of the prisms using epoxied brackets.

Figure 15. Modulus of elasticity test setup

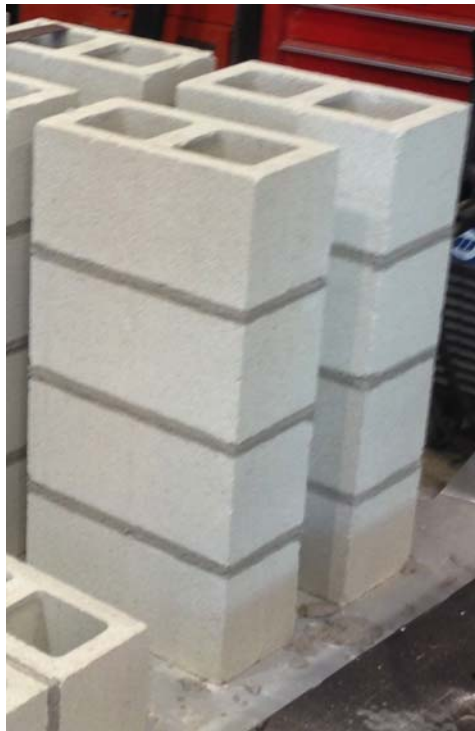
It is difficult to directly measure the tensile capacity of masonry assemblies; therefore, the tensile capacities were inferred through unreinforced bending tests. In this research, two masonry layups were tested for each grouting method. These layups consisted of a simple 4-block prism (Figure 17), and a double-wythe 6-course running-bond assembly (Figure 18). The nominal dimensions of the 4-block prisms were 16-by-8-by-32 inches, while the nominal dimensions of the 6-course assemblies were 24-by-16-by-48 inches. These assemblies were constructed by experienced masons on the same day as the wall assemblies discussed in the following chapter, and were cured alongside the wall specimens at room temperature in dry conditions.

Figure 17. 4-block prism prior to grouting

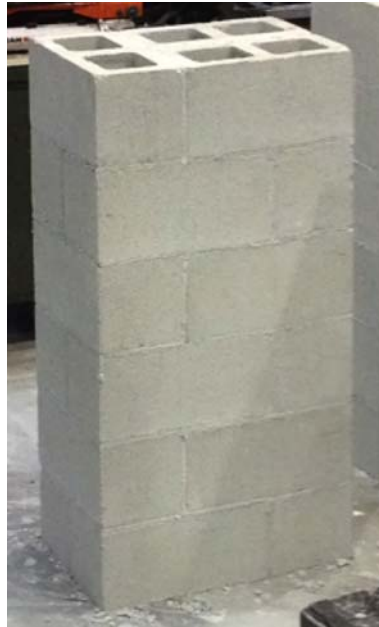
Figure 18. 6-course running bond layup prior to grouting

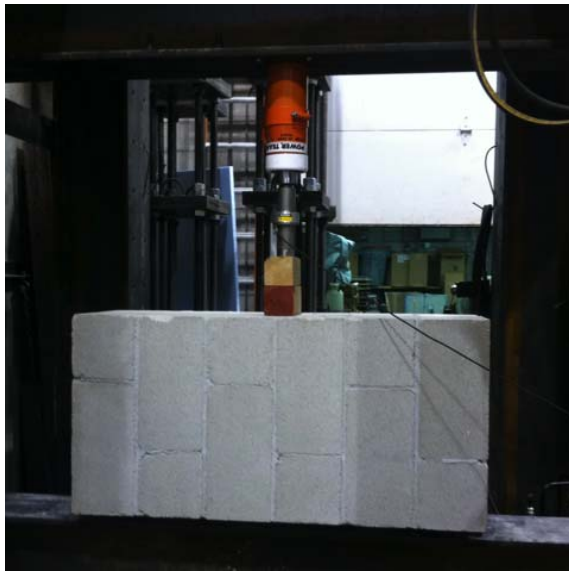
These layups were tested lengthwise in three-point bending about their strong axes until failure, while monitoring the applied load (Figure 19). The tensile stress ( $f_t$ ) is then calculated from the maximum-recorded load by determining the moment at failure ( $M$ ) and then calculating the tensile stress in the extreme bottom fiber at this moment, assuming a linear-elastic material response. That is, the tensile stress is calculated as  $f_t = \frac{M}{S}$ , where  $S$  is the section modulus of the assembly. In these calculations, the self-weight of the specimens is considered, and the section moduli were obtained from values published by the National Concrete Masonry Association (2003). Specifically, the section moduli for the perlite-grouted specimens are based on ungrouted values, while the structural specimens values are assuming that the specimens are fully grouted. Also, it

Figure 19. Tensile specimen prior to testing

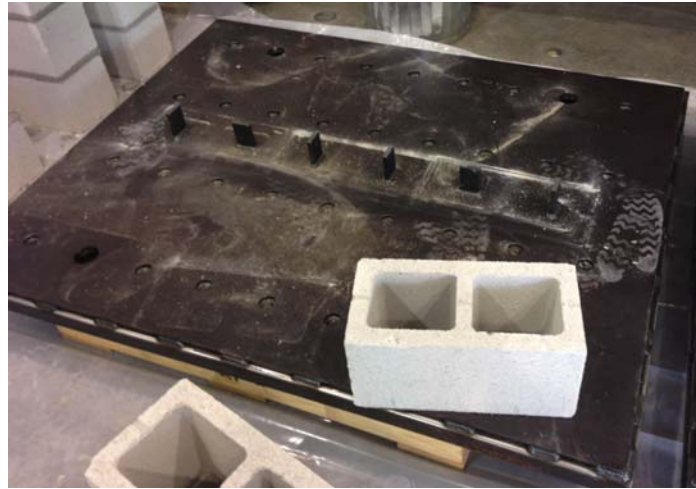
The block layouts for the various wall specimens are shown in Figure 21 and Figure 22, and the grouting pattern for the wall consisting of perlite and structural grout (TPS) is shown in Figure 23. The walls were constructed on top of steel base plates that were designed to be post-tensioned to the floor (Figure 20). These plates had shear tabs that were located such that they would line up with the cells of the CMU walls, as indicated in Figure 21 and Figure 22. A conventional portland cement grout was used in the bottom half of the base course of the wall around these shear tabs. This was done to ensure that the failure mechanism would be forced into the main wall and not simply reflect a poor connection between the wall and the base.

Figure 20. Wall assembly base

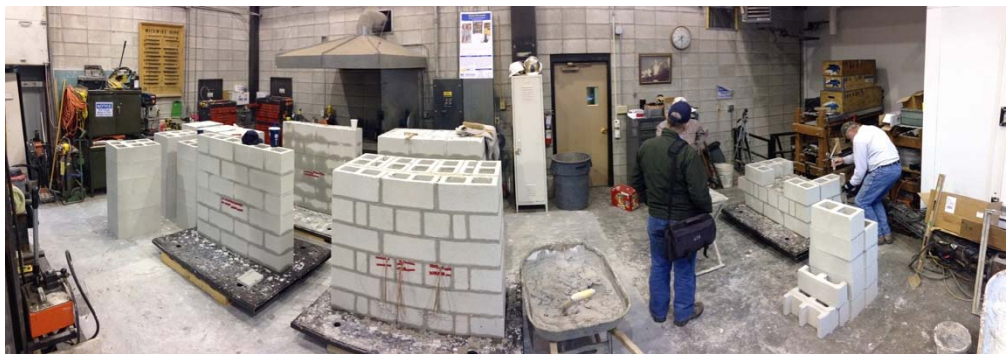
The wall specimens were constructed by experienced masons using the standard lime CMU blocks discussed in a previous chapter, and the Wisconsin lime was used as the binder in the mortar and grout. The walls under various stages of construction are shown in Figure 24. Upon assembly, the walls were then cured at room temperature under dry conditions in the structures lab until the day of testing, which was at 400 days after casting. Note that in the interim some of these wall panels were subjected to thermal testing.

Figure 24. Wall specimens under construction

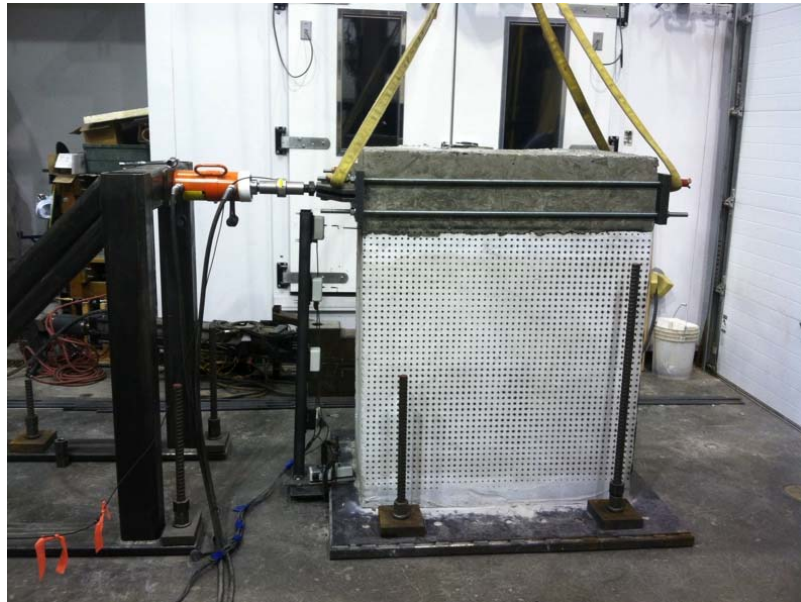
Figure 26. Wall test setup prior to testing

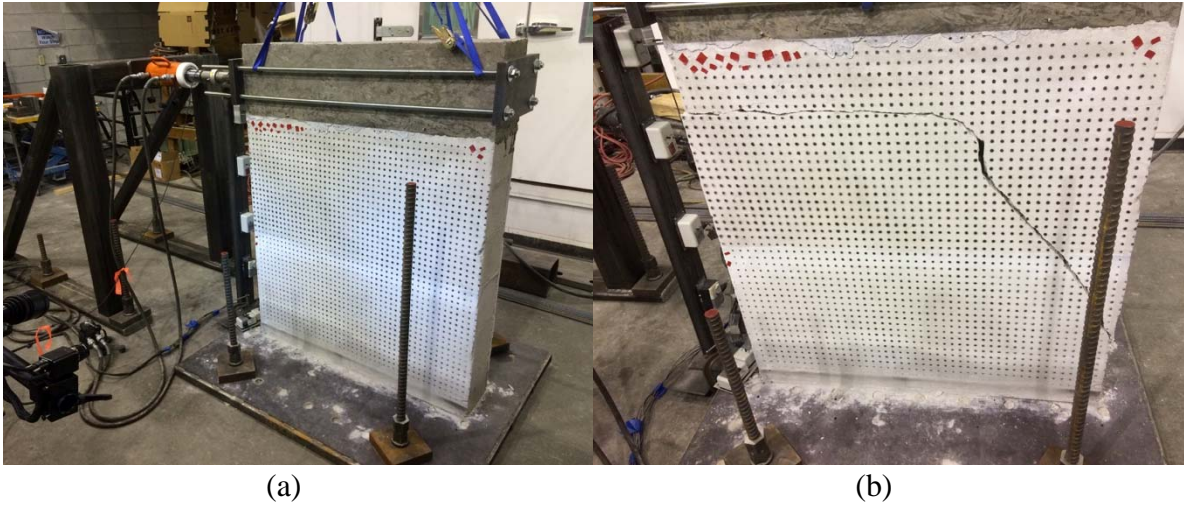
The single-wythe wall with perlite grout was tested first in this research, and was expected to be the weakest of the five walls. The wall specimen at commencement of the test is shown in Figure 27a, while the wall immediately after failure is shown in Figure 27b. The applied load versus the deflection of the top of the wall is shown in Figure 28.

This wall failed at a load of approximately 2.0 kips due to the formation of a horizontal crack in the mortar line near the top of the wall that then propagated across the wall until it reached the compression zone on the far side of the wall, at which point the crack propagated diagonally downward (Figure 27b). The peak top displacement at ultimate load was 0.034 inches, and the peak uplift displacement was 0.02 inches.

Figure 27. SP wall: (a) before loading and (b) after loading

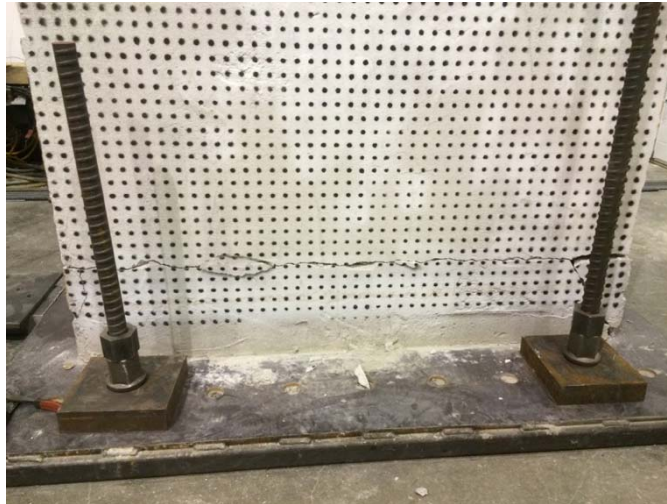
The third wall that was tested was the triple-wythe perlite grouted wall – TP. The wall immediately after failure is shown in Figure 33, and the force-deflection response of the top of the wall is shown in Figure 34. This wall failed at a load of approximately 2.5 kips due to the formation of a horizontal crack near the base of the wall on a mortar line. This crack initiated on the side of the wall closest to the lateral load, and then propagated

across the wall. It should be noted that in the process of transferring the TP wall between the thermal testing lab and the structures lab, some damage was sustained in the form of a small crack in the mortar joint at this same location. Indicating that this crack may have initiated prior to testing. Similar to what was observed in the single-wythe walls, the top portion of the wall then began sliding relative to the base after reaching the peak load. The maximum lateral and uplift displacements at failure were 0.028 inches and 0.022 inches, respectively.

Figure 33. TP wall after failure

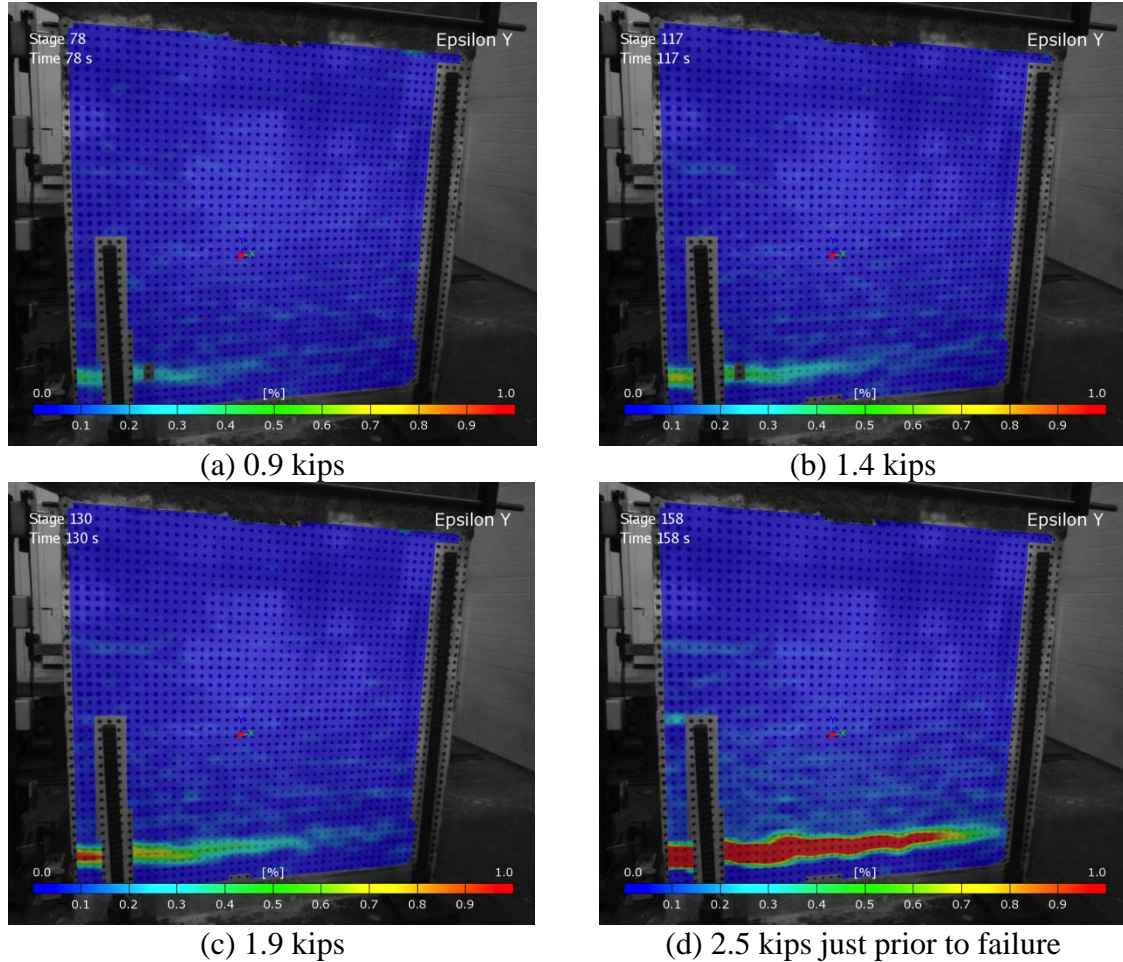
The strain fields (in the vertical direction,  $\epsilon_y$ ) within the wall at multiple load levels are shown in Figure 35. As was the case in the single-wythe walls, a normal-strain concentration can be observed at the base of the wall prior to the crack becoming evident at this location. This strain concentration indicates that this crack initiated due to uplift.

Figure 35. Vertical normal-strain fields ( $\epsilon_y$ ) observed in the TP wall at various load stages

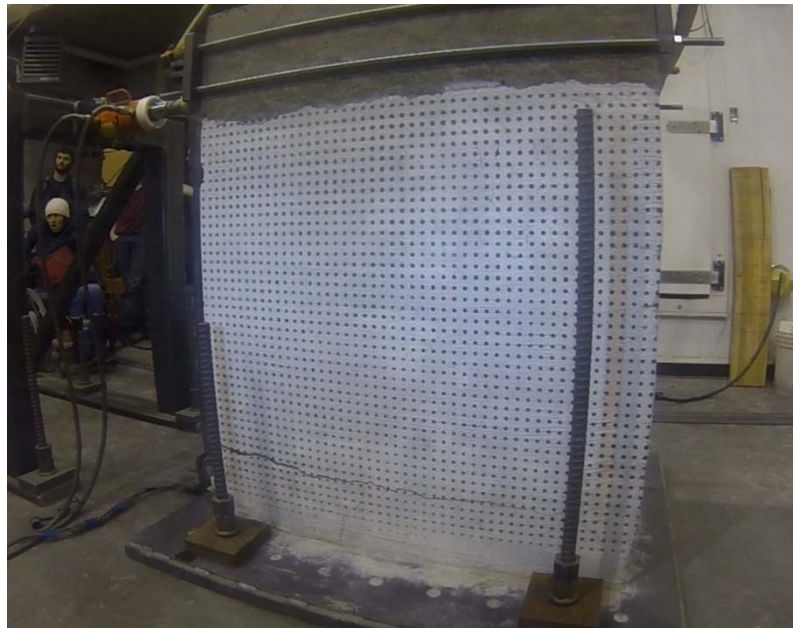
kips. The lateral deflection and uplift deflection at failure were approximately 0.033 and 0.026 inches, respectively.

Figure 36. Failure surface of TPS wall

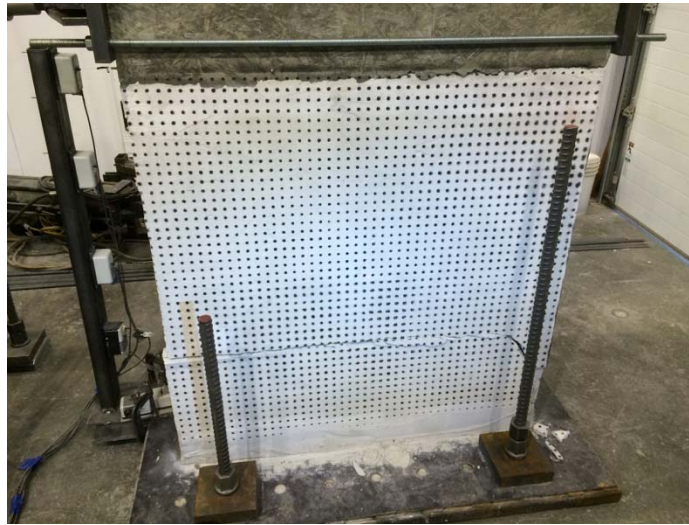
Figure 39. TS wall after failure
