Influence of Surface Features on Microbial Colonization and Susceptibility to Corrosion of Stainless Steels Used in the Food Processing Industry

Geesey G.G., Gillis R.J., Zhang H -J, and Bremer, P.J

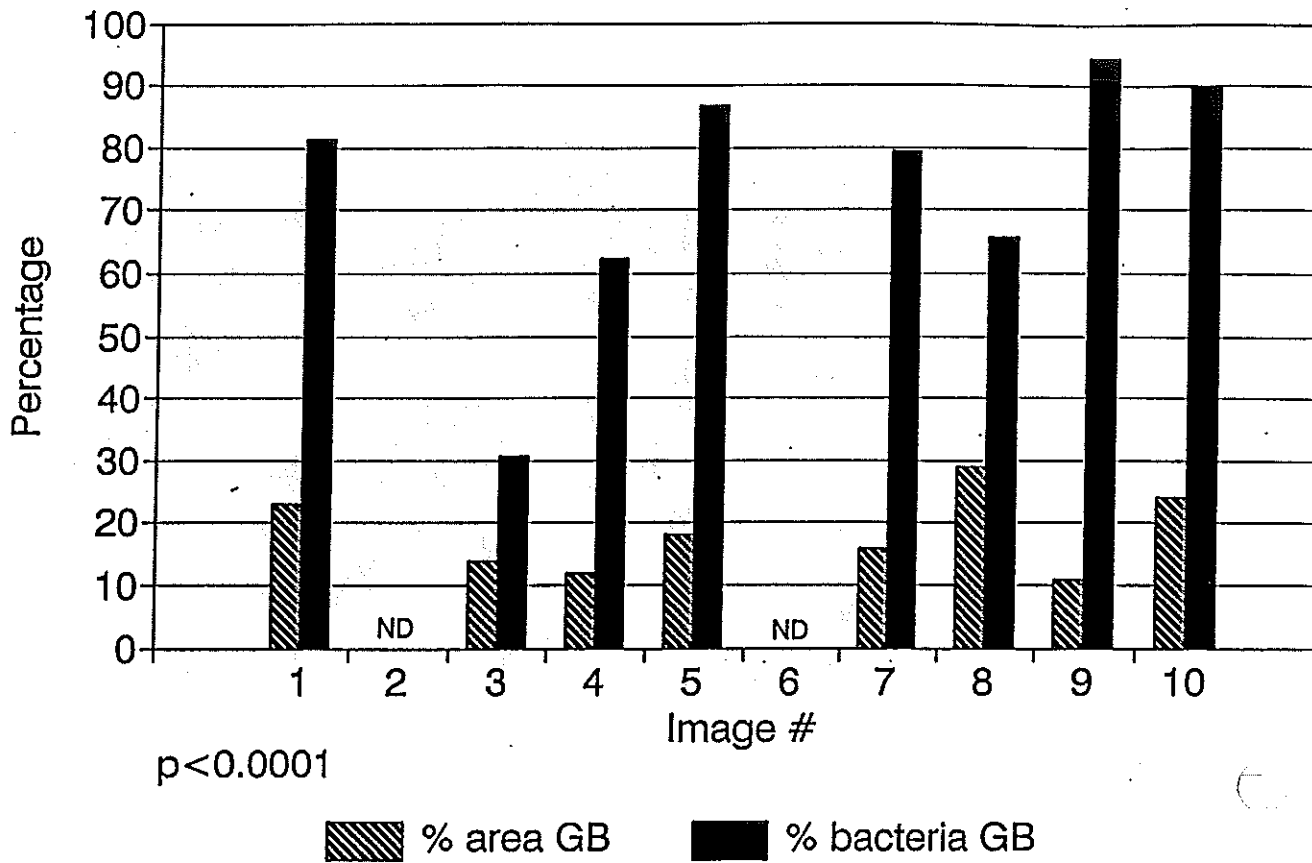
Figure 3

Comparison of fraction of total area of 316L ss coupon, prepared as in previous figures, that was contributed by grain boundaries around the islands of oxide formed on the surface of the alloy with the fraction of total bacteria (*Citrobacter freundii*) attached to the surface that were in or immediately adjacent to the grain boundaries. Data is presented for 8 separate areas (image #) of the coupon. Fractions are expressed as percentage. The differences are significant at the p value indicated.

Thirty to ninety five percent of the total bacteria associated with the surface of the metal were concentrated in or adjacent to the oxide grain boundaries, which represented 10-30% of the total surface area (Figure 3).

These differences were significant at the confidence level of $p < 0.0001$. Selective colonization of the depressions in the ss surface defined by the oxide grain boundaries was maintained for periods of at least 1 month exposure to bacteria-containing, bulk aqueous phase [11]. These surface features are removed by mechanical or electropolishing producing a surface that is colonized randomly by adherent bacteria [12].
