RESPONSE AND RESILIENCE OF RIVERS TO HISTORICAL RESOURCE USE IN  
THE GREATER YELLOWSTONE ECOSYSTEM: A REPEAT  
PHOTOGRAPHY ANALYSIS

A thesis submitted in partial fulfillment  
of the requirements for the degree

Land Rehabilitation

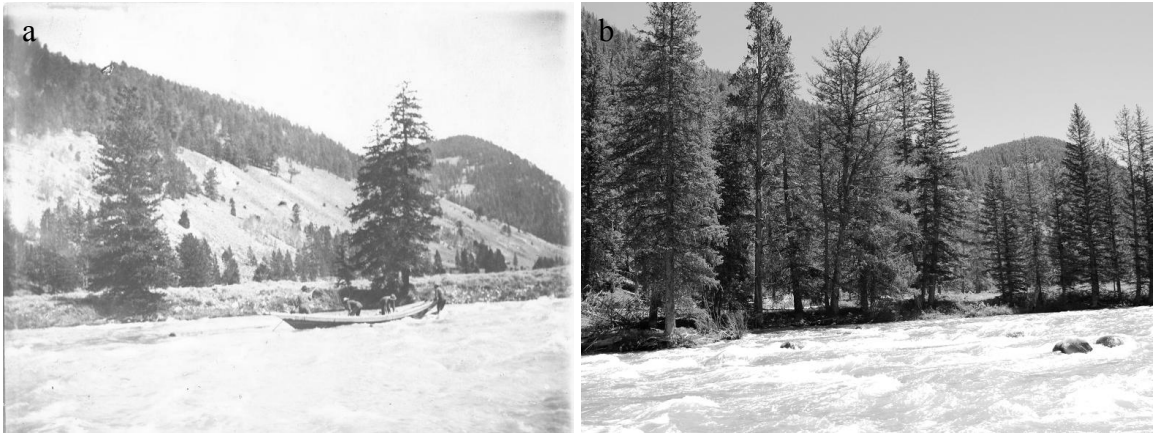
Below Taylor Fork and the Gallatin confluence, tie hacks had to dislodge logjams with long steel hooks when ties became tangled up on logs or snags (Figure 9 and Figure 10) (Cronin & Vick, 1992). This area does not indicate much change other than increased conifer growth along riverbanks. After the cessation of tie driving, lack of disturbance most likely led to succession toward later seral stages.

Figure 9. Upstream of 320 Ranch, Gallatin Canyon, MT (photo point 125) a. Unknown ca. 1907, Courtesy of the Museum of the Rockies. b. Clark, H.M. 6/15/2013.

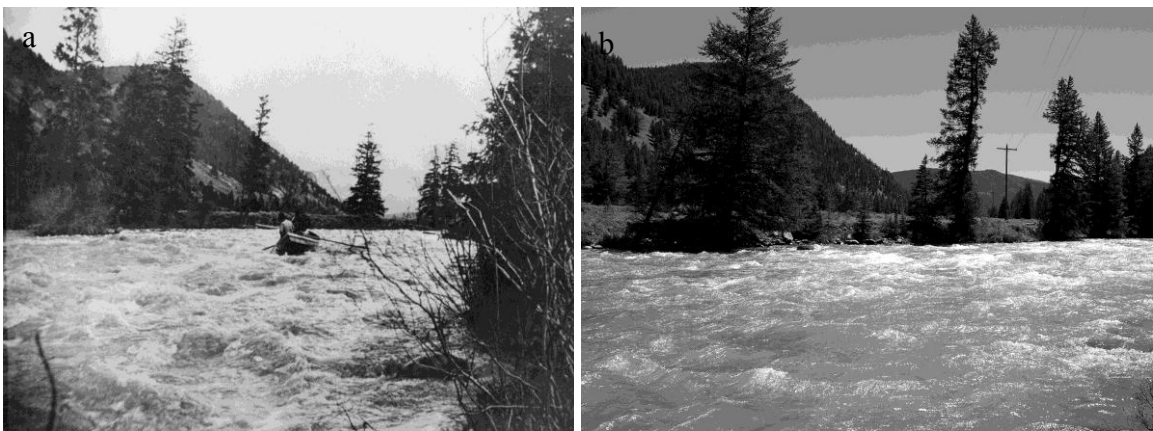
Figure 10. Upstream of 320 Ranch, Gallatin Canyon, MT (photo point 232) a. Unknown ca. 1907, Courtesy of the Museum of the Rockies. b. Clark, H.M. 6/15/2013.

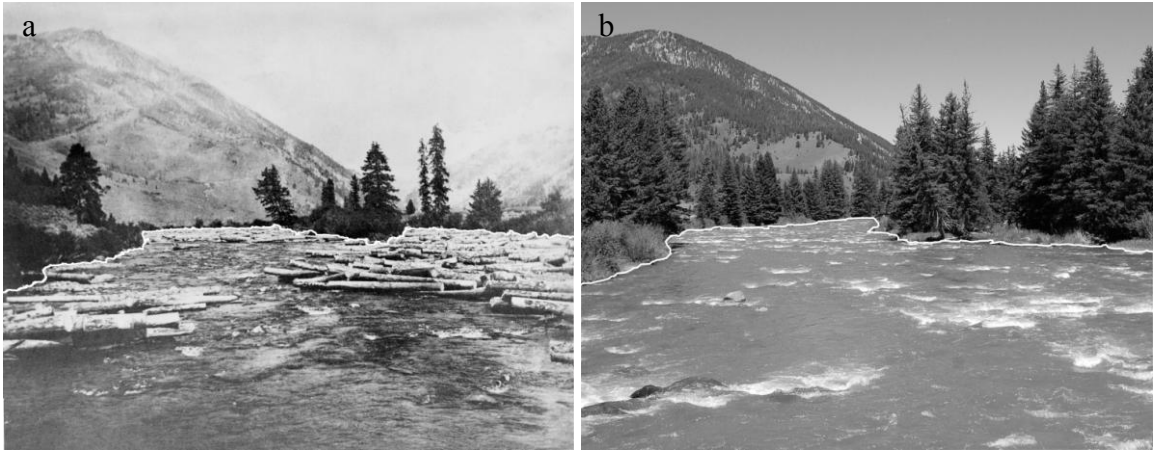
Downstream from 320 Ranch Bridge, photos indicate more noticeable changes (Figure 11). With the conclusion of tie driving, the right middle ground has been able to stabilize and fill in with vegetation (Figure 11). In this photo comparison, tie drive impact is hard to assess, because the trees could have regrown over the last century and there is no change in the pixel coverage of river surface area (i.e., 0%); however, there must have been extensive initial impacts from ties, especially because about 75% of ties floated down the right side of the river where there appears to have been a side channel

(Figure 11a). This side channel is now sufficiently elevated beyond reach of relatively high flows.

Figure 11. 320 Ranch, Gallatin Canyon, MT (photo point 224) a. Unknown 1906, Courtesy of Museum of the Rockies. b. Clark, H.M. 6/15/2013. Quantified polygons are outlined in white.

Even though photo comparisons along with previous research indicate impacts of tie driving, all of the tie drive photo comparisons reveal recovery, including: increased vegetation along riverbanks (Figure 6 and Figure 40), decreased scouring (Figure 7, Figure 8, and Figure 11) and increased instream heterogeneity, especially in former dammed locations (Figure 5, Figure 38, and Figure 39).

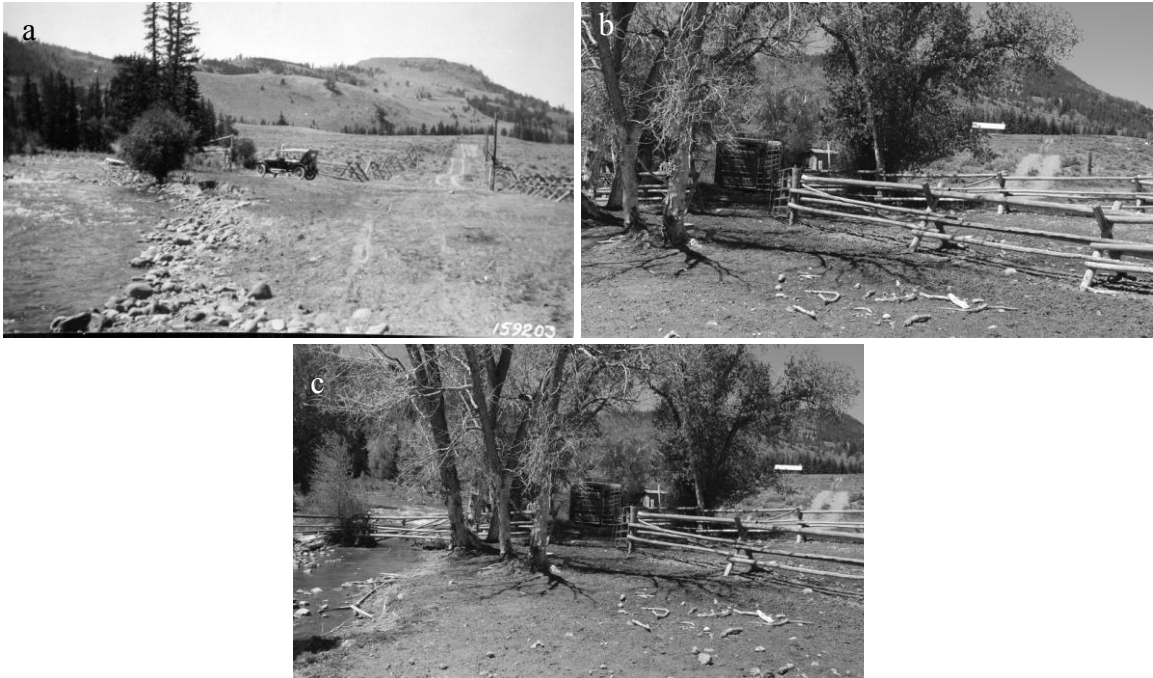
Figure 34. Upstream of Dunoir River, Wind River, WY (photo point 435) a. Unknown 8/1/1921, Courtesy of Dubois Museum. b. Clark, H.M. 6/9/2013 (actual view) c. Clark, H.M. 6/9/2013 (slightly to the left to include the river).

Livestock impacted and continue to affect riparian areas along the Wind River. Even though tie driving has ceased, signs of scouring and lack of vegetation suggest lingering impacts (Figure 34a). Currently, heavy livestock use extends into the river, increasing erosion and decreasing vegetation, leaving cottonwood roots exposed (Figure 34).

In historical photos, larger crop fields, center pivot irrigation, cattle fences, and local histories provide evidence for increase in intensity of agricultural use. Cattle enclosures directly overlying the Wind River near DuNoir River have allowed cattle to completely graze and trample within a fenced-in area, most likely leading to soil erosion and manure contamination (Figure 34) (Belsky, Matzke, & Uselman, 1999). Excessive livestock use can degrade riparian habitats by reducing vegetation, increasing bare ground, diminishing rare species, and allowing invasive weed infiltration; in particular,

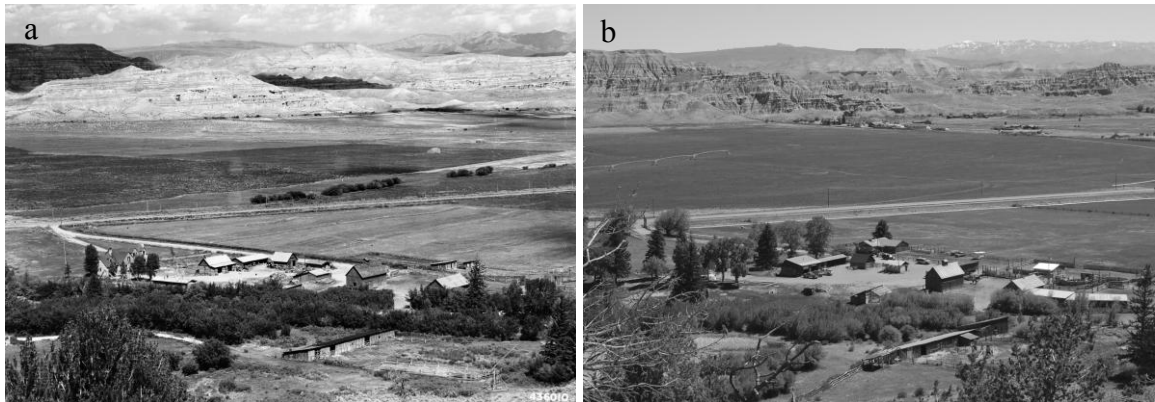
Figure 37. Warm River Ranch, Wind River, WY (photo point 428) a. Unknown 8/4/1945, Courtesy of Shoshone National Forest. b. Clark, H.M. 6/9/2013.

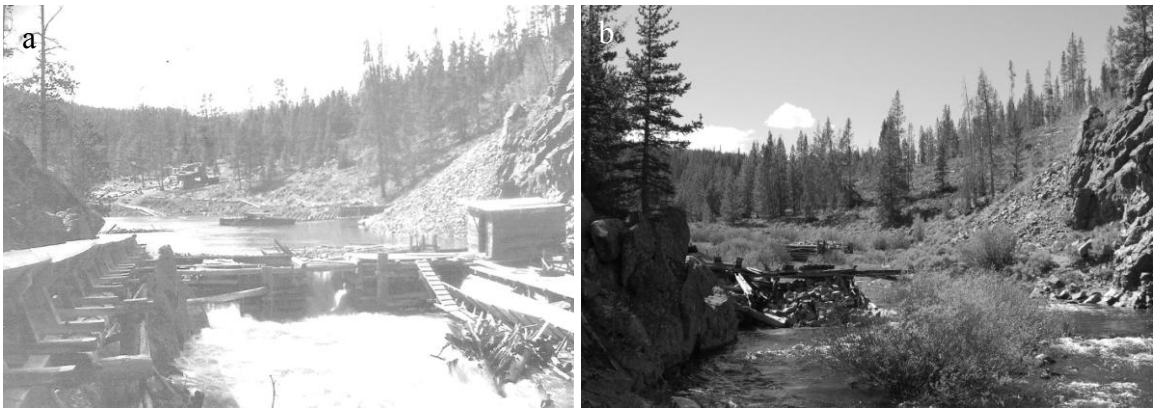
In addition to ranching, tie driving was a major influence in the Wind River basin. Several surge dams were located along the Warm River above the Warm River Canyon. A surge dam, at the mouth of the canyon, created a large pond containing about 300,000 ties at a time (Figure 38). Tie hacks fed ties from this pond down a flume, transporting ties through the canyon and ultimately reaching the Wind River. When tie operations terminated, the dam was destroyed and the river resumed a natural flow, allowing vegetation to reestablish. Accumulation of sediment behind the dam provided a base for

natural plant colonization. A variety of floodplain species, including willow, have grown in and along the channel and stabilized the riverbanks (Figure 39).

Figure 39. Warm River, tributary of the Wind River, WY (photo point 409) a. Trego, A.B. ca. 1940, Courtesy of Dubois Museum. b. Clark, H.M. 6/9/2013.

Repeat photograph evidence of Wind River tributaries indicates signs of resilience (Figure 35, Figure 38, and Figure 39). The Front Range of Colorado provides examples where stream physical processes and aquatic biota have been resilient to former impacts of natural resource use, mainly mining and deforestation. Recovery of these streams following natural resource use is evident by improved channel stability and habitat diversity, which supports a variety of aquatic and riparian species. This recovery is apparent where anthropogenic perturbations have ceased; however, continued contamination and regulated flows still affect riverine systems in this area, reducing resilience (Wohl, 2006).

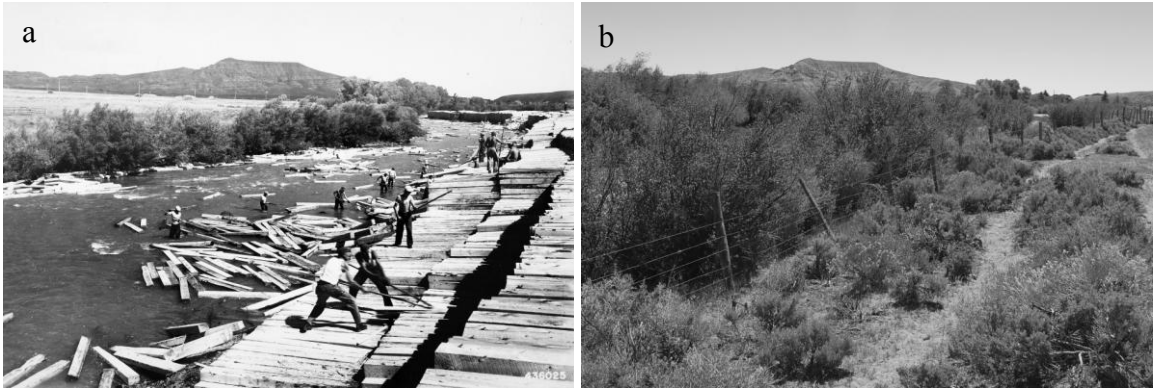
Figure 40. Upstream of Warm River Ranch, Wind River, WY (photo point 438) a. Unknown 8/4/1945, Courtesy of Dubois Museum. b. Clark, H.M. 6/9/2013.

Ties flowed past Warm River Ranch from 1914 to 1946 (Pinkerton, 1981). When trucks replaced flume operations in 1943, tie hacks stored ties along the riverbank just upstream from Warm River (Figure 40). Ties remained along riverbanks until summer when bulldozers would push them into the Wind River (Rosenberg, 1999). This activity completely removed any riparian vegetation on the right bank. Presumably due to the

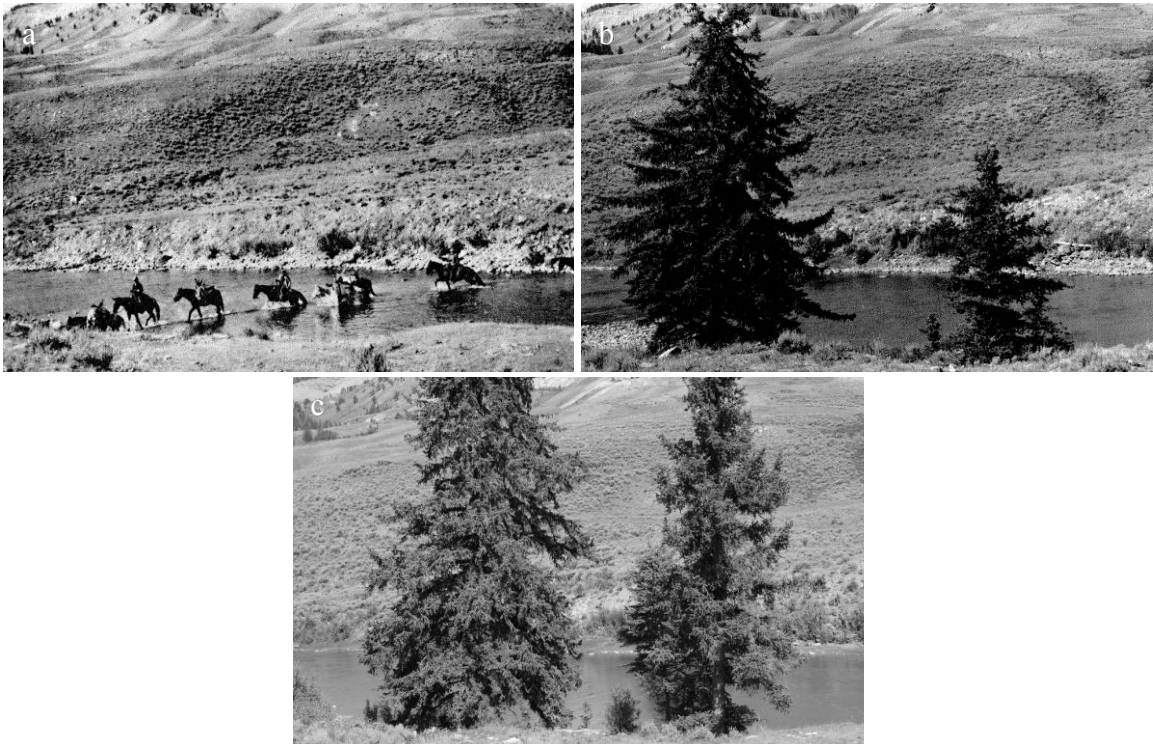
Figure 46. Below the outlet of Slate Creek, Gros Ventre River, WY (photo point 583). a. Unknown 1905, Courtesy of USDA. b. Gruell, G.E. 9/25/1970 c. Clark, H.M. 7/20/2013.

Fire could have contributed to historical riverbank scouring in the Gros Ventre River (Figure 46). Forest fires exacerbate flooding impacts by removing vegetation and organic matter making soil highly vulnerable to erosion and also increasing overland flow, which cause flash flows that scour riverbanks (Wohl, 2006).
