FIELD INSTRUMENTATION AND LIVE LOAD TESTING TO EVALUATE
BEHAVIORS OF THREE REINFORCED CONCRETE BRIDGE DECKS

A thesis submitted in partial fulfillment
of the requirements for the degree

MONTANA STATE UNIVERSITY
Bozeman, Montana

May 2004

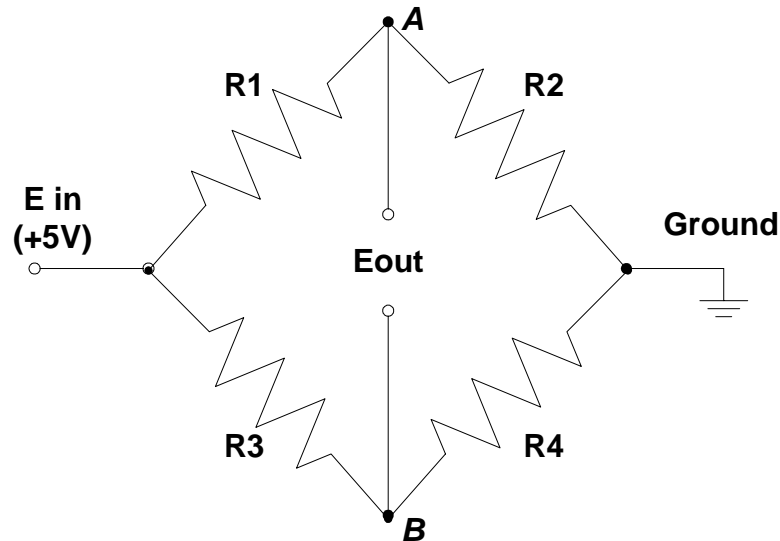
In its simplest form, the Wheatstone Bridge is composed of four resistors, as depicted in Figure 15. A voltage E_{in} is applied to the circuit; for this project, +5V was used. If the resistances in the upper arms of the bridge are identical (i.e., $R1 = R2$), the voltage-divider theory dictates that the voltage at point A will be exactly half of the input voltage (i.e., +2.5V). The same relationship holds true for the lower arm. Therefore, if $R1 = R2$ and $R3 = R4$, points A and B have equal voltages. Thus, the bridge is perfectly *balanced*, and E_{out} equals zero volts. However, a change in resistance in any one of the four arms of the bridge (i.e., if one of the arms is a strain gage) results in a voltage difference between points A and B. The resulting imbalance is detectable using sensitive voltage-reading equipment. Using theoretical calculations, the resistance change may be calculated using E_{out} . The resistance change is proportional to the strain experienced by the gages and may be converted to a real strain using the manufacturer's published gage factor.

Figure 15 Ideal Wheatstone Bridge circuit arrangement

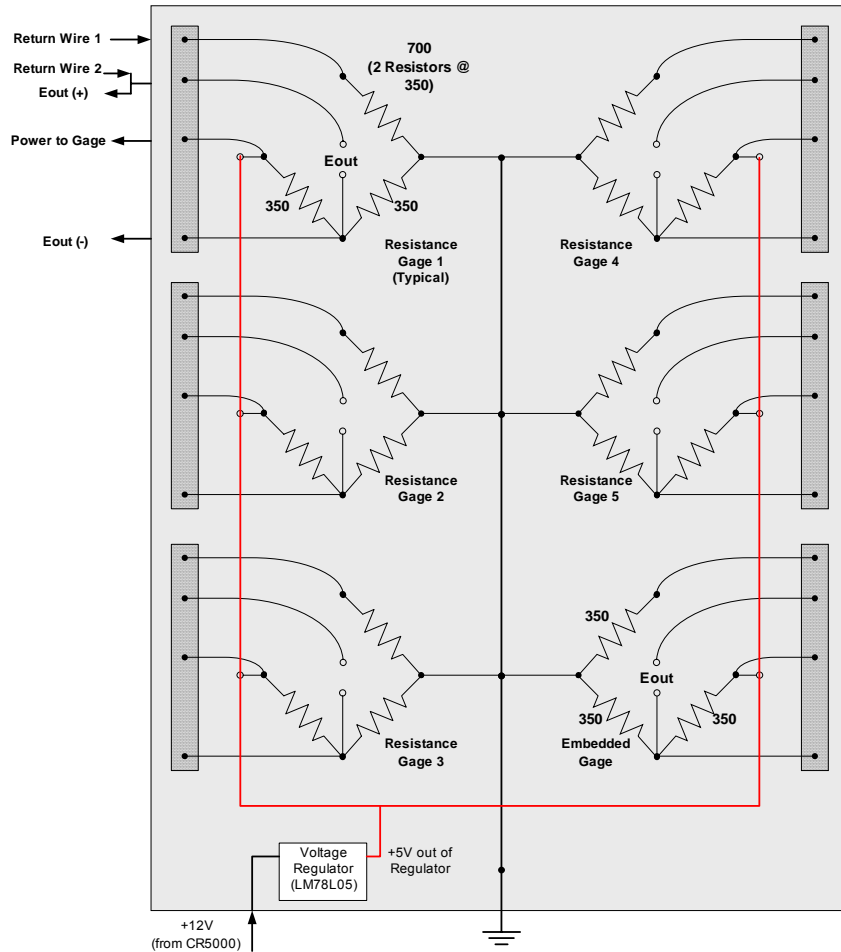
The circuitry described above was assembled on each daughterboard to accommodate six gage locations: five resistance strain gage locations and one embedment gage location, in the configuration shown in Figure 17. Thus, seven daughterboards are required to accommodate 35 bonded and 7 embedment gages. A single +5V voltage regulator (LM78L05) is used to ensure that a low-noise constant supply voltage is provided to the six Wheatstone Bridges on each board.

Figure 17 Diagram of daughterboard configuration

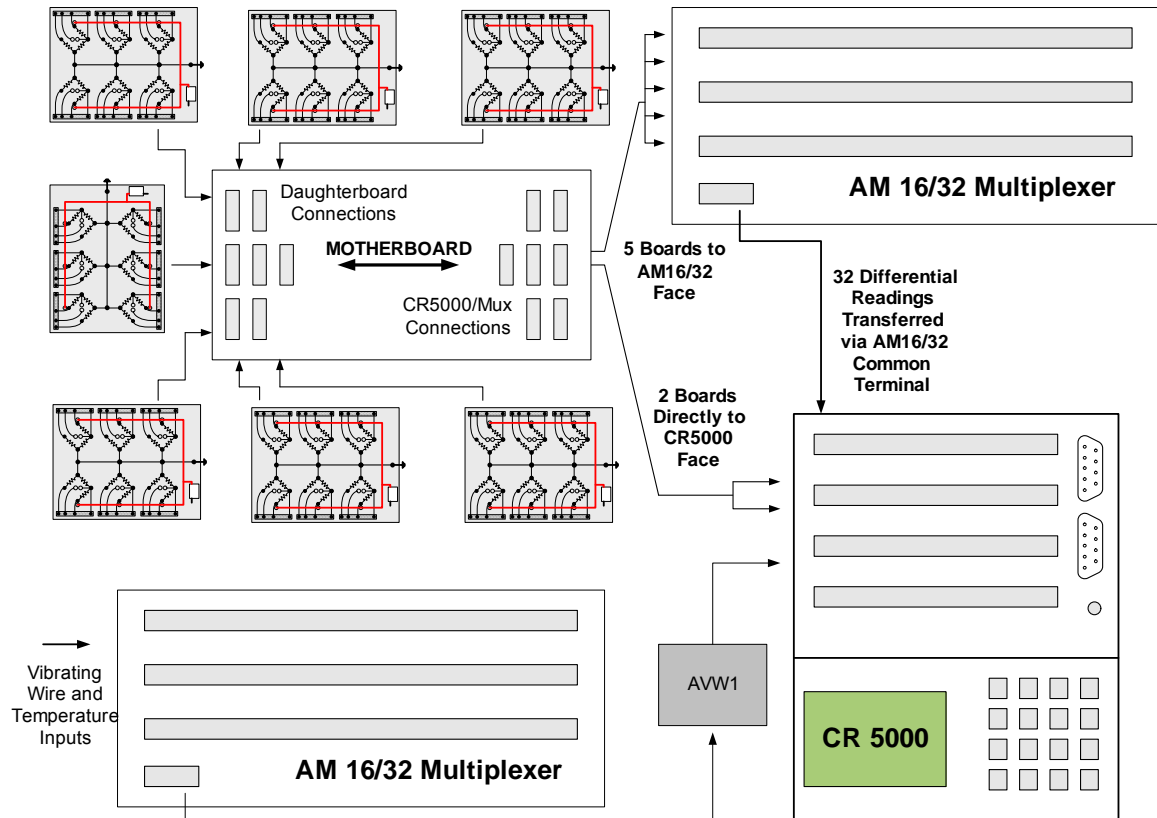
datalogger, allowing the gages wired into these boards to be logged at a relatively rapid rate. Events involving the passage of large trucks are being recorded on each of the bridges using the 12 gages wired through these two boards.

Figure 19 Data acquisition layout – long-term monitoring arrangement

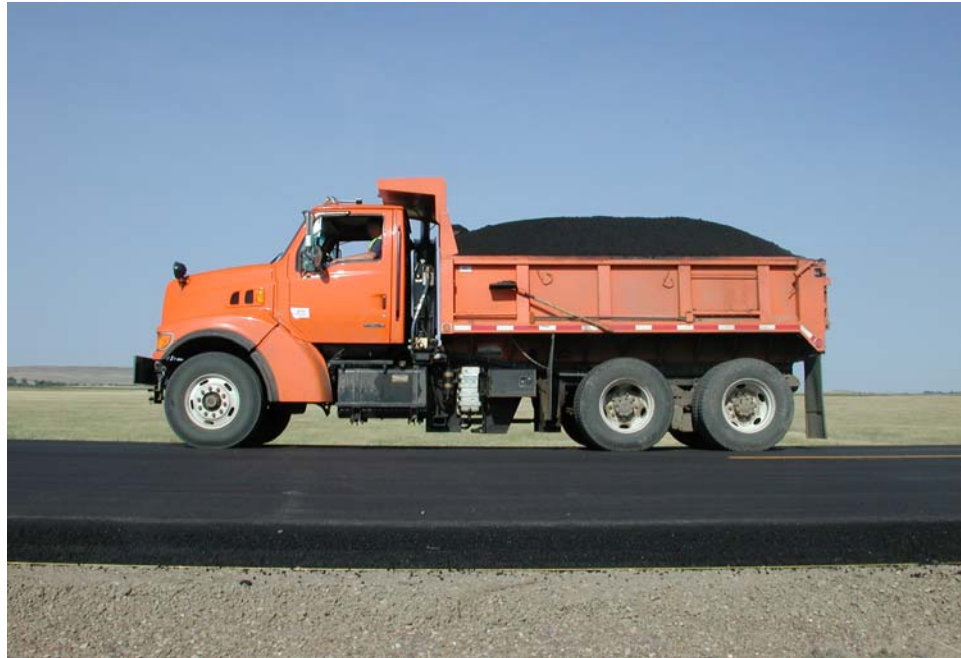
Figure 23 Side view of the Sterling 3-axle dump truck

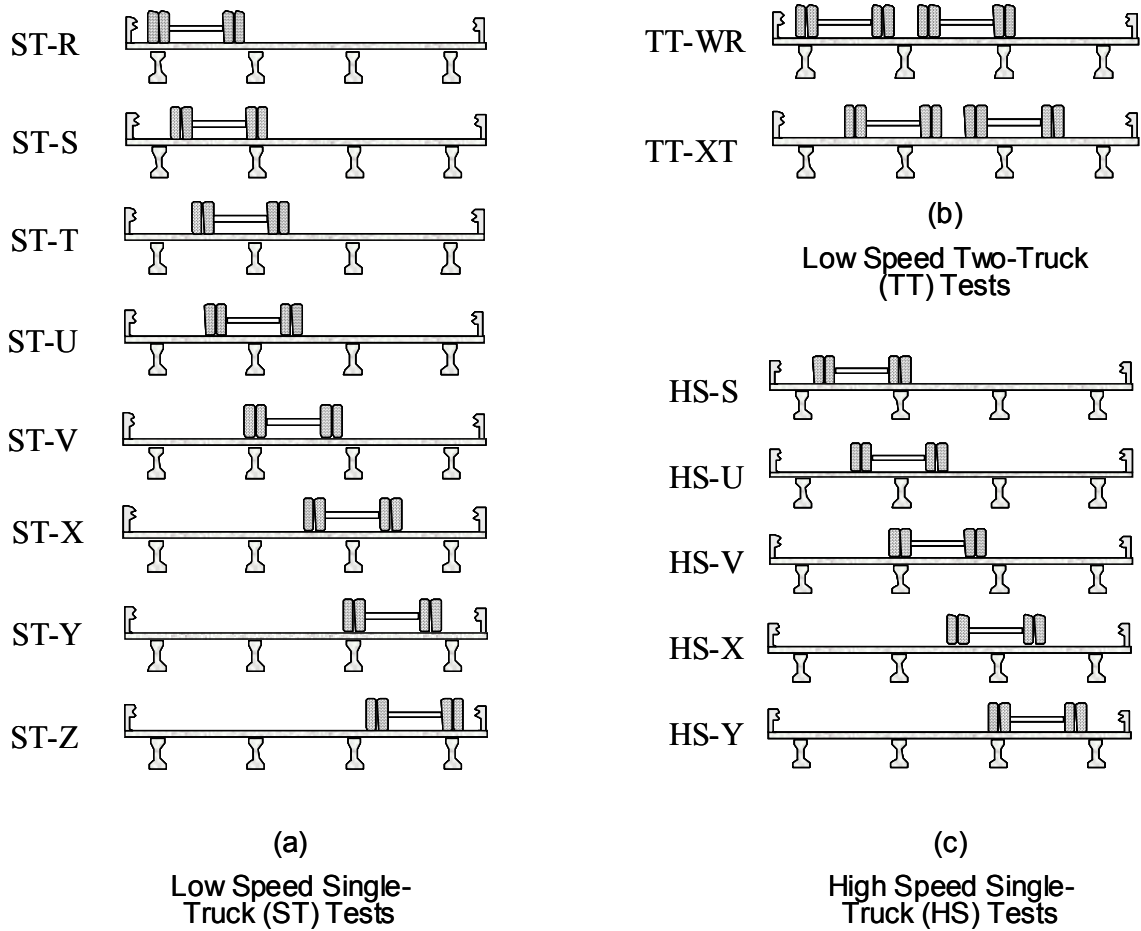
The nine truck positions were selected to characterize deck response under the most critical loading combinations. Generally, tire loads are positioned to either be directly over a girder or at the midspan between girders, as shown in the cross-section views of Figure 25. Truck paths U and X are exceptions to this general rule, positioning the center of the truck directly over a girder, such that the tires symmetrically straddle the girder.

Figure 25 Cross-section views of truck tire placement for live load tests

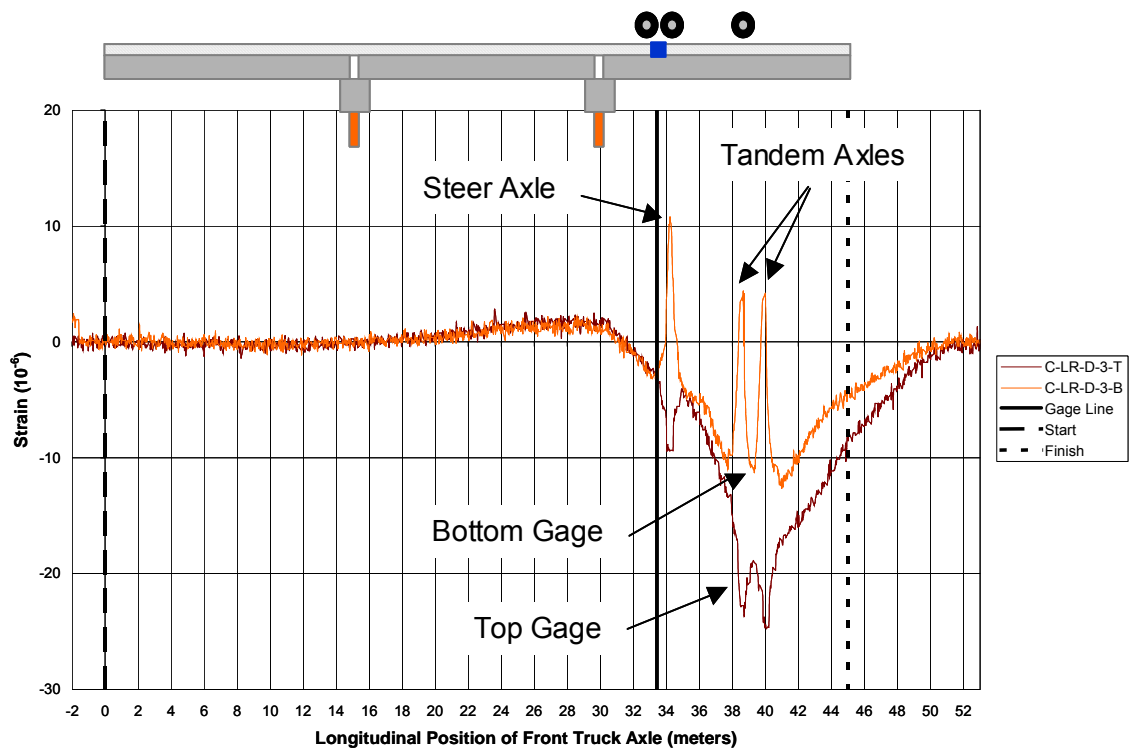
various longitudinal positions along the deck. Thus, for example, the peaks corresponding to the tandem axles are later in the strain history than the front axle (i.e., the front axle passes over the fixed gage location first, followed by the tandem axles about 5m later). The “Finish” line indicates the point at which the front axle of the truck leaves the south end of the deck; the rear tandem axles remain on the deck for approximately five more meters.

Figure 27 Strain history - Conventional deck longitudinal Gage Location D-3 (ST-T test)

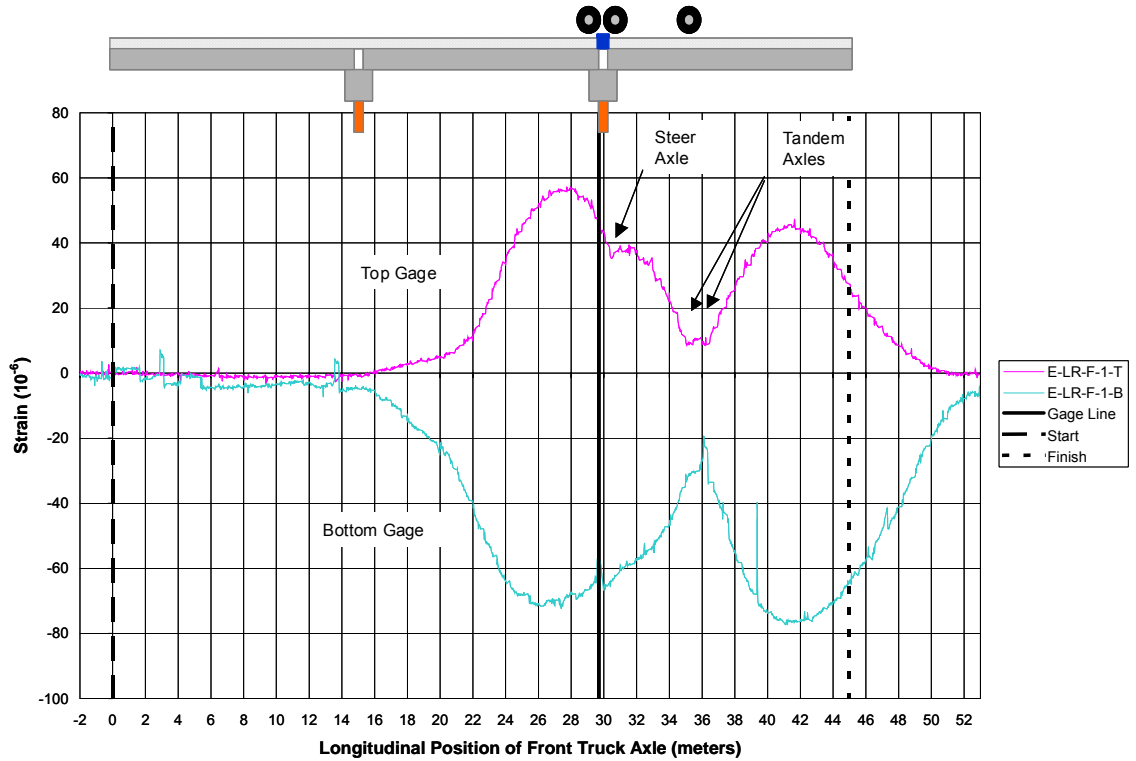
Figure 29 Strain history - Empirical deck longitudinal Gage Location F-1 (ST-T test)

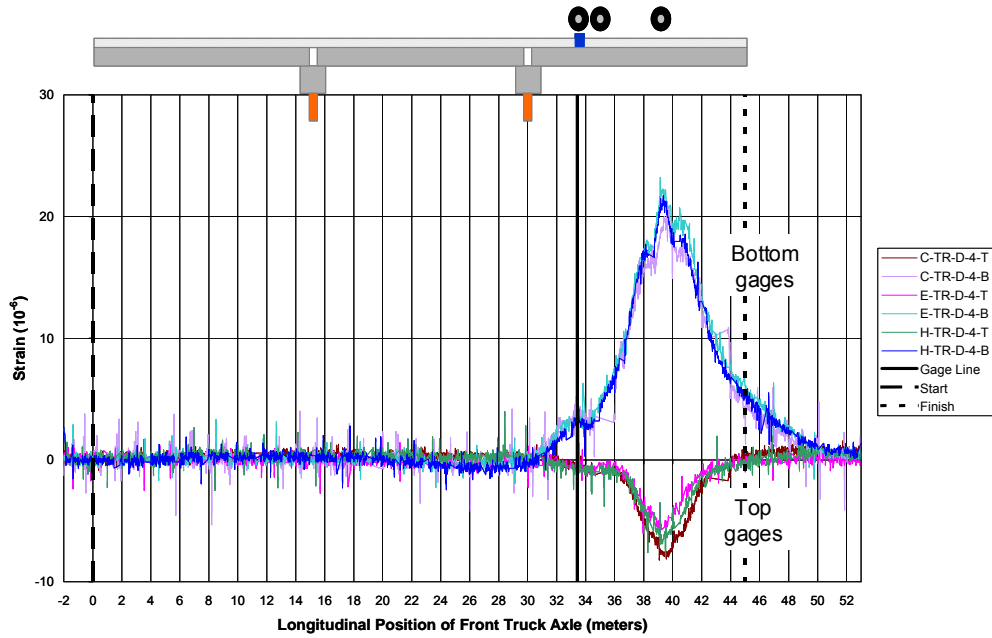
is proportional to the bending moment, indicating both the sign and the relative magnitude of the moment (i.e., larger ϕ indicates larger magnitude moment, assuming the stiffness remains unchanged). Positive values of ϕ are counterclockwise and indicate positive moment, while negative values of ϕ indicate negative moment.

Figure 33 Typical positive moment response (Gage Location D-4, ST-S test)

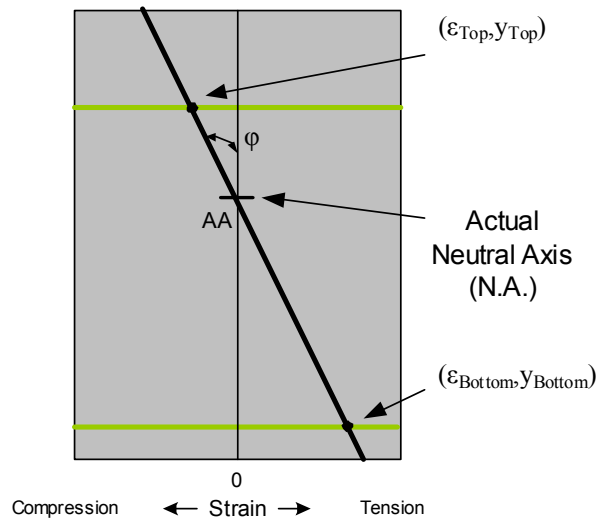
Figure 34 Determination of actual neutral axis height

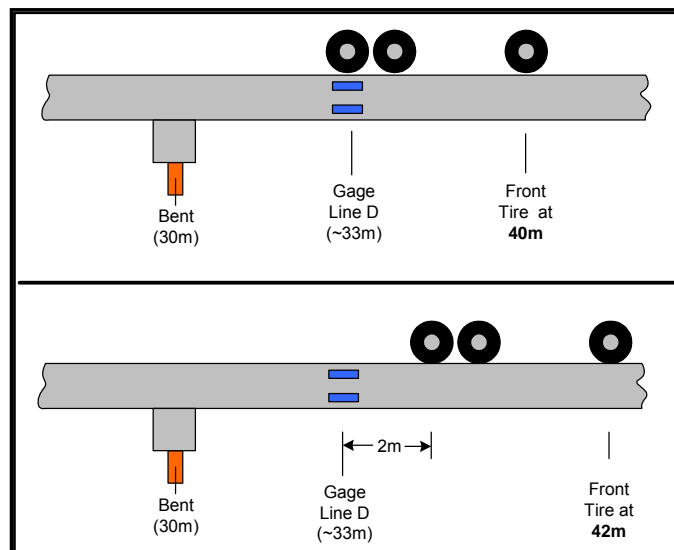
Figure 35 Distinction between 40m and 42m truck positions, relative to Gage Line D

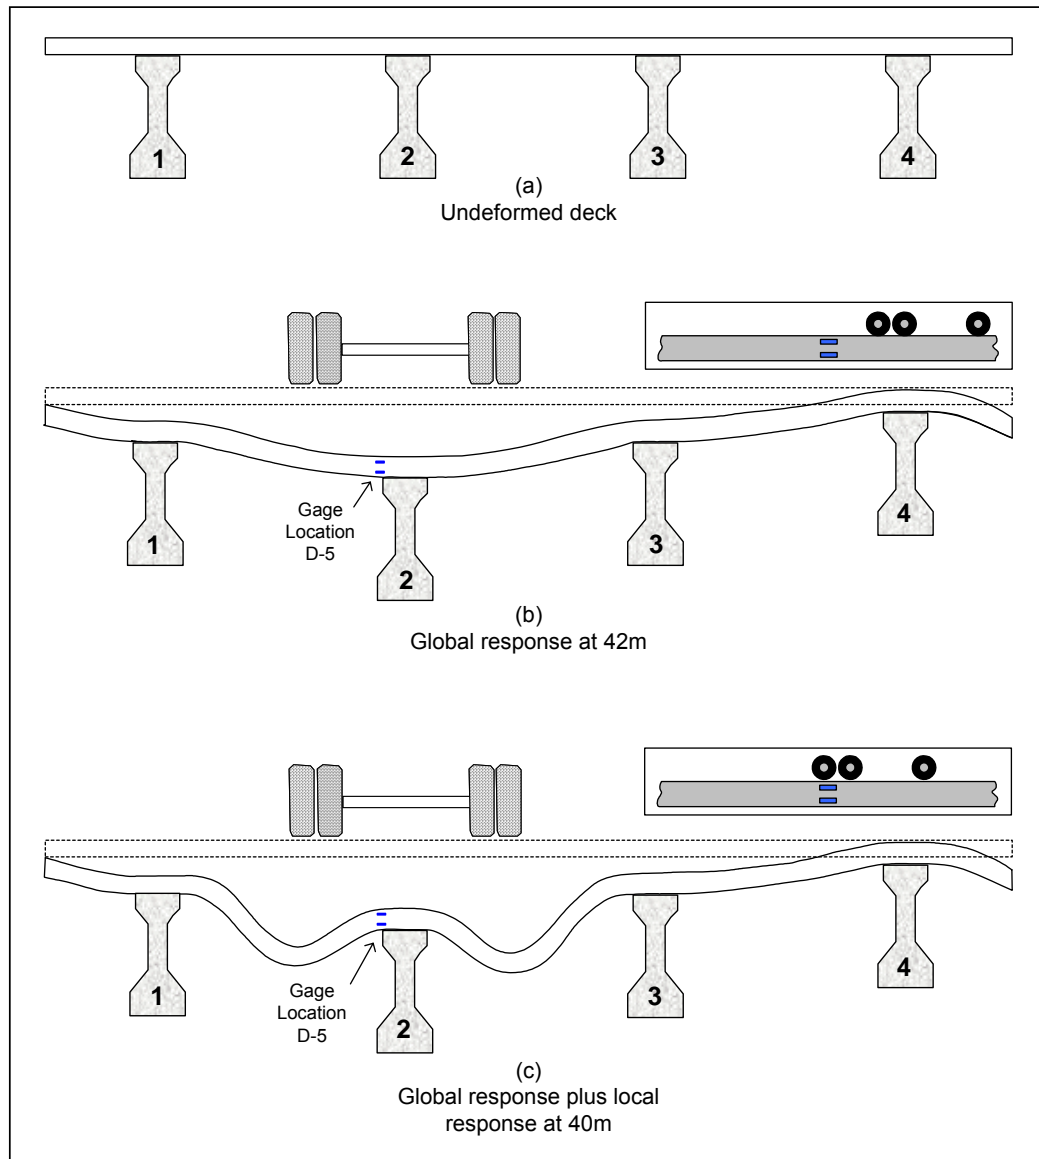
The distinct presence of the global positive moment and the local negative moment in the deck response at Gage Line D are best seen in the strains measured at the 42m and 40m truck positions, respectively. Transverse strain profiles for the Conventional deck at Gage Line D for these two longitudinal truck positions are shown in Figure 44, for the ST-U test (truck straddling Girder 2). The solid points show the transverse strain profile when the tandem axle was away from Gage Line D (42m), revealing the global positive moment effect (Figure 43 (b)). The dashed points show the transverse strain profile when the rear tandem axle was at Gage Line D (40m), reflecting the local bending effect in the immediate vicinity of the axle and tires (Figure 43 (c)). Especially notable in the 40m (dashed) profile of Figure 44 is the local negative bending moment of over Girder 2, superposed atop the global positive bending moment. The net result of these superposed moments is a relatively small net negative bending moment over Girder 2 (top tension, bottom compression). In the clear span region (Gage Location D-4), the tires increase the positive moment, resulting in a relatively higher net positive moment (top compression, bottom tension) than observed for the global 42m response.

Figure 43 Exaggerated depiction of Global (42m) and Local (40m) responses

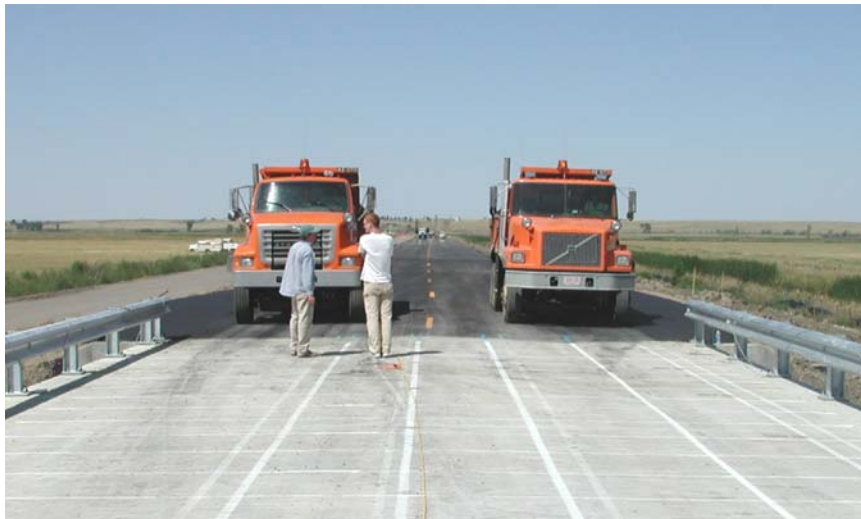
Figure 46 Test trucks preparing for a Two-Truck test

To verify the applicability of the Principle of Superposition, the three Saco bridges were tested using two heavily loaded three-axle dump trucks, traveling side-by-side along the length of the bridge, as seen in Figure 46. If superposition is valid, strains calculated by adding together the strains measured during two single-truck (ST) events should

match the strains measure during a corresponding two-truck (TT) event. A minimum of (2) Two-Truck live load tests was conducted on each bridge. Each of the three bridges was subjected to a Two-Truck X-T (TT-XT) experiment and a Two-Truck W-R (TT-WR) experiment (refer to Figure 25 (b)).

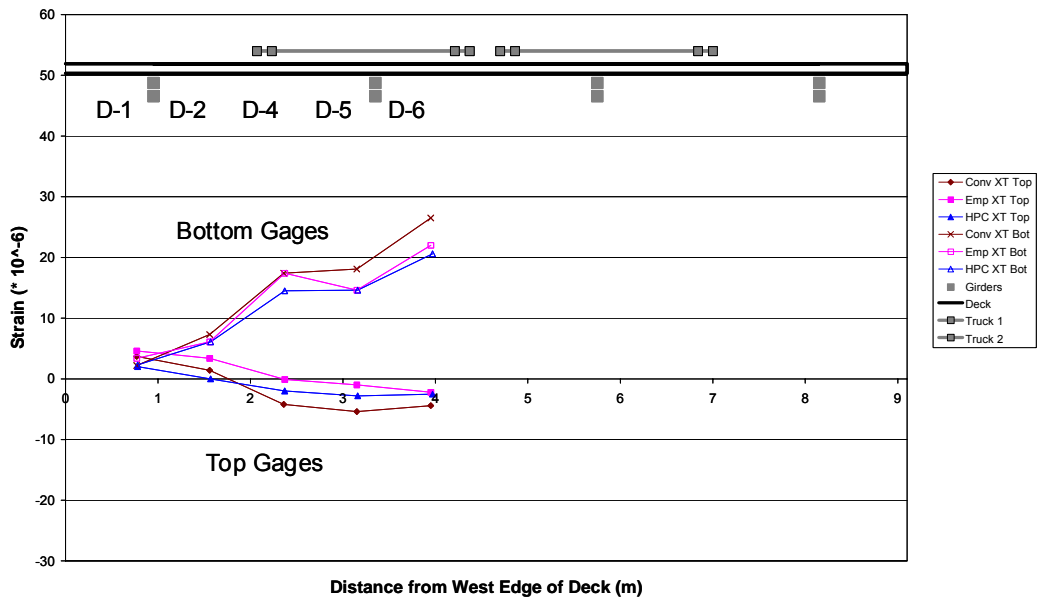
Figure 48 TT-XT transverse strain profile at 42m – All three decks

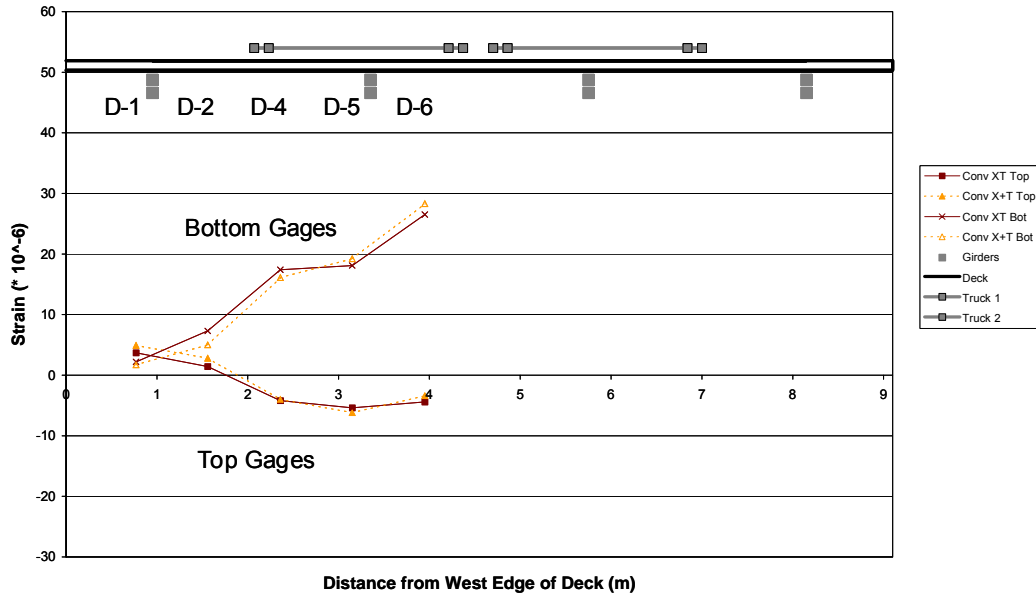
Figure 50 Typical TT-XT linear superposition comparison (Conventional deck at 42m)

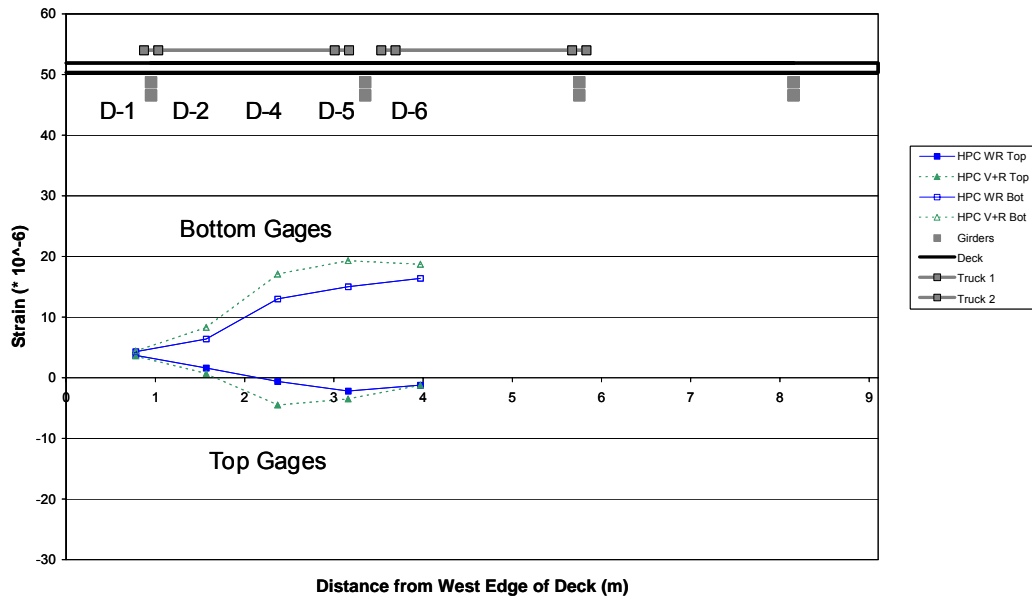
Figure 53 Typical TT-WR linear superposition comparison (HPC deck at 42m)
