CHARACTERIZATION AND ENERGY ANALYSIS OF  
FIBER REINFORCED POLYMER COMPOSITES  
BY ACOUSTIC EMISSION ANALYSIS

A thesis submitted in partial fulfillment  
of the requirements for the degree

Mechanical Engineering

MONTANA STATE UNIVERSITY  
Bozeman, Montana

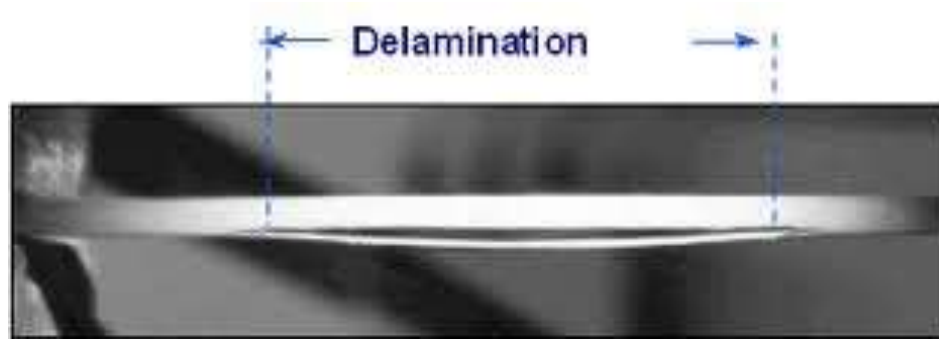
Figure 8: Delamination<sup>7</sup>

Delamination is a significant failure mode that is characterized by separation of adjacent laminate plies of composite material, this can be seen in Figure 8. Delamination can be caused by numerous loading scenarios but is most prevalent in bending as is experienced in an aircraft wing or wind turbine blade. As the plies peel away from each other, they lose flexural stiffness and the matrix can no longer distribute load to neighboring plies. Depending on the loading scenario the composite may be unable to carry the load that is required and fail. In terms of micro-mechanical damage, delamination is a combination of matrix cracking and interphase failure induced by various loading scenarios. For this reason, delamination will not be explicitly investigated in this research.

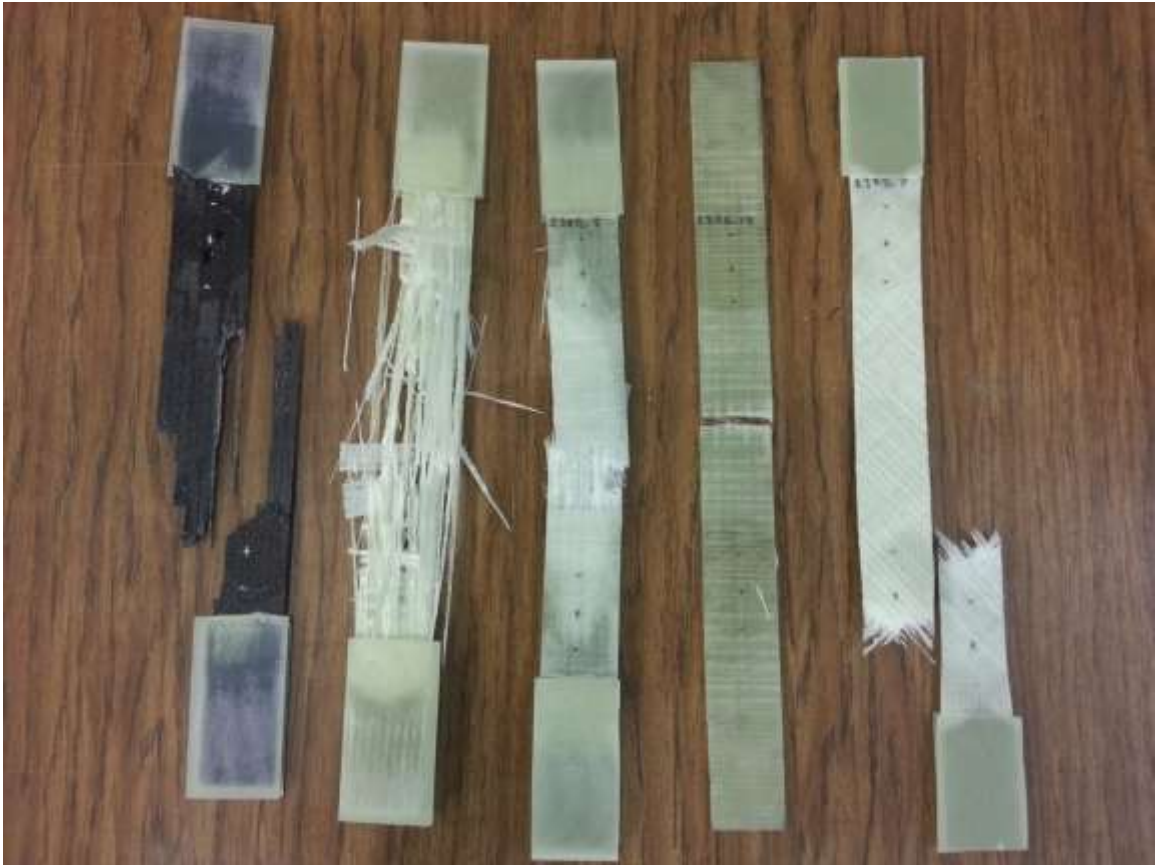
Figure 21: Various Failed Coupons from Left to Right:  $[0]_n$  Carbon-D and Glass-B,  $[90/0]_s$  Glass-A,  $[90]_n$  Glass-A and  $[45]_4$  Glass-C

Following will be an in-depth analysis of several methods used to characterize the damage progression of tensile tested composite coupons analyzed with acoustic emission instrumentation. Specifically monitored metrics are peak frequency, absolute energy and events over the course of a test. The energy of individual events as well as the accumulation rate will be taken into consideration for the test progression as well. These metrics be analyzed for all variants of static tests as well as representative tests of each layup type for the LUR dataset. Comparisons between materials and test types will be made and overall trends observed. Various failed coupons after testing can be seen below in Figure 21.
