Characterization of four inactive hard rock mines in western Montana  
by Jeffrey Harris Deckler

A thesis submitted in partial fulfillment of the requirements for the degree of MASTER OF SCIENCE  
in Land Rehabilitation

This study involved an inventory and characterization of four abandoned hard rock mine sites in western Montana to ascertain the hazards to public health, safety, and general welfare, as well as other environmental impacts, associated with these mines.

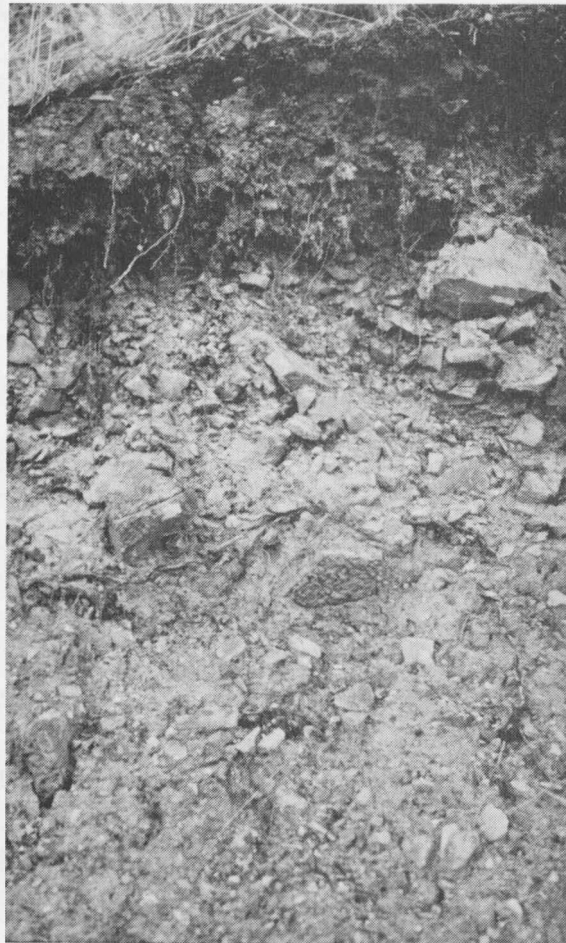
Figure 12. Profile of an undisturbed soil, showing soil development and horizonation. This pit is located at the Alta mine (site 09).

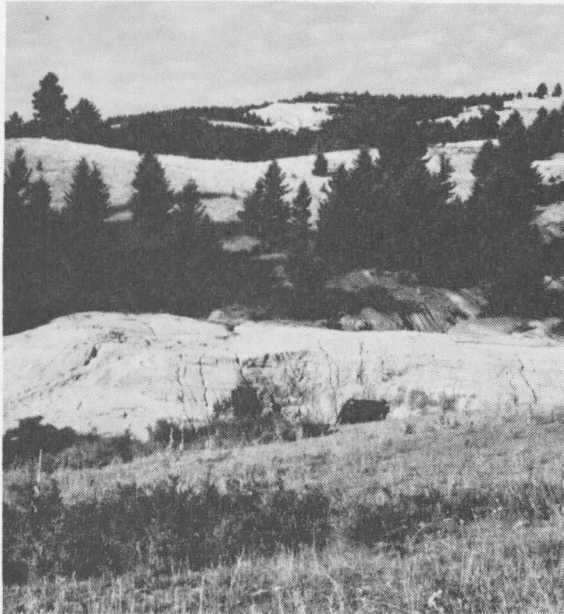
Figure 16. View of Bertha tailings looking south.

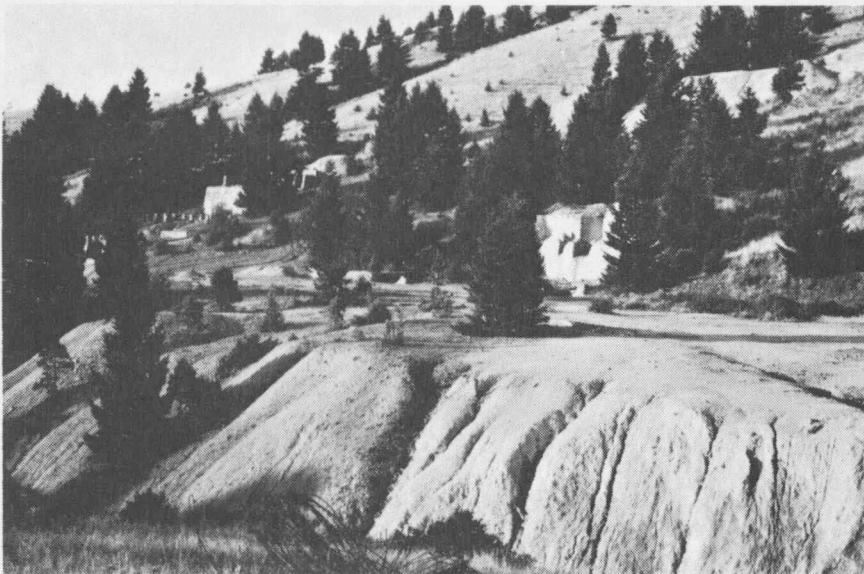
Figure 17. View of the Bertha mill site looking south.

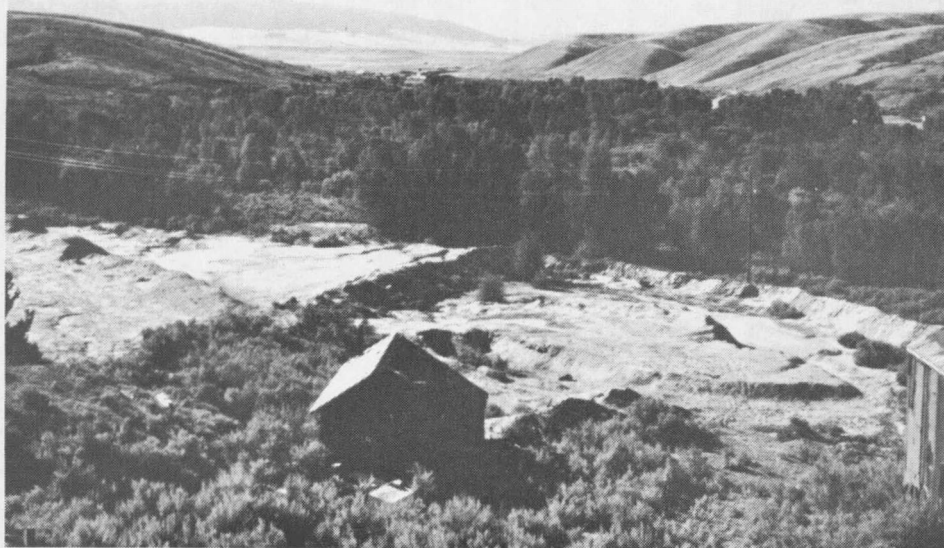
The disturbed area, which totaled approximately 2 ha, may be divided into upper and lower sections. The upper section consisted of the Hendricks mine excavations, and contained an open adit which should be considered a hazard to public health and safety. There were also hazardous areas of eroded, steep slopes associated with the open pit and areas of apparent hydraulic mining. The (lower) tailings pond area consisted of four diked levels of tailings which increased in thickness from 1.5 m at the eastern end of the ponds to 3.5 m at the western end. The dike of one of the ponds was breached. Adjacent to the northeastern perimeter of the ponds was an area with scattered piles of waste rock approximately 1.5 m high. These were probably remnants of former placer and hydraulic mining. The general features of the Bannack tailings site are illustrated in Figure 19. The lower portion of the mine also contained the remains of the old mill structure. Although the structure was in relatively good condition it was considered a potential safety hazard.

Figure 19. View of the Bannack tailings ponds looking NE from the Hendricks mine adit.

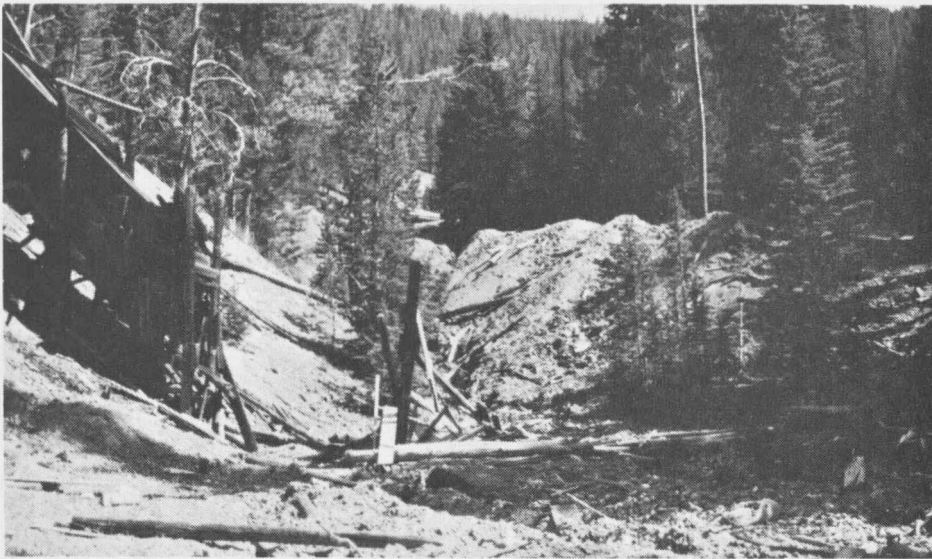
were found at the bottom of the pit. The Wasa 1, 2, and 3 adits also constitute a safety hazard as they were all open to the surface and filled with water. The Zimmer Jack adit was collapsed at the surface. The only mine structures remaining were a loading chute and remnants of a dumping ramp on the lower portions of the mine. Of these, only the chute was viewed as a potential hazard. There were no tailings materials on the Wasa site, as ore from the mine was trucked to and milled at the Forest Rose mine (Popoff, 1953).

Figure 23. View of the Wasa mine looking east from below the Zimmer Jack adit.
