EXPERIMENTAL AND ANALYTICAL INVESTIGATION  
OF MASONRY INFILL AND CONFINED  
MASONRY WALL ASSEMBLIES

A thesis submitted in partial fulfillment  
of the requirements for the degree

Civil Engineering

MONTANA STATE UNIVERSITY  
Bozeman, Montana

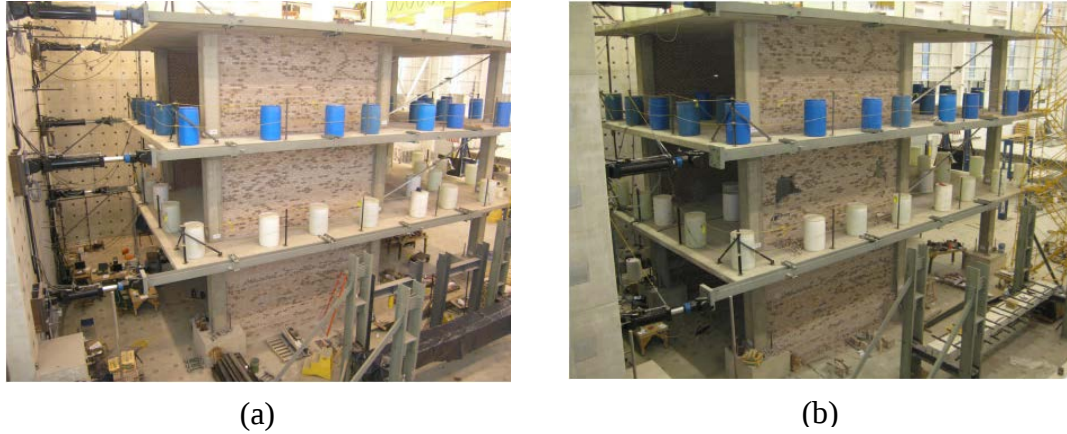
Figure 3: Three-story masonry infill test structure (left) before testing, (right) after testing (Pujol and Fick 2010)

The concentration of damage in the second floor implies that the load being applied to the test structure is not being distributed uniformly, and that the second floor gathers the majority of the load with little relief from the first and third floors. This type of behavior can be unfavorable if more stories are added to the structure.

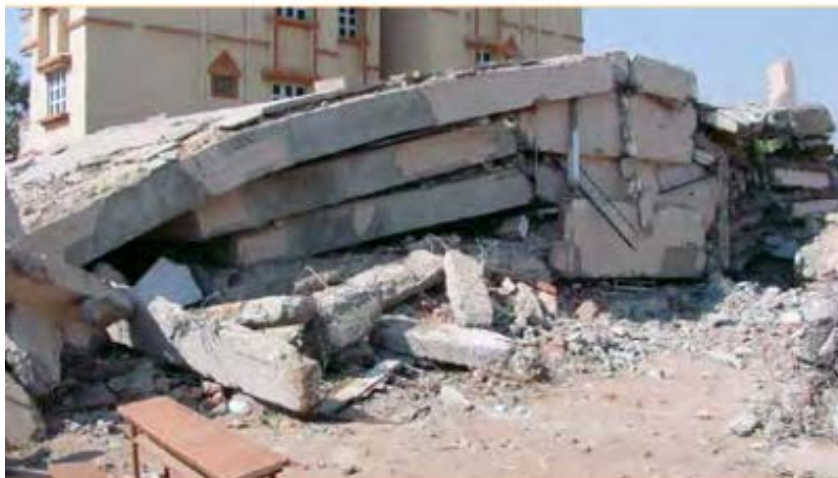
Figure 5: Building collapse due to strong beam-weak column design in 2001 Bhuj, India earthquake (Murty, Brzev et al. 2006)

One way to improve seismic resistance in masonry infill structures is to design for strong column – weak beam behavior. The intended failure occurs first in the beams which are detailed to act as ductile members. These detailing requirements are necessary for the dissipation of seismic energy and to minimize damage and possibility of collapse. Reports from various global earthquakes including the 1999 Duzce earthquake in Turkey, 2001 Bhuj earthquake in India, and the 2003 Boumerdes earthquake in Algeria revealed that buildings that were not proportioned consistent with this design methodology suffered severe damage and collapsed in some cases (Murty, Brzev et al. 2006). Collapses due to strong beam - weak column behavior are shown in Figure 5 and Figure 6.

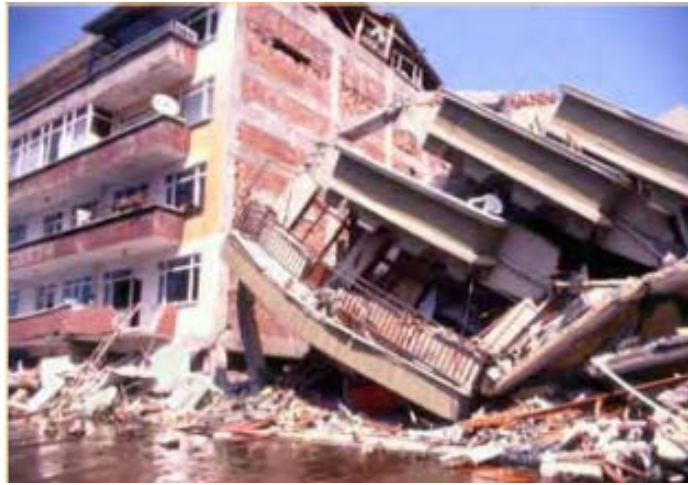
Figure 6: Multi-story collapse due to strong beam-weak column design in 1999 Turkey earthquake (Murty, Brzev et al. 2006)

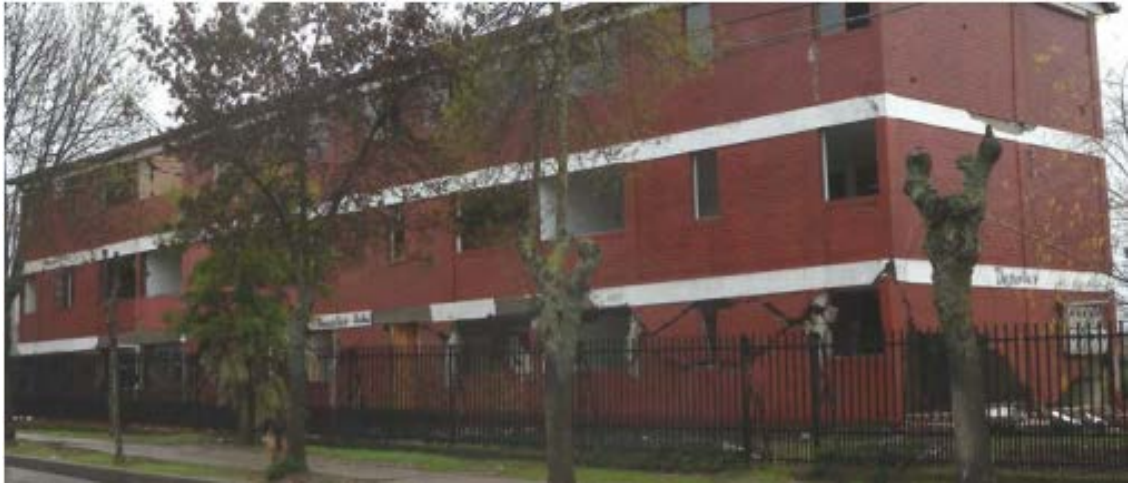
Figure 8: Damage sustained to the first floor of a three-story confined masonry building after Chile's 2010, 8.8 Mw earthquake (Brzev, Astroza et al. 2010)

Unlike masonry infill walls, the performance of confined masonry walls subjected to earthquake loads has been found by researchers to be a function of “wall densities”. The “wall density” is defined as the ratio of the cross-sectional area of the walls in a principal plan direction to the total floor area of the building. Brzev, Astroza et al. 2010 found that confined masonry buildings performed exceptionally well during the February 27, 2010 Chile earthquake with a majority of the one to two-story buildings having negligible damage. A few confined masonry buildings, however, suffered moderate to severe damage, including complete collapse. These buildings, such as the building in shown in Figure 8, were found to have wall densities of approximately 1% compared with recommended wall densities for low-rise buildings of 2-3% (Brzev, Astroza et al. 2010).

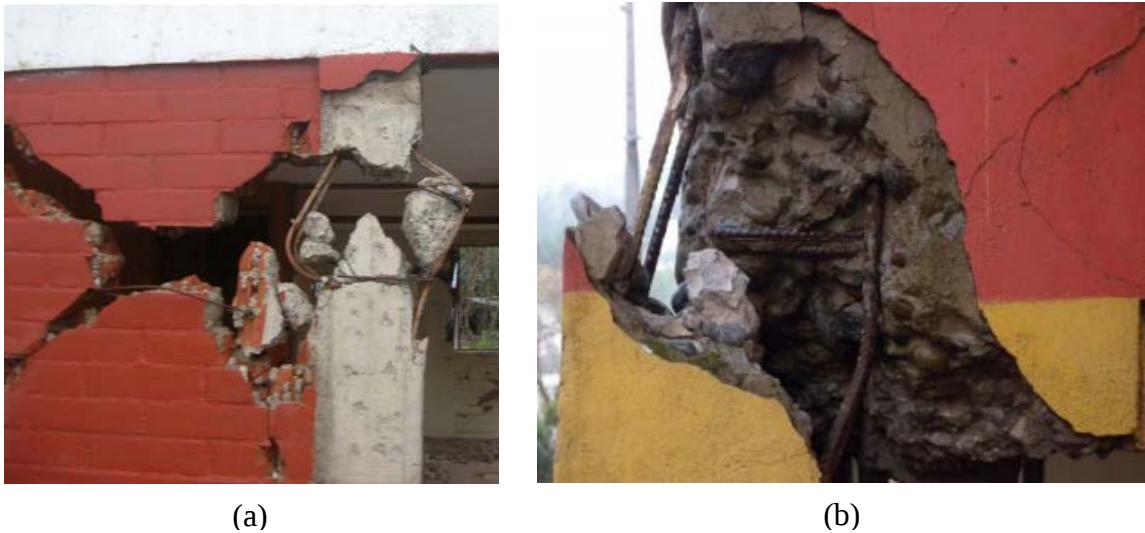
Figure 9: Inadequate reinforcement detailing causing (a) buckling of longitudinal column reinforcement, and (b) shear cracks forming at connection of tie-column and tie-beam (Brzev, Astroza et al. 2010)

Detailing of reinforcement in the concrete confining elements was also found to be a main source of deficiency in the confined masonry walls within damaged buildings in Chile, where inadequate confinement by tie-column reinforcement was noted. The increased spacing of tie column reinforcement resulted in buckling of the column longitudinal bars (see Figure 9). The current Chilean code requires an end spacing of 4 in. (Brzev, Astroza et al. 2010); however, this reduced spacing was not found within any of the damaged buildings because at the time of construction it was not required by the Chilean building code.

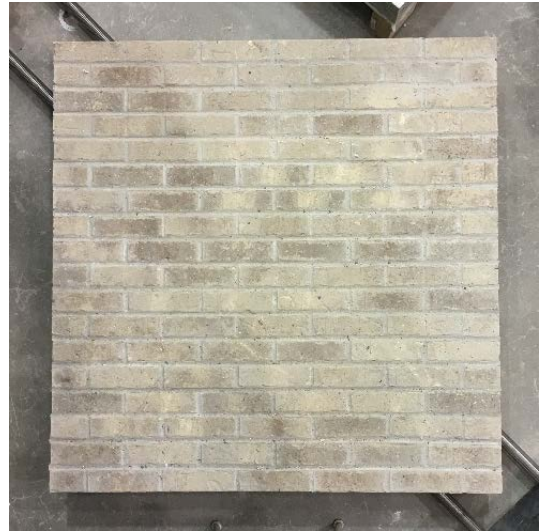
Figure 12: Plan view of the plain masonry specimen as a (a) reference drawing and (b) post construction

Plain masonry (PM) wall specimens were constructed with 8 in. x 3-5/8 in. x 2-1/4 in. modular blocks held together by a 3/8 in. mortar bed. The bricks were selected to represent the traditional modular brick size and finish of standard face brick (see Figure 13). The wall is 4 ft. x 4 ft. in dimension. Masonry cores were fully grouted. The plain masonry wall is shown in Figure 12.

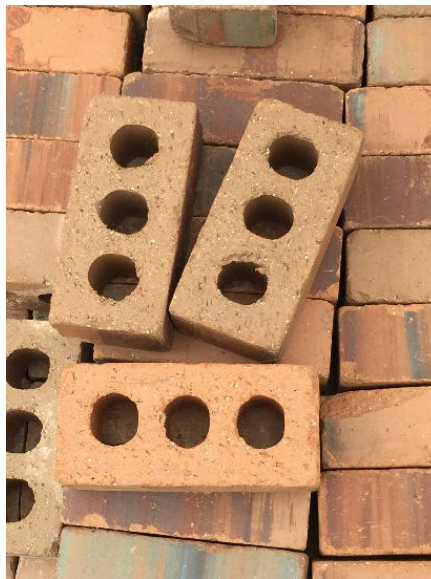
Figure 13: Standard clay masonry units used in all masonry panels

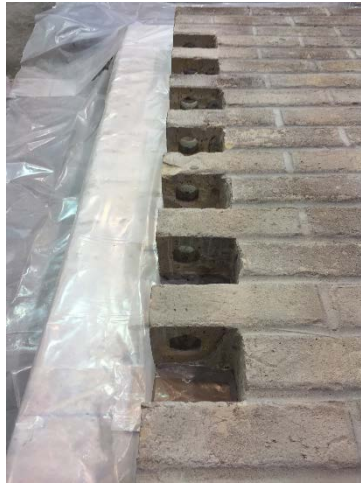
Figure 17: Shear keys present in confined masonry wall

For the confined masonry wall, the masonry panel was constructed first and laid onto a platform. After the masonry panel is constructed, the concrete is cast around the perimeter. Shear keys form in the brick recessions and provide an interaction between the concrete and masonry and help resist a portion of the shear placed onto the wall. Unlike the masonry infill wall, the materials in the confined masonry configuration interact through a bond developed during the curing of the concrete. The masonry shear keys can be seen in Figure 17 and are shown prior to casting the concrete frame.

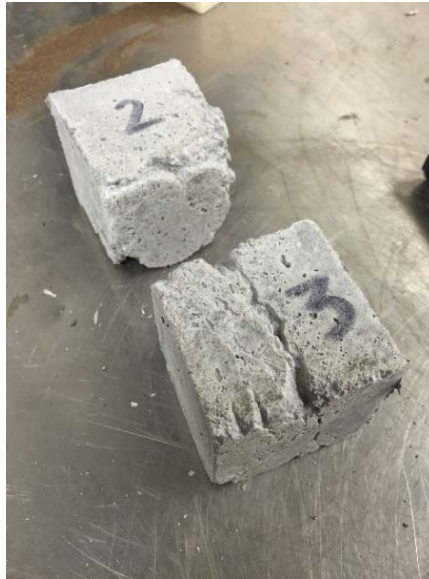
Figure 18: Typical mortar prisms

Each masonry panel was constructed using a Type S, Quickrete mortar. Mortar beds were approximately 3/8 in. thick for each masonry course. Three mortar cubes were made for each wall assembly, which can be seen in Figure 18. Mortar compression test results performed according to ASTM C109M at 28 days are shown in Table 2.

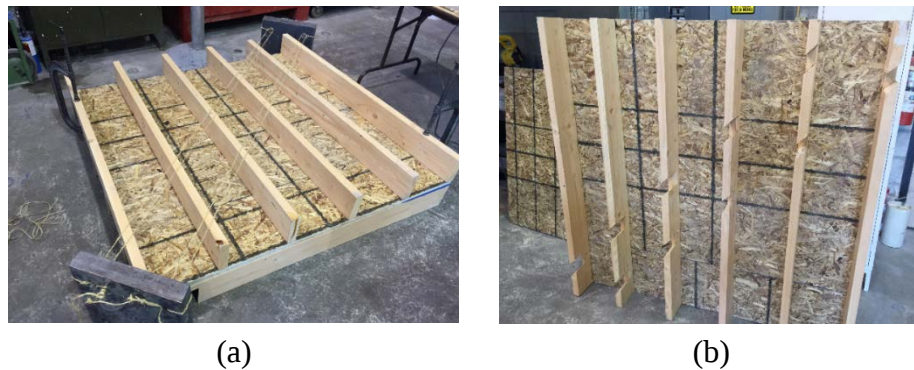
Figure 20: Platform construction for wall specimens. (a) creating holes for tension rods to pass through underneath the specimens and (b) completed platform

The walls were constructed on 3/4 in. OSB board supported by 2 in. x 6 in. wood supports. The supports were notched so the bottom two 1-1/2 in. diameter loading rods could pass underneath the specimen (rods are described in more detail in experimental setup). Photos of the test specimen's support platforms are shown in Figure 20.

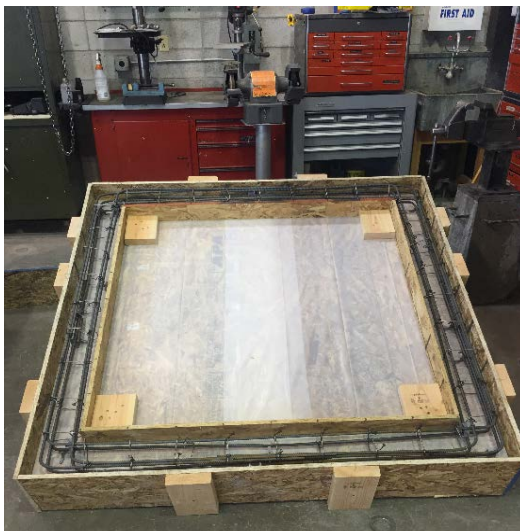
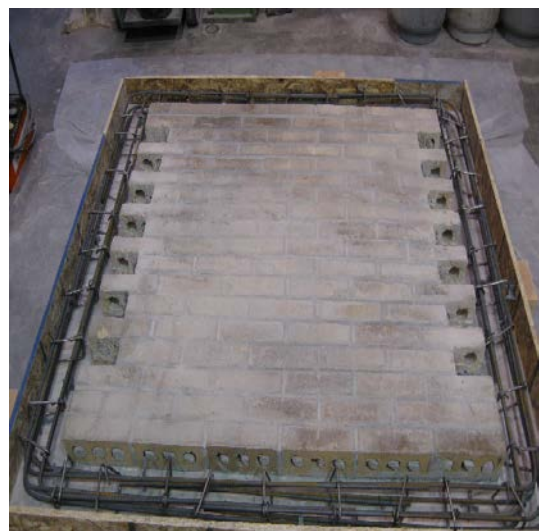
Figure 23: Reinforcement used in confinement for both (a) masonry infill wall and (b) confined masonry wall

The rebar layout for each frame is shown in Figure 22. Completed rebar placement for the masonry infill walls is shown in Figure 23. As a note, shear keys in the confined masonry wall received no additional reinforcement.

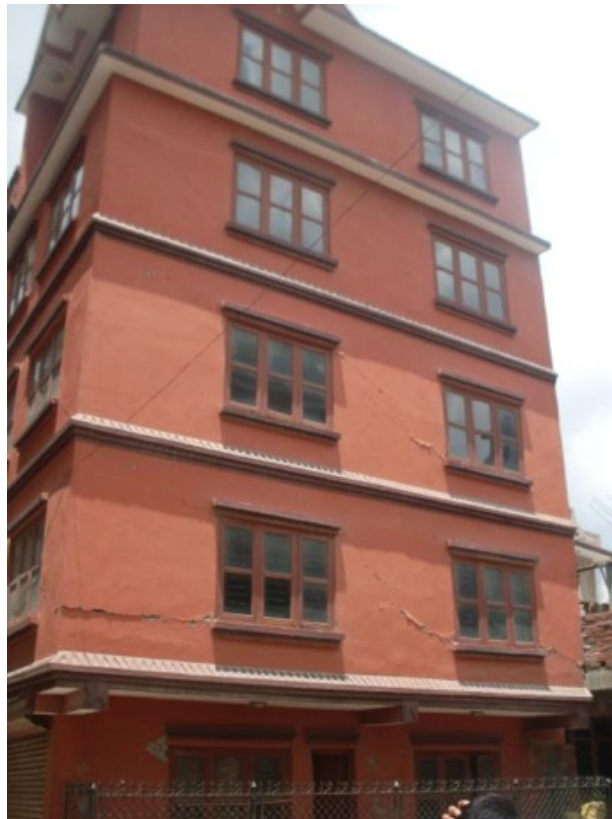
Figure 60: Masonry damage observed on the eastern wall of the Gongabu Bus Park Building 2A

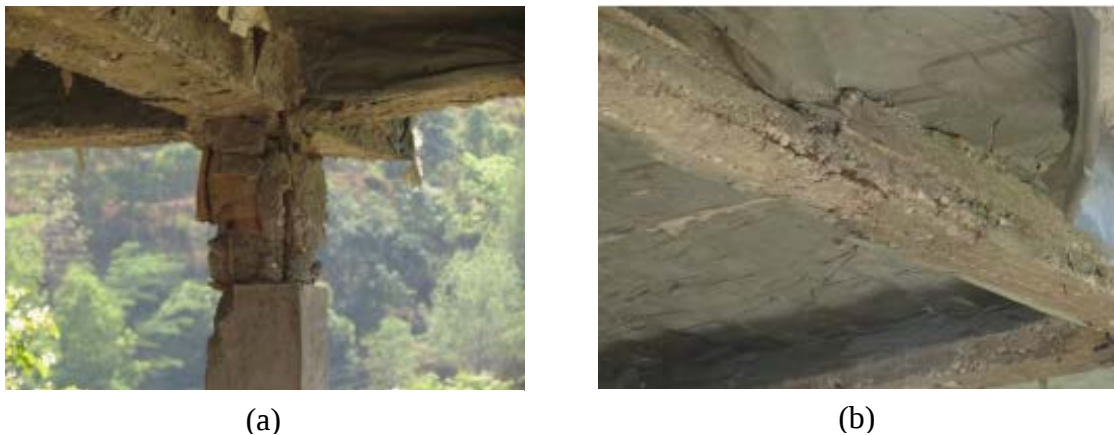
Figure 71: Severe failure caused by poor detailing. (a) insufficient joint reinforcement at beam-column connections, (b) poor quality concrete in structural elements (Lizundia, Shrestha et al. 2016)

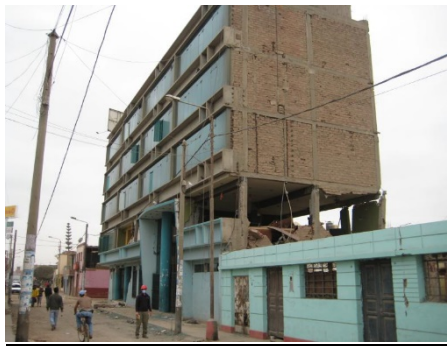
Figure 72: Severely damaged masonry infill building in Peru following the 8.0 Mw earthquake (DataHub 2015)

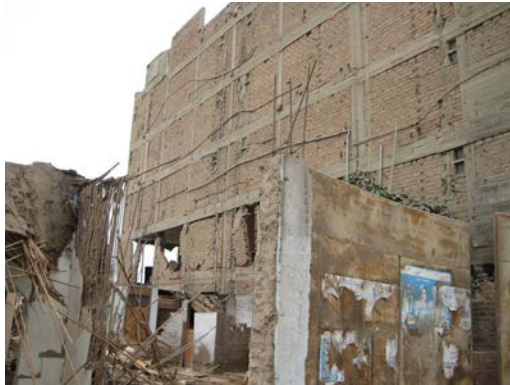
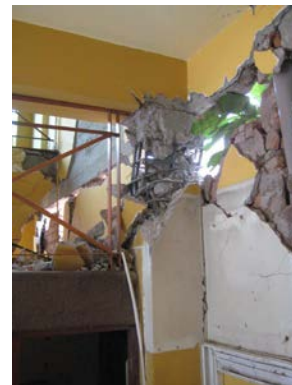
Figure 73: Severely damaged structural elements found in the building; (a) Masonry infill panels that have been crushed or have fallen out completely, (b) Severely damaged concrete captive column (DataHub 2015)

earthquakes suggests these structures may have performed with brittle behavior. Therefore, even if all structures did have priority indices greater than 0.4%, they may have still been at risk due to an inability to dissipate the seismic energy through ductile behavior. Severe damage resulting from the initial 8.0 Mw earthquake is shown in Figure 72 and Figure 73.

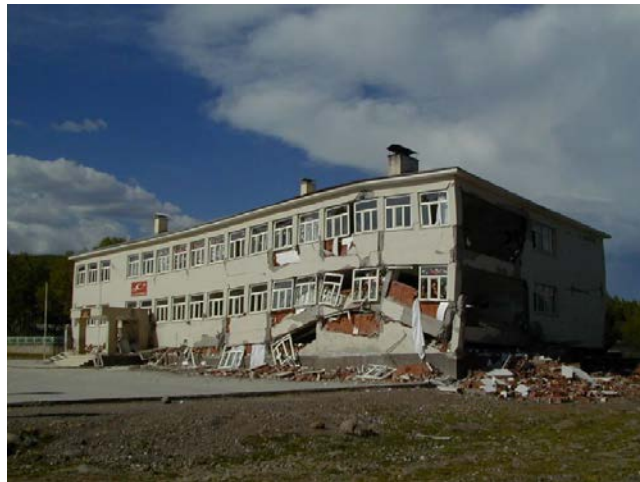
Figure 74: School building in Bingol, Turkey that suffered collapse in the 6.4 Mw earthquake (DataHub 2015)

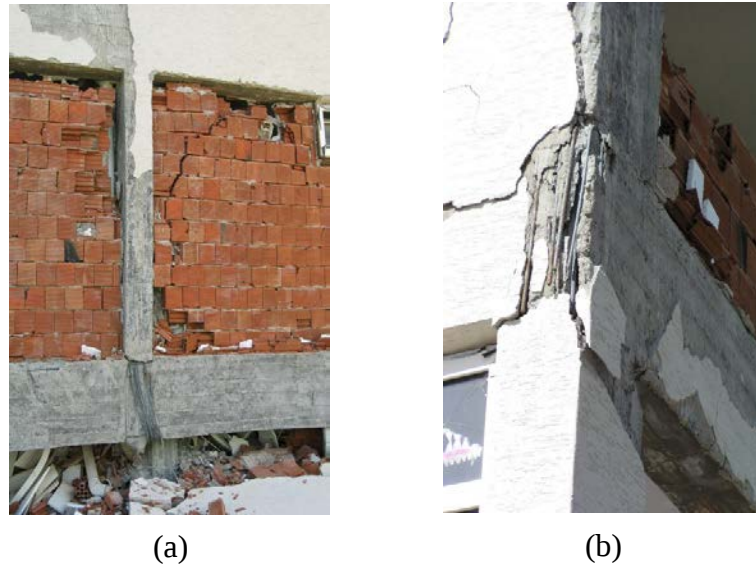
Figure 75: Severely damaged structural elements found in the collapsed school building; (a) masonry exhibiting large shear cracks and crushing, (b) concrete beam-column connection failure as a result of poor detailing (DataHub 2015)
