Bacterial colonization and modification of grain boundaries on 316L stainless steel  
by Richard John Gillis

A thesis submitted in partial fulfillment of the requirements for the degree of Master of Science in  
Microbiology  
Montana State University  
© Copyright by Richard John Gillis (1993)

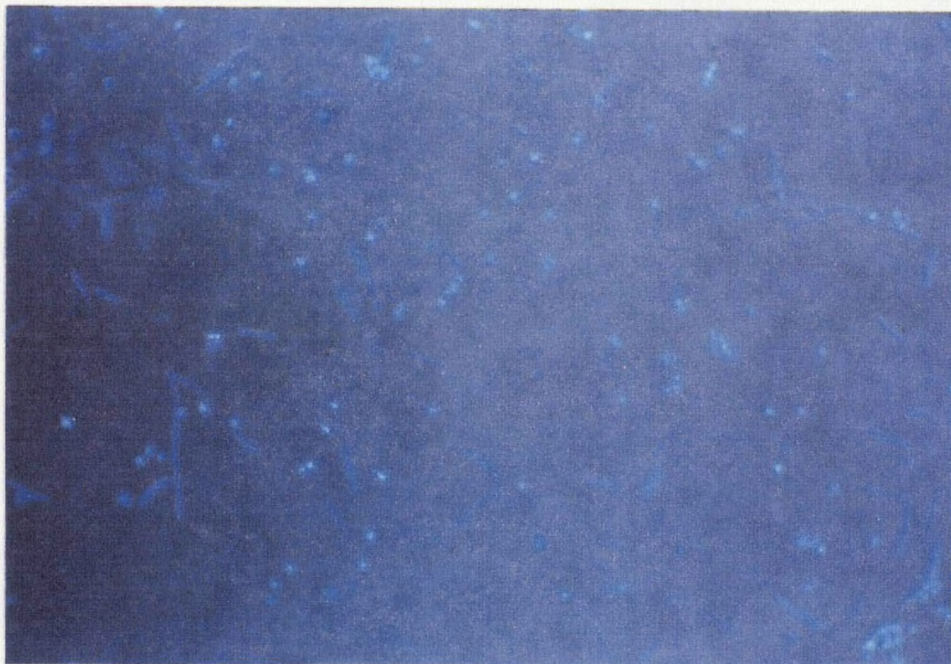
**Figure 2.** Image showing *D. gigas* (large vibroid bacteria) and *C. freundii* (very small rods) stained with DAPI on the same membrane filter at 400X magnification.

A growth curve was performed using *D. gigas* in the presence or absence of *C. freundii*. Replicate stopper-sealed flasks were filled with 10 strength EPRI medium as described below, amended with resazurin (0.1 mg/ml) and ascorbic acid (1 g/l) as a reducing agent, flushed with nitrogen, then autoclaved for 15 minutes. Modified Hutner salts and iron chloride were added after autoclaving. An inoculum of approximately  $1 \times 10^5$  cells of *D. gigas*, verified via AODC, from a culture grown anaerobically for 14 days at 22°C was used. An inoculum of approximately  $1 \times 10^8$  cells of *C. freundii* was used from a 24 hour batch culture of *C. freundii* grown in EPRI medium at 22°C. Samples of suspended cells were enumerated daily for 27 days via AODC on membrane filters as will be described. *C. freundii* was enumerated at 1000X magnification, while *D. gigas* was enumerated at 400X and differentiated from *C. freundii* on the basis of morphology (Figure 2).

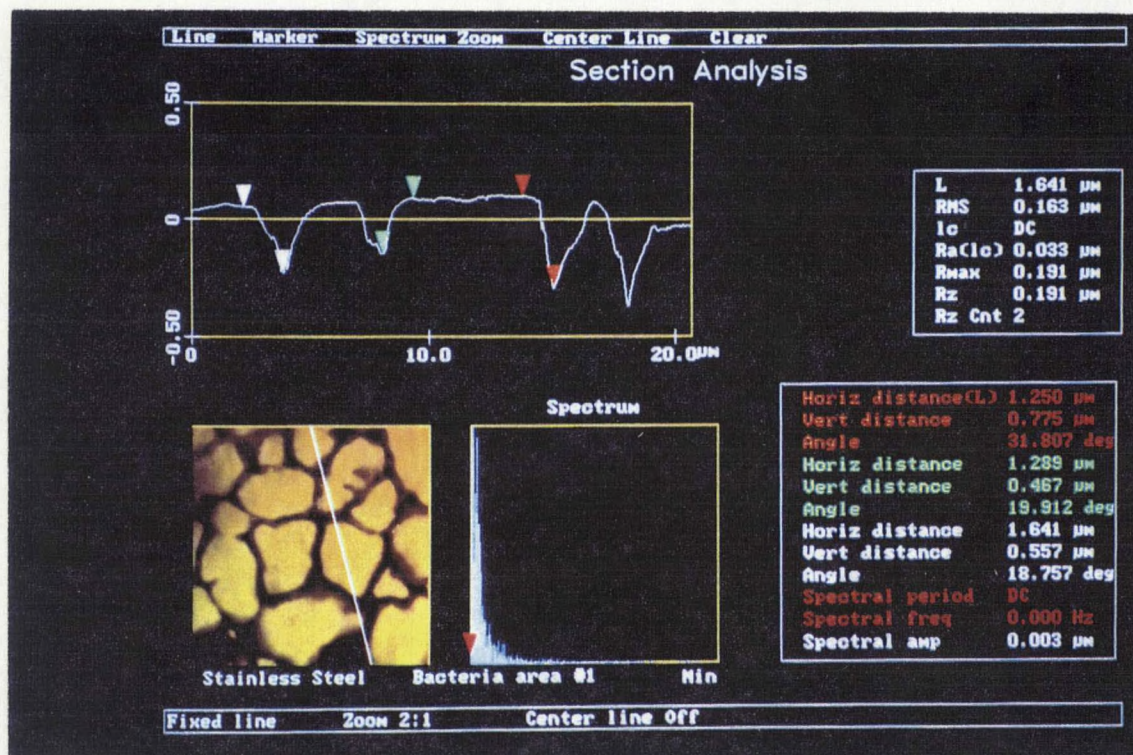
**Figure 3.** Section analysis generated by atomic force microscopy of the 316L stainless steel surface. Arrow color in upper left depth profile corresponds to vertical distance data in lower right.

A coupon exposed to bacteria was examined using an atomic force microscope (AFM) to determine depth and width of grain boundaries. This was done by Clint Callahan at Imaging Services, Santa Barbara, CA. The sample was imaged in air using a Nanoscope III multimode AFM (Digital Instruments, Santa Barbara, California) operating in contact mode. The AFM was equipped with a 450  $\mu\text{m}$  silicon cantilever (Digital Instruments) with an imaging force of approximately  $10^{-9}$  N. Three different fields were examined on the sample with three different AFM section analyses done for each field. An average vertical distance or depth was determined for the grain boundaries based on 24 vertical distance measurements from the top of a grain to the bottom of a grain boundary (see Figure 3). An average horizontal distance of width was determined based on 12 horizontal distance measurements from each side of a grain boundary.

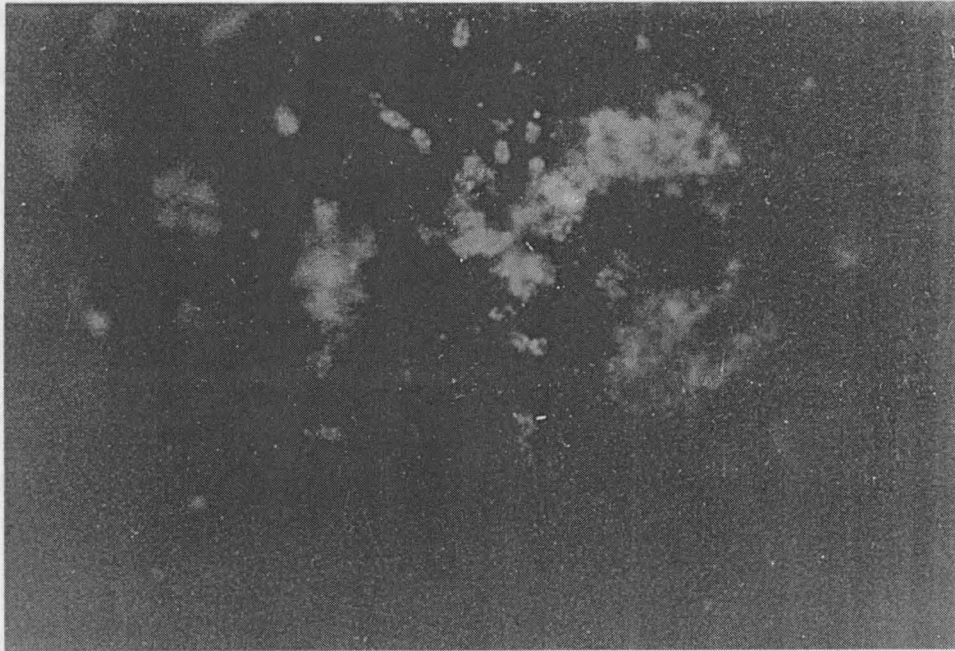
**Figure 4.** Biofilm containing *C. freundii* and *D. gigas* grown aerobically on hand polished 316L SS. Two illuminations of the same field (a) SRB stained with antibody (b) Total cells stained with DAPI. Magnification 1000X

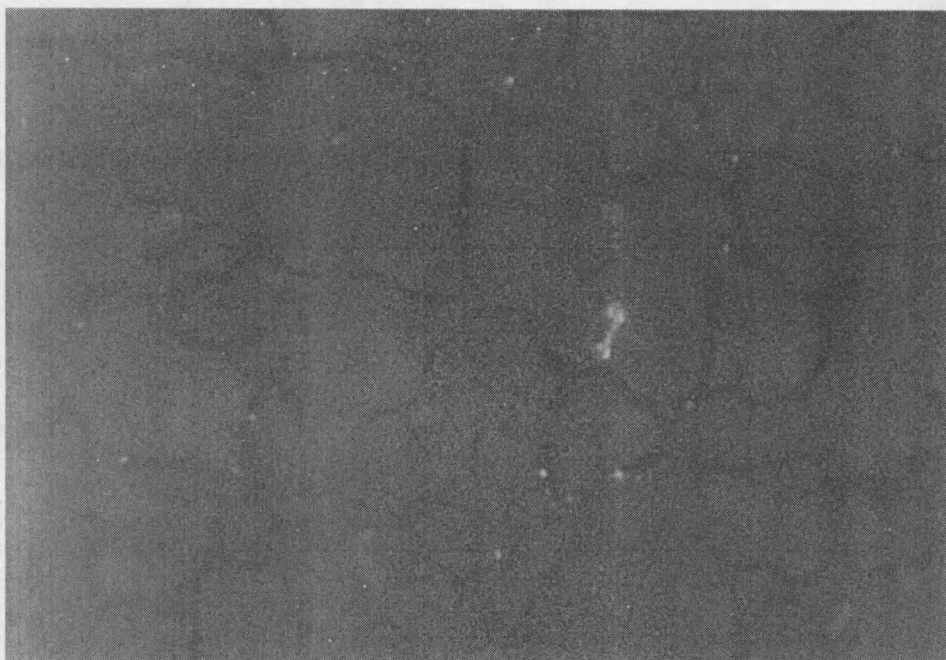
**Figure 5.** Epifluorescent micrographs of unstained as-received 316L SS surface, comparing (a) non-passivated to (b) passivated. Autofluorescing material is very abundant in (a). Magnification 1000X.

The passivation procedure previously described proved useful in removing autofluorescing material from the surface (Figure 5). Hand-polishing was originally done to eliminate this material from the surface. When the SRB antibody was introduced to the passivated surface, non-specific fluorescence

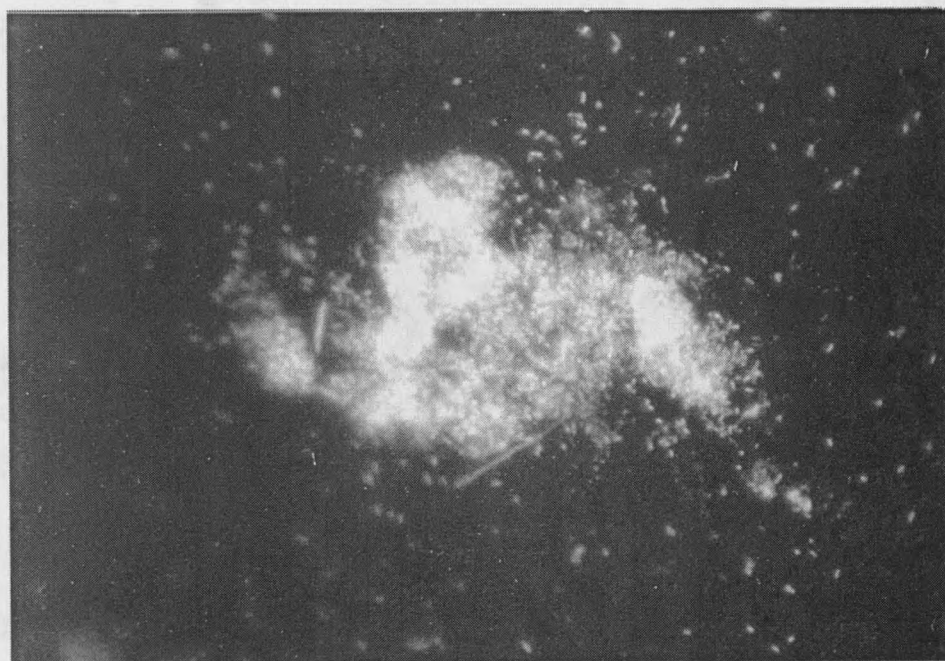
**Figure 10.** Epifluorescent micrograph of DAPI stained biofilm on 316L SS from batch culture containing *D. gigas* and *C. freundii*. Magnification 1000X.
