# **Exploration of Opportunities to Address the Impacts of Roads and Traffic on Wildlife Around Rocky Flats National Wildlife Refuge**

FINAL REPORT

Prepared by  
Marcel P. Huijser, PhD  
James S. Begley, MSc  
Western Transportation Institute  
Montana State University

November, 2023

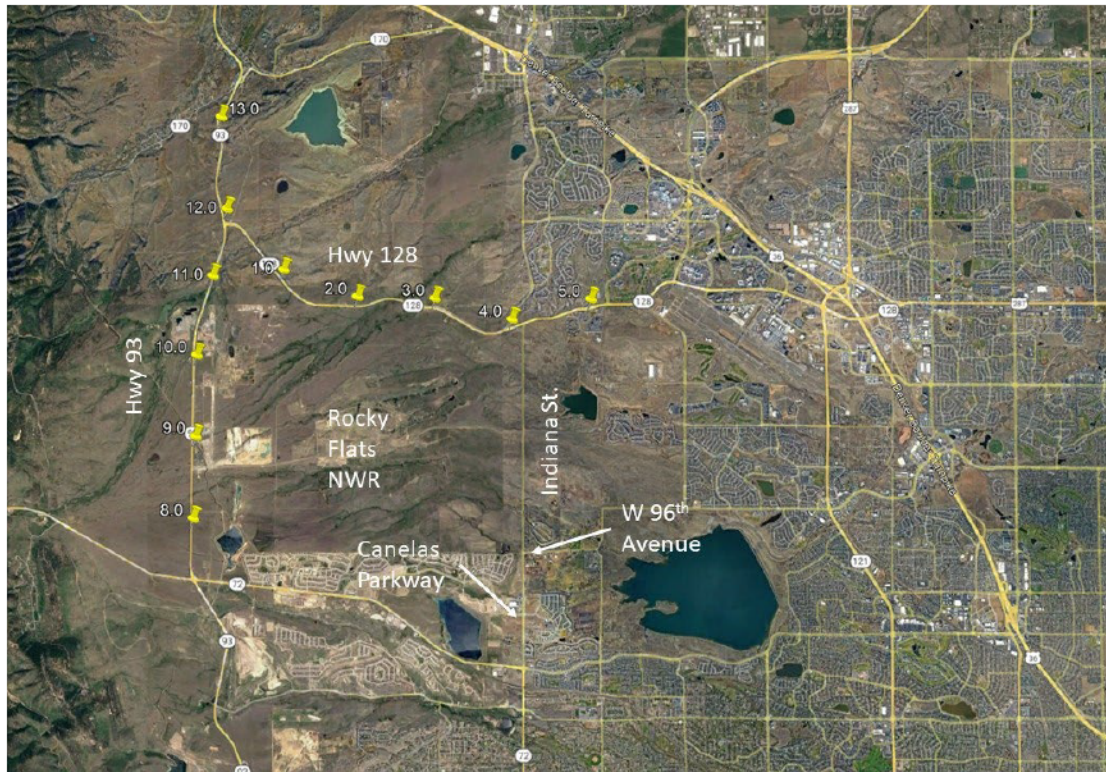
*Figure 2: The highway sections with mile reference posts and crossroads included in the animal-vehicle crash data analyses.*

1. Hwy 93
  - a. Start mile reference post: 7.2 (Junction with Hwy 72, Coal Creek Canyon Rd.).
  - b. End mile reference post: 11.9 (Junction with Hwy 128).
  - c. Length: 4.7 miles.
2. Hwy 128
  - a. Start mile reference post: 0.0 (Junction with Hwy 93).
  - b. End mile reference post: 4.2 (Junction with Indiana St.).
  - c. Length: 4.2 miles.
3. Indiana St. (no mile reference posts present, description based on crossroads)
  - a. Start: Junction with Hwy 128.
  - b. End: Junction with Canelas Parkway.
  - c. Length: 3.5 miles.

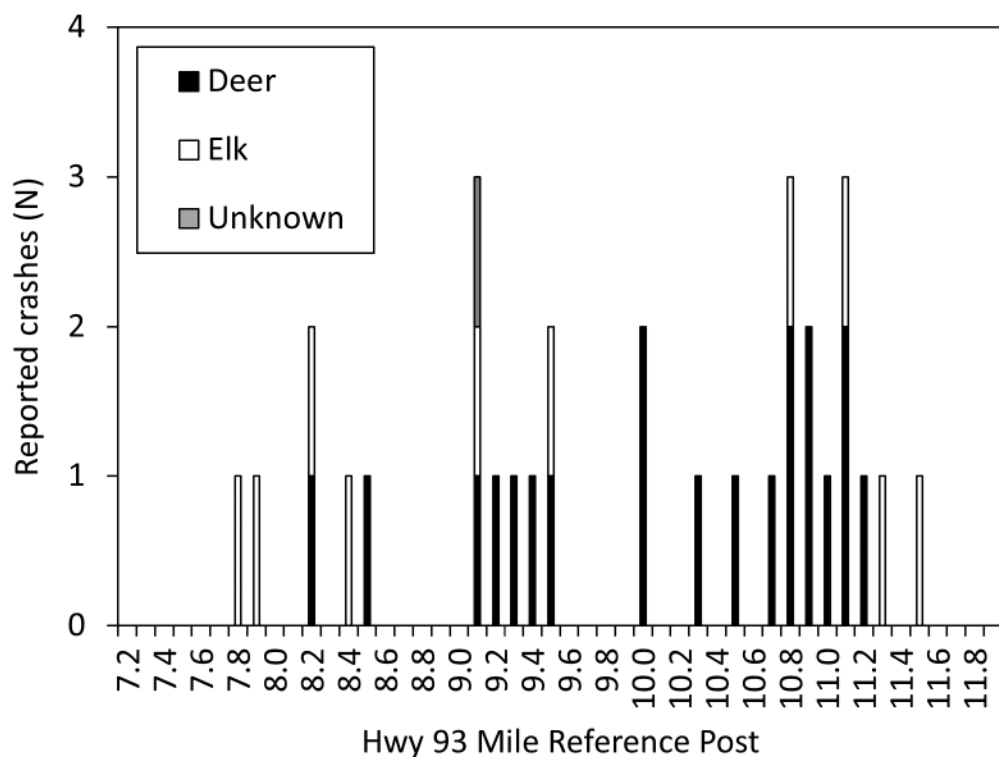
Figure 3: The number of reported crashes with animals along Hwy 93 between mile reference post 7.2 (Junction with Hwy 72, Coal Creek Canyon Rd.) and 11.9 (Junction with Hwy 128).

Along Hwy 93, deer and elk crashes were most abundant between mile reference posts 9.1-9.5 and between 10.7 and 11.3 (Figure 3). Along Hwy 128, deer and elk crashes were most abundant at mile reference post 2.0 and 3.9 (Figure 4). Along Indiana St., deer and elk crashes were most abundant south of the junction with Hwy 128 (Figure 5).

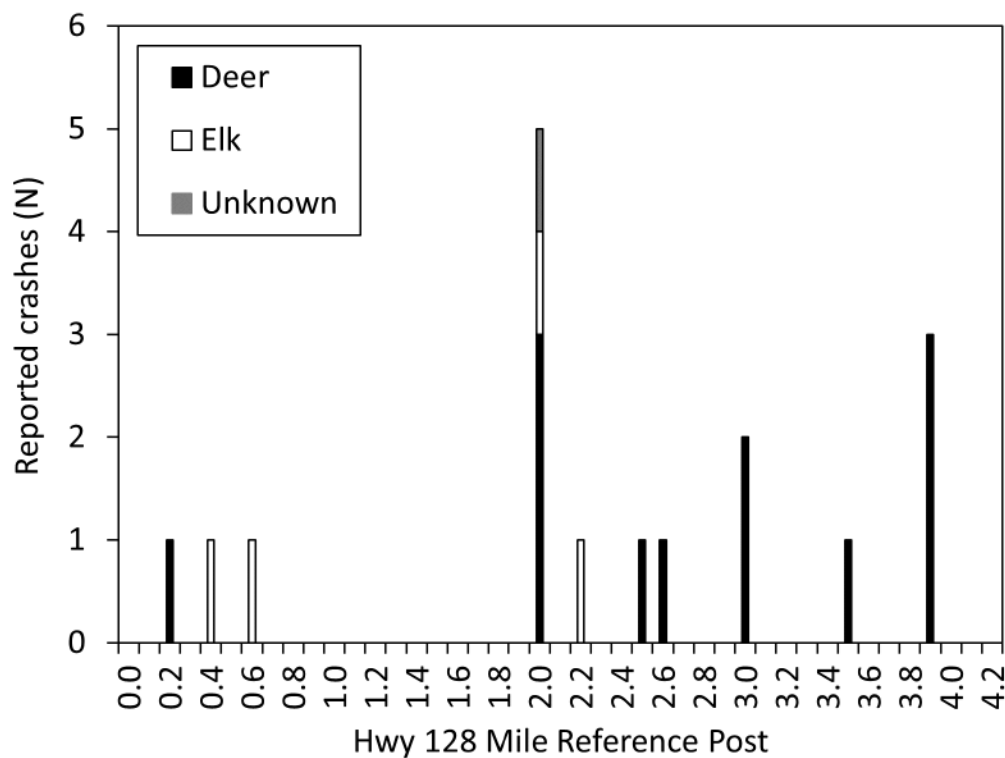
Figure 4: The number of reported crashes with animals along Hwy 128 between mile reference post 0.0 (Junction with Hwy 93) and 4.2 (Junction with Indiana St.).

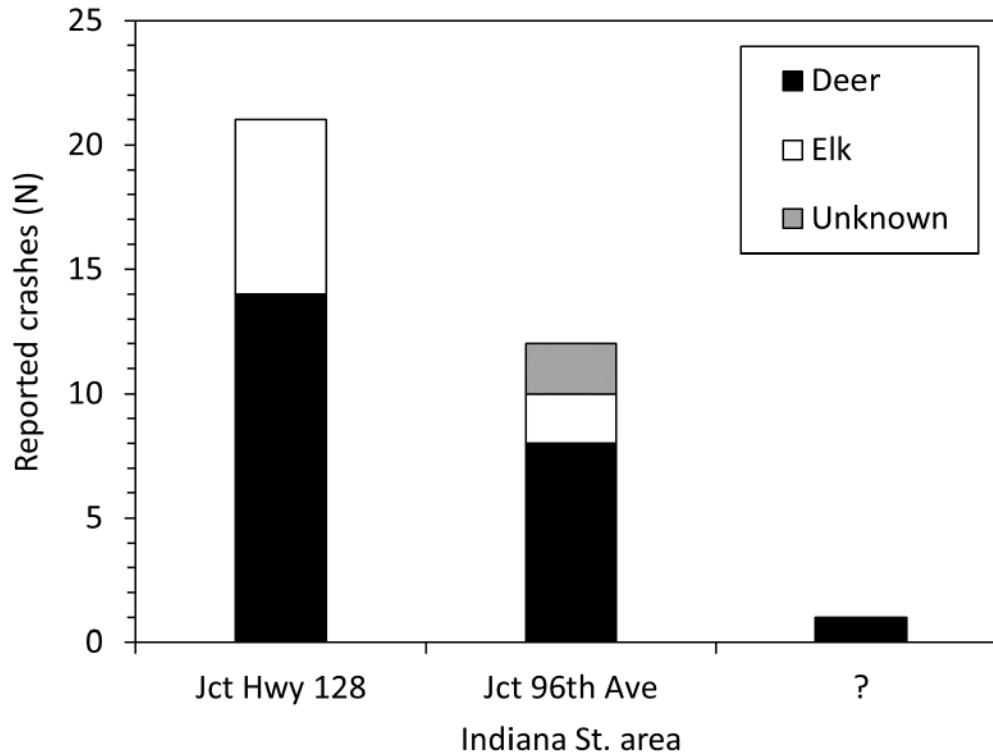
Figure 5: The number of reported crashes with animals along Indiana St. in 2 areas: South of Junction with Hwy 128 (north end), and around the Junction with W 96<sup>th</sup> Avenue (south end).

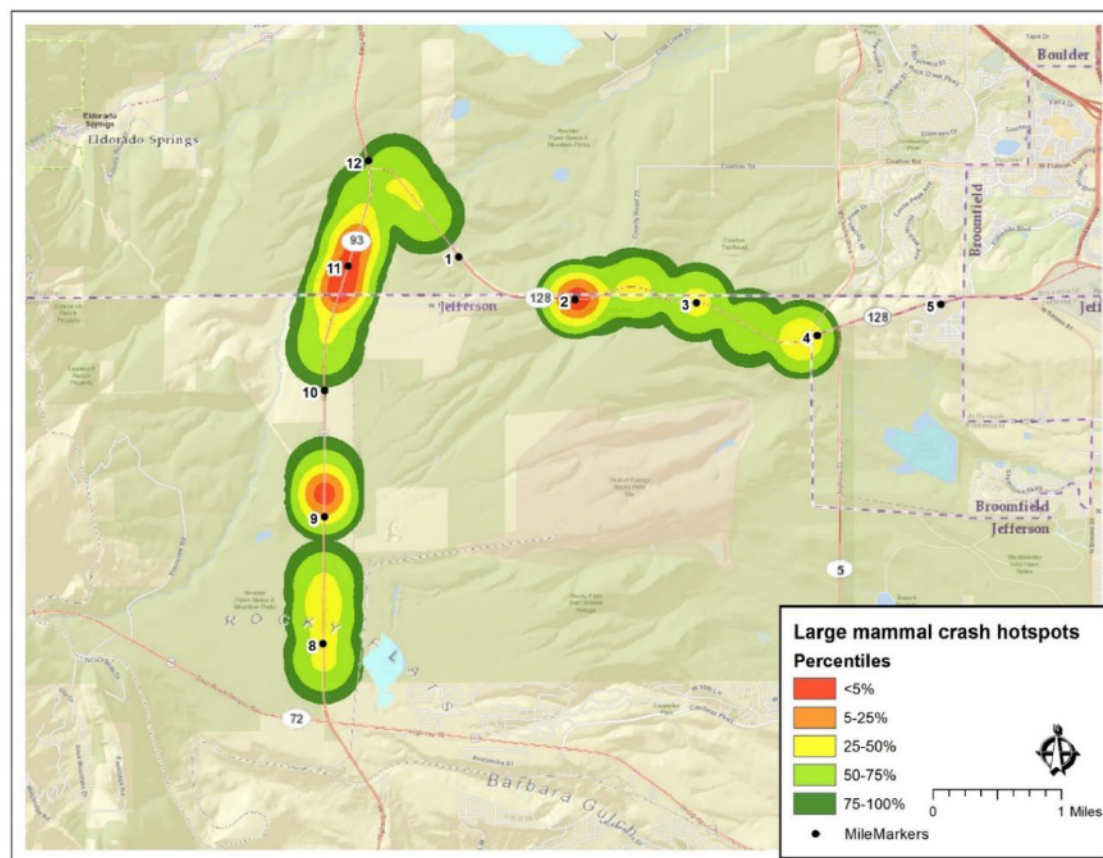
Figure 6: Kernel density hotspot percentiles for large mammal-vehicle crashes for Hwy 93 and Hwy 128 (2011–2020).

We investigated where the highest concentrations of large mammal-vehicle crashes were along Hwy 93 and Hwy 128 through a hotspot analysis. Large mammal-vehicle crashes along Indiana St. could not be included as the location of the observations was not spatially precise. The hotspot analysis was based on a Kernel density analysis using ArcGIS 10.6.1 (ESRI 2018) for point features of large mammal-vehicle crash locations using a 25 m cell size (82 ft × 82 ft). A 25 m cell size is relatively fine scale but still accommodates for some spatial inaccuracies in GPS coordinates. The Kernel density analysis calculates the density of crashes in a neighborhood around each cell and is based on the quartic kernel function described by Silverman (1986). We set the neighborhood search radius at 1,000 m (0.62 mi). On a straight road this means that large mammals crashes that are up to about 1,000 m away are included in the density analysis for each cell. To help interpret the results of the Kernel density analyses and identify hotspots, we displayed the raster output using a heat map classification with varying densities of crashes. We used percentage breaks to create five categories (<5%, 5-<25%, 25-<50%, 50-<75%, and 75-100%) that display the areas with the highest densities of crashes (<5%) to areas with the lowest densities (75-100%). The highest concentrations of large mammal-vehicle crashes were just north of mile reference posts 9 and 11 along Hwy 93, and around mile reference post 2 along Hwy 128 (Figure 6).

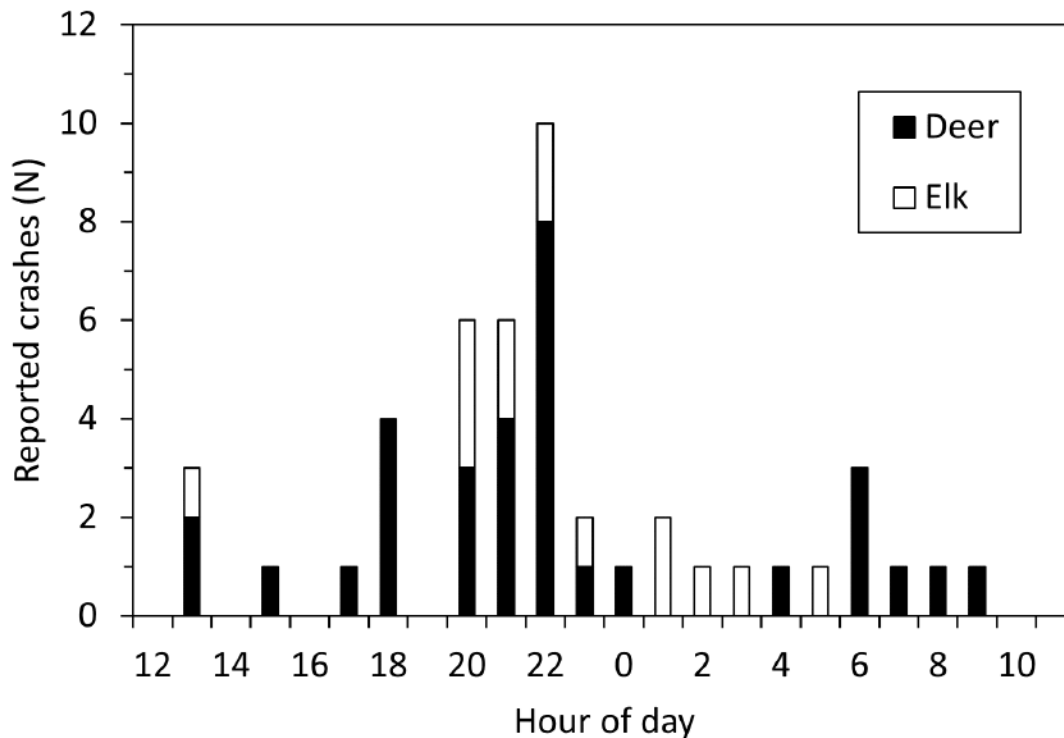
Figure 7: Deer and elk crashes by the hour of day (2011–2020). 20 = between 8 and 9 pm.

Deer and elk crashes predominantly occurred during the dark hours, especially between 8 and 11 pm (Figure 7).

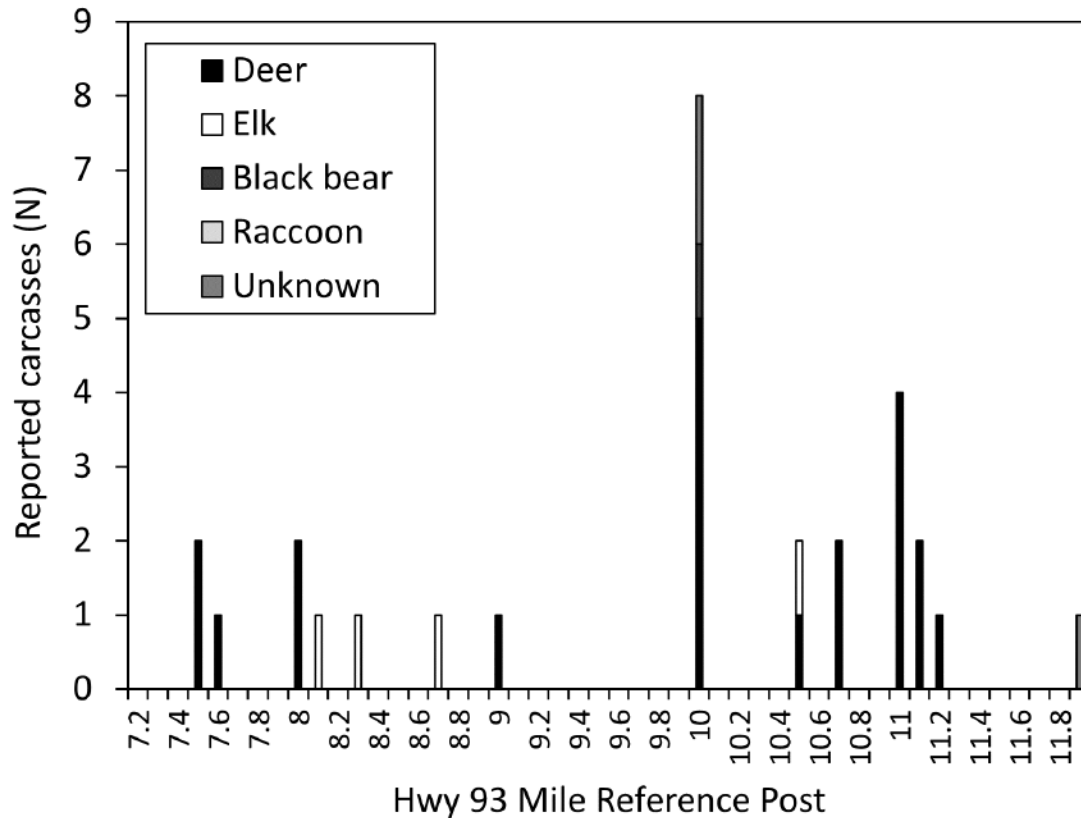
Figure 8: The number of reported carcasses with animals along Hwy 93 between mile reference post 7.2 (Junction with Hwy 72, Coal Creek Canyon Rd.) and 11.9 (Junction with Hwy 128).

Along Hwy 93, deer and elk carcasses were most abundant at mile reference post 10.0 and between 11.0 and 11.2 (Figure 8). Along Hwy 128, the number of recorded carcasses was low and deer and elk crashes did not have a particular concentration (Figure 9).

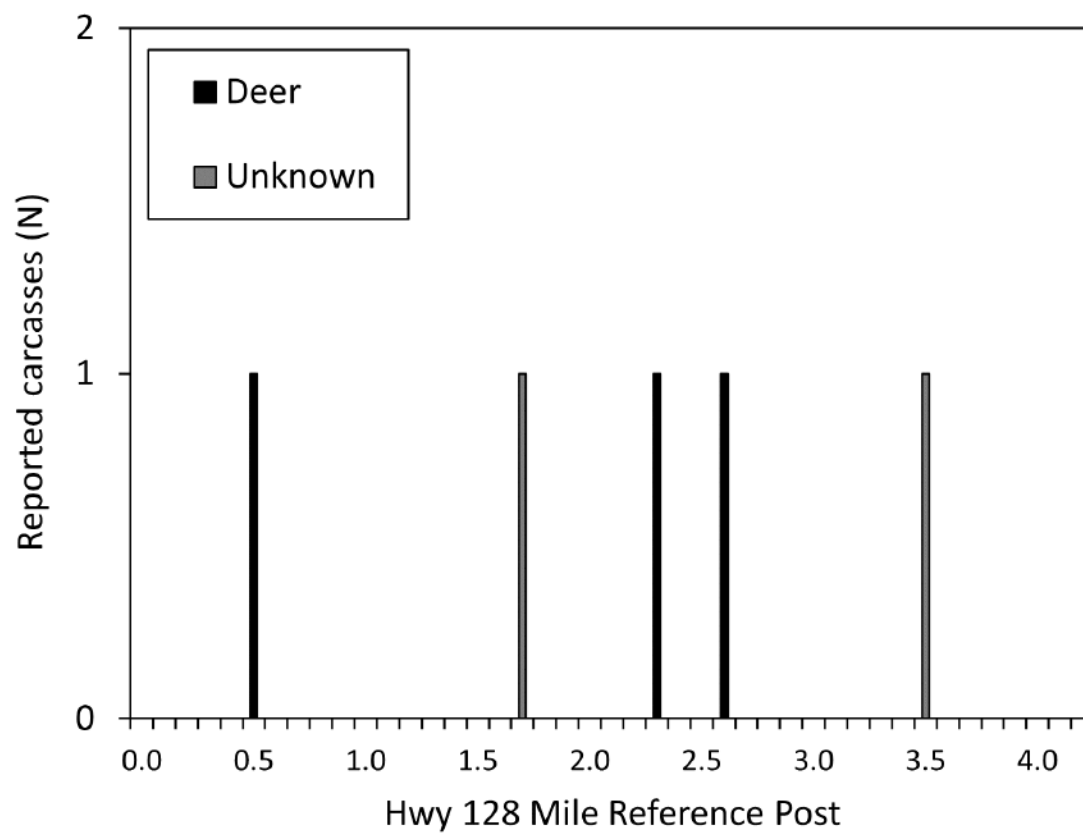
Figure 9: The number of reported carcasses with animals along Hwy 128 between mile reference post 0.0 (Junction with Hwy 93) and 4.2 (Junction with Indiana St.).

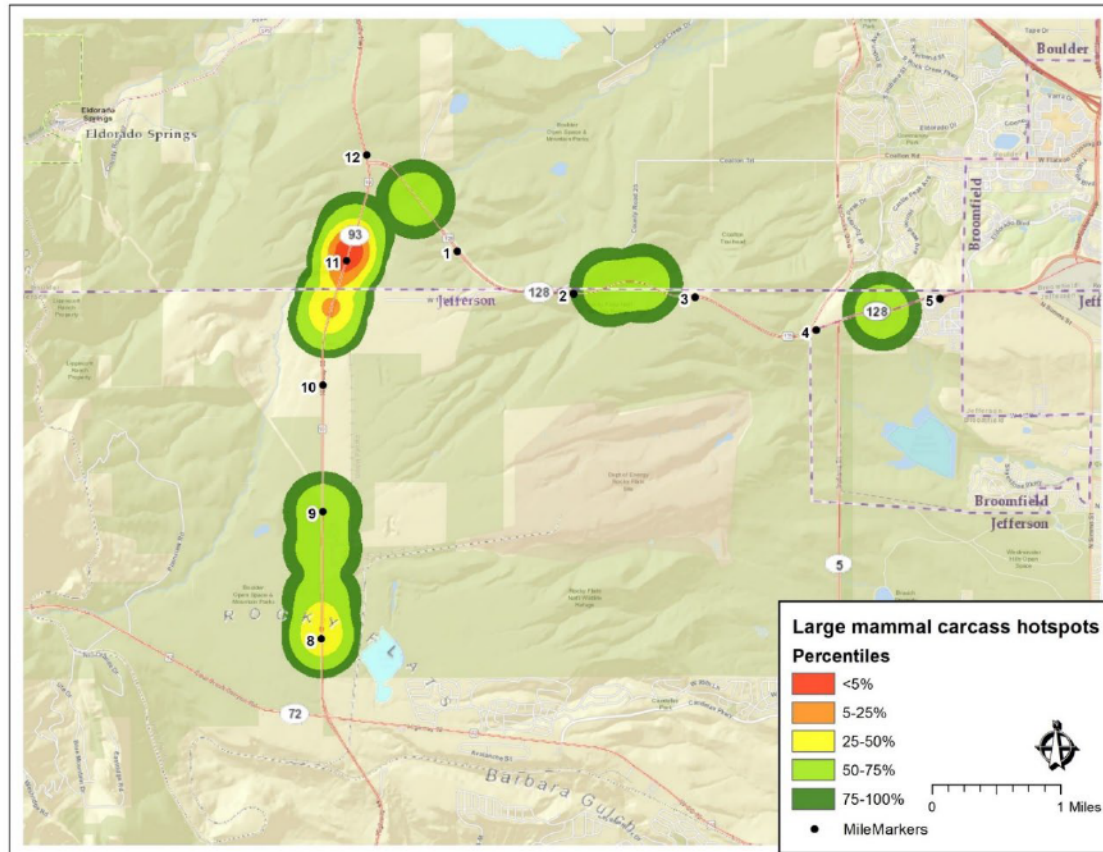
Figure 10: Kernel density hotspot percentiles for large mammal carcasses for Hwy 93 and Hwy 128 (2002–2022).

We investigated where the highest concentrations of large mammal-vehicle carcasses were along Hwy 93 and Hwy 128 through a hotspot analysis, similar to the analysis described for crashes. Large mammal-vehicle carcasses along Indiana St. were not available. The highest concentration of large mammal carcasses was along Hwy 93 from just south to just north of mile reference post 11.0 (Figure 10).

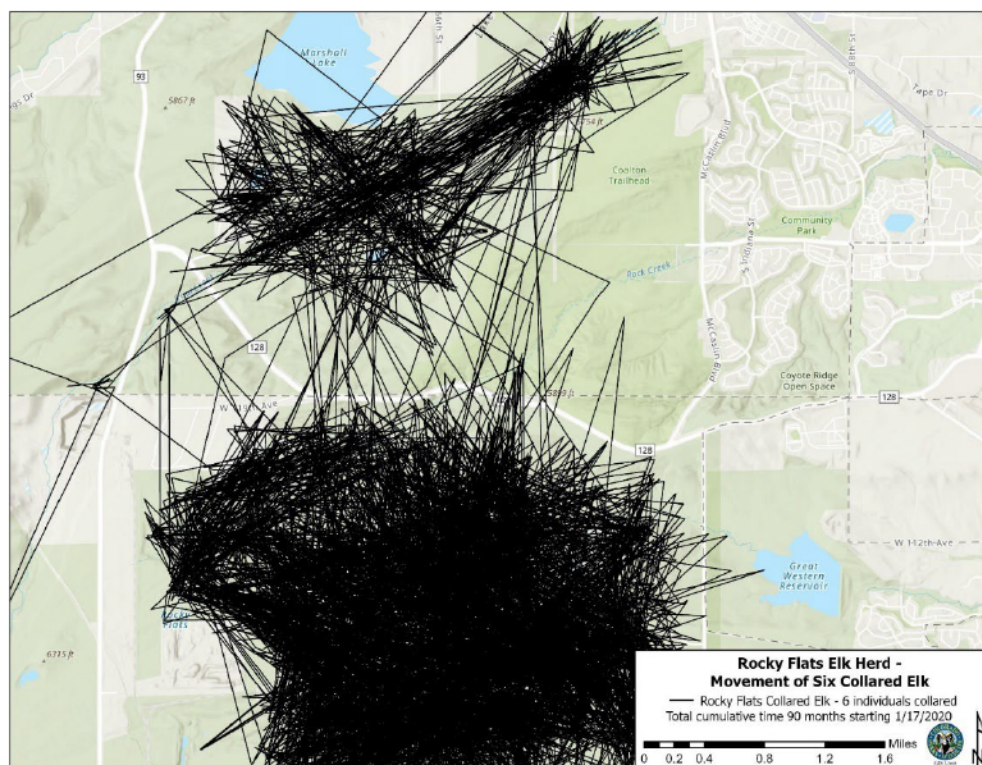
Figure 12: Locations and movements of GPS-collared elk from the Rocky Flats National Wildlife Refuge herd (Source: Joe Halseth, Colorado Parks and Wildlife).

GPS-collared elk from the herd that resides mainly in the Refuge cross Hwy 128 regularly, but cross Hwy 93 only occasionally (Figure 12). GPS-collared elk from the herd that resides mainly west of Hwy 93 (Plainview herd) were not observed crossing Hwy 93 into the Refuge or into the area north of Hwy 128 (Figure 13). These movement data suggest that elk mostly stay away from the main roads; they are mostly confined to the meshes within the road network with the highways being partial or near complete barriers. The elk also seem to spend most of their time on the legacy site in the center of the Refuge where the public is not allowed and where human disturbance is lowest.

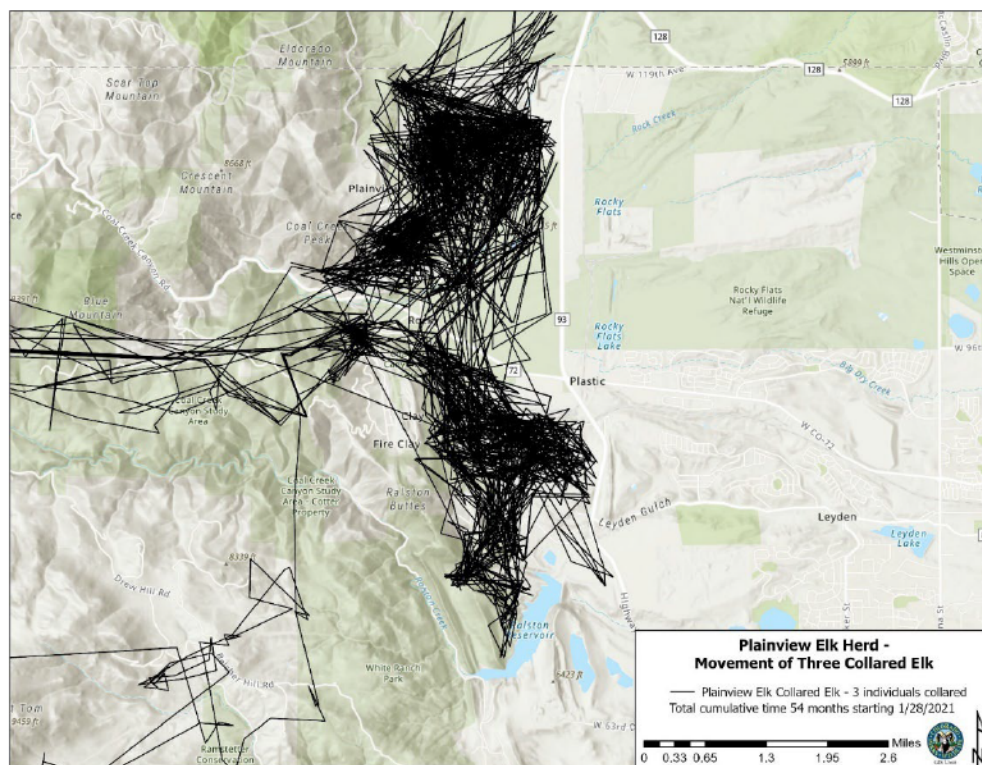
Figure 13: Locations and movements of GPS-collared elk from the Plainview herd (Source: Joe Halseth, Colorado Parks and Wildlife).

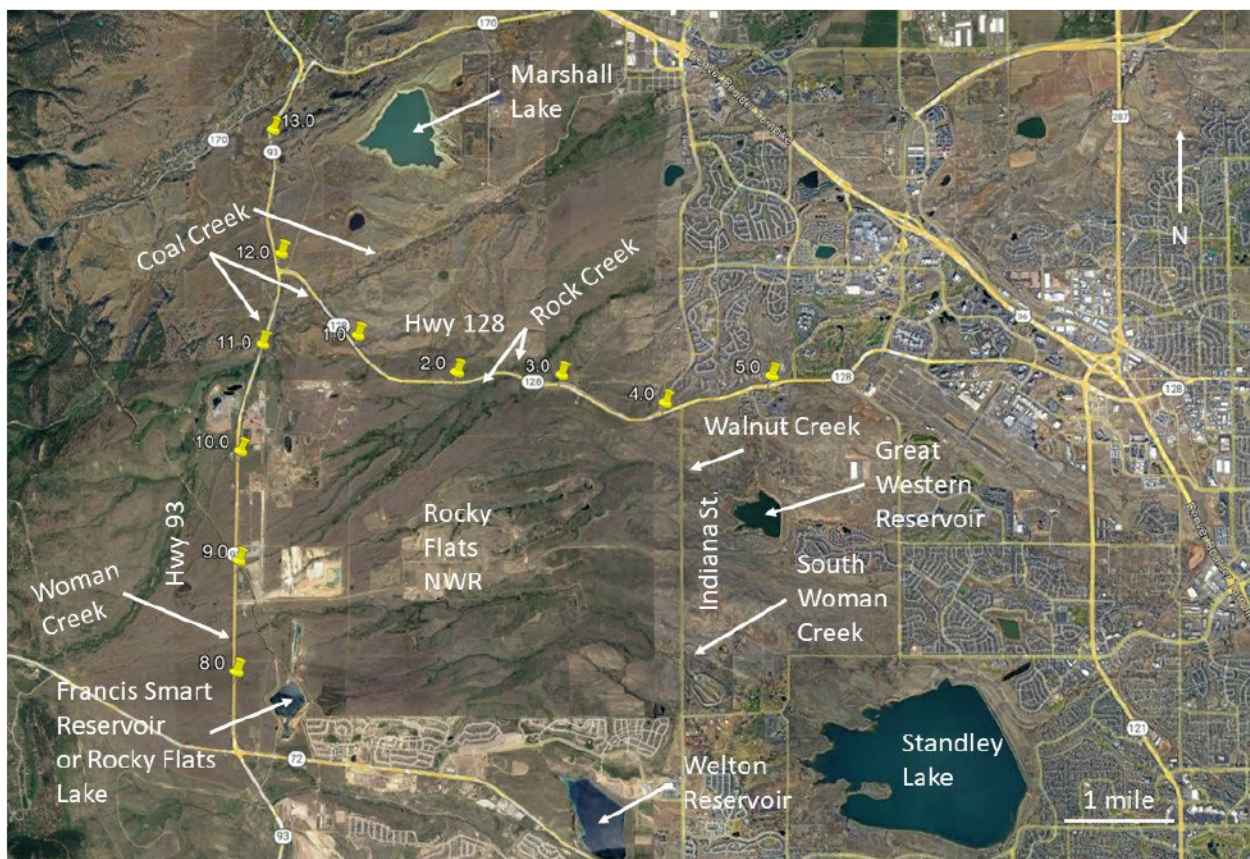
Figure 14: Map of Rocky Flats National Wildlife Refuge showing highways and associated mile reference points, creek crossings and water bodies.

The Refuge is surrounded by roads to the west, north, and east, and has developments just beyond its southern boundary (Figure 14). Hwy 93 has an estimated Annual Average Daily Traffic Volume (AADT) of about 18,000 vehicles, Hwy 128 about 4,200 vehicles, and Indiana St. about 7,000 vehicles (Michael Baker International 2016, CDOT 2023). There are several water bodies in the area that are likely important to ungulates, especially during the dry summer months (Figure 14). The area mostly consists of dry grassland with some shrubs and trees along some of the creeks (Figure 15, 16).

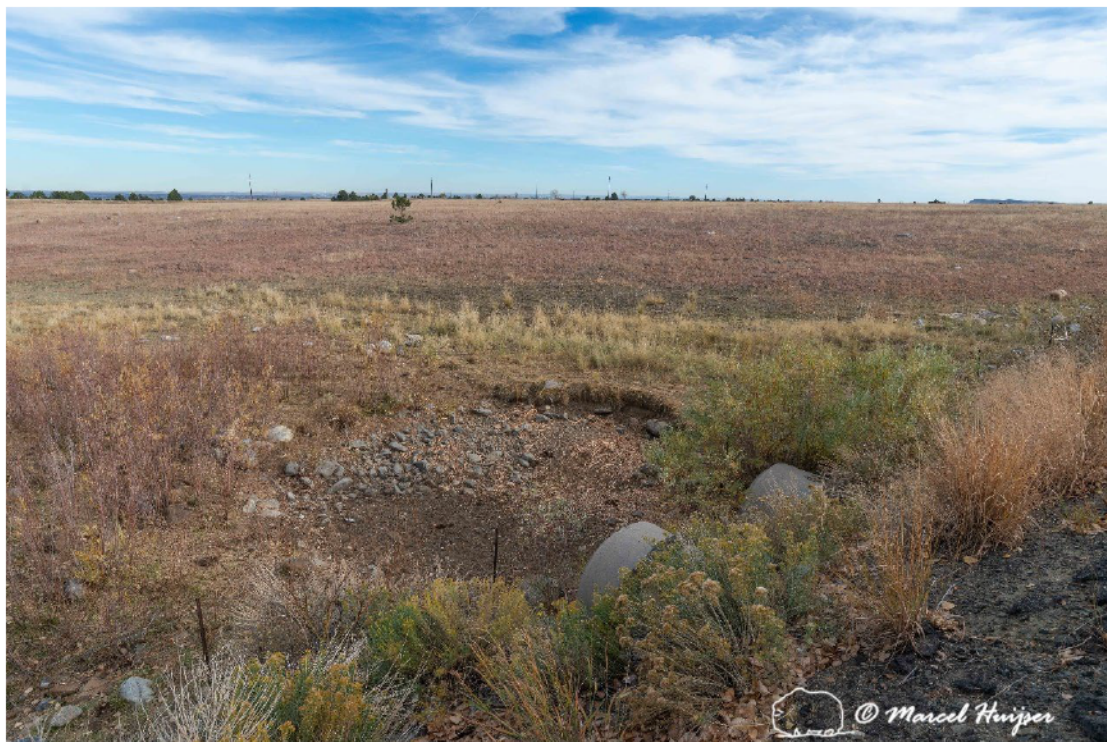
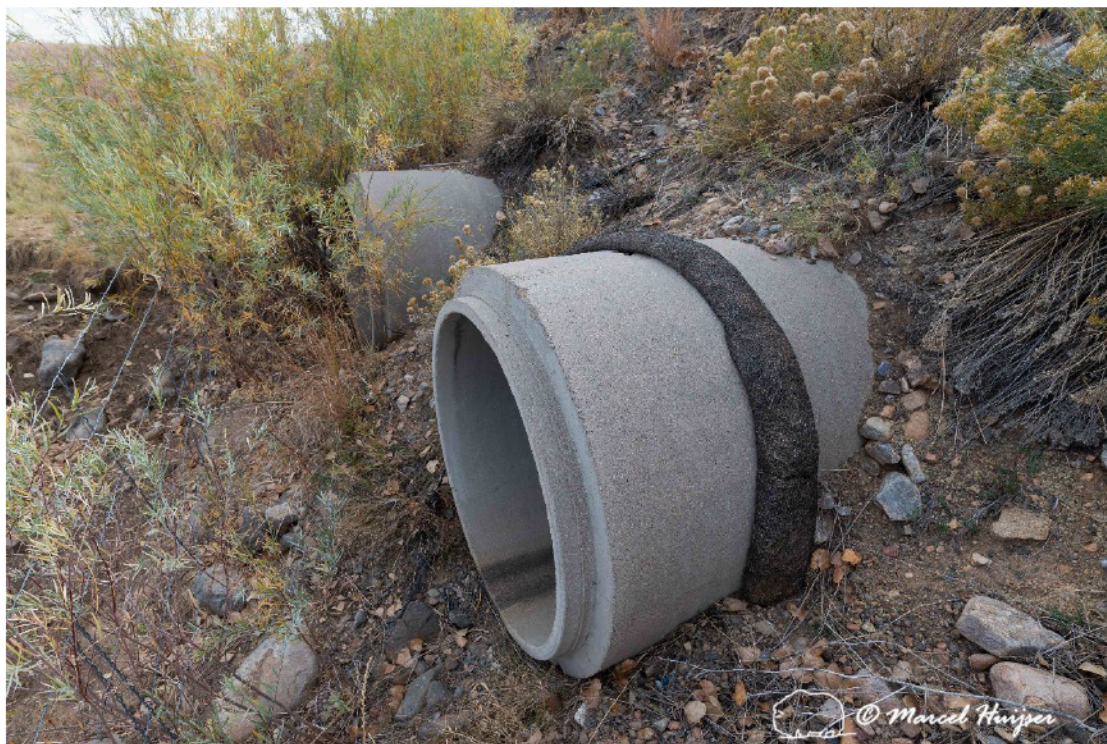
Figure 17: Double culvert, Woman Creek (Hwy 93, mile reference post 8.40), east side, outflow.

Figure 18: Double culvert, Woman Creek (Hwy 93, mile reference post 8.40), east side, outflow.

The crossing for Woman Creek along Hwy 93 (mile reference post 8.40) consists of a double culvert (Figure 17, 18).

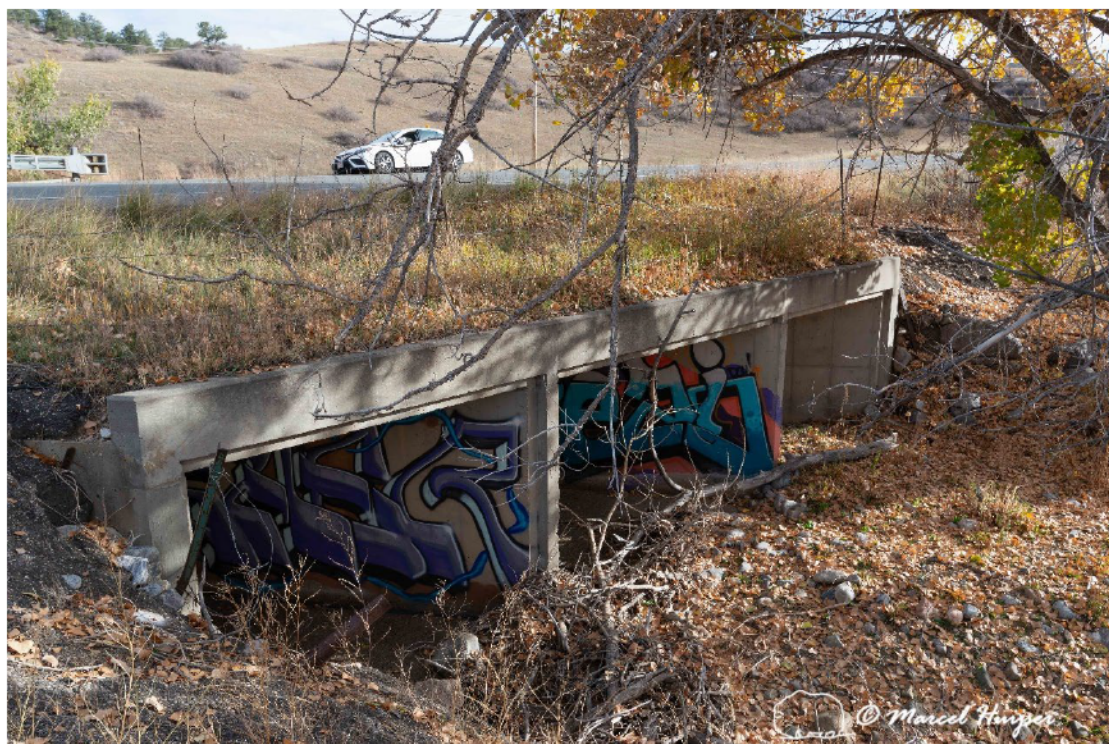
*Figure 20: Divided box culvert, Coal Creek (Hwy 93, mile reference post 10.95), west side, inflow.*

The crossing for Coal Creek along Hwy 93 (mile reference post 10.95) consists of a divided box culvert (Figure 19, 20, 21).

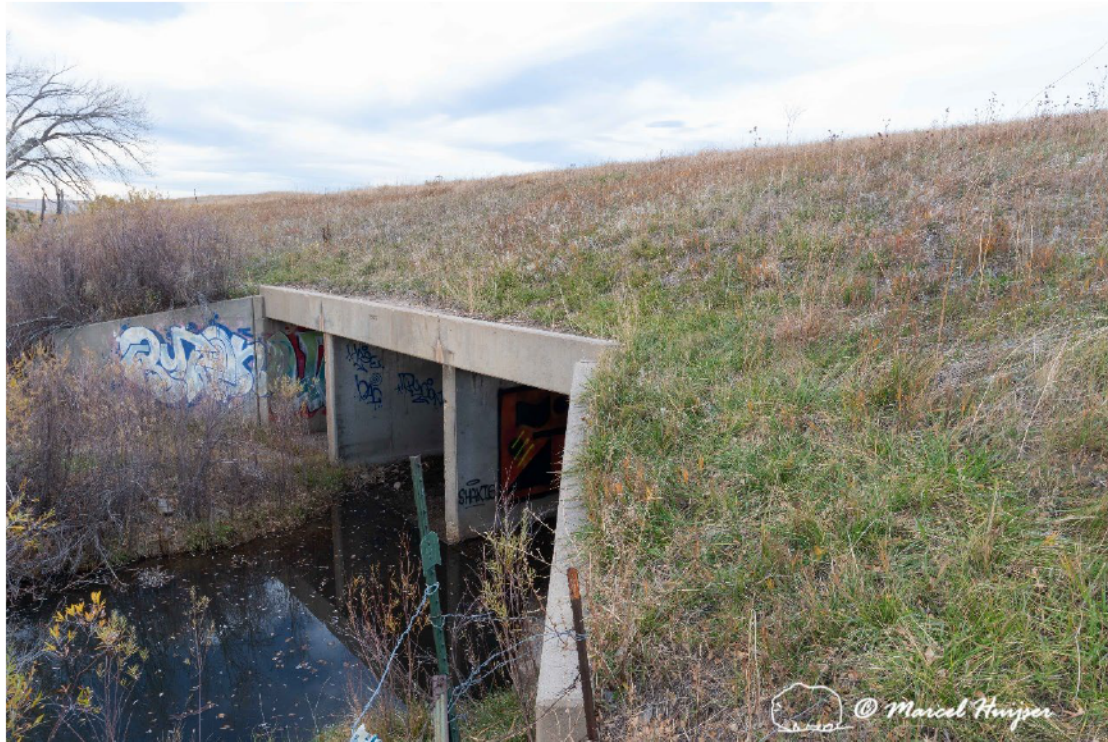
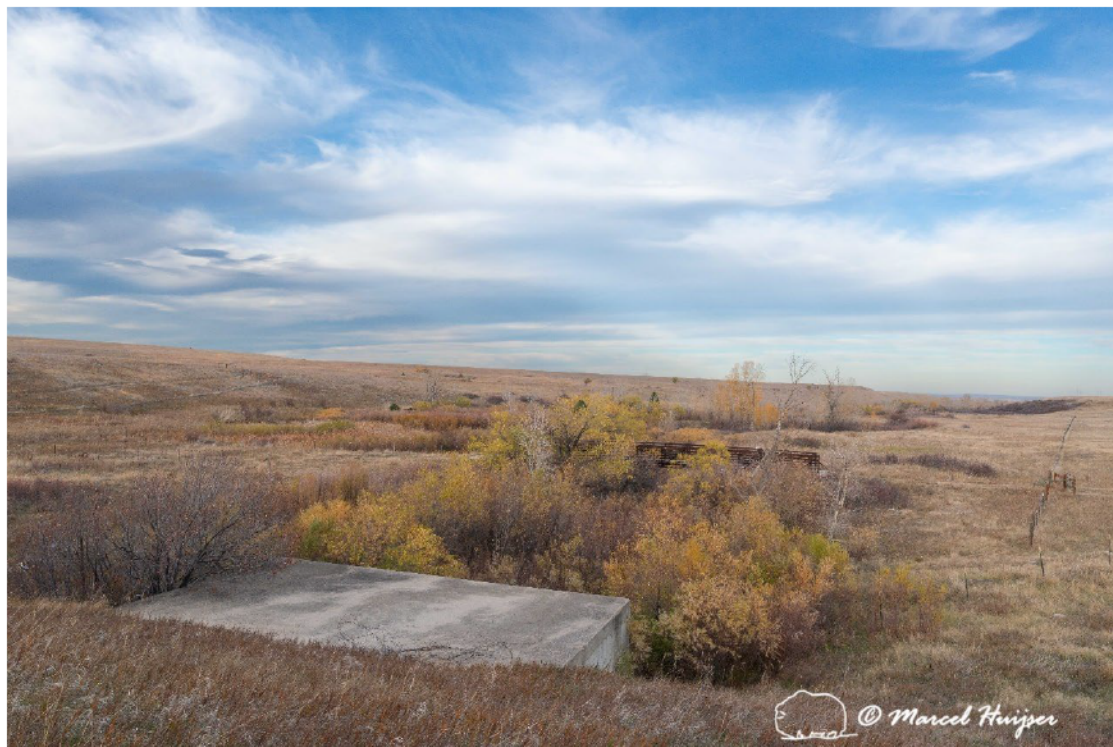
*Figure 22: Divided box culvert, Coal Creek (Hwy 128, mile reference post 0.47), south side, inflow.*

*Figure 23: Divided box culvert, Coal Creek (Hwy 128, mile reference post 0.47), north side, outflow.*

The crossing for Coal Creek along Hwy 128 (mile reference post 0.47) consists of a divided box culvert (Figure 22, 23).

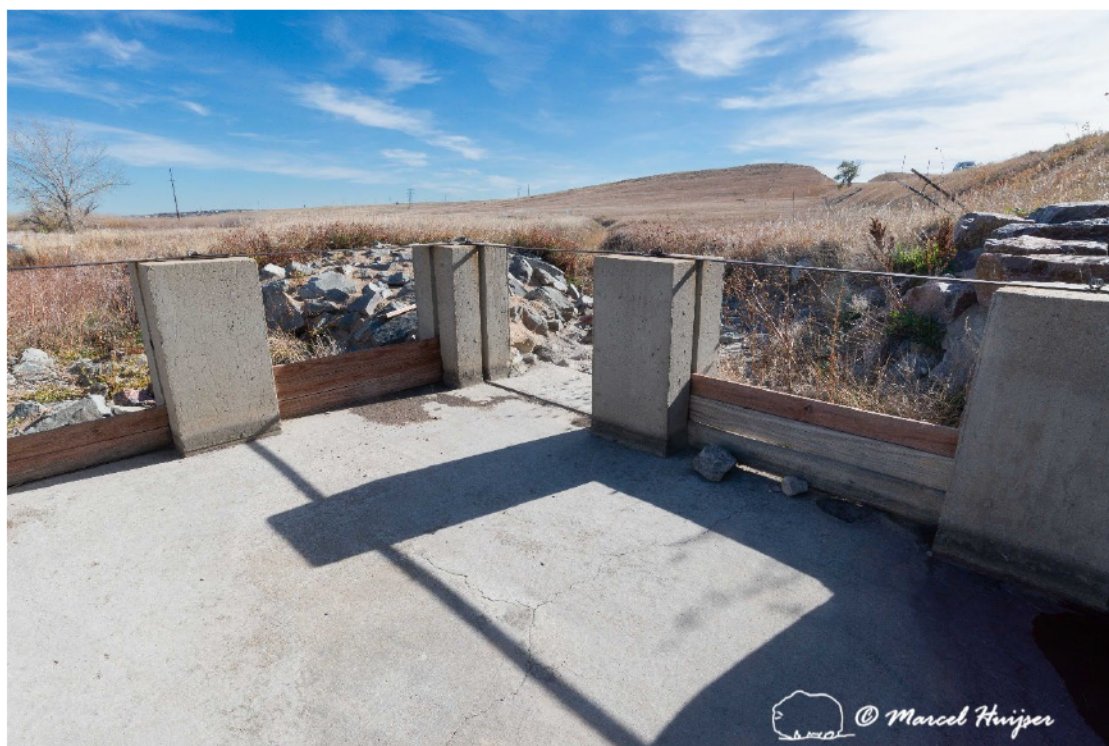
Figure 28: Outflow structures, Walnut Creek (Indiana St., 0.62 mile south of junction with Hwy 128), east side, outflow.

The crossing for Walnut Creek along Indiana St. (0.62 mile south of junction with Hwy 128) consists of a round culvert (Figure 26, 27, 28, 29).

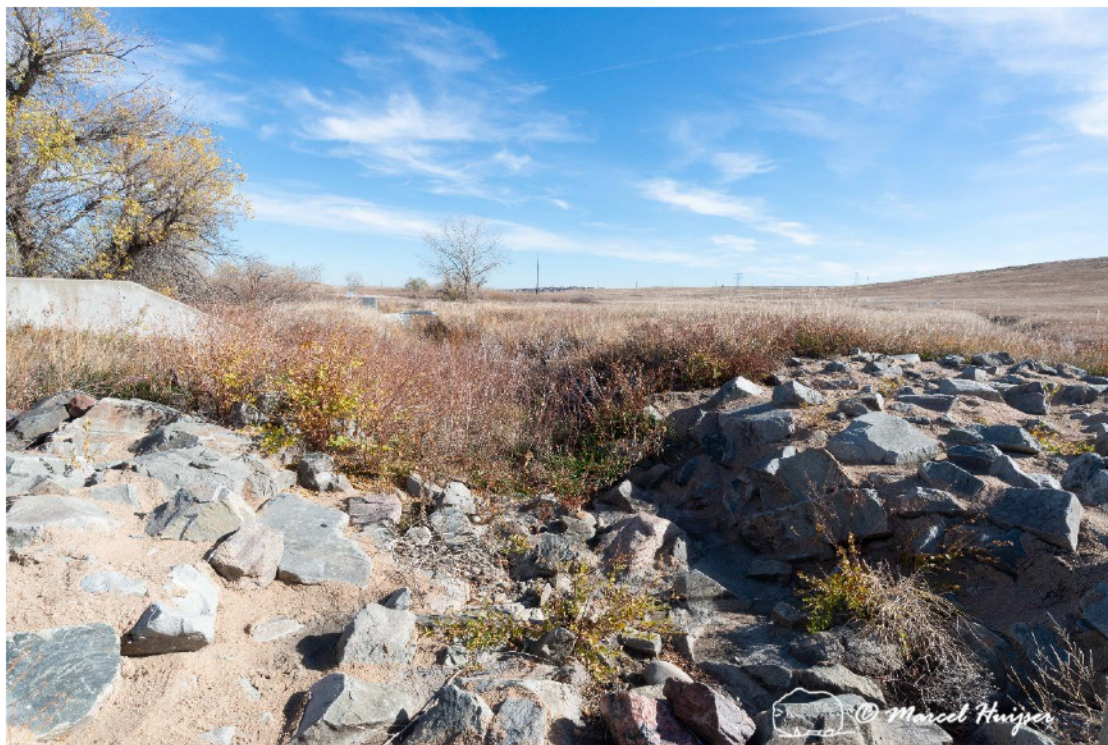
*Figure 29: Riprap at outflow, Walnut Creek (Indiana St., 0.62 mile south of junction with Hwy 128), east side, outflow.*

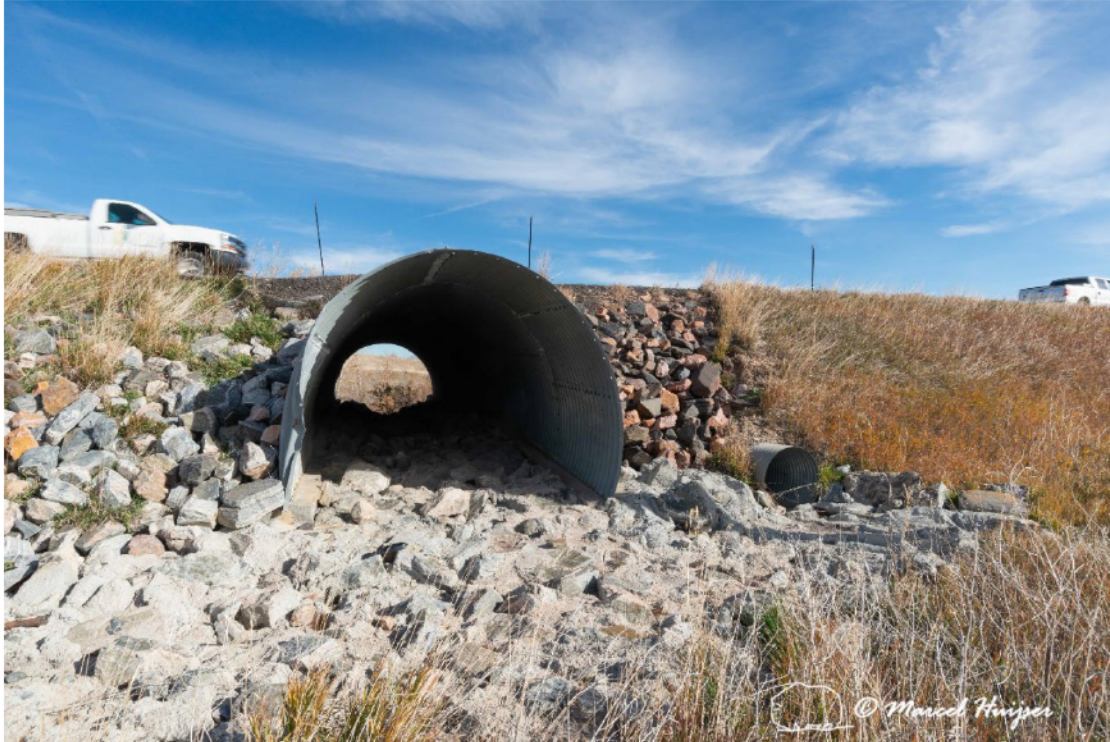
*Figure 30: Riprap at inflow, South Woman Creek (Indiana St., 2.25 mile south of junction with Hwy 128), west side, inflow.*

The crossing for South Woman Creek along Indiana St. (2.25 miles south of junction with Hwy 128) consists of a round culvert (Figure 30, 31, 32).

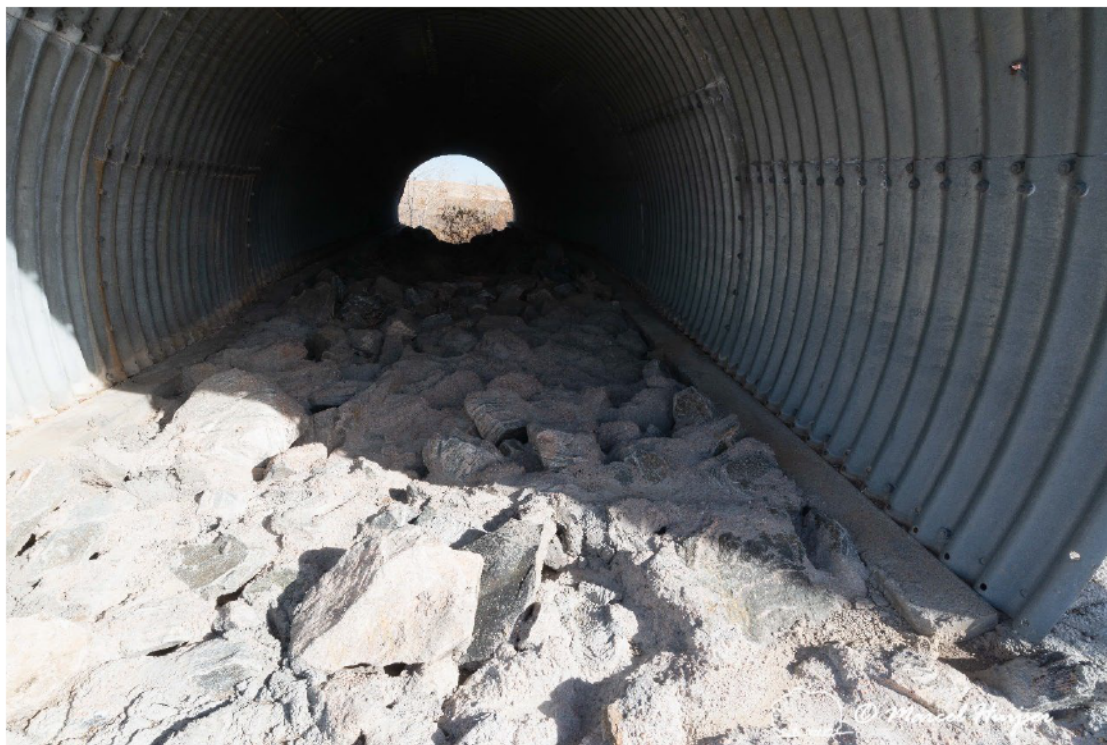
*Figure 31: Riprap inside culvert, South Woman Creek (Indiana St., 2.25 mile south of junction with Hwy 128), west side, inflow.*

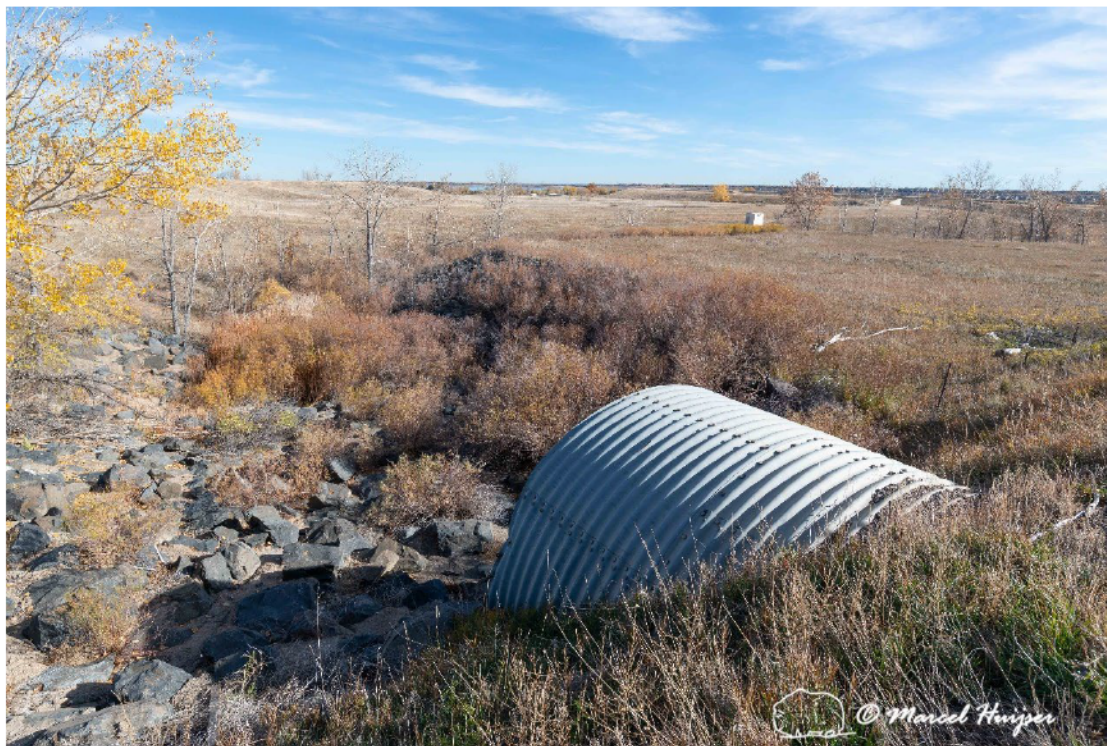
*Figure 32: Riprap at outflow, South Woman Creek (Indiana St., 2.25 mile south of junction with Hwy 128), east side, outflow.*

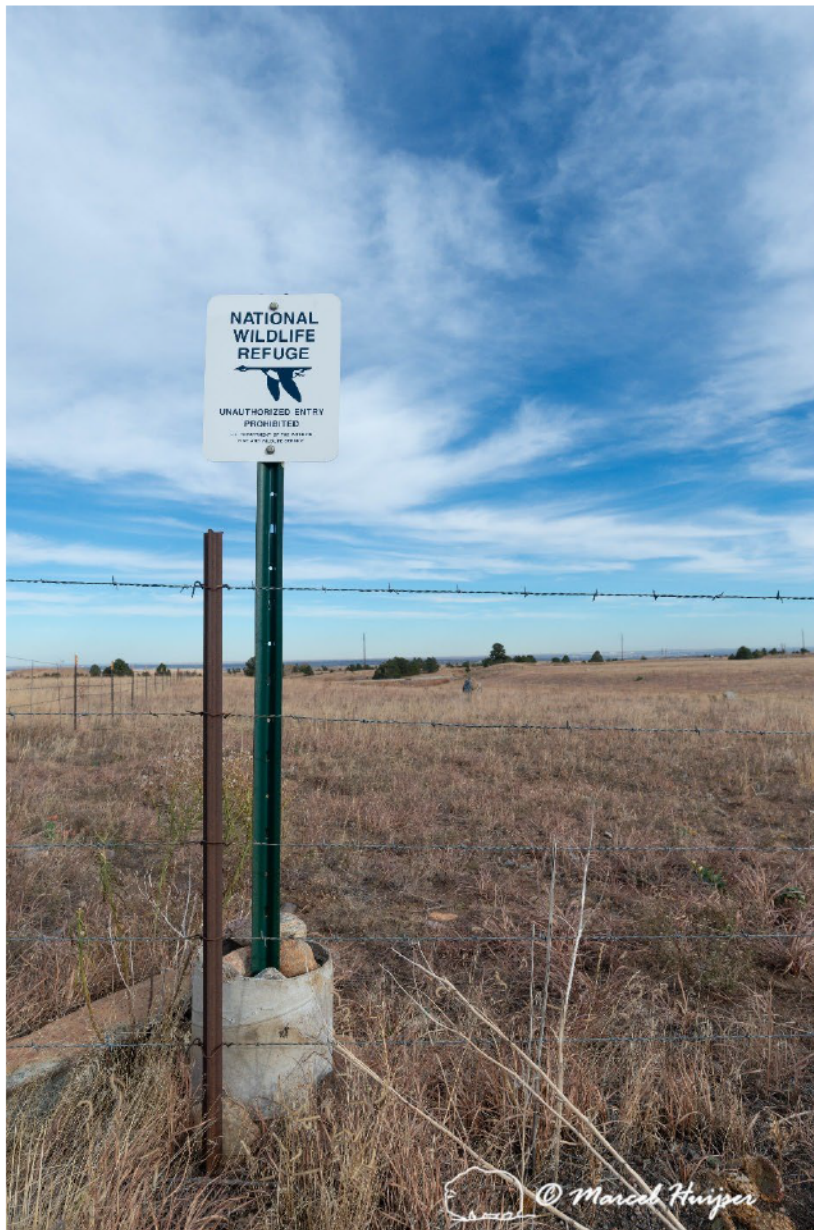
Figure 33: Right-of-way fence, Hwy 93, east side, near mile reference post 8.4.

There are right-of-way fences or livestock fences along the highways, both on the side of the Refuge, and the other side of the highways (Figure 33, 34). These fences are not designed to keep large wild ungulates off the highway, but they can cause injuries, and even entanglement or death of large wild ungulates. Should the fences be required to keep livestock off the road, then they are likely more detrimental to wildlife than needed as wildlife friendly livestock fence designs are available (see e.g., Paige 2015).

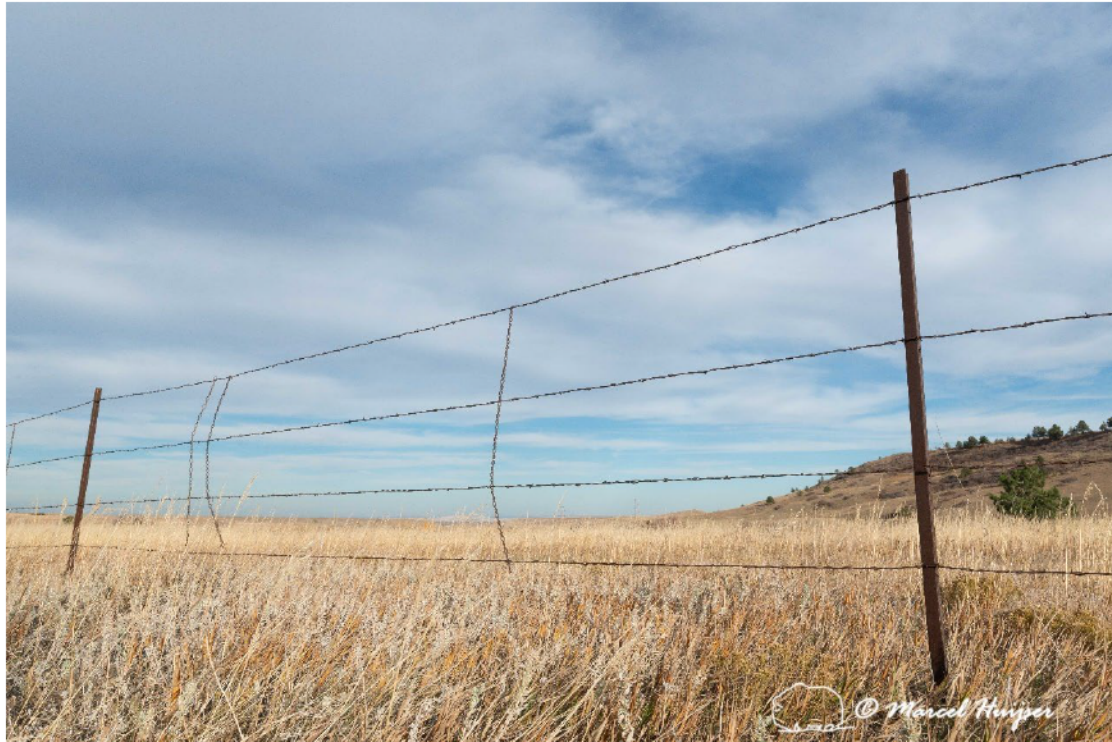
*Figure 34: Right-of-way fence, Hwy 93, east side, near mile reference post 11.3.*

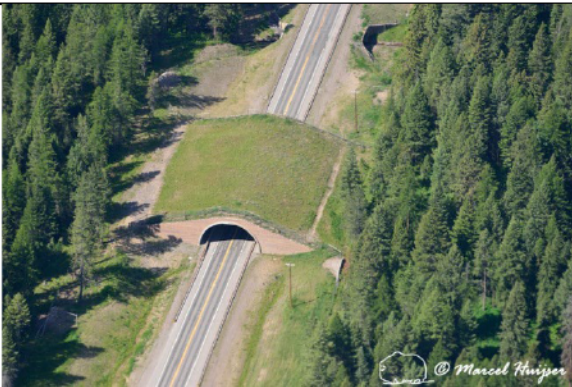
| Safe Crossing Opportunity type | Indicative dimensions (as seen by the animals) | Image |
|---|---|---|
| Wildlife overpass | 50-70 m wide | |
