# **Exploration of Opportunities to Address the Impacts of Roads and Traffic on Wildlife Around Rocky Flats National Wildlife Refuge**

FINAL REPORT

Prepared by  
Marcel P. Huijser, PhD  
James S. Begley, MSc  
Western Transportation Institute  
Montana State University

November, 2023

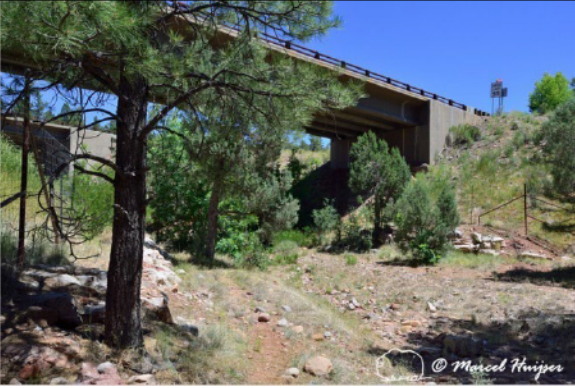
| Safe Crossing Opportunity type | Indicative dimensions (as seen by the animals) | Image |
|---|---|---|
| Open span bridge | 12-30 m wide,<br>≥5 m high | |

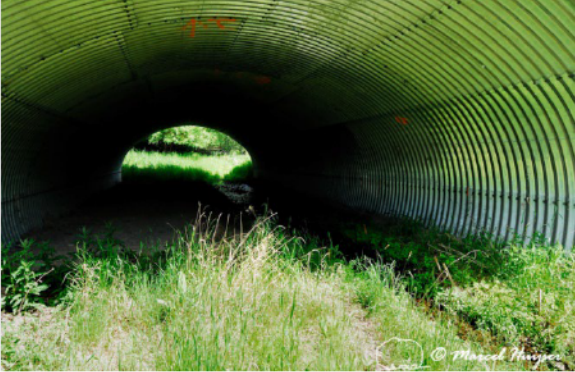
| Safe Crossing Opportunity type | Indicative dimensions (as seen by the animals) | Image |
|---|---|---|
| Large mammal underpass | 7-8 m wide,<br>4-5 m high | |

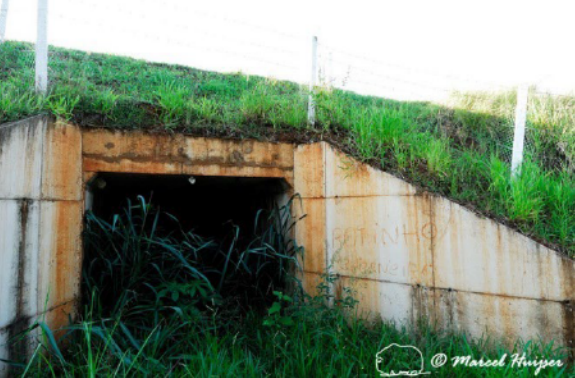
| Safe Crossing Opportunity type | Indicative dimensions (as seen by the animals) | Image |
|---|---|---|
| Medium mammal underpasses | 0.8-3 m wide, 0.5-2.5 m high | |

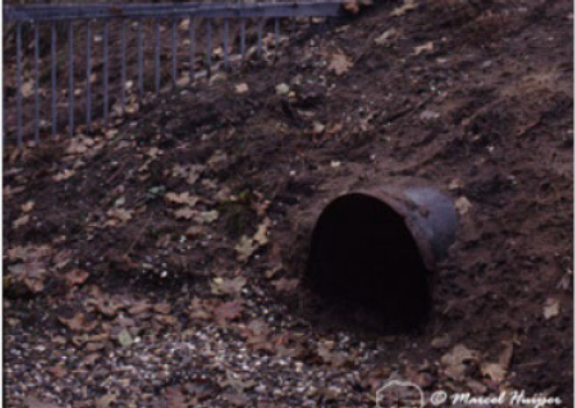
| Safe Crossing Opportunity type | Indicative dimensions (as seen by the animals) | Image |
|---|---|---|
| Small-medium mammal pipes | 0.3-0.6 m in diameter | |

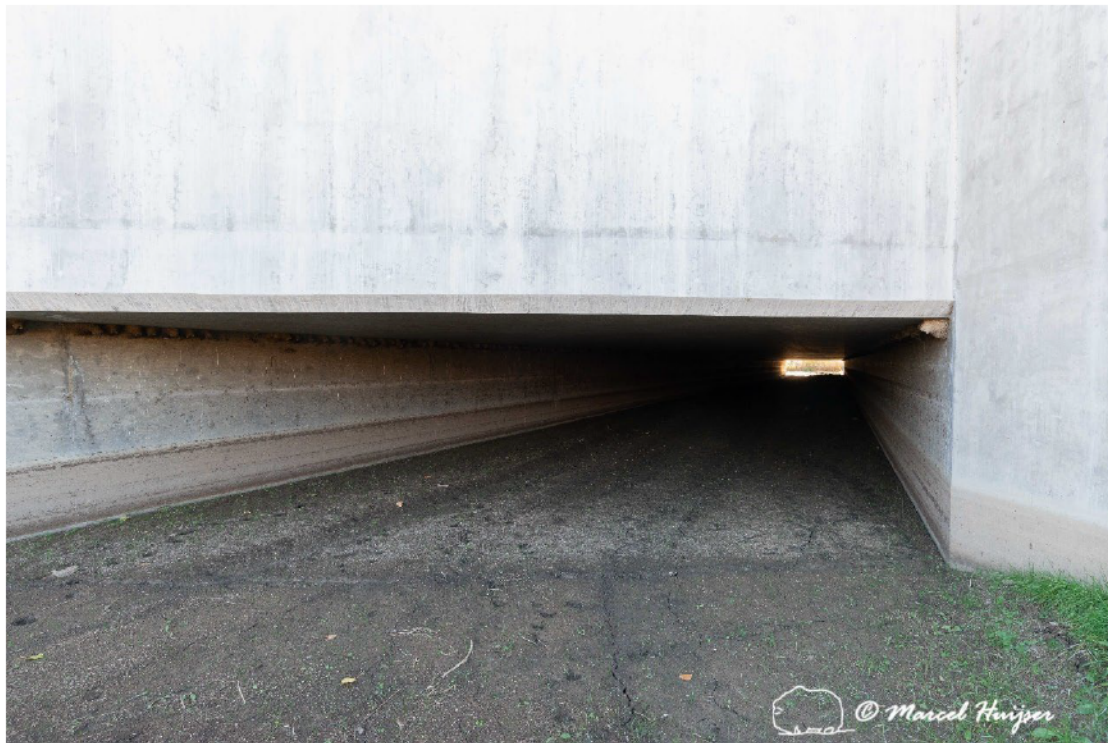
Figure 38: Culvert at Davidson Ditch (Hwy 36, mile reference post 40.8).

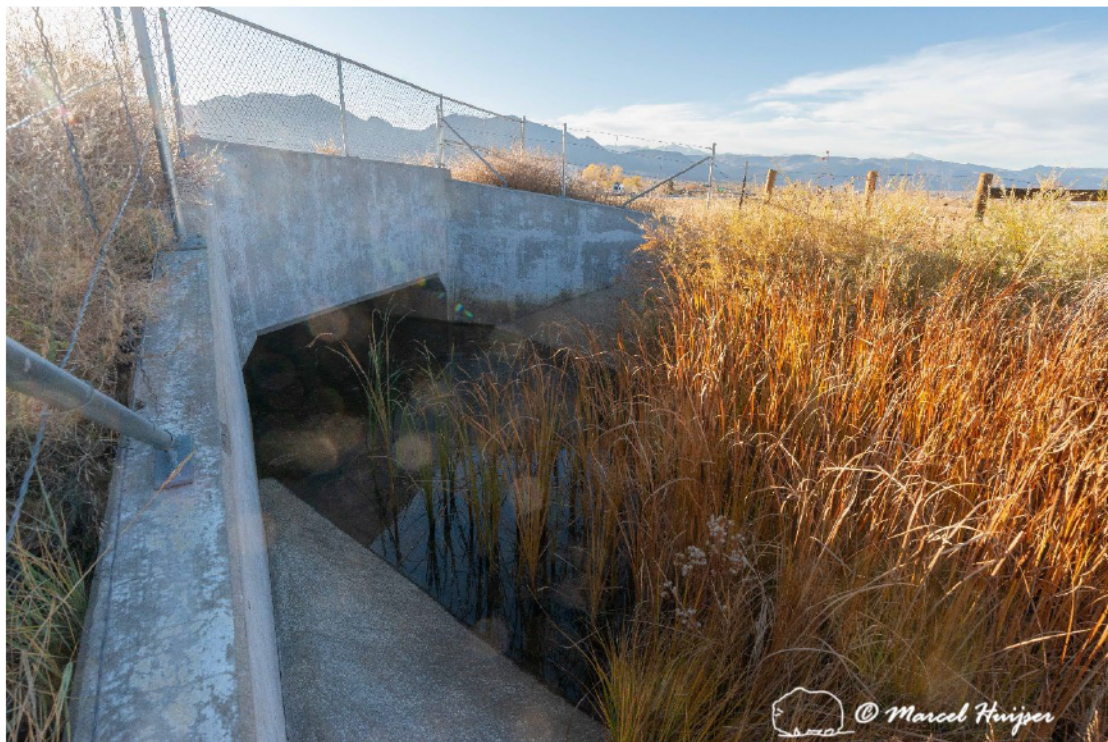
Figure 39: Culvert at Goodhue Ditch (Hwy 36, mile reference post 41.2).

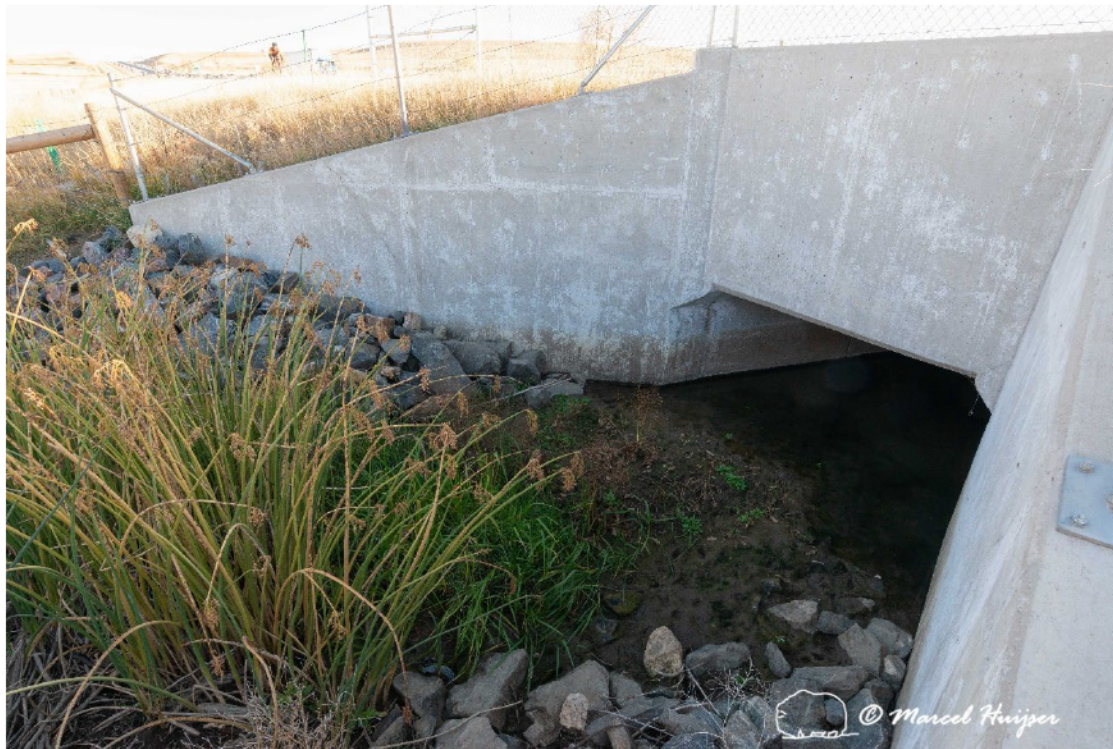
Figure 40: Culvert at Marshallville Ditch (Hwy 36, mile reference post 41.5).

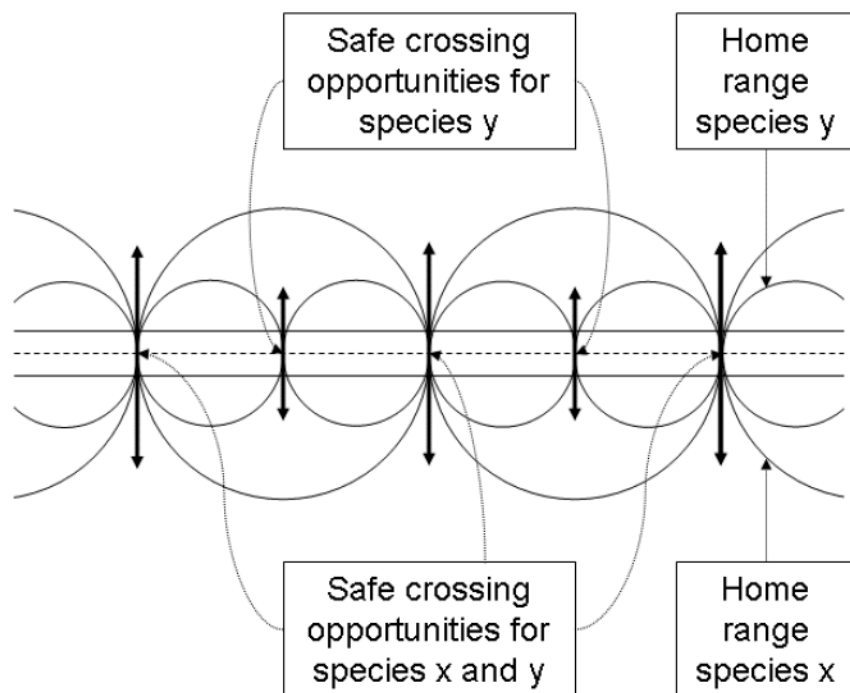
Figure 41. Schematic representation of home ranges for two theoretical species projected on a road and the distance between safe crossing opportunities (distance is equal to the diameter of their home range).

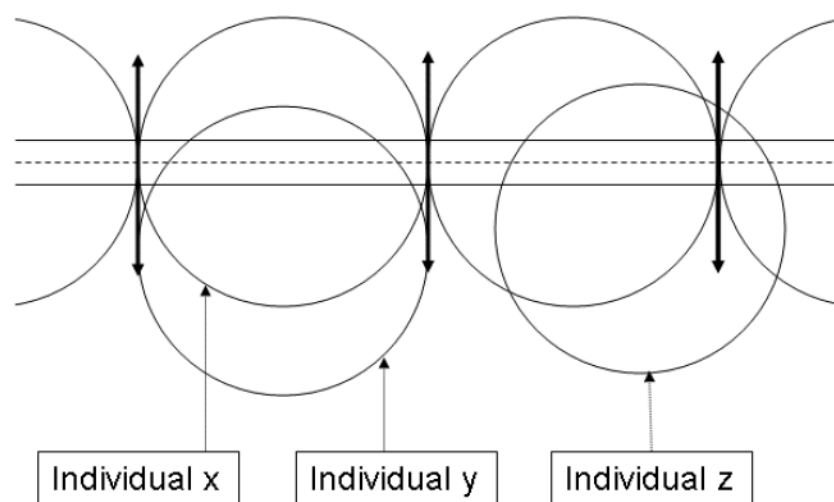
Figure 42. Schematic representation of home range for an individual (x) that has the center of its home range on the center of the road (access to two safe crossing opportunities), an individual (y) that has the center of its home range slightly off the center of the road exactly in between two safe crossing opportunities (no access to safe crossing opportunities), and an individual (z) that has the center of its home range slightly off the center of the road but not exactly in between two safe crossing opportunities (access to one safe crossing opportunity).

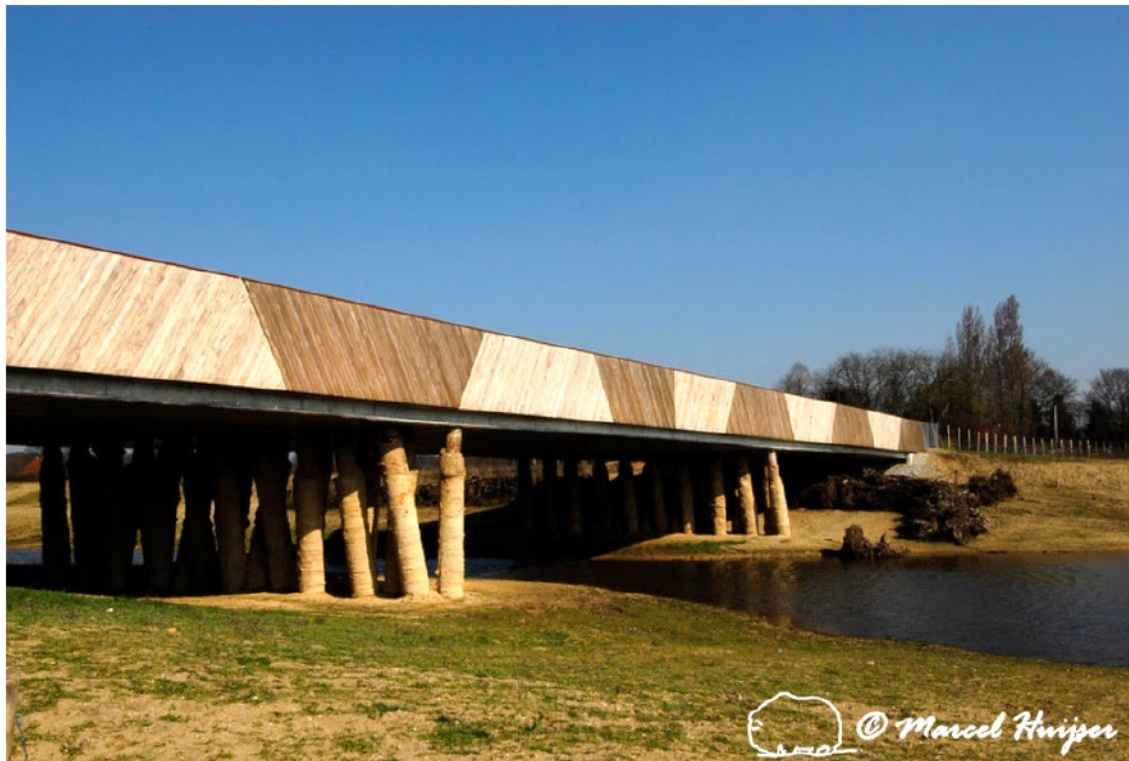
Figure 43. Multifunctional underpass, The Netherlands. The underpass is for hydrology and wildlife.

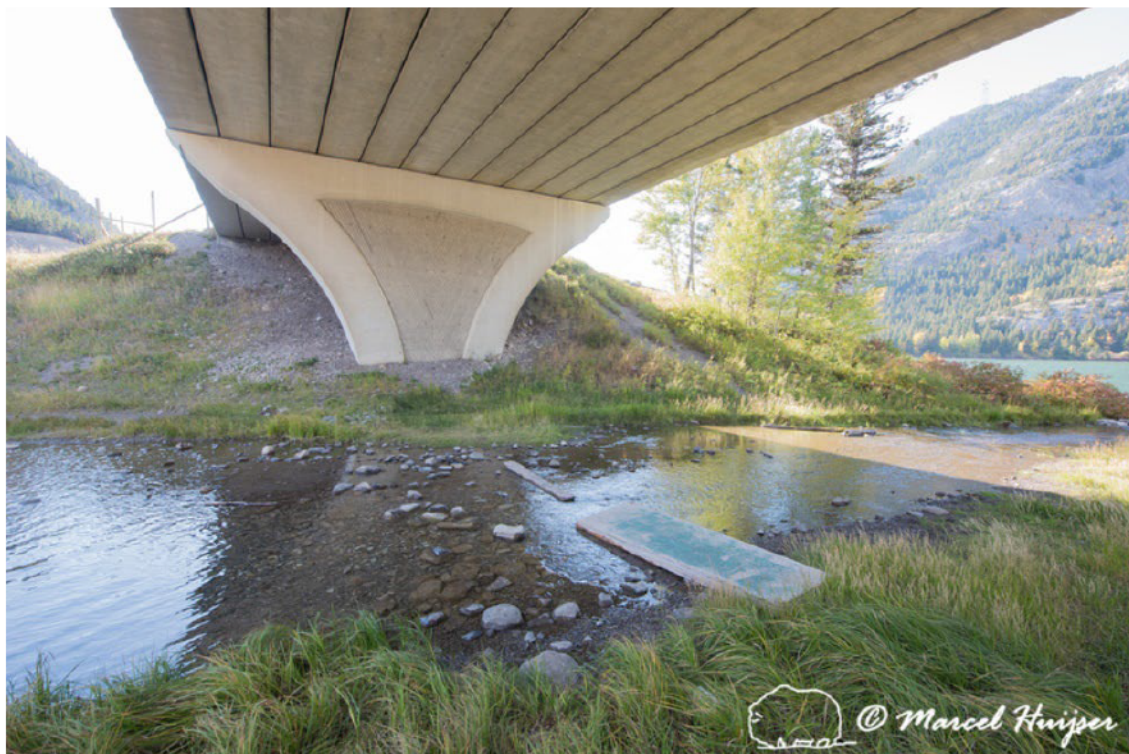
Figure 44. Multifunctional underpass, Hwy 3, Crowsnest Pass, Alberta, Canada. The underpass is for hydrology and wildlife. Note how the substrate and stream dynamics are unaffected by the structure and how light and moisture reaches the entire area under the bridge allowing for natural vegetation in the riparian and terrestrial zones.

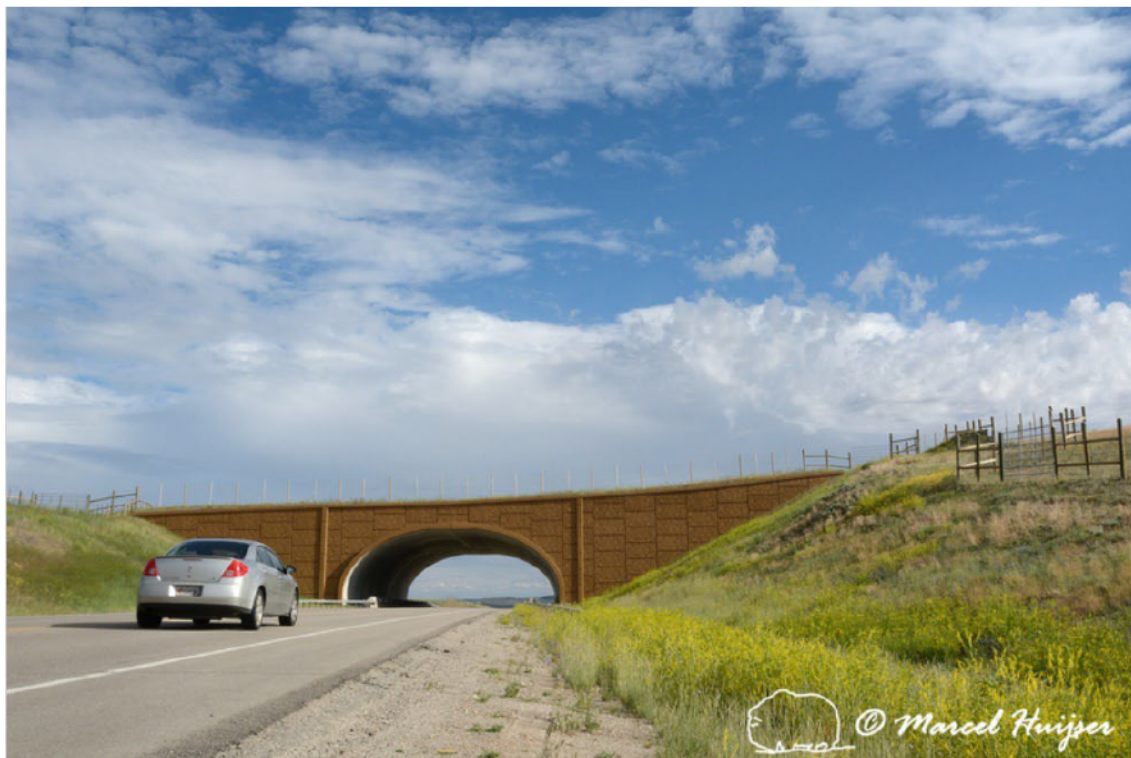
Figure 45. Wildlife overpass, primarily for pronghorn (*Antilocapra americana*) (46 m (150 ft) wide), on the Path of the Pronghorn, Trapper's Point, US Hwy 191, near Pinedale, Wyoming, USA.

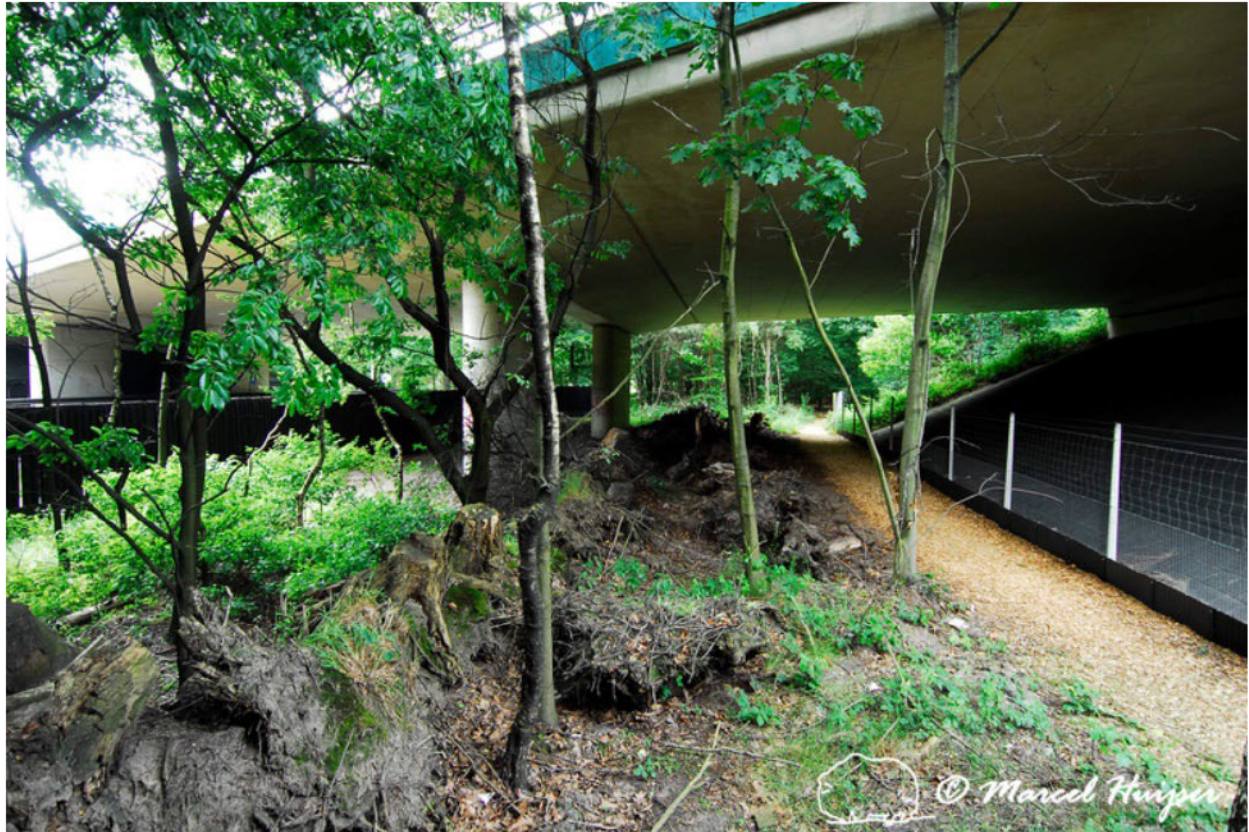
*Figure 50. Multifunctional underpass under A28 motorway near Hilversum, The Netherlands. The trail for non-motorized human use is on the far-right side. A berm with root wads, small trees and shrubs in the center separates the trail from the wildlife zone further to the left. Beyond the black screen on the far left there is a 2-lane road.*

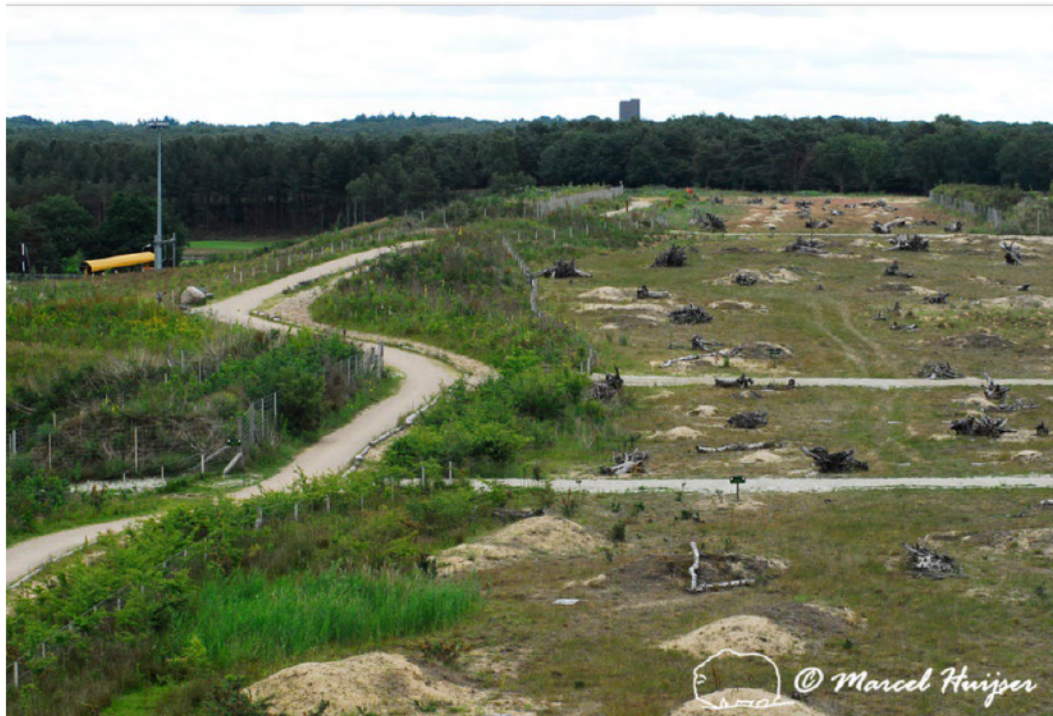
Figure 51. Multifunctional overpass across a 2-lane road and railroad tracks with a trail for non-motorized recreation on the left side, Natuurbrug Zanderij Crailoo, The Netherlands. The trail has a berm with trees and shrubs to reduce human presence and disturbance in the wildlife zone that is further to the right. The habitat on top of the overpass is dry and sandy grassland and heathland.

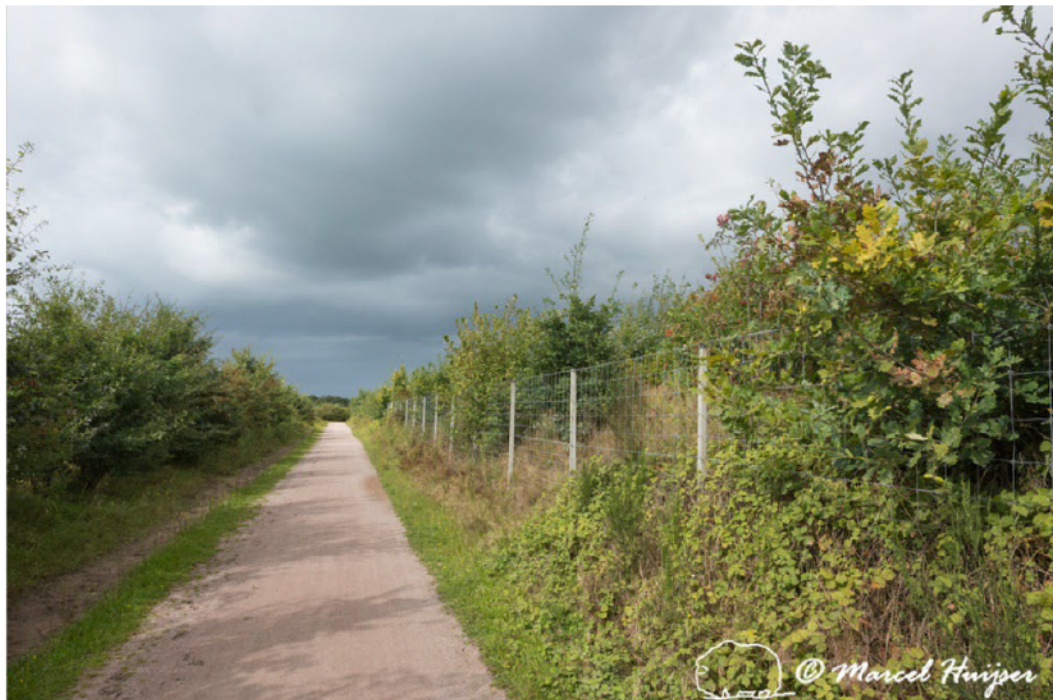
Figure 52. Multifunctional overpass across a 2-lane road and railroad tracks with a trail for non-motorized recreation, Natuurbrug Zanderij Crailoo, The Netherlands. The trail has a berm with trees and shrubs on the left-hand side to reduce human presence and disturbance in the wildlife zone that is further to the left. There is also a berm with trees and shrubs to the right of the trail, reducing visual and noise disturbance from vehicles towards the trail.

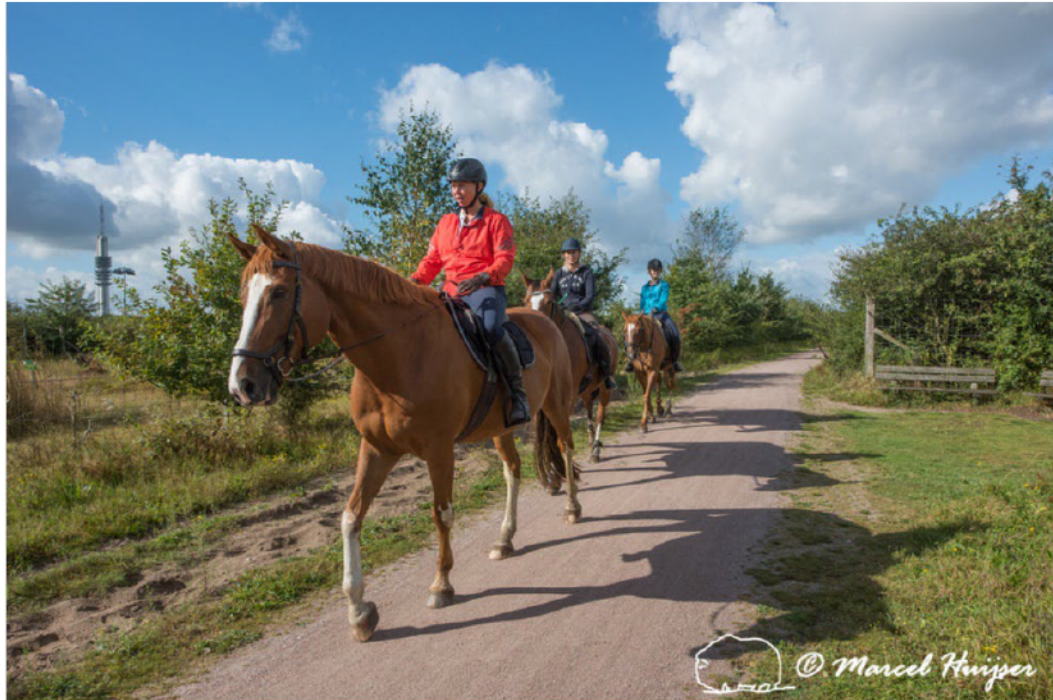
Figure 53. Horseback riders on a trail on a multifunctional overpass across a 2-lane road and railroad tracks. The trail is for non-motorized recreation. Natuurbrug Zanderij Crailoo, The Netherlands. The trail has a berm with trees and shrubs on the right-hand side to reduce human presence and disturbance in the wildlife zone that is further to the right. There is also a berm with trees and shrubs to the left of the trail, reducing visual and noise disturbance from vehicles towards the trail.

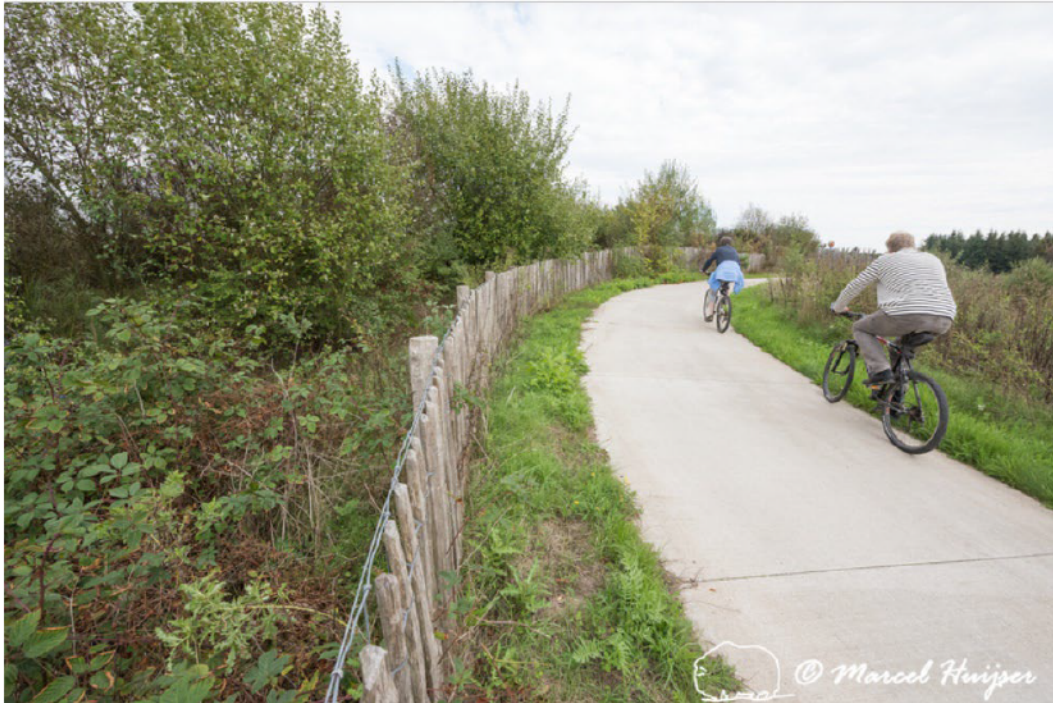
Figure 54. Bicyclists on a trail on a multifunctional overpass. The trail is for non-motorized recreation. Soest, The Netherlands. The trail has a fence and a berm with trees and shrubs on the left-hand side to reduce human presence and disturbance in the wildlife zone that is further to the left.
