A STUDY ON DYNAMIC BICYCLE DETECTION AND WARNING DEVICE

A thesis submitted in partial fulfillment  
of the requirements for the degree

Civil Engineering

MONTANA STATE UNIVERSITY  
Bozeman, Montana

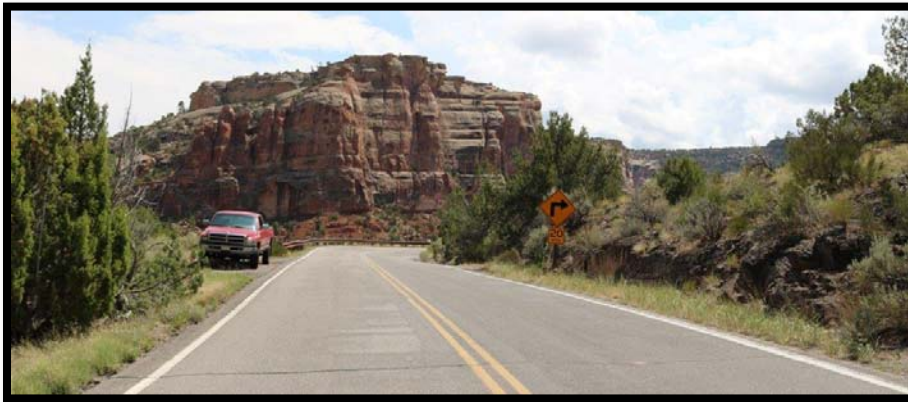
Figure 1. Site 1 before the installation of the Dynamic Bicycle Detection and Warning System facing North.

The first site is located approximately 0.7 miles from the East Entrance. There are two unofficial pull offs on either side of the roadway with enough room for a vehicle to pull off on the east side of the road. The hillside on the west side prevents vehicles from being able to pull off the road and thus creates a restriction with no shoulder. A view of Site 1 can be seen in Figure 1. The site is an approximately 330-foot-long straight section between two curves, the second curve is the first hairpin turn going up the hillside.

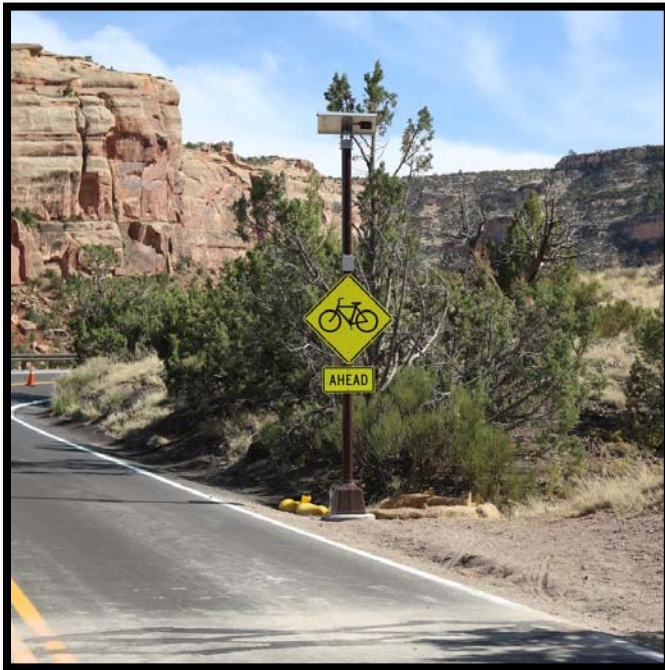
Figure 2. Site 1 after the installation of the Dynamic Bicycle Detection and Warning System facing North.

saw cuts for the induction loops were only two inches deep on the loops closest to centerline and two and a half inches deep for the induction loops closest to the fog line. This was to enable the wires from the induction loops farthest from the counter to reach the counter. Each of the 44-feet of saw cut was  $\frac{3}{8}$ <sup>th</sup>s inch wide. Backerod was used to insulate the wire from the epoxy and prevent it from floating. All wires for the loops were wrapped tight and counter clockwise. Test readings of 100 and 130 microhenries confirmed the proper functionality of the loops before sealing them.

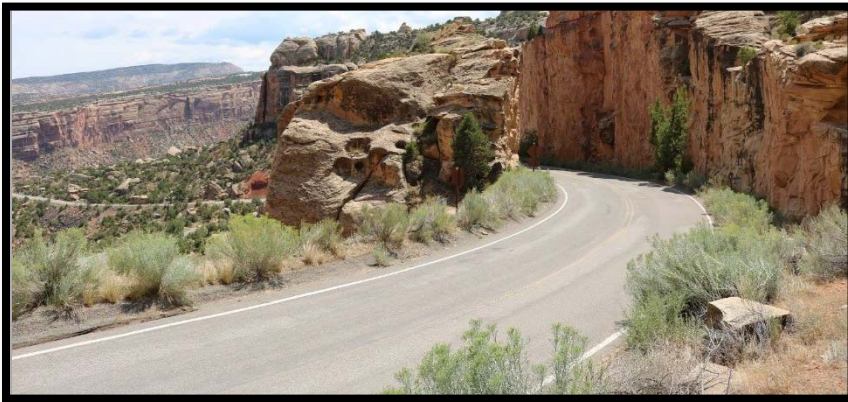
Figure 3. Site 2 before the installation of the Dynamic Bicycle Detection and Warning System facing South.

The second site shown in Figure 3 is located approximately 2.4 miles from the East Entrance. Site 2 is also sandwiched between two curves, the second of which is a hairpin turn. However, the straight section of about 800 feet is comprised mostly by a tunnel. Due to the tunnel, lay of the land, and vegetation there is some room for a bicycle to pull off to the side of the road but nothing larger. The whole section is also on an incline. However, due to restrictions posed by terrain site 2 is specifically the area right before the tunnel.

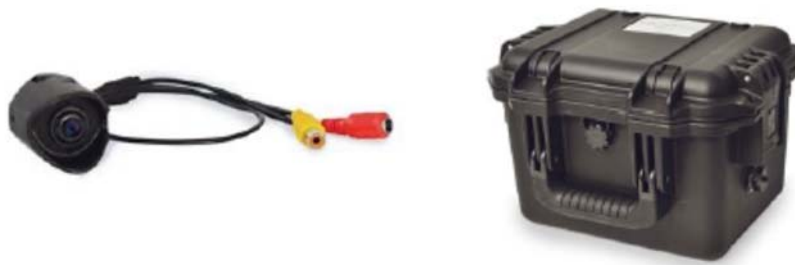
Figure 5. COUNTcam Camera Left and COUNTcam 200 Unit Right

sites, roadway and warning sign. From these requirements two devices were selected as options: MioVision and COUNTcam. In the end the COUNTcam unit in Figure 5 was selected because of the ease and flexibility of the system. The system can be easily set up in varying locations and environments. Replacement and additional parts are normally easier to get locally from hardware and electronic stores with some exceptions. However, the major difference between the two was the size and cost. The COUNTcam was about \$4000 less and is self-contained in a 12-inch by 9-inch 8-pound case.

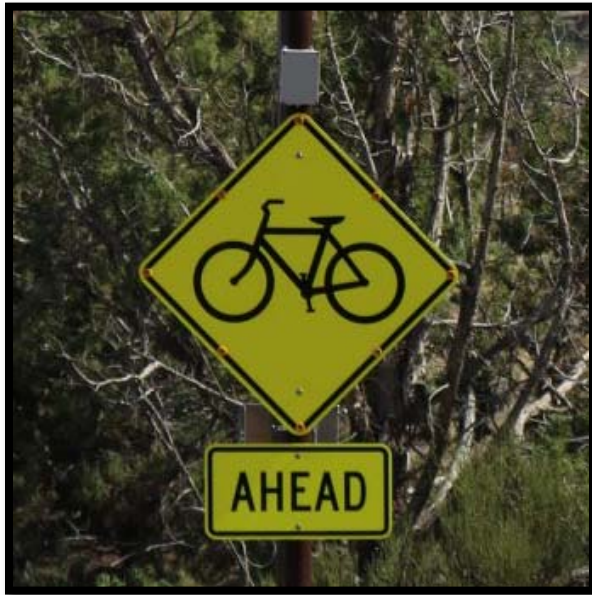
Tapco produces all types of signage for road projects. In this case a W11-1 BlinkerSign LED Bike Lane (Symbol) Sign shown in Figure 6 was used. Unlike the traditional W11-1 signs a BlinkerSign has eight LED lights around the outside of the sign to grab the driver's attention. The sign is fluorescent yellow green with dimensions of thirty inches high and thirty inches wide. A solar panel is used to charge the Nickel Metal Hydride battery, which has a life span of up to five years, for the LED lights. Each light has a life expectancy of over 100000 hours. Both the sign and the flash pattern of the sign are MUTCD compliant. The sign is expected to function for up to thirty days without being charged and has a one-year full warranty ("W11-1 SOLAR." 2018; BlinkerSign® LED Bike Lane (Symbol) Sign W11-1." 2018).

Figure 6. W11-1 BlinkerSign LED Bike Lane (Symbol) Sign by Tapco

There are four functional settings for the W11-1 BlinkerSign LED Bike Lane (Symbol) Sign, which costs \$1600. The sign can be set to 24/7 continuous flashing, time clock activation, wireless control activation, or vehicle detection activation. In this case it was desired to have the light flash every time a bicycle passed. Therefore, the vehicle detection activation setting was chosen. For this setting the sign can be activated through a push button or a motion detector. Unfortunately, a motion detector would set the sign off for all vehicles instead of just bicycles and it was undesirable to have the bicyclist stop on a hill to activate the sign. The ZELT Range bicycle counter was installed in place of the push button or motion detector to activate the lights on the sign (“W11-1 SOLAR.” 2018; BlinkerSign® LED Bike Lane (Symbol) Sign W11-1.” 2018).

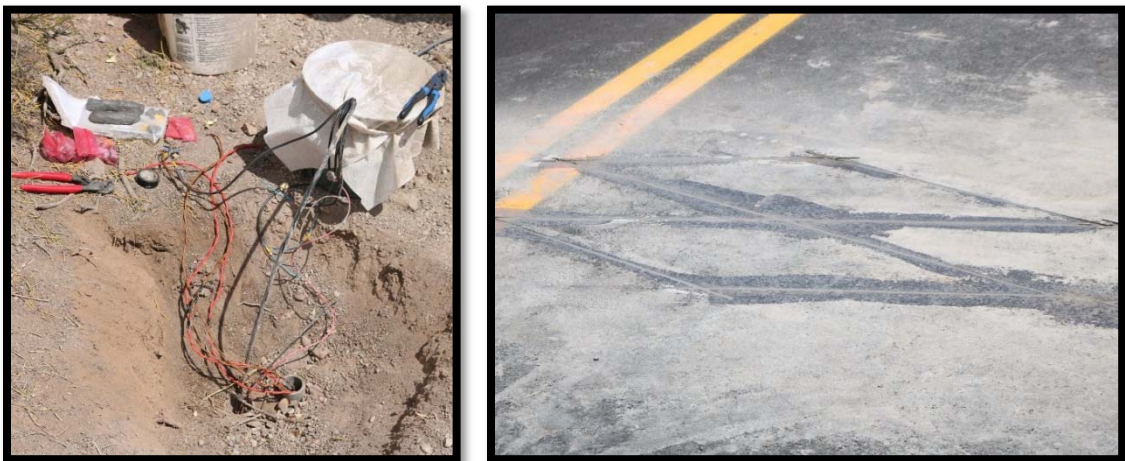
Figure 7. Urban ZELT bicycle counter left and induction loops right

The Urban ZELT bicycle counter shown in Figure 7 was designed specifically for shared roads so that cyclist counts can be determined accurately. Urban ZELT’s inductive loops are forty-three to fifty-nine inches long and sixteen inches wide. The system should function for one to two years with the replaceable battery and works in all weather conditions. EcoCounter’s software provides seamless data transmission allowing easy data collection from around the world (“Urban ZELT - Bicycle Counter.” 2010).

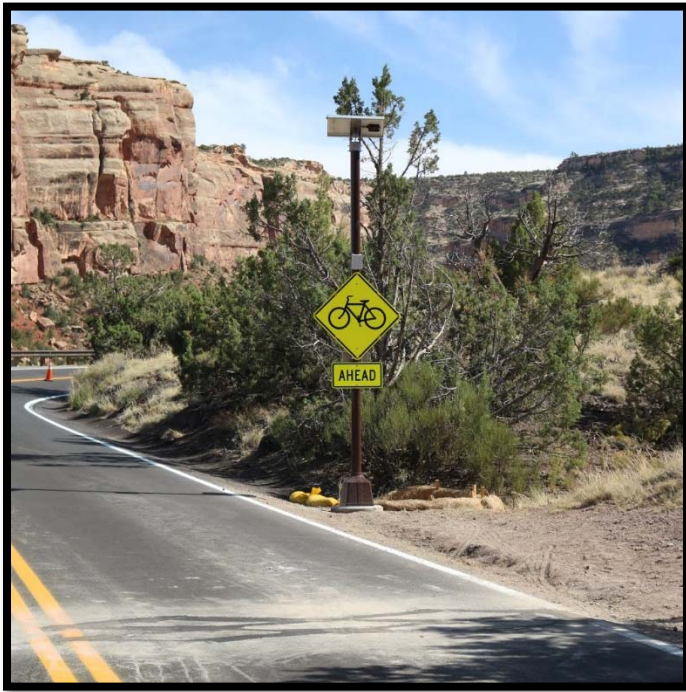
Figure 8. Dynamic Bicycle Detection and Warning System installed at site 1.

Together the ZELT bicycle counter and LED Tapco W11-1 sign in Figure 8 function as one complete system. The Urban ZELT bicycle counter induction loops detect electromagnetic signatures of objects passing over the loops. If the object detected is below a set speed threshold and is categorized as a bicycle by the algorithm an event is recorded in a fifteen-minute bin. Each time an event is recorded a signal is sent from the Urban ZELT bicycle counter to the Tapco W11-1 sign. The sign was set to flash for a total of three minutes when a signal was received from the counter. The system functions not only as a warning device but also as a bicycle counter, allowing road owners to document bike use over time.
