THE ROLE OF SECONDARY PRECIPITATES AND SULFATE REDUCING  
BACTERIA IN MICROBially INFLUENCED STEEL CORROSION:  
IMPLICATIONS FOR FUEL TANK DEGRADATION

A thesis submitted in partial fulfillment  
of the requirements for the degree

MONTANA STATE UNIVERSITY  
Bozeman, Montana

May 2013

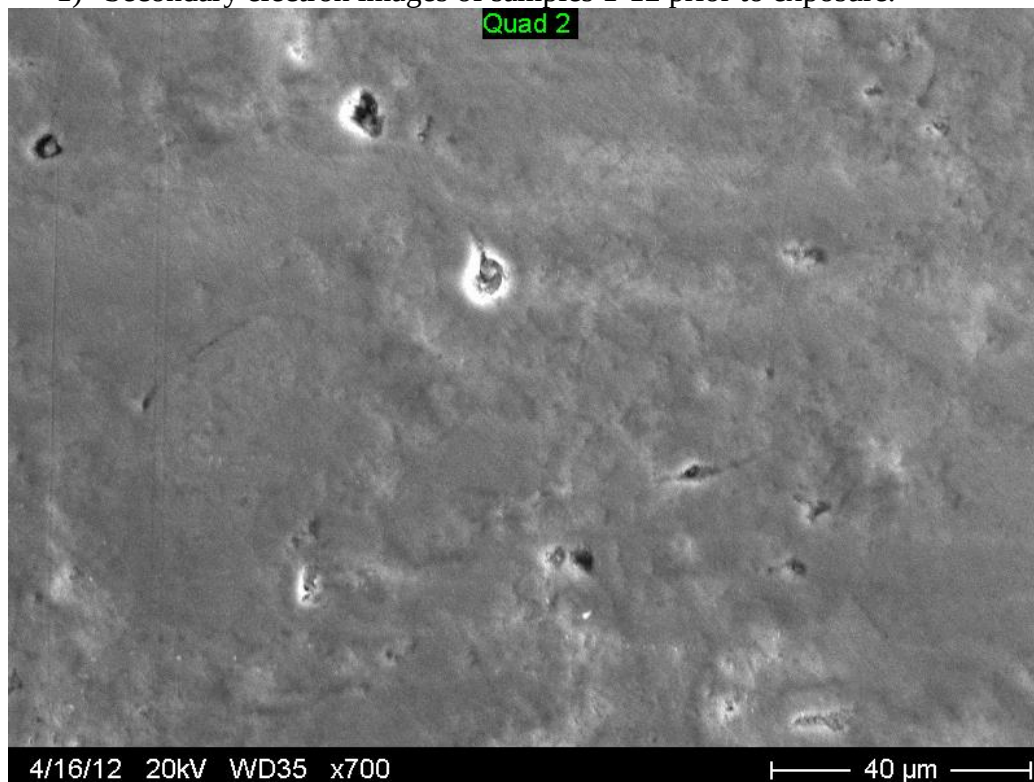
- 1) Secondary electron images of samples 1-12 prior to exposure.

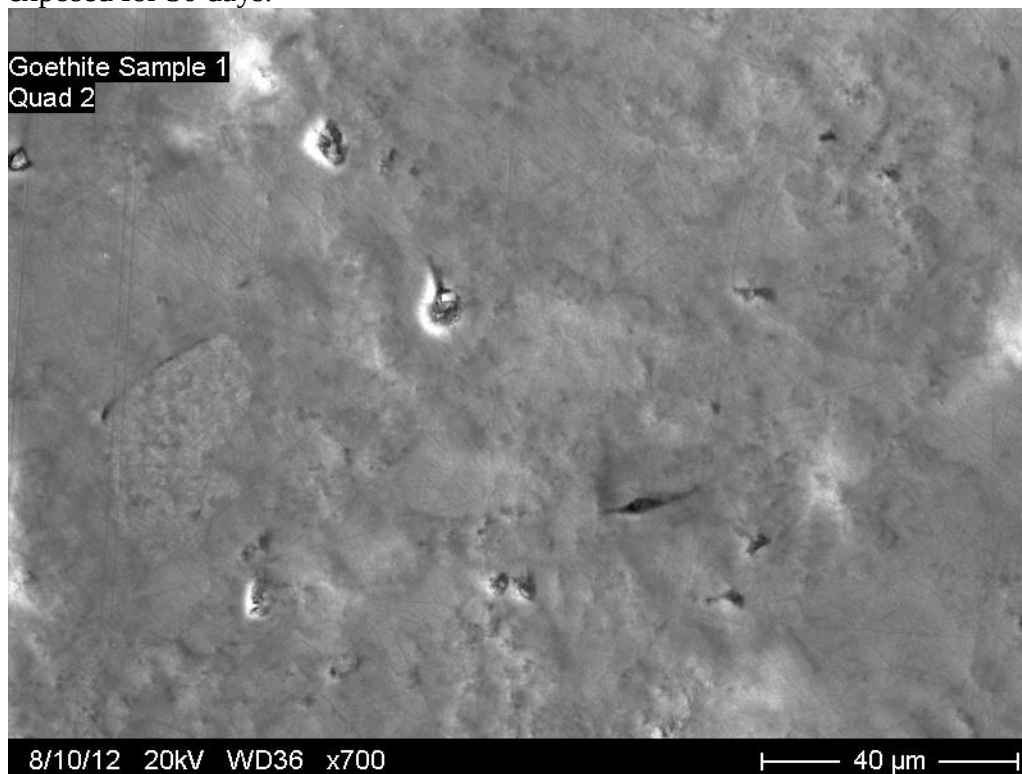
4) Secondary electron images of goethite samples 1-10 after exposure to SRB. Samples 1-4 were exposed for 7 days; samples 5-8 were exposed for 14 days; samples 9-10 were exposed for 30 days.

The results of experiments run at 7, 14 and 30 days of incubation with SRB did not provide any evidence of interaction with iron oxy-hydroxide (goethite), as suggested by the lack of cells observed in the FE SEM images. Bladed goethite crystals were observed in both the inoculated and sterile control batches, indicating that an abiotic reprecipitation mechanism controlled crystal growth on the substrate surface. Goethite was observed to have a less than a one nanometer thick layer of organic metabolites on the surface as determined by XPS multiplex data of carbon and oxygen. The goethite substrate was present in the survey scans after the removal of one nanometer of the surface via argon sputtering. The results were the same, independent of exposure time and independent of the presence/absence of cells. Since the SRB did not interact with goethite, it seems plausible that a thin layer of iron oxy-hydroxide as an armoring surface in fuel tanks could shut down the microbially influenced corrosion process. Goethite in polycrystalline form, however, is quite porous so it may not be the best iron oxide to use as a passivating layer. Further research is needed in a longer time exposure if our model SRB and other anaerobic and/or aerobic bacteria interact with this mineral or if it is inert

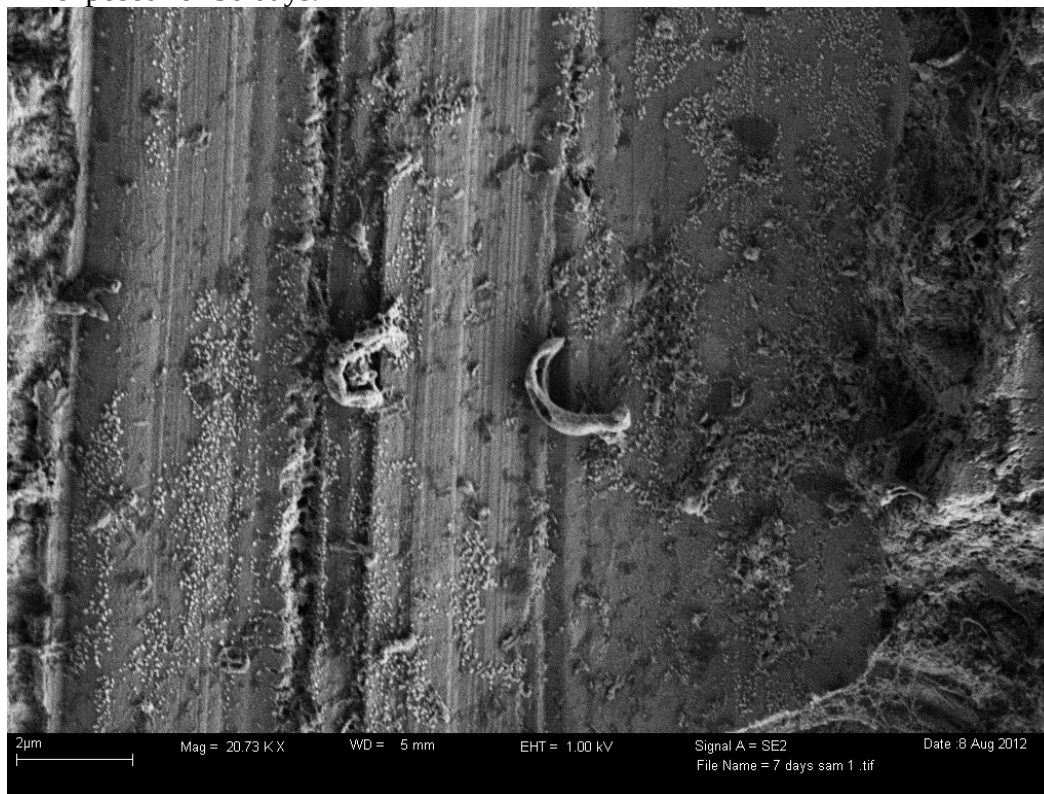
- 1) Secondary electron images of goethites samples after exposure to SRB. Samples 1-4 were exposed for 7 days; samples 5-8 were exposed for 14 days; samples 9-12 were exposed for 30 days.

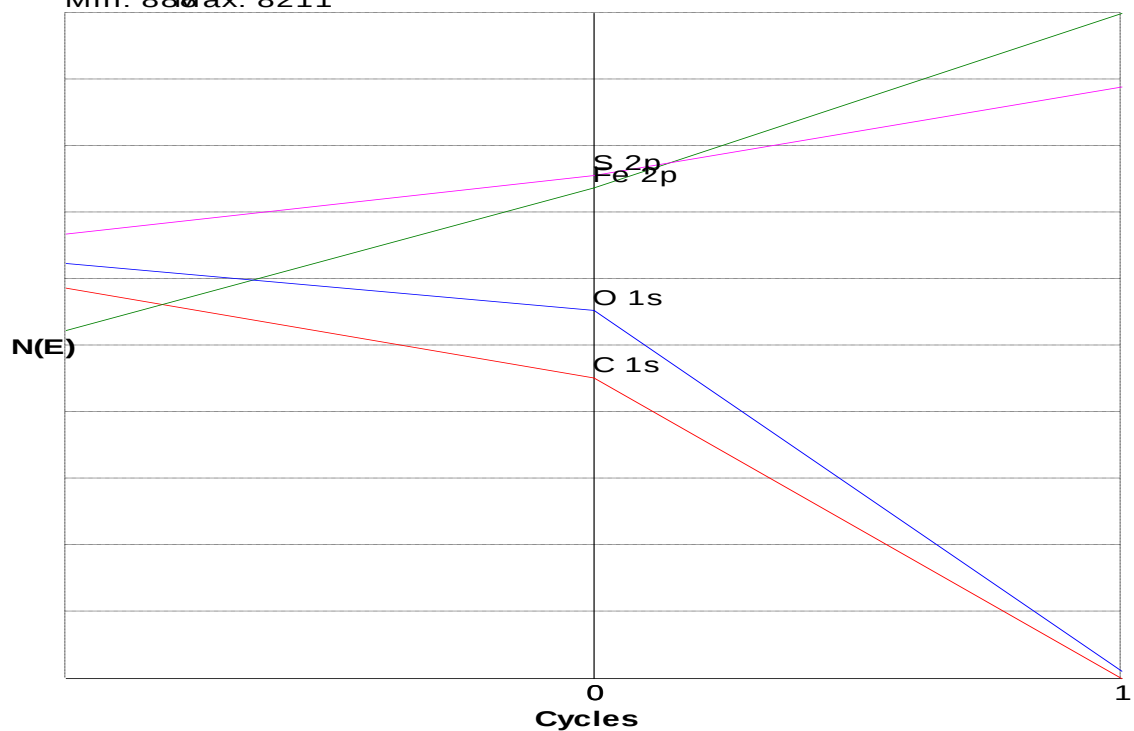
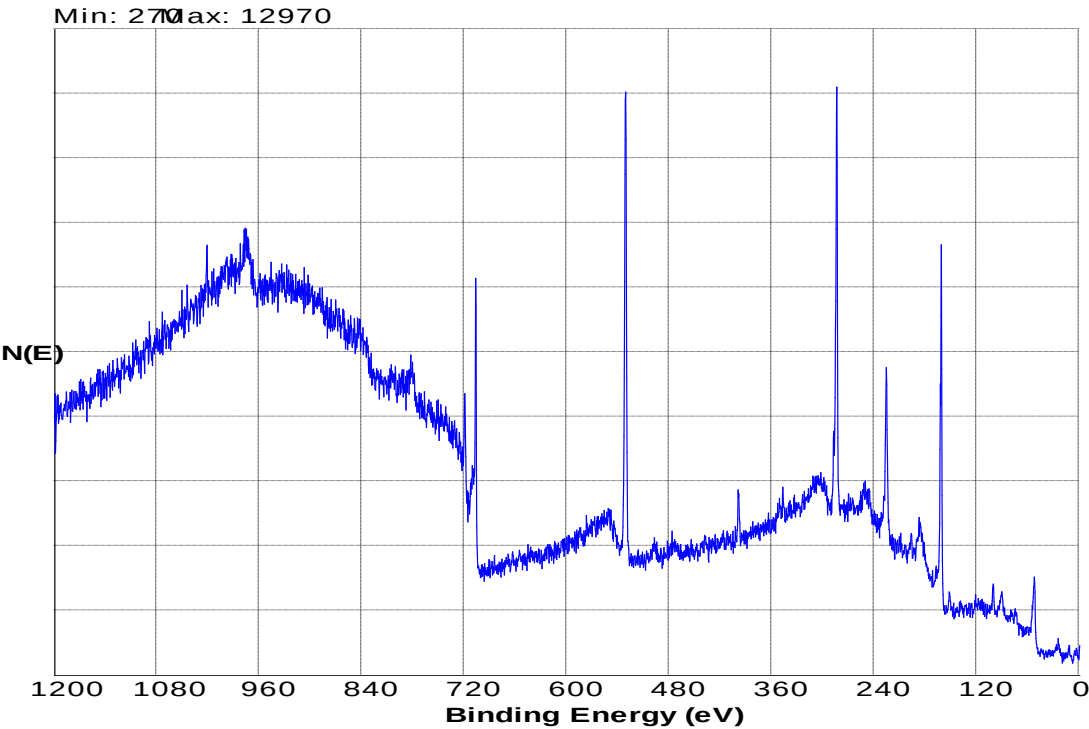
3) XPS depth profile and survey scan for pyrite control sample 4.

SRB cell attachment to pyrite was significant on samples that had fallen to the bottom of the container as well as the samples that were suspended in the medium. EDS, and XPS depth profiles indicate the precipitation of secondary pyrite and iron (III) oxide, most likely goethite, in a layer about 2 nanometers thick in all experiments independent of exposure time. Pyrite was also observed as a reactant in abiotic corrosion processes in a study by Starosvetsky et al. (2010). It was determined that iron sulfide precipitates act as a cathodic reduction site, thus furthering the anodic oxidation of the steel. Iron sulfides are good electrical conductors and act as conduits of electron transfer pathways from the steel to the locations where the cathodic reactions take place on the surface. Starosvetsky et al. (2010) also concluded that "various forms of iron sulfides detected among corrosion products, accumulated on the steel surface in SRB media are actually cathodic reduction products of primarily precipitated ferrous sulfides." This mechanism
