# Hydraulic Analysis at the Interface of the Yellowstone River and the Huntley, Montana Irrigation Diversion Fish Bypass

Andrew Johnson, Joel Cahoon, Al Zale, Katey Plymesser, and  
Matthew Blank

Andrew Johnson, MS <sup>1</sup>  
Joel Cahoon, PhD, PE <sup>1</sup>  
Al Zale, PhD <sup>2</sup>  
Katey Plymesser, PhD, PE <sup>1</sup>  
Matthew Blank, PhD, PE <sup>3</sup>

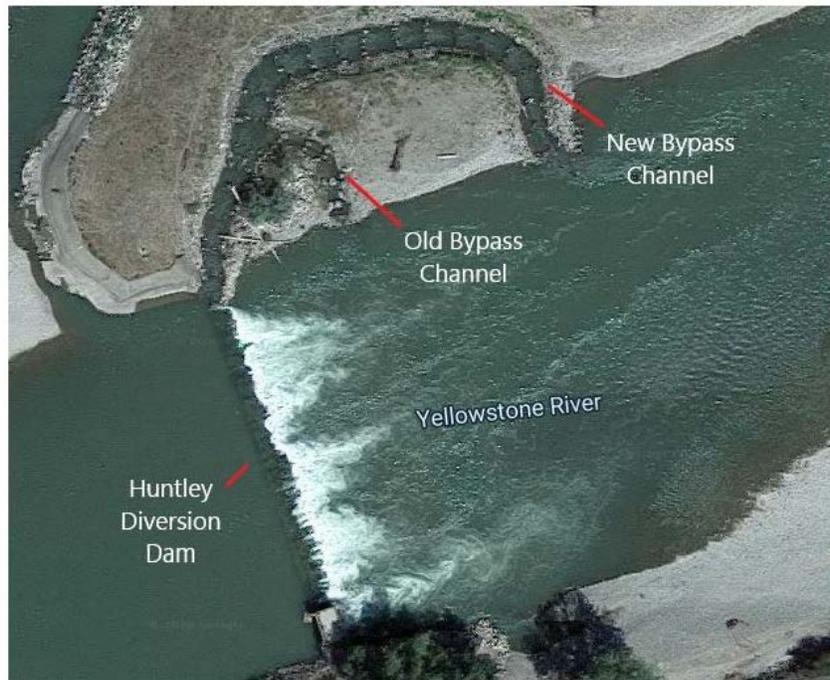
*Figure 2 - Huntley Diversion showing the old and new nature-like bypass channels. Image from Tupen (2020) and Google Earth.*

with riprap to make it into a nature-like bypass to help fish navigate around the impassible diversion. This “Old Bypass Channel” (Figure 2) was deemed ineffective as a pass way for upstream fish travel due to steep slope and high velocities (Zale, et al., 2018). In June of 2011, the Silvertip Pipeline ruptured by Laurel, MT upstream of the diversion. In the wake of the spill, plans were made to modify the bypass by making it longer and therefore less steep. The redesigned nature-like bypass (*New Bypass Channel* in Figure 2) was finished in 2015 and is the focus of this project.

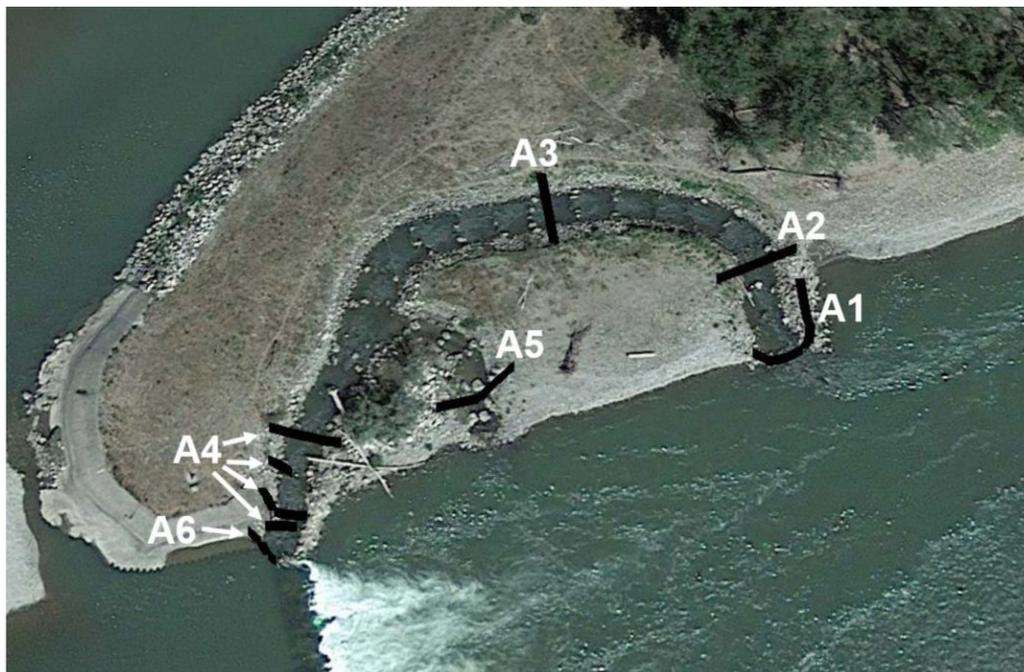
*Figure 3 - PIT tag antenna locations. These record every occurrence of a tagged fish swimming over one of the buried cables. Image by Ian Anderson on Google Earth.*

In the fisheries experiment (Anderson, forthcoming), 14 of the over 50 fish species that can be found in the Yellowstone River were included in a passive integrated transponder (PIT) based direct assessment of passage throughout the bypass. In order to determine if fish find and use the bypass, PIT tags were inserted into the abdominal cavity of nearly 4,000 individual fish. These fish were caught using electro-fishing in the vicinity of the diversion, measured, recorded, and fitted with a PIT tag before being released downstream of the bypass. A series of antennas that record the incidence of proximity of PIT tag were placed across the bypass in several locations as shown in Figure 3. Many useful analytics can be determined from recording the tagged fish at these antenna locations. Attraction to the bypass, passage to different points along the bypass, and occurrences of exiting the bypass can be determined and analyzed statistically. Many other interesting relationships can also be determined such as the size of the fish passing, and the temperature, flow rates, and time at which fish movements occur.

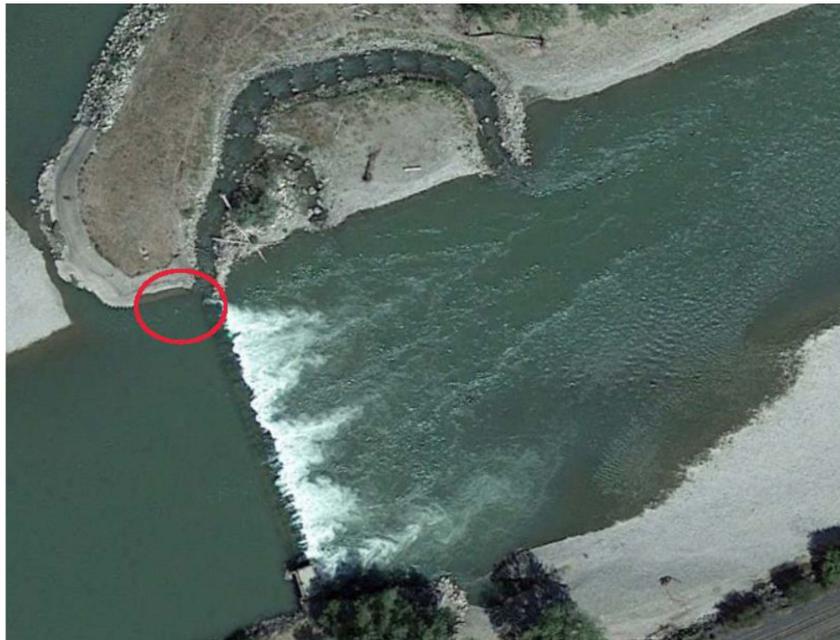
*Figure 4 - Study area for this project looking at the area around the bypass exit. Imagery from Google Earth (2021).*

The motivation to examine the hydraulic conditions more closely in the area shown in Figure 4 was a result of the observations of Anderson (forthcoming) and Tupen (2020). Anderson found some fish returning to the downstream end of the bypass after successful ascent, and Tupen found difficult velocity conditions at the upstream end of the bypass. In the study detailed herein, we have used an additional 2-D HEC-RAS model to explore the hydraulic conditions at that location more thoroughly.

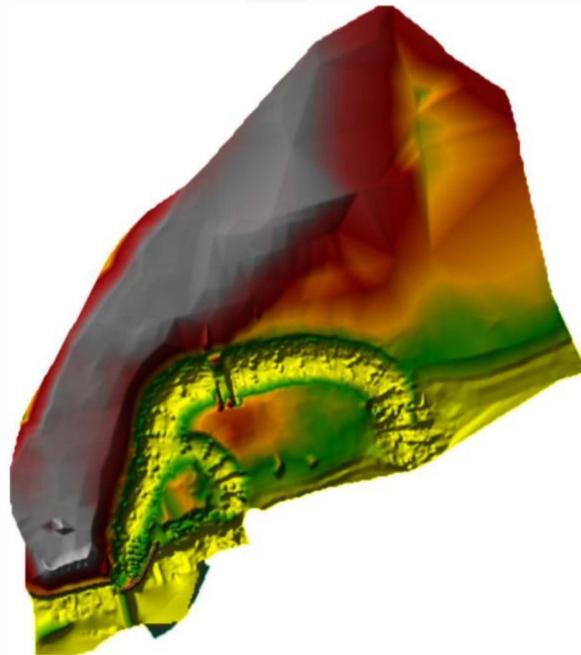
The two data strands were then combined using time as the common factor to accurately attain the bathymetry of the site. Some of the data was removed to eliminate noise from poor depth measurements. The survey data was combined in Civil3D and added to the previous topographical survey of the site to create a surface. The diversion itself was unsafe to deploy the equipment over the crest and was therefore described from historical construction photos and limited survey data and merged into the terrain surface. This surface was then exported from Civil3D as a raster file to be imported into HEC-RAS via RAS-Mapper using the NAD 1983 State Plane Montana FIPS 2500 Feet projection. This projection was also used in the previous modeling. The terrain can be seen above in Figure 5 as it can be viewed in RAS-Mapper.

*Figure 5 - Terrain raster used in HEC-RAS.*

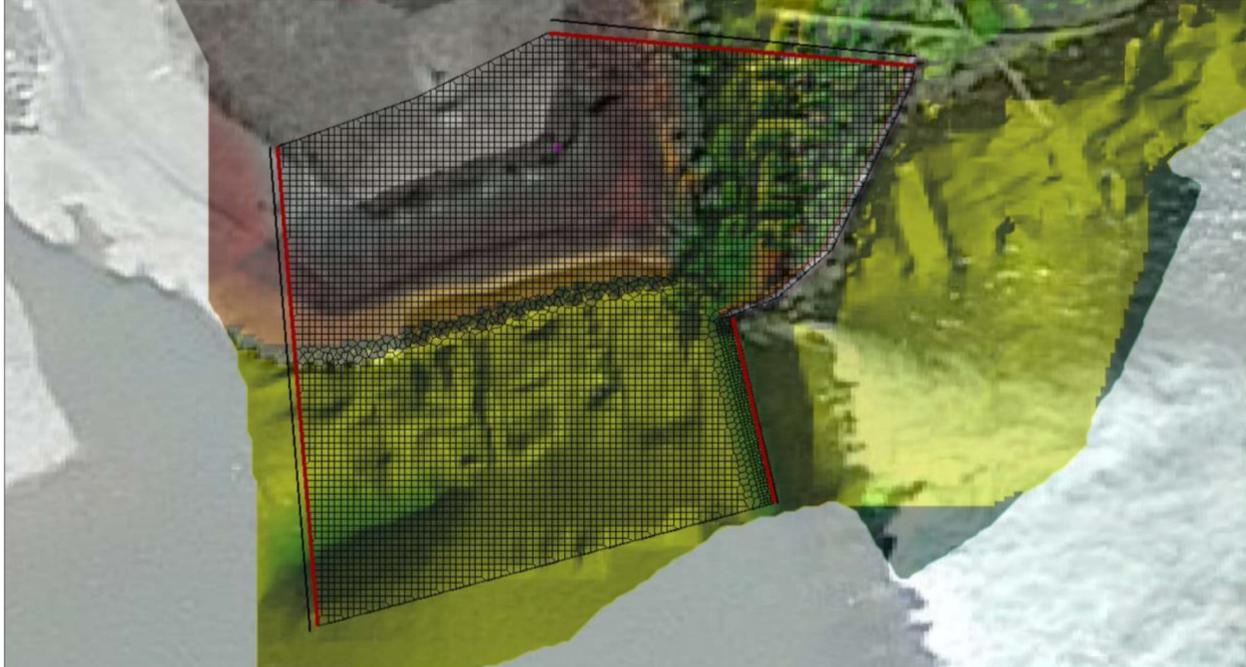
Boundary conditions are arguably the most important part of a model as the rest of the model needs to match these 'known' requirements at its extents. This model utilizes three, as shown in red in Figure 6. The upstream boundary condition (left) passes water into the model as a stage hydrograph. This stage was iteratively adjusted so that the flow rate into the bypass corresponded to previous modeling and field measurements at different flow rates in the Yellowstone. The first of the two exit boundary conditions seen over the diversion has a rating curve of stage vs discharge. This rating curve uses the standard HEC-RAS weir equation with a discharge coefficient of 3.5. This is within the recommended range for an ogee-crested weir (Brunner, HEC-RAS River Analysis System Hydraulic Reference Manual, 2016). The other exit is another stage hydrograph. This stage matched the results of the previous modeling results by using data from a cross section where measurement was taken within the bypass. At this line, both the stage and discharge were matched to accurately portray the interface of the bypass fish exit. At the site, water flows over the rock pile delineating the bypass from the main channel of the Yellowstone. This is a tricky situation to represent with boundary conditions, so an artificial 'wall' was built into the terrain at the flow area boundary to force this flow out of the model through the boundary condition in the bypass. The discharge measured at the boundary condition ignored this additional flow by only measuring the part of the flow that was in the bypass channel. This additional flow was easily identified at low flows because it never re-entered the bypass channel. At large flows when the bypass channel overfills, streamlines made the distinguishment possible.

*Figure 6 – Two dimensional flow area computational mesh and boundary conditions.*

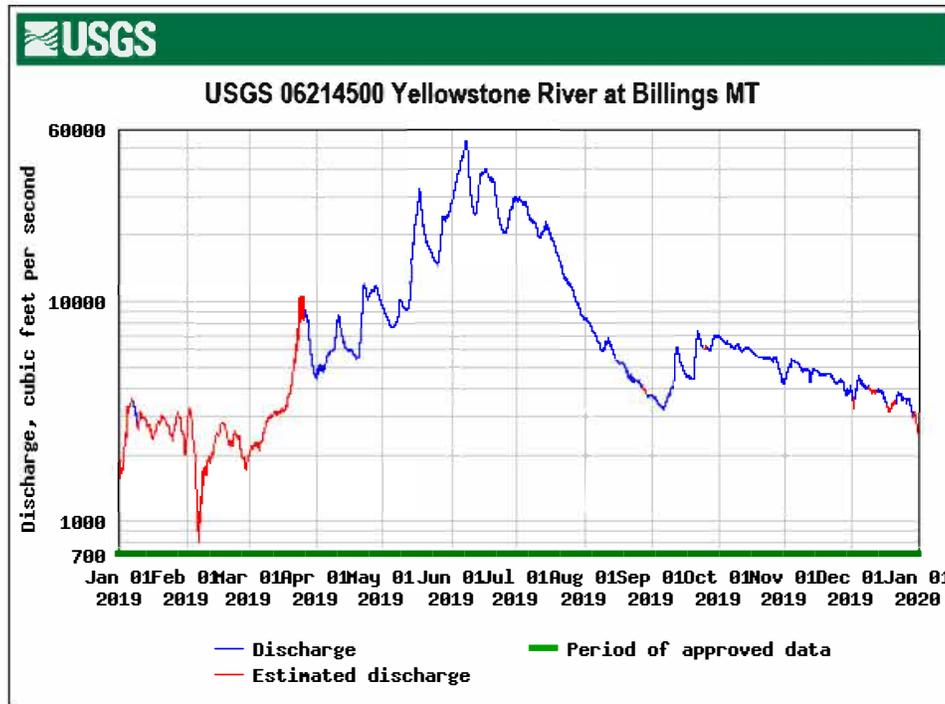
Figure 7 - Yellowstone River 2019 hydrograph.

As mentioned in the previous section, each flow rate modeled must be iteratively solved by changing the upstream boundary to match the flow and stage across the downstream boundary within the bypass for each run. This requirement makes it impractical to run the entire hydrologic year through the model as in the previous models of the bypass itself. To capture as much of the hydrograph as possible, six flow rates in the Yellowstone were chosen to represent the curve. These flow rates were 3000, 5000, 10000, 20000, 35000 and 50000 cfs. More flow rates were chosen at the lower end of the hydrograph, which can be seen in Figure 7, as low flows occur frequently. The maximum flow was 50000 cfs even though the Yellowstone exceeds this discharge most years but typically only for a short duration. Additional flow rates were run between 10000 cfs and 20000 cfs to provide more resolution in this area where it is believed that fish may experience passage problems.

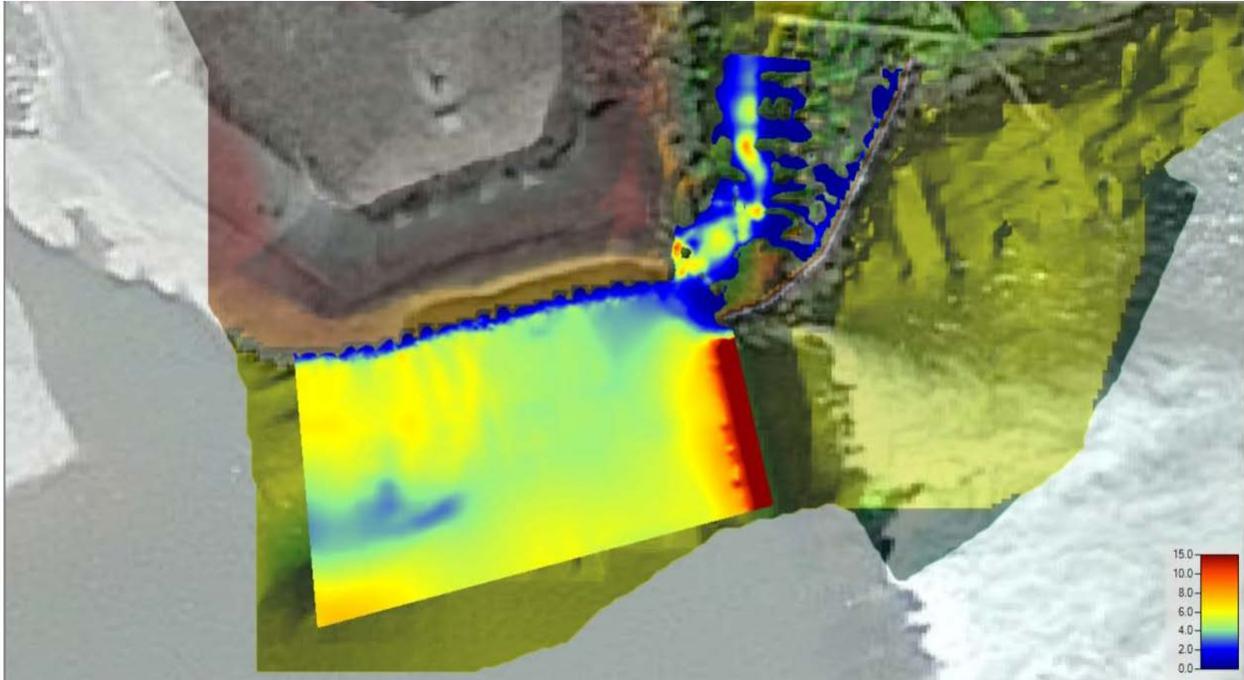
Each of the six flow rates were run until steady and can be seen in the following figures. The velocity scale bars are in ft/s and flow is going from left to right. The flow rates listed are for the entire Yellowstone at the USGS Yellowstone River Gage 06214500, upstream of the diversion. The flow rate into the bypass was measured so that the offshoot of the bypass channel seen in Figure 8 below was not included.

*Figure 8 - 3,000 cfs in the Yellowstone.*

Figure 8 and Figure 9 show the bypass exit at base or low flows. While there are some higher velocity areas in the bypass, clear low-velocity routes are visible. Fish are expected to be able to navigate these velocities. The next two, Figure 10 and Figure 11, show the mid-range flow rates. Preliminary fisheries results indicate that in this range many species begin experiencing difficulties successfully passing the diversion and continuing upstream. Fish appear to make it to the upstream antennas and pass the bypass but may not completely navigate past the diversion. A high velocity spot appears on the river left of the bypass and grows in size and magnitude as the flows increase. Somewhere in this range a high velocity plume takes over much of the bypass. The clearest route around this plume is to the river right of the bypass which would put fish in a position to re-enter the Yellowstone just above the diversion. High flows, seen in Figure 12 and Figure 13 are dominated by high velocities and deep waters. Based on these model results it would be unlikely for many fish to pass the diversion.

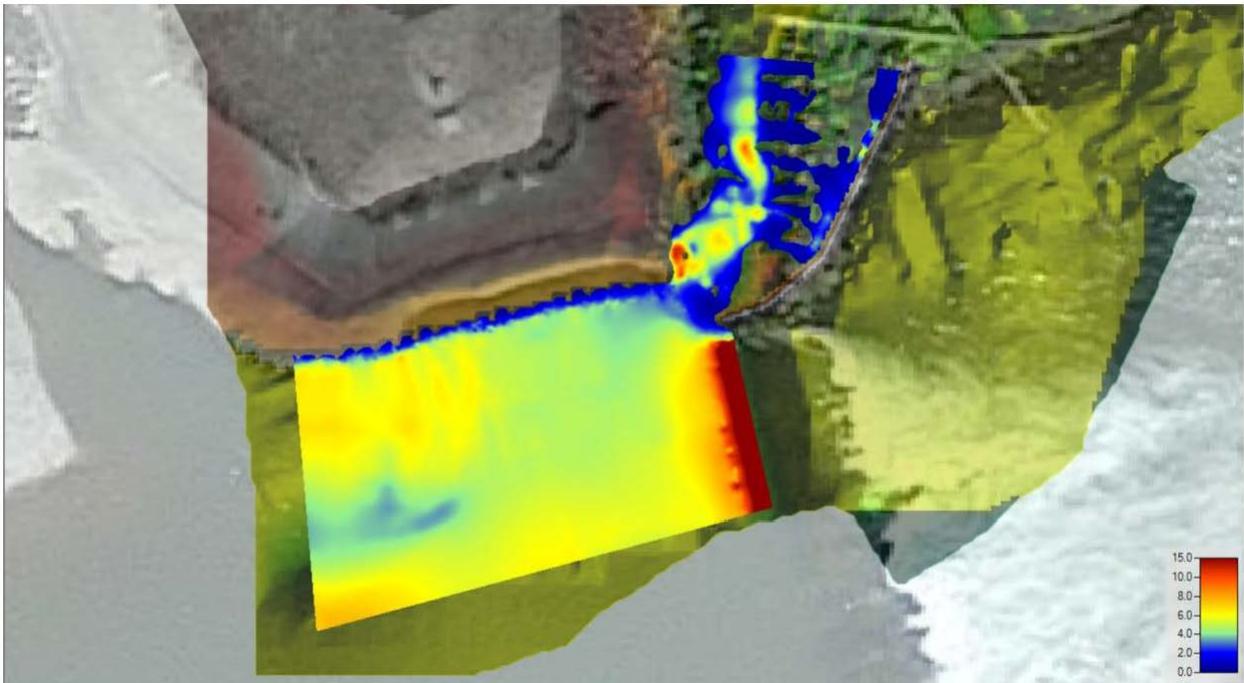
*Figure 9 - 5,000 cfs in the Yellowstone.*

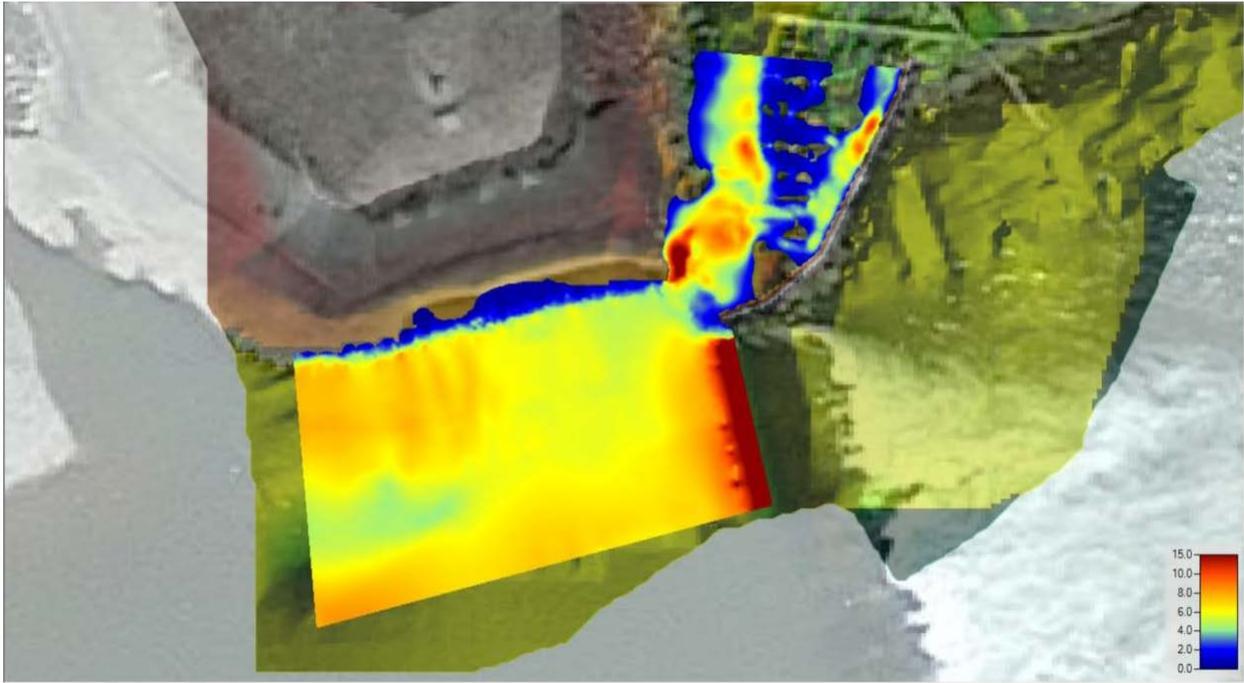
Figure 10 - 10,000 cfs in the Yellowstone.

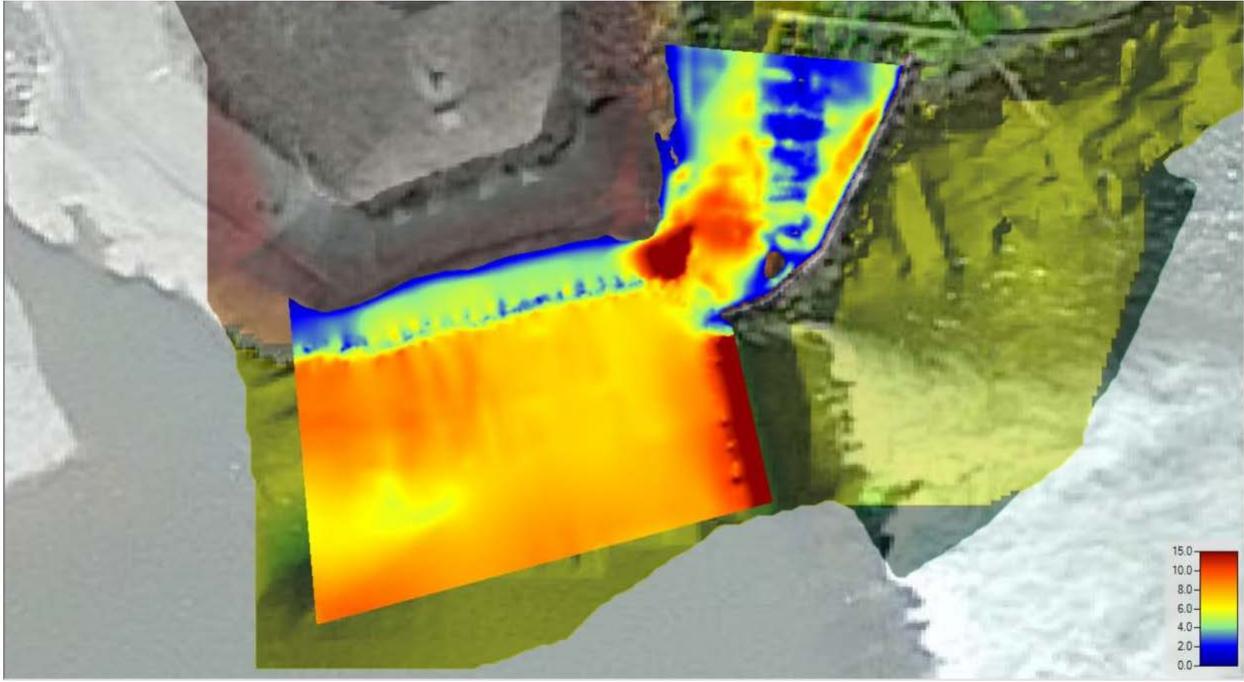
Figure 11 - 20,000 cfs in the Yellowstone.

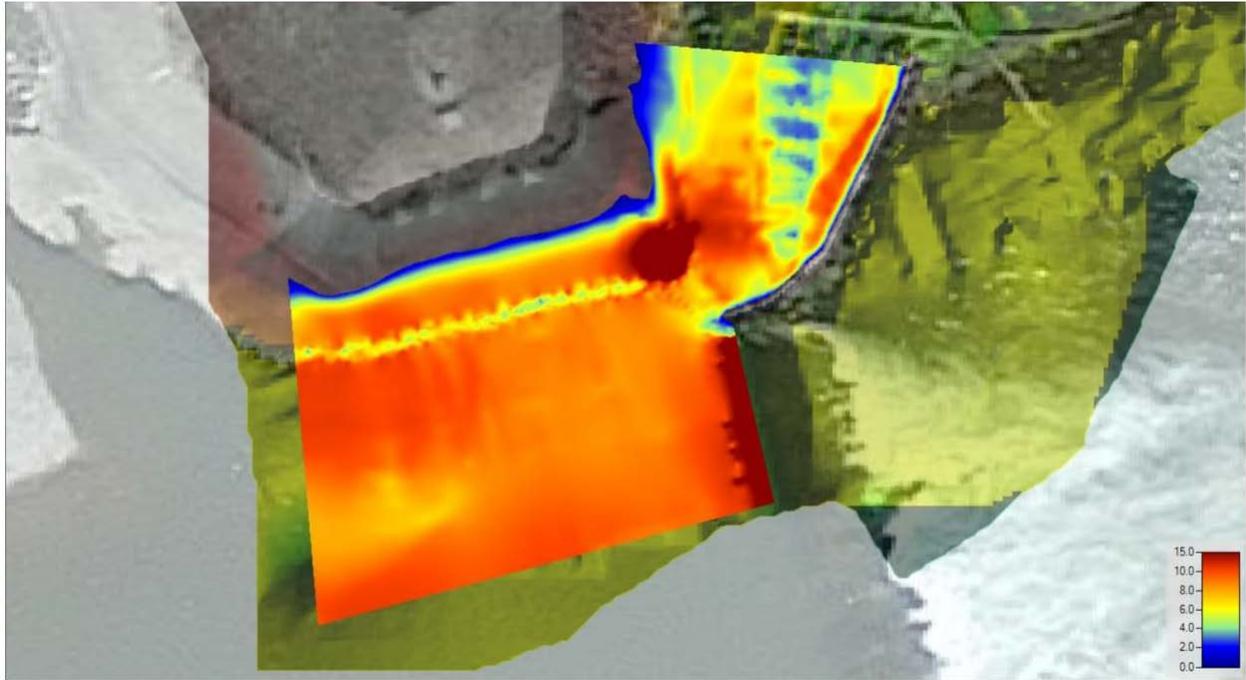
*Figure 12 - 35,000 cfs in the Yellowstone.*

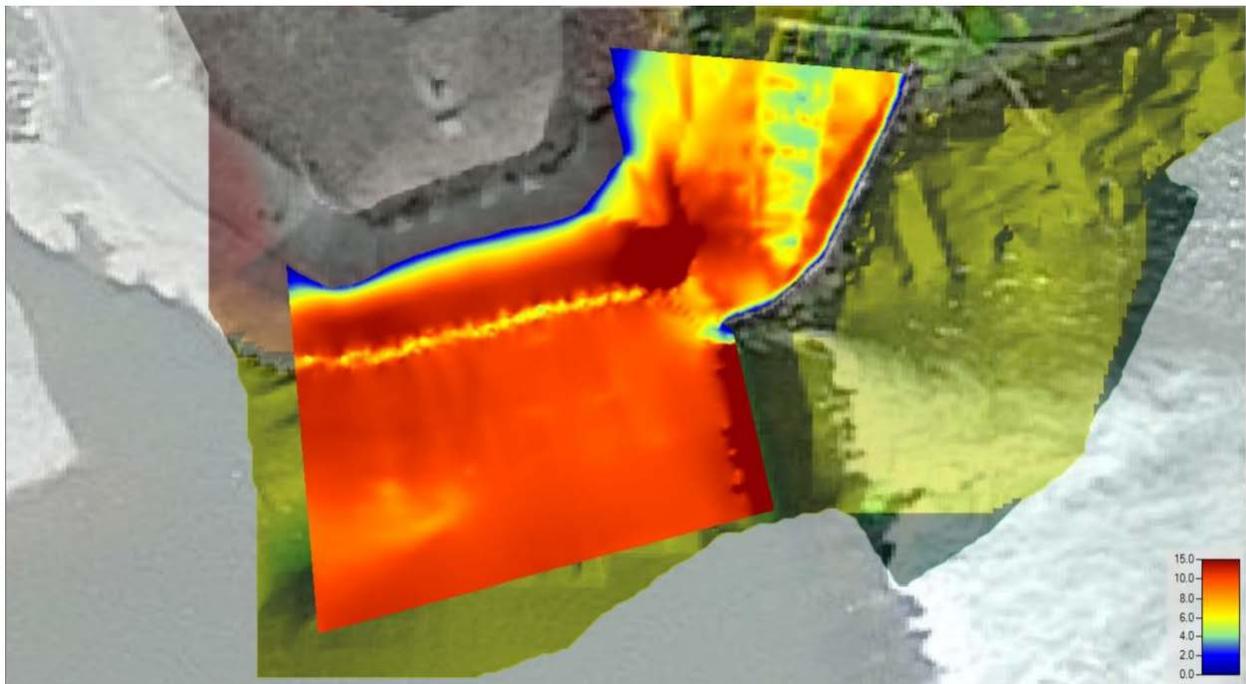
*Figure 13 - 50,000 cfs in the Yellowstone.*

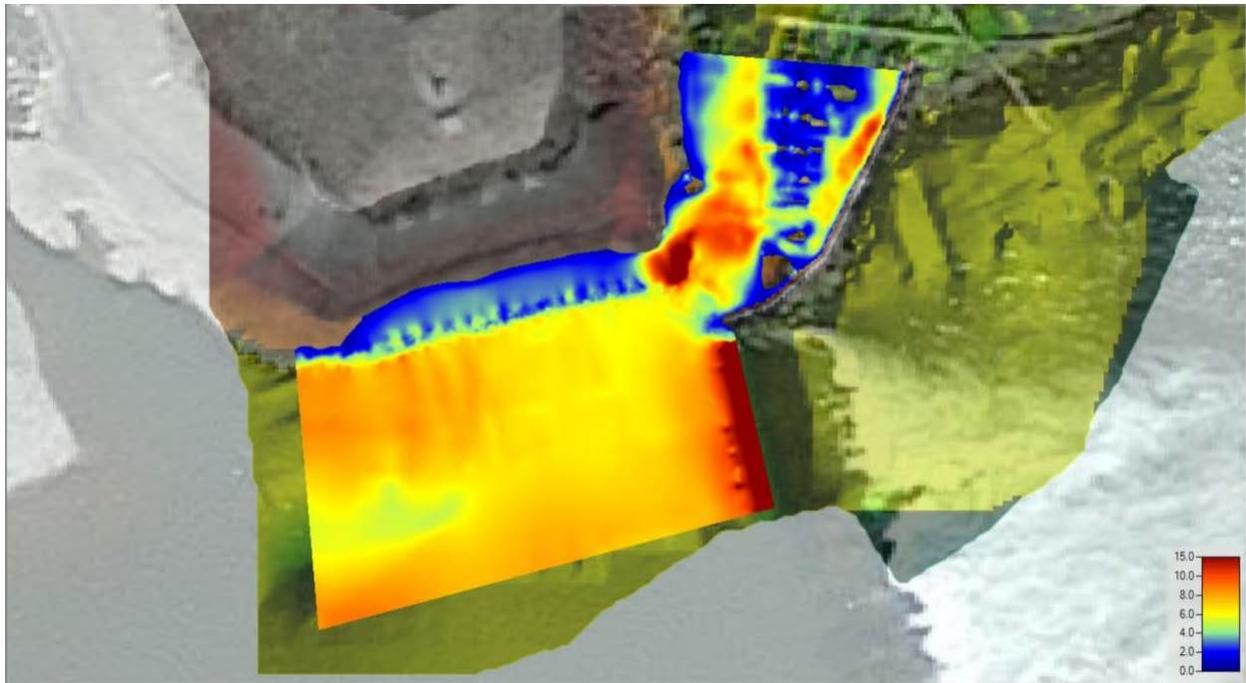
Figure 14 - 15,000 cfs in the Yellowstone

To get a better view of the changes in flow patterns between 10000 and 20000 cfs, every 1000 cfs from 10000 to 18000 was also modeled. It is believed that in this range of flows fish experience difficulty fully passing the diversion and may be getting swept over the dam after successfully navigating the bypass. While the changes in each increment are quite small, a cut off at 15000 cfs was established as the flow at which if fish are seen at the upstream end of the bypass and then shortly after back at the downstream end, they would be considered having failed to pass the diversion. Figure 14 below shows this discharge. Figure 15 shows a profile line that was cut to expose velocities from the tip of rock pile at the bypass exit across to shore. This plot is shown as a fish swimming upstream would see it, the long stretch on the right side of the figure being the shore on the river left of the bypass. The depth averaged velocities are quite large on the river left of the bypass so fish trying to navigate around this barrier would choose to go left (river right) of the bypass into the slower flows. This action places these fish in a position to re-enter the Yellowstone nearly on top of the diversion which could be causing them to be swept downstream as the velocities over the diversion are quite large. This theory needs to be confirmed with the fisheries findings, but the preliminary results suggest this may be true.

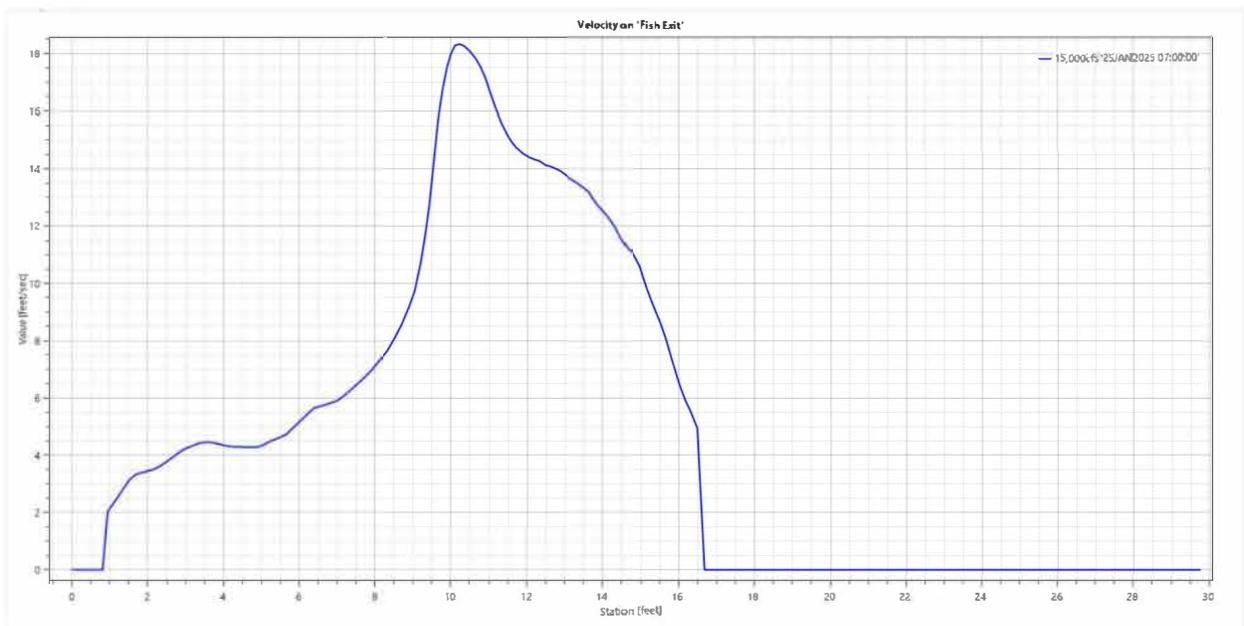
Figure 15 - Velocity profile at the mouth of the bypass exit

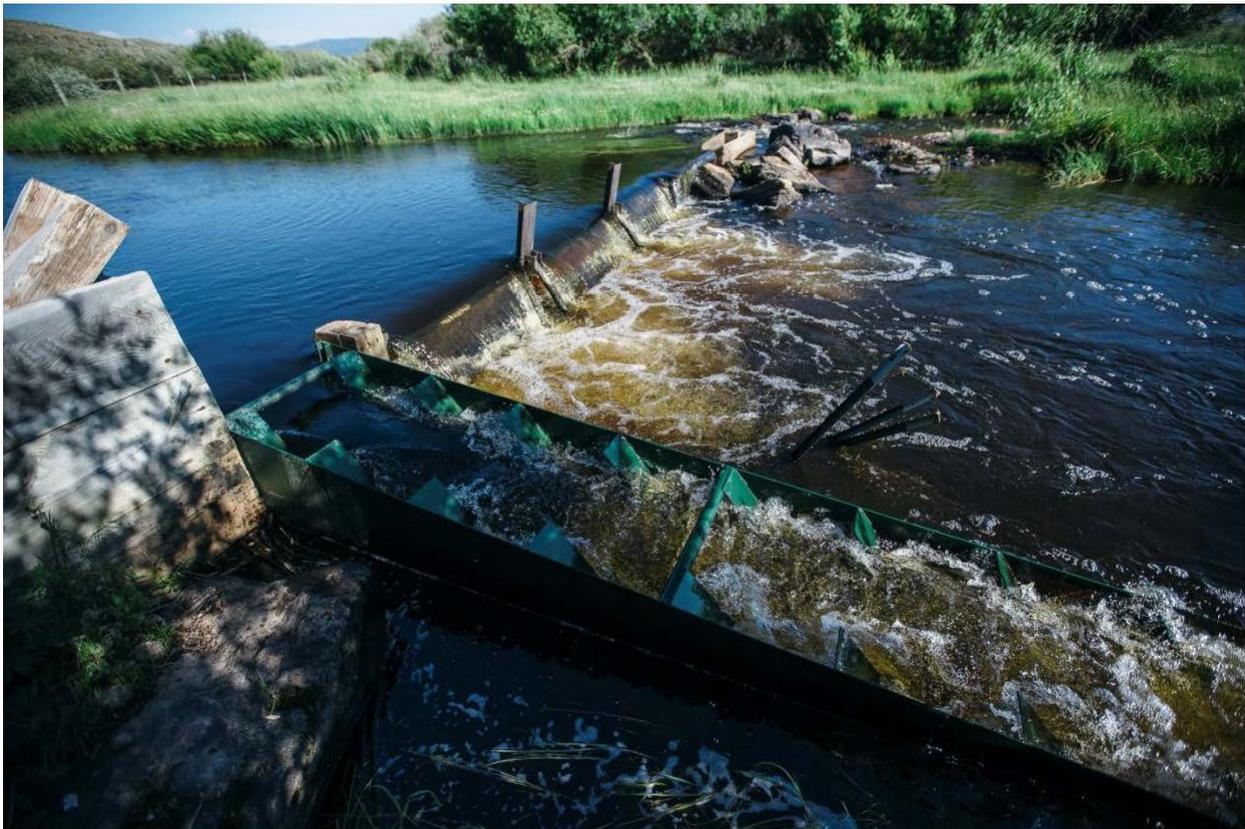
*Figure 16 - Denil fish ladder. Photo by Matt Blank*

One solution could be to place a structural passage feature at the bypass exit. A Denil fish ladder (Figure 16) could be perched across the high velocity area to span this spot during the higher flows as shown in Figure 17. It may need to be placed such that it is only useful during parts of the year. This could help some of the stronger swimming species continue upriver when the flows are high (Katopodis, Kells, & Acharya, 2001) but may not provide passage to all species. This solution could also keep fish on the river left side of the bypass and away from the diversion itself and the accompanying faster velocities.

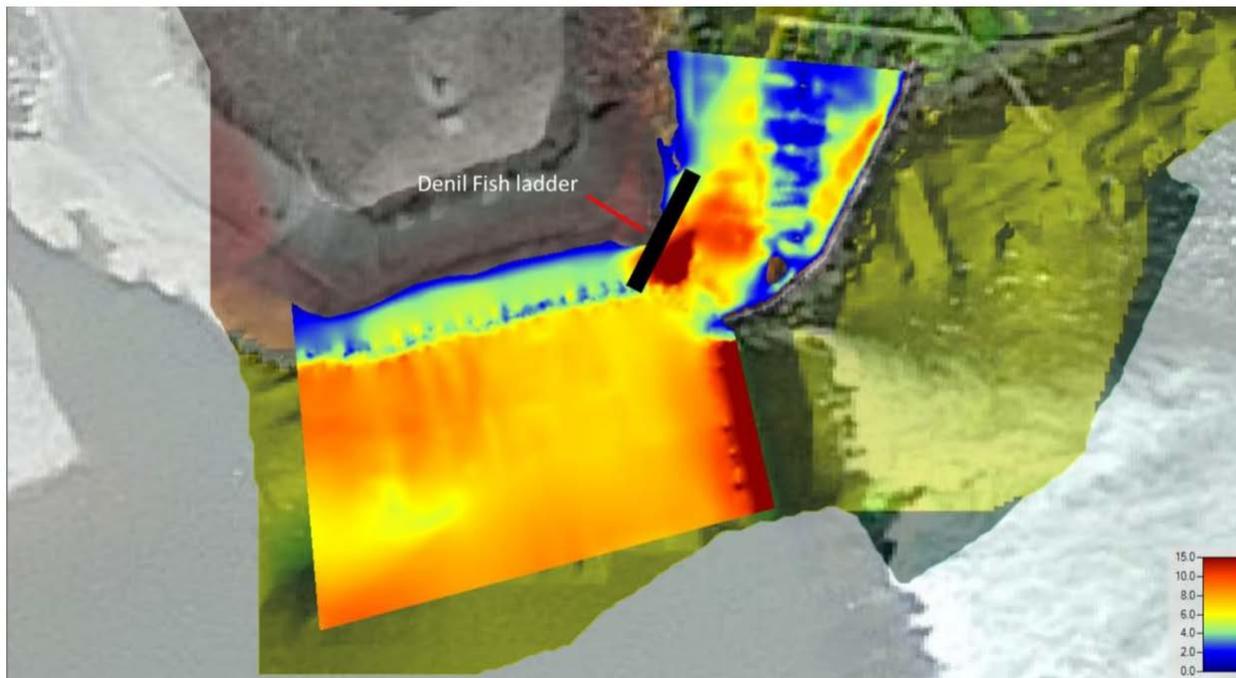
Figure 17 - Possible fish ladder location at the bypass exit

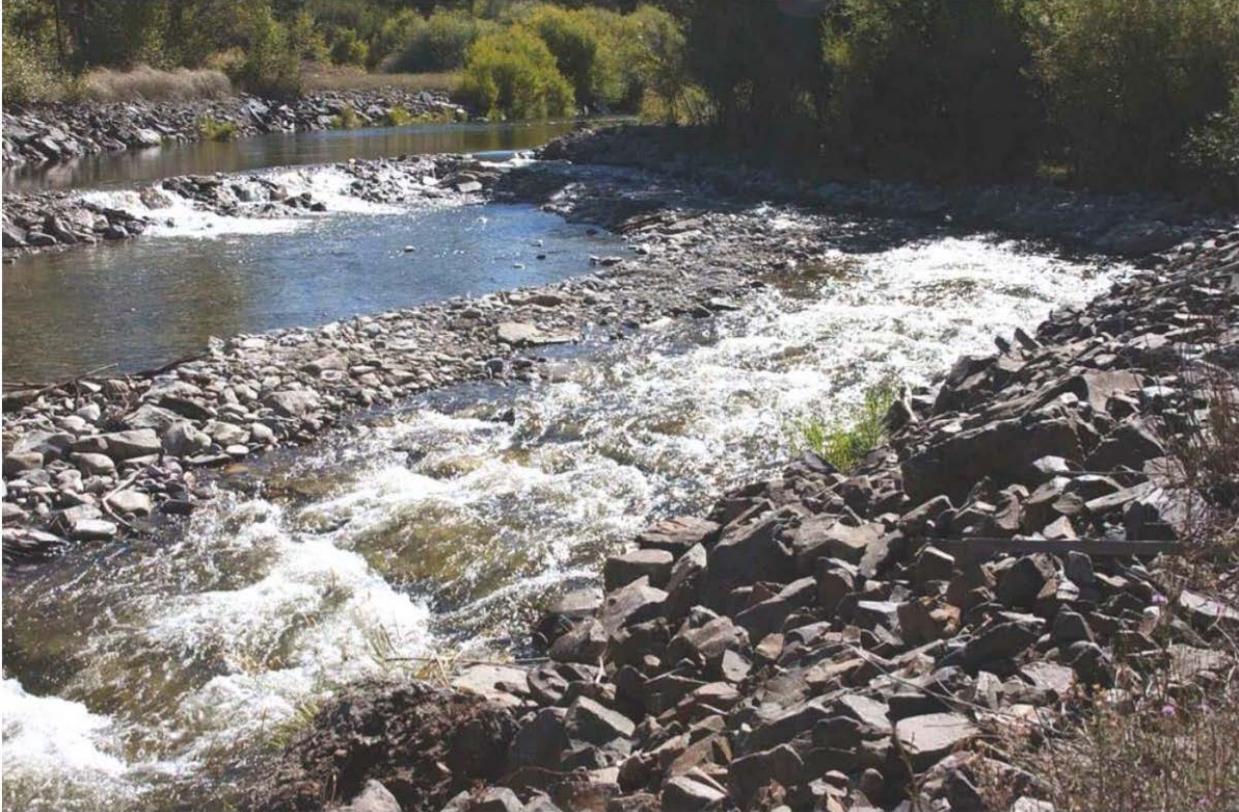
*Figure 18 - Example of a rocky ramp style fish way. Photo by USBR.*

Another option, more alike to the nature-like bypass itself could be to modify the bypass exit into a rocky ramp style fishway, an example of which can be found in Figure 18. This ramp could be installed to span the bypass width such that it provides passage to fish throughout the hydrologic cycle. By strategically placing additional boulders, the fishway could provide resting places and a route of low velocity (Mooney, Holmquist-Johnson, & Broderick, 2007). An advantage to this type of passage structure is that it can be used successfully at a broad range of flow rates and by the diverse selection of species as it mimics natural stream hydraulic conditions (Calles & Greenberg, 2005). This solution could also be constructed in a way that would keep fish away from the diversion and release fish further upstream than at present.
