Evaluation of the strength of a reactor pressure vessel
by Everett E Shaw

A THESIS Submitted to the Graduate Faculty in partial fulfillment of the requirements for the degree
of Master of Science in Mechanical Engineering
Montana State University
© Copyright by Everett E Shaw (1955)

This report is an appraisal of the strength of a reactor vessel. It is based on 1) a consideration of the mechanical properties of the vessel components, and 2) a series of three tests made to record outside surface principal strains vs internal pressure.

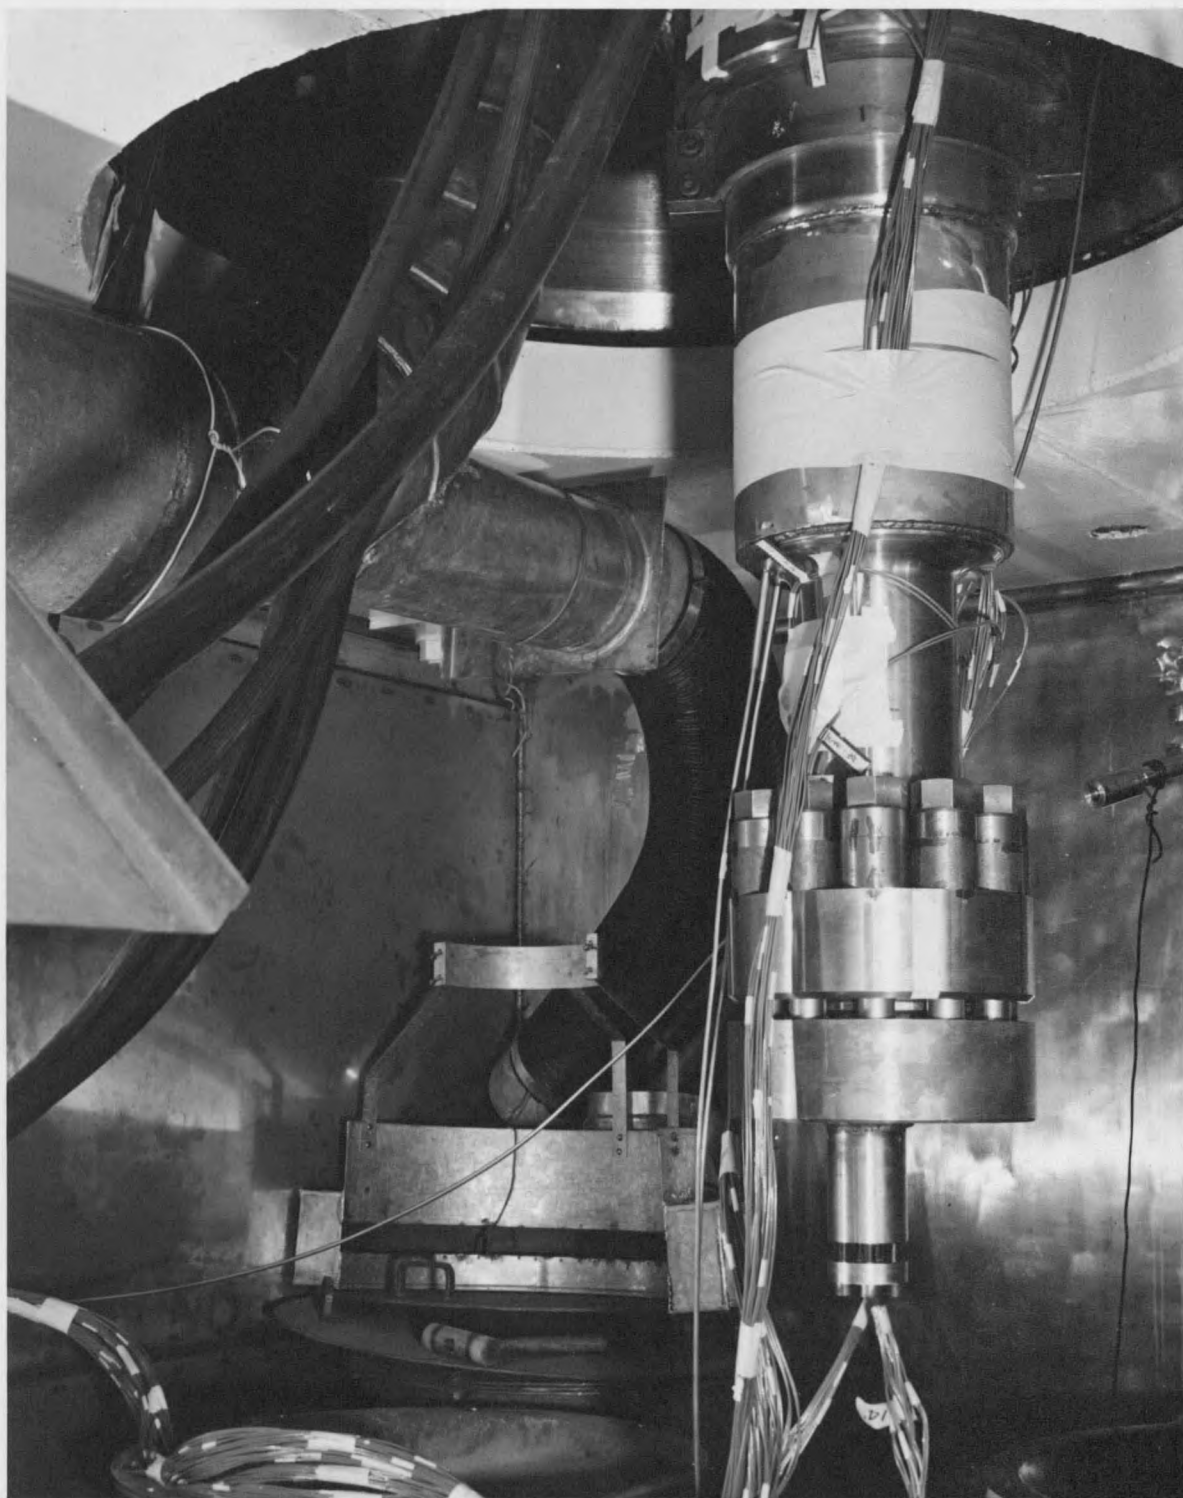
Fig. 8 - Lower end of completed vessel assembly in test cell.

The retort was then carried to the test cell, and suspended vertically between two I-beams under the flange. After inspection for leaks at the lead wire seal and flange closure, the pump casing flange bolts were loaded, following the usual procedure for setting heater bolts.* The vessel was filled with water, which was the medium of pressure transmission, the head assembled, and head flange bolts loaded.* Lines were run from the vessel to pressure source and gage, and lead wires pulled to the control room. Figures 8 and 9 show respectively the lower end and head assembly of the vessel ready for test.

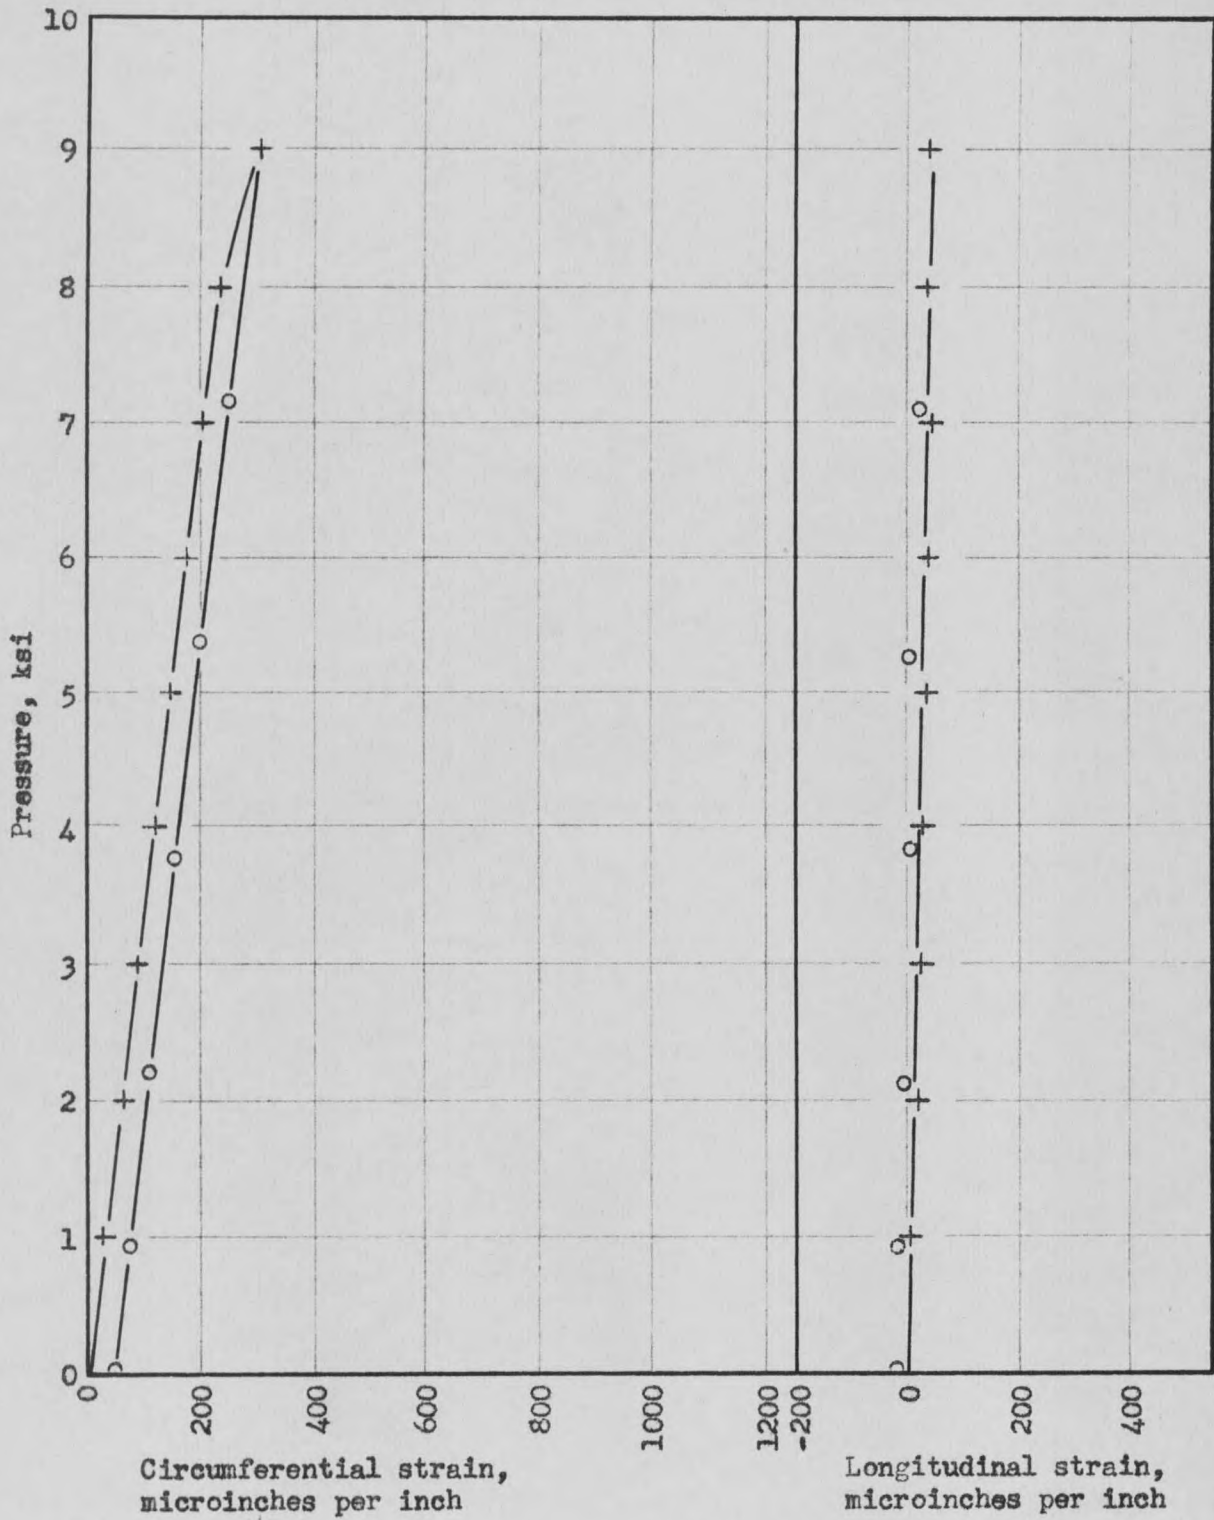
Fig. 36 - Pressure vs strain at section I, test #1.

Fig. 37 - Pressure vs strain at section I, test #2.

Fig. 38 - Pressure vs strain at section I, test #3.

| Section | Pressure, psi* | | | | | |
|---|---|---|---|---|---|---|
| I | 5000 | | 8000 | | 9000 | |

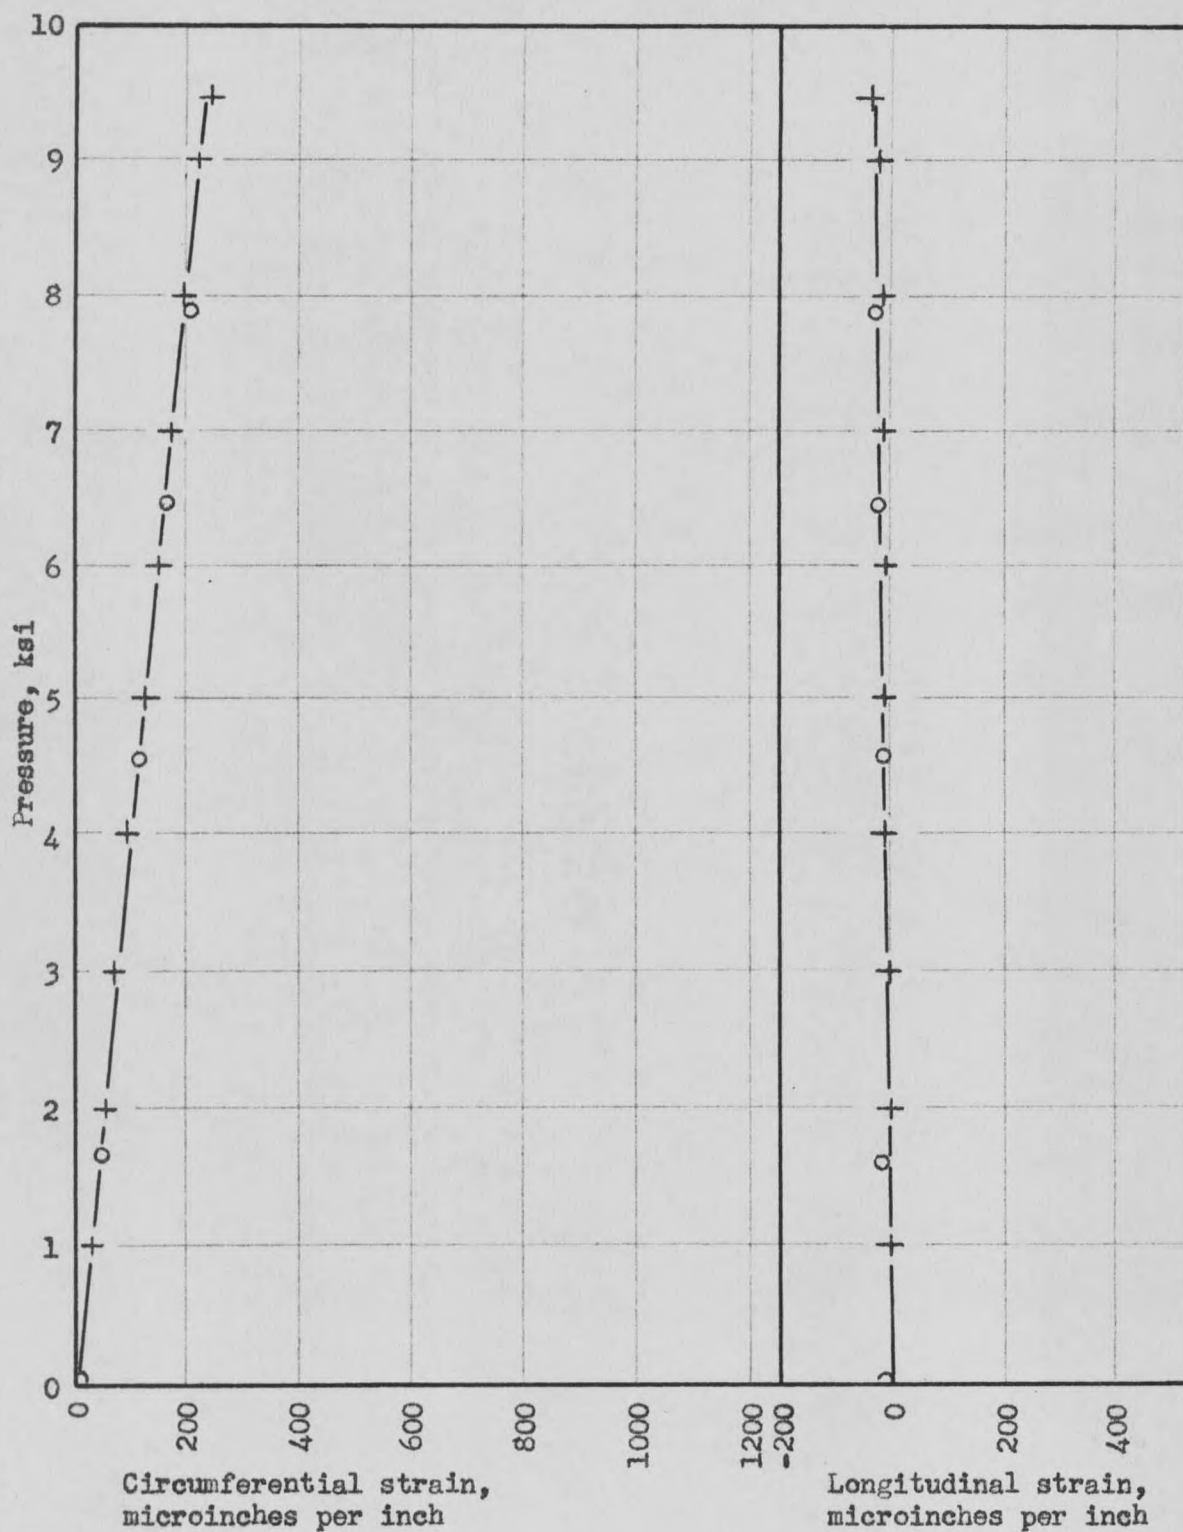
Fig. 39 - Pressure vs strain at section J, test #1.

Fig. 40 - Pressure vs strain at section J, test #2.

Fig. 41 - Pressure vs strain at section J, test #3.

| Section | Pressure, psi* | | | | | |
|---|---|---|---|---|---|---|
| J | | | | | | |
