CHARACTERIZATION OF THE EFFECTS OF HYGROTHERMAL-AGING ON
MECHANICAL PERFORMANCE AND DAMAGE PROGRESSION OF
FIBERGLASS EPOXY COMPOSITE

A thesis/dissertation submitted in partial fulfillment
of the requirements for the degree

Master of Science

Mechanical Engineering

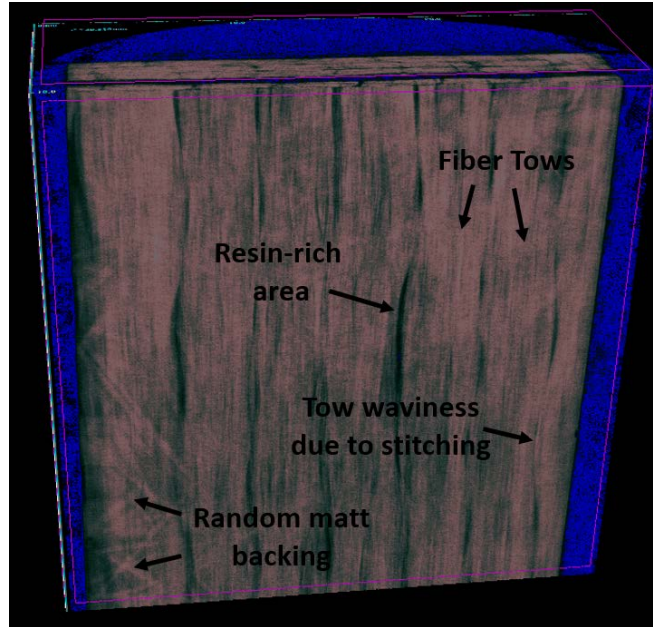
Figure 6: Micro-CT (3D) of unidirectional textile type composite manufactured using VARTM.

The RTM processes can result in several types of defects in the manufactured laminates. Defects such as porosity and inadequately wet-out tows are intrinsic to the manufacturing process itself. Defects from constituent fabrics such as tow waviness and heterogeneity due to spacing tows and the resin-rich areas between tows may also be present. Some of these defects can be seen in Figure 6.

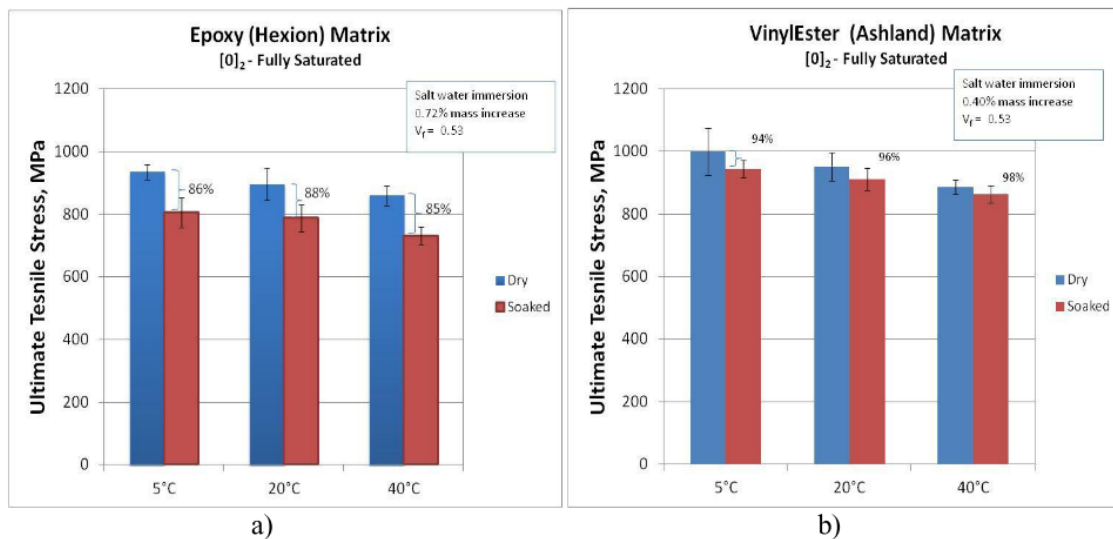
Figure 11: Degradation of static tensile strength for an epoxy system (a) and vinyl-ester system (b) [20]

[26-28]. The resultant changes mechanical properties are scattered amongst researchers. In general, moisture absorption typically results in a moderate reduction in strength and minor changes in modulus. Results can vary significantly depending on the material system and aging conditions. Previous work at MSU has compared the hygrothermal degradation of two material systems, a glass-vinyl ester and a glass epoxy which showed degradation in static performance of the epoxy system to be much higher than that of the vinyl ester system (Figure 11).

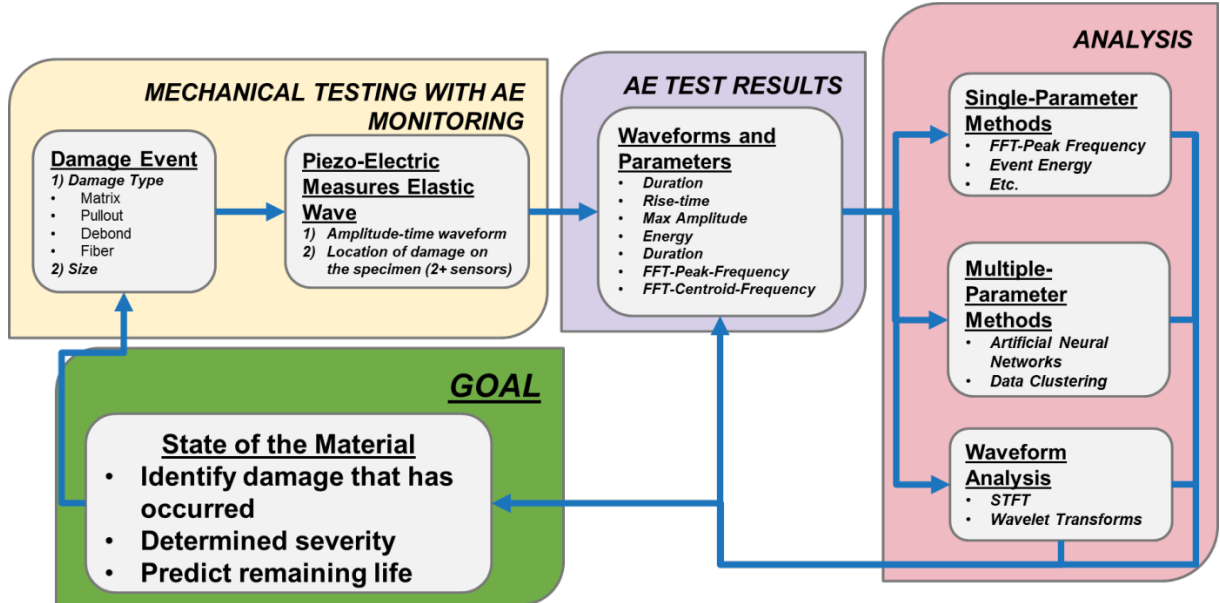
Figure 16: AE Data collection and processing flow chart

A multitude of analysis techniques exist to interpret the AE results including single parameter methods, multiparameter methods, and waveform analysis. Figure 16 summarizes AE data collection and analysis techniques.

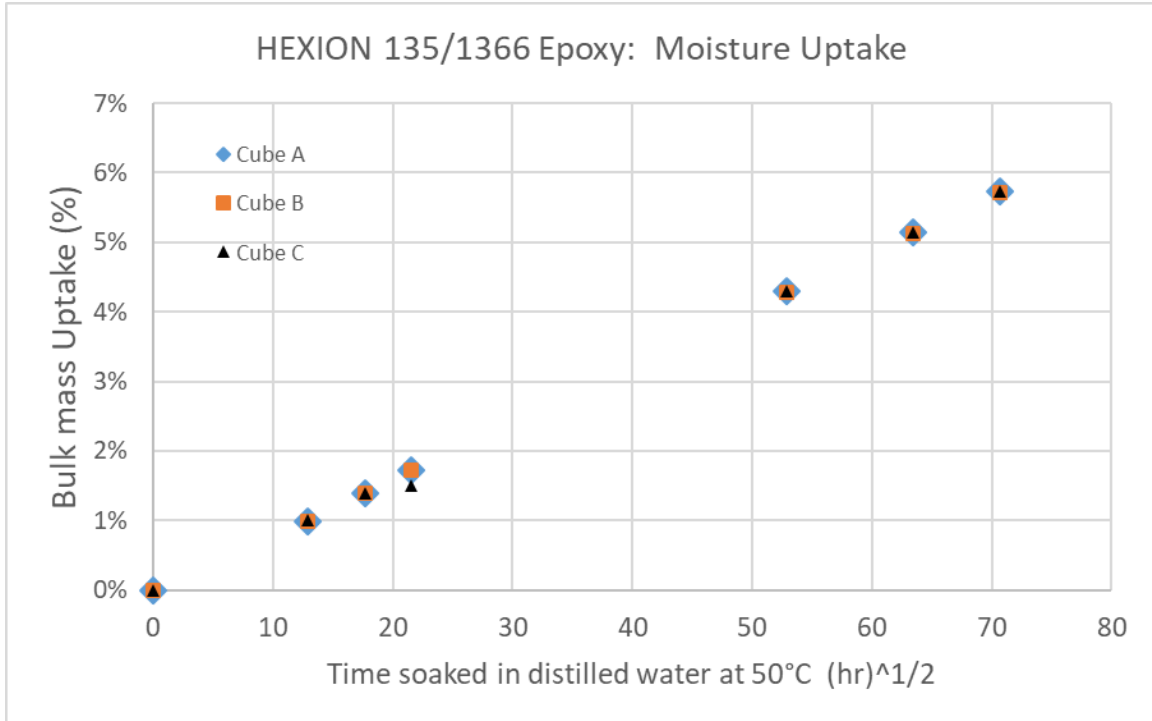
Figure 22: Neat resin cube bulk diffusion

Figure 22 shows the bulk mass diffusion for the three neat resin cubes plotted versus the square root of time. The diffusion behavior of the pure matrix material appears linear in the square root of time domain, as anticipated for Fickian behavior. However, due to the size of the samples, the diffusion process takes an exceedingly long time to reach equilibrium, and as seen in Figure 22, the neat resin cubes have not yet begun to approach the asymptotic equilibrium value. The final data point published in this work was for an aging time of 5000 hours. After 5000 hours of aging, samples absorbed 5.72% moisture by mass and could increase with continued aging. This value is more than observed in the DSC test (not soaked to equilibrium) and is on the upper end of the 2-7% expected for an epoxy system [12]. These values will be compared to the *in situ* matrix-uptake values of composite specimens in the subsequent section.

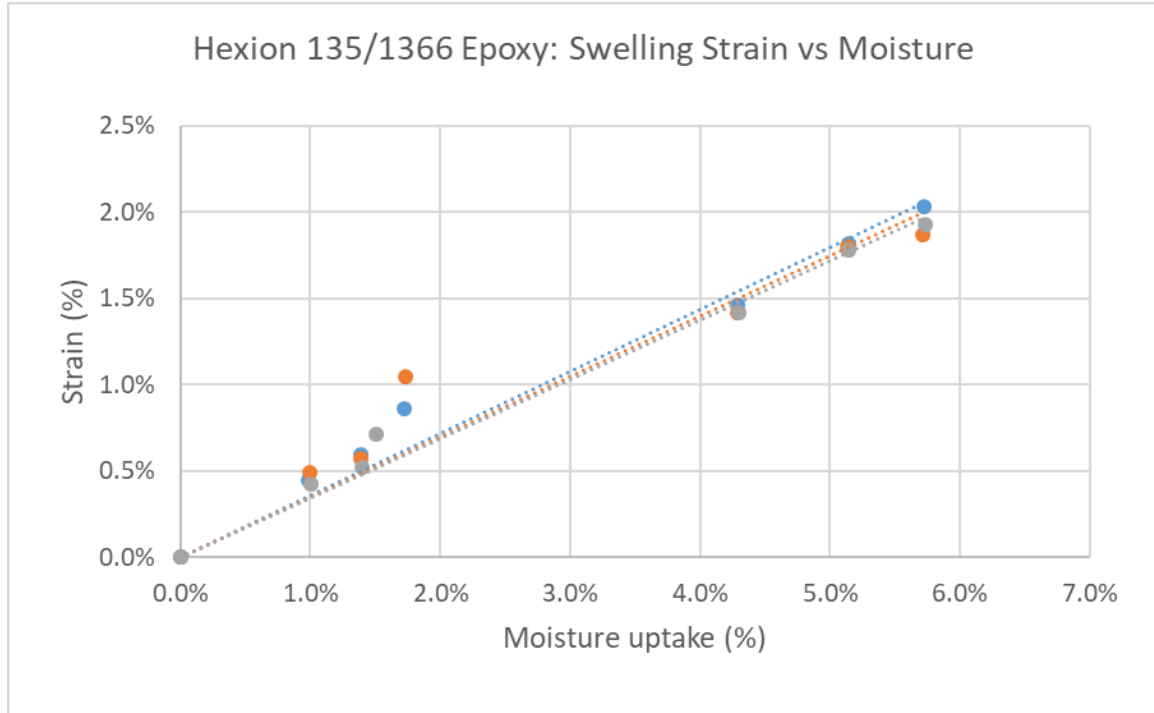
Figure 23: Swelling strains during transient diffusion of neat resin cubes.

A significant amount of moisture uptake resulted in a significant swelling strain, shown in Figure 23. After 5000 hours, strains reached an average of 1.94% strain. The increase in swelling strain correlates well with the increase in moisture content.

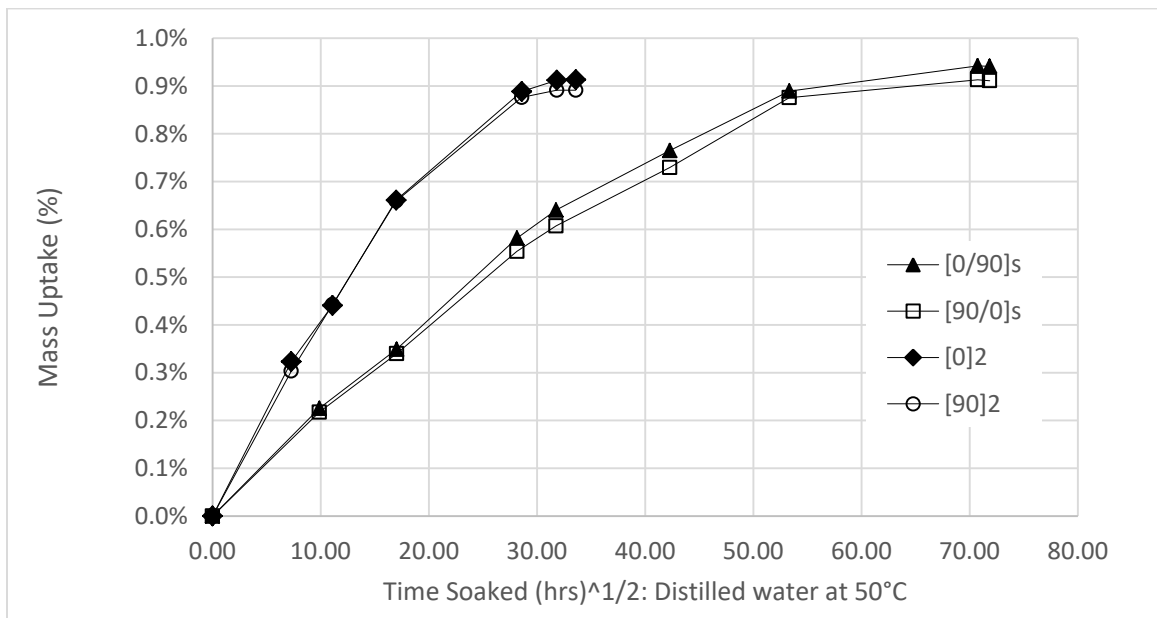
Figure 28: Bulk moisture absorption curves

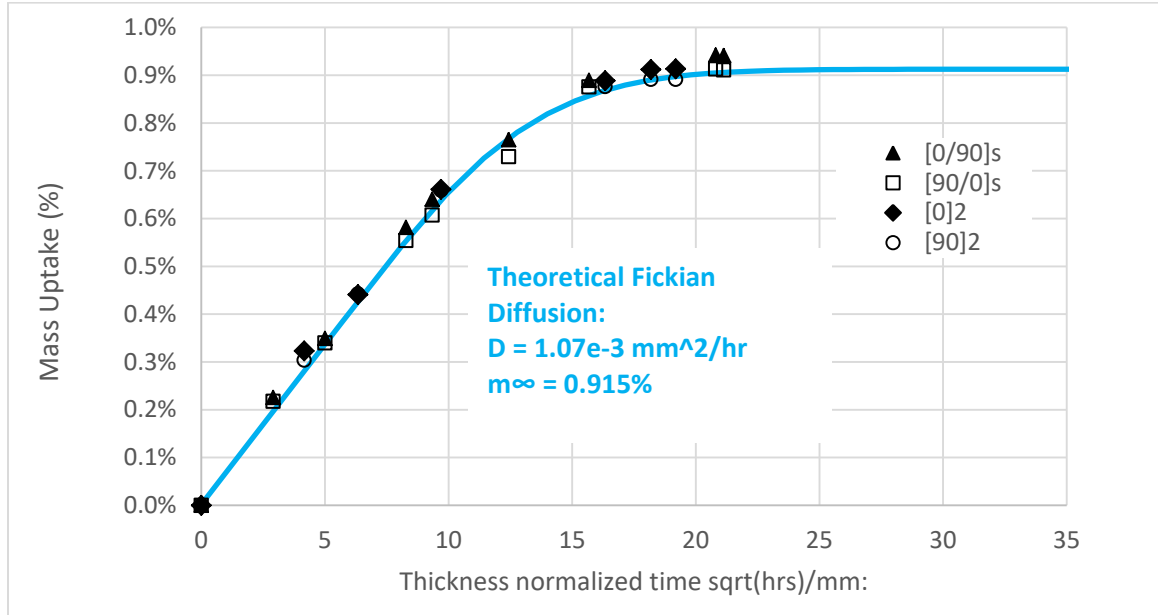
Figure 29: Thickness-normalized absorption curves with theoretical Fickian diffusion.
