High cycle tensile fatigue of unidirectional fiberglass composite tested at high frequency
by Richard Francis Creed, Jr

A thesis submitted in partial fulfillment of the requirements for the degree of Master of Science in
Chemical Engineering
Montana State University
© Copyright by Richard Francis Creed, Jr (1993)

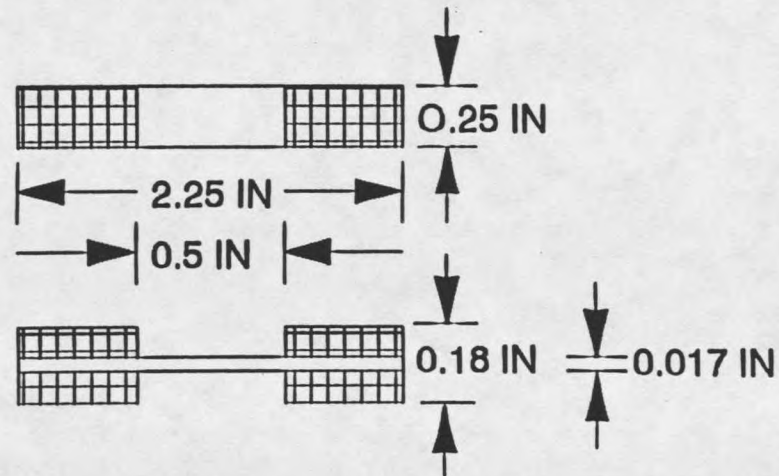
Figure 3. Schematic of tabbing for test specimen.

To prepare the test specimen tabs (Figure 3 shows an exaggerated cross section of tab area and dimensions of specimen), a single layer of 3M SP-250E unidirectional E-glass prepreg was cured into a flat sheet and cut into pieces 0.25 in. by 0.75 in. by 0.02 in., with the fibers in the long direction. These were used as the first layer of the tab. Each specimen had four of these prepreg pieces, one on both sides of both ends, bonded on with Hysol 9309.2 NA high toughness epoxy. The method of keeping the prepreg fibers aligned with the specimen fibers was to put the specimens between rubber sheets and apply roughly 0.5 psi over the entire surface. The prepreg pieces tend to slip out of alignment with other assembly methods. The last part of the tabbing procedure was to again use Hysol 9309.2 NA to bond on a relatively thick piece of 0/90 glass reinforced

- A) GRVE (0.0625 IN. THICK)
 - B) EPOXY (0.002 IN. THICK)
 - C) TEFLON FILM (0.002 IN. THICK)
 - D) SP250-E UNIDIRECTIONAL GLASS/EPOXY (0.02 IN THICK)
 - E) SPECIMEN(0.017 IN THICK)
- (EXAGGERATED THICKNESSES)

vinyl ester (GRVE) 0.0625 in. by 0.25 in. by 0.75 in. on both sides of each end (this is unpunched electrical vectorboard obtained from Plastifab inc.). Between the SP250-E and the GRVE, a 0.125 in. wide layer of teflon film was added on the gauge end of the tab (Figure 3). After each layer was added, a curing period of 24 hr. at 140° F. was necessary to cure the adhesive.

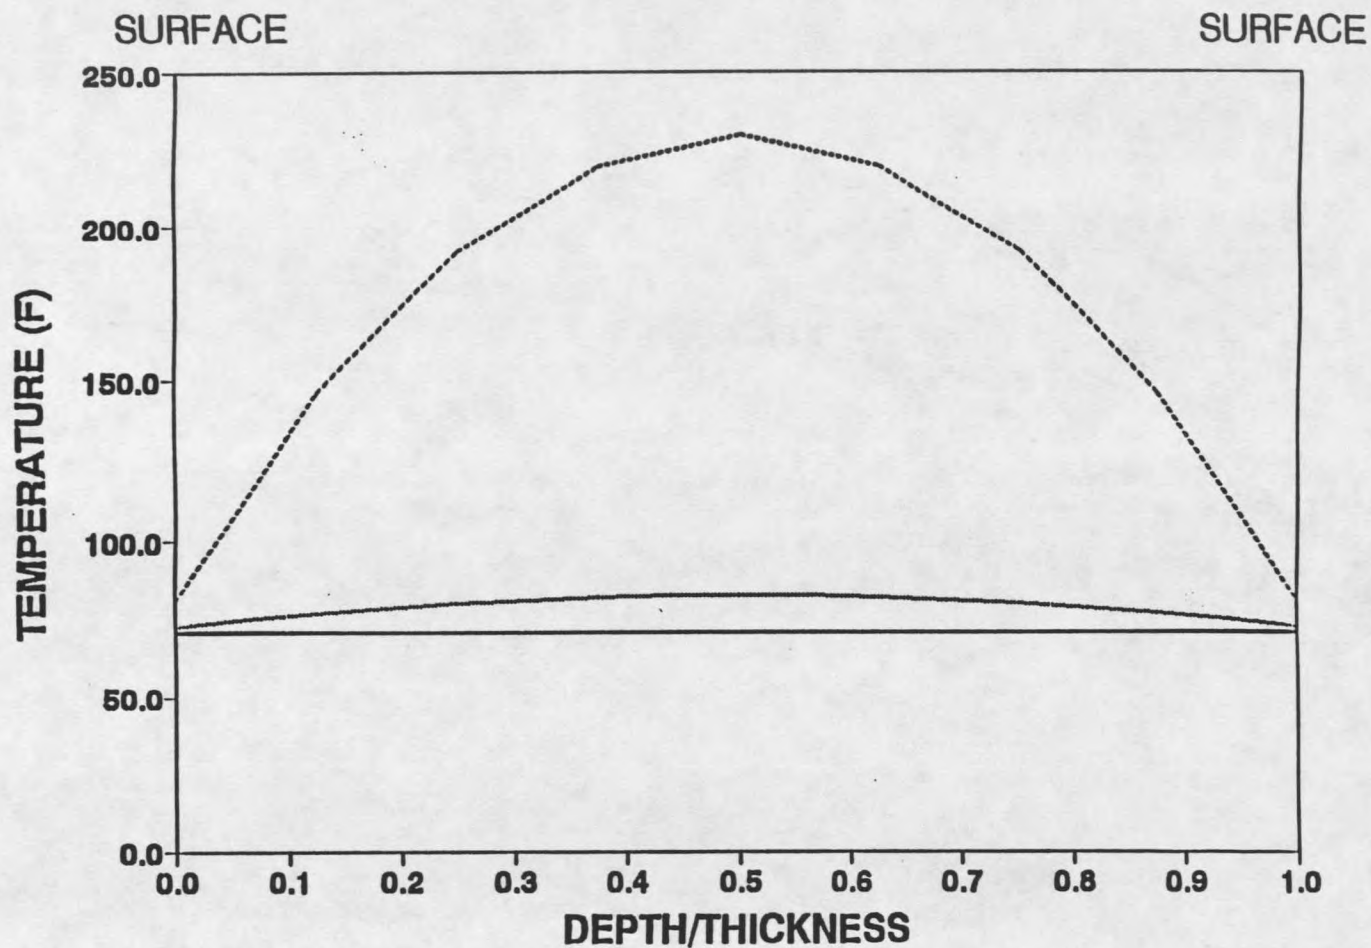
SPECIMEN THICKNESS:

— 0.017 IN. THICK — 0.068 IN. THICK 0.272 IN. THICK

The other finite element model was of the heat transfer in the specimen. The model is of a cross section in two dimensions, run for several thicknesses. Input variables were obtained as follows: the convection coefficient of air on the surface was obtained from Geankopolis [28], the heat transfer coefficient for polyester and vinylester matrix/fiberglass was obtained from Reference [24], and the heat generation term is an order of magnitude approximation from a damping test and a computer program hysteresis analysis (see Appendix B for these tests).

The model of the actual specimen at 100 Hz with the best approximations of the constants gave a temperature plot that was between the limits of 71.0° F in the center (mid-thickness), and 70.8° on the surface. On the progressively thicker specimens, the temperature at the center increases, which is observed experimentally [2]. Figure 10 shows the results for the three different trials with the depth into each specimen normalized by its thickness. For a specimen that is 16 times as thick as the test specimen, under the same conditions, the center of the specimen is over 225° F. The temperature where polyester begins to yellow is near 175° F (experimentally determined), which is an indication

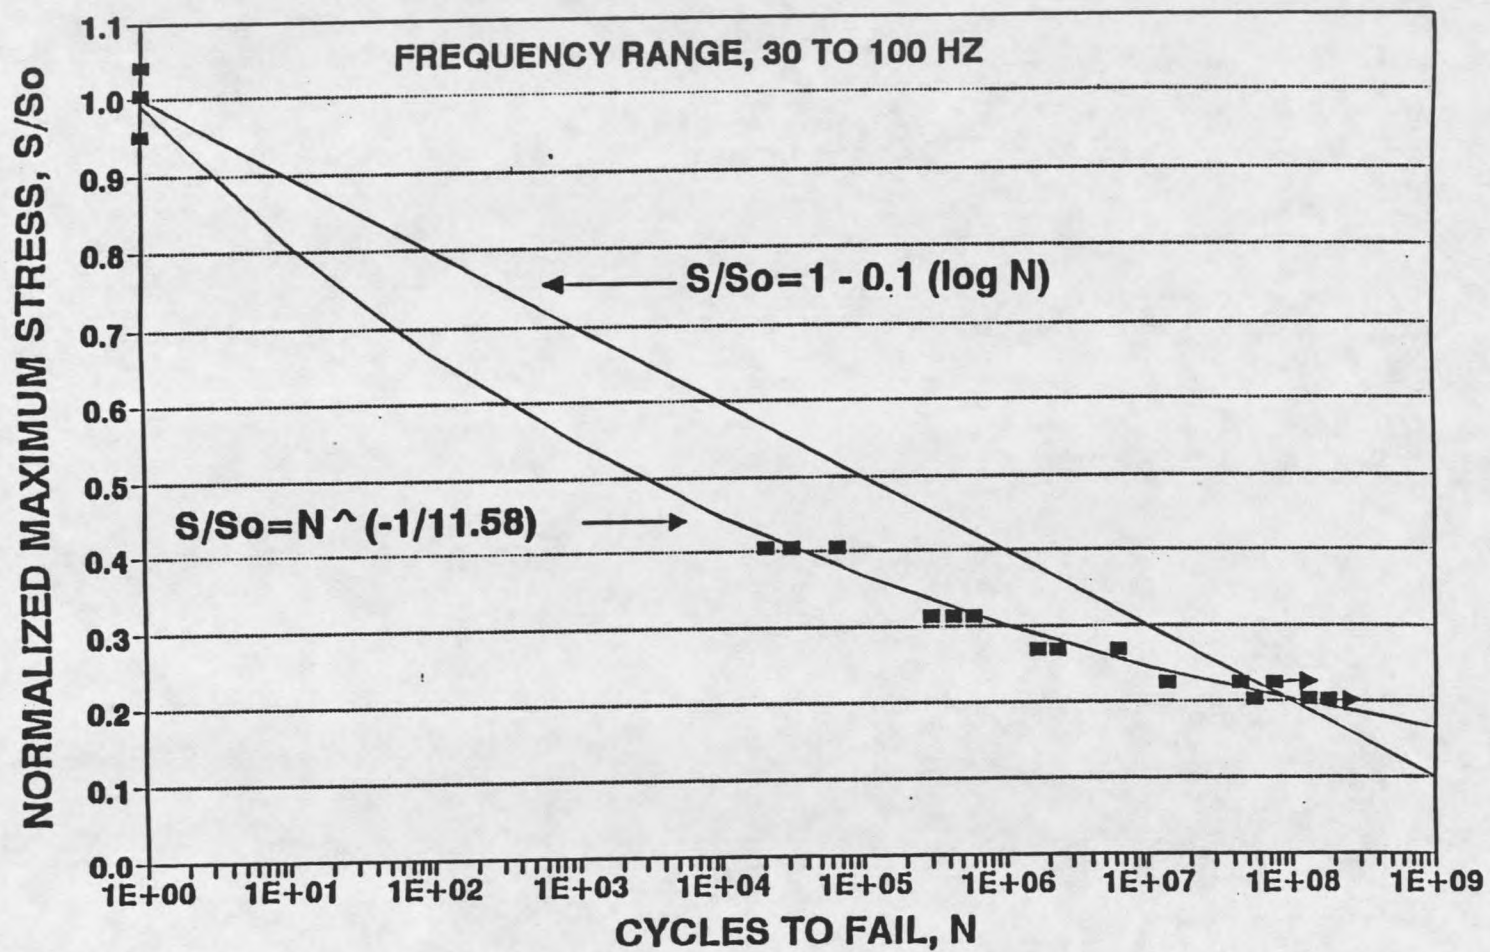
Figure 12. Normalized S/N curve of high frequency fatigue tests.

The maximum stress versus number of cycles to failure (S/N) data for the unidirectional E-glass/polyester composite are given in Figure 12. There are two trend lines for comparison. The linear equation, with a slope of ten percent of the one cycle strength per decade of cycles, has been shown to fit a variety of E-glass composites with well aligned fibers, as discussed above. The power law trend is a least squares fit to the data, forced through 1.0 at one cycle.

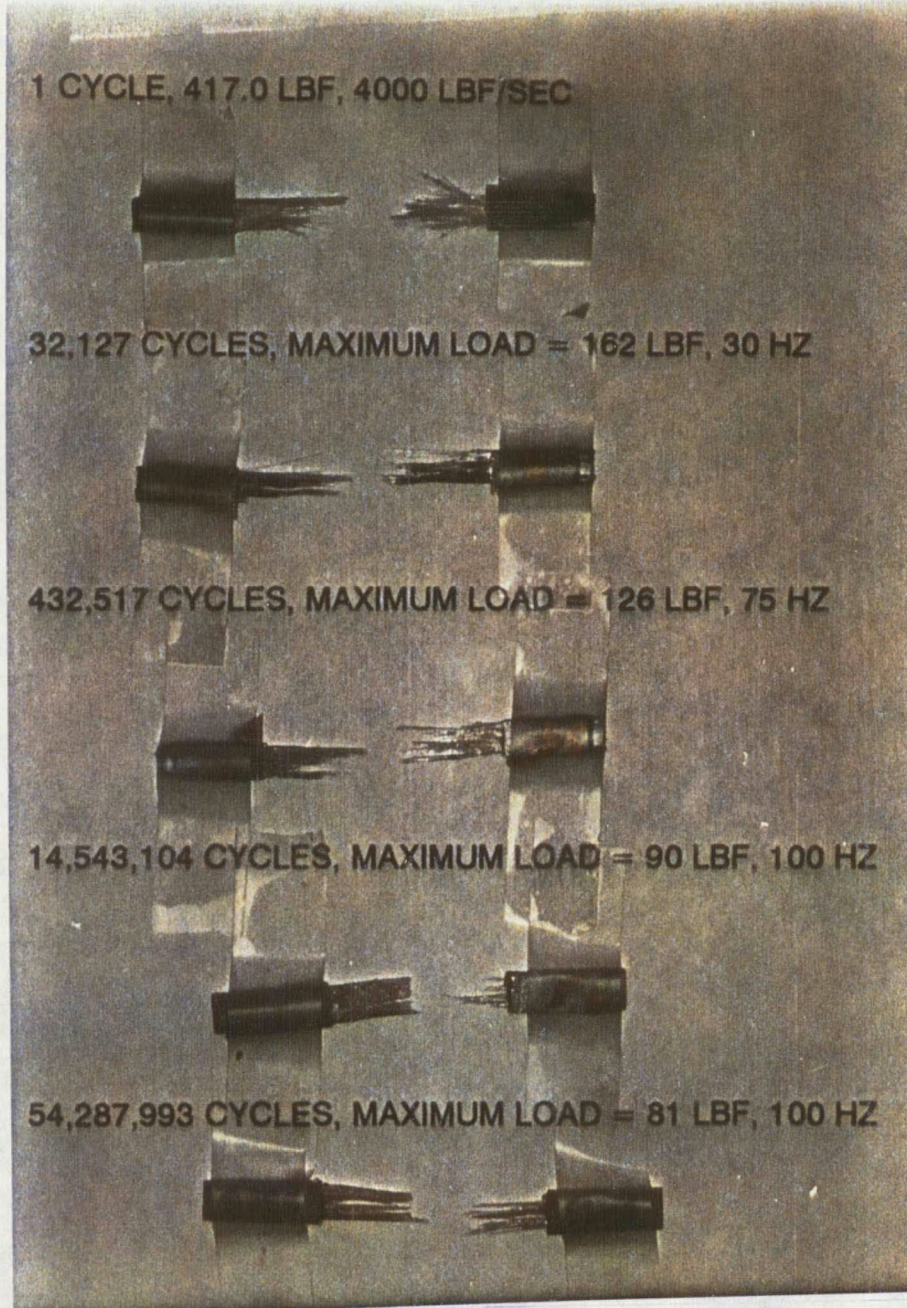
Figure 13. Photograph of typical broken specimens from different load levels and frequencies.

Representative specimens broken at different stress levels and frequencies can be seen in Figure 13. One characteristic of all failures was the development of axial splits in the specimens at different times depending on the load level. The high load level test specimens developed axial cracking on the first cycle, but the high cycle tests only showed these cracks after some period of cycling. For example, the first test run at the 20.5 percent load level did not have any axial cracking until over half the total number of cycles had been run. This damage began at a wave in the material (Figure 2), where most of this type of damage originates. Little other damage was evident prior to total failure, similar to observations with larger unidirectional coupons [2].
