The effectiveness of electrified barriers to keep large mammals out of a fenced road corridor and a campground

Marcel P. Huijser, PhD

Parks Canada Agency

20 June 2024

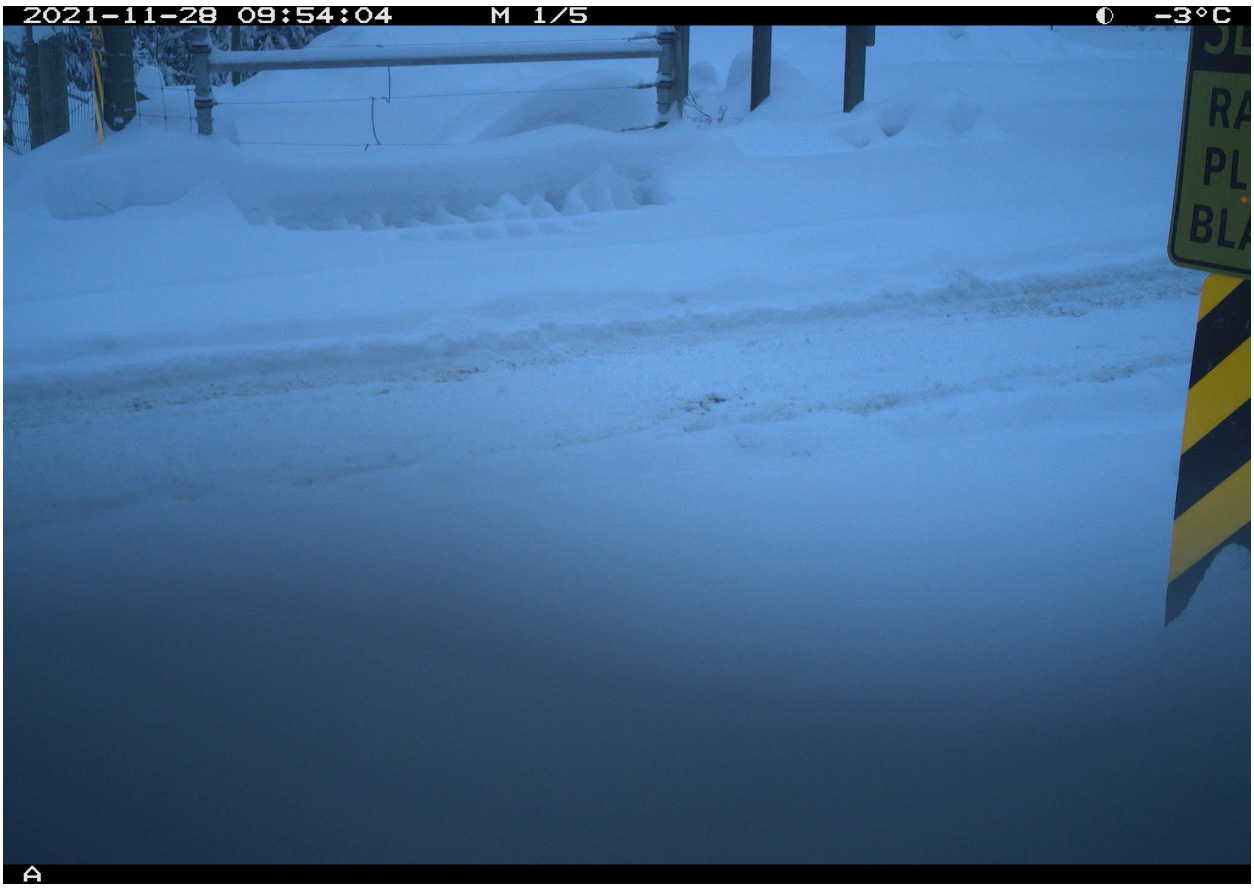
- Snowplows or front loaders carefully maneuvered at the barriers, clearing the snow as much as possible. This does require more time and skill compared to not having a barrier in place.
- Protective strips for the grounding plates and the insulators are important; snowplows can otherwise easily damage the grounding plate, insulators, or the individual bars. The protective strips seemed to hold up through the winter.
- Some of the barriers filled up with snow in winter, making them not functional, as expected (Figure 15).

Figure 15: Snow fills up the barrier at Lake O’Hara Road, making it no longer a barrier to large wild mammals
