Investigation of contamination flashover as a possible cause for unexplained faults on the Montana Power Company 500kV transmission lines  
by Mark Grant Major

A thesis submitted in partial fulfillment of the requirements for the degree of Master of Science in Electrical Engineering  
Montana State University  
© Copyright by Mark Grant Major (1993)

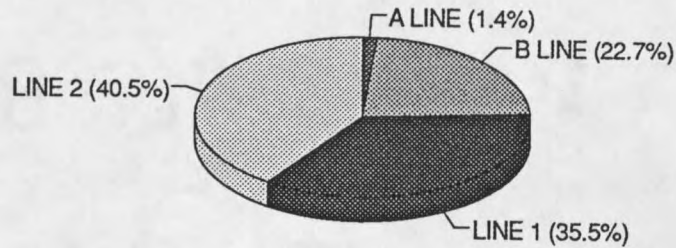
Figure 2

What differentiates the A Line from the other lines is the mechanical construction of the towers and the length of the insulator strings. Although the towers are almost identical in construction, the A Line has larger towers. The minimum air gap between a conductor and a tower on the A Line is 138 inches compared to 116 inches on the B Line and Lines 1 and 2. Furthermore, 25 insulators are present in the insulator strings for the A Line, where only 22 are used on the B Line and Lines 1 and 2. The insulators on all four lines are very similar and made of glass by the Sedivar Company in Carlstadt, New Jersey. The excellent performance of the A Line suggests that the B Line and Lines 1 and 2 are under-insulated. The question at issue is: what instigates the unexplained faults on the B Line and Lines 1 and 2? The research presented in this thesis addressed dust contamination as a possible cause for the faults. When insulator strings contaminated by dust or pollution become wet, they sometimes flashover and

cause a single-phase, self-clearing fault. The contaminants must contain one or more salts and be water-soluble for flashover to occur.

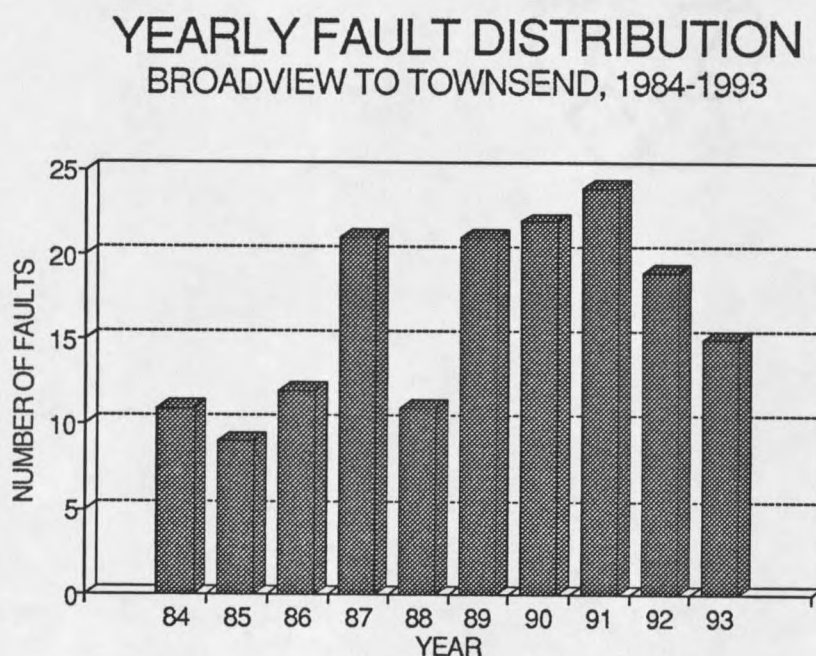
Figure 13

The number of faults on the Broadview-to-Townsend lines per year is shown in Figure 13. It is worth noting that during the first full year of operation, 11 unexplained faults occurred on these lines. If contamination flashover caused these faults, then the time required for problematic contamination accumulation is relatively short and several years of exposure is not needed.

The number of unexplained faults gradually increased each year from 1985 to 1991 with the exception of 1988, when fault activity decreased significantly from the previous year. The year 1988 is when many forests throughout Montana, and most notably, Yellowstone National Park (Approximately 100 miles south of the 500kV

lines), suffered extensive forest fires. It is interesting to observe that fault activity has been decreasing in 1992 and 1993, both considered years of higher-than-normal summertime precipitation.

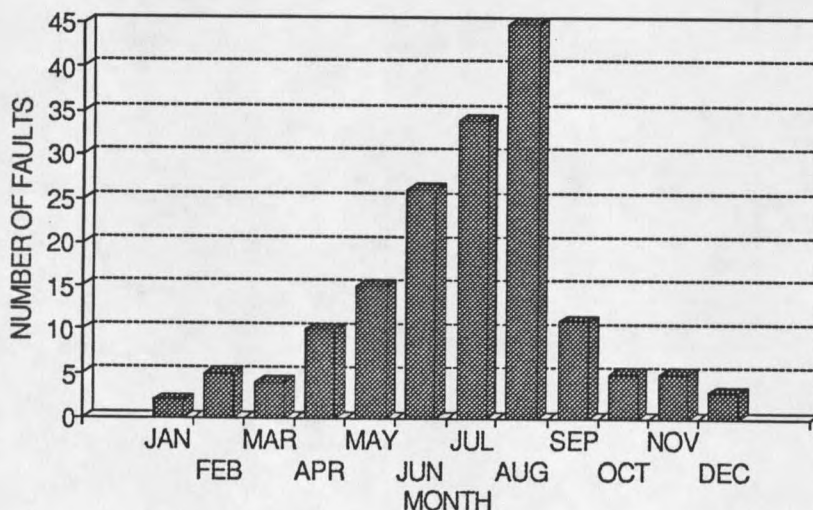
Figure 14 is the monthly fault distribution for the Broadview-to-Townsend lines. This graph, generated from the 1984-1993 fault data, clearly displays the above mentioned tendency for faults to occur mainly during the summer months. Figure 14 also illustrates a significant increase in fault activity each month from March through August. This too is consistent with contamination flashover theory, since dry summer months provide the best opportunity for contamination levels to increase. However, it is not well understood why there is such a sudden reduction in fault activity for the month of September.

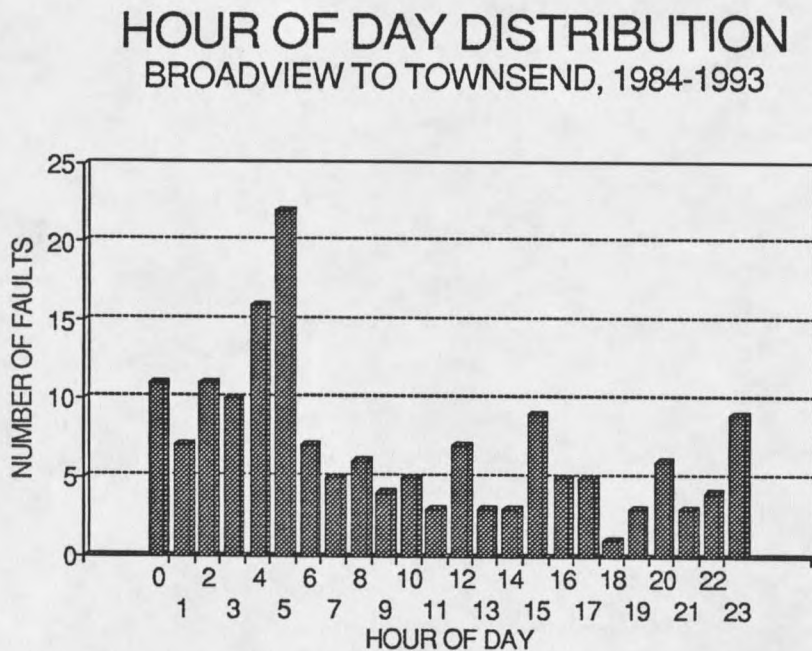
Figure 18

The fault times were categorized hourly and plotted in Figure 18. Sixty seven percent of the faults occurred between the hours of 8 p.m. and 8 a.m. and there is a distinct peak in fault activity during the early morning hours of 4 a.m. to 6 a.m..

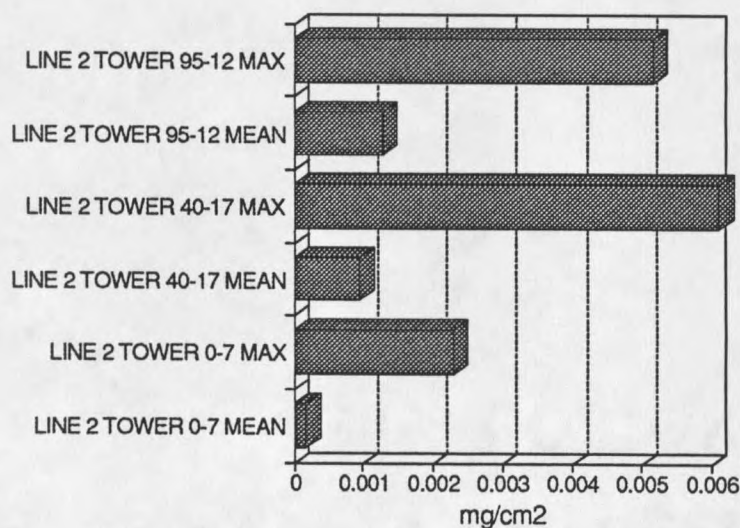
Insulator strings from three towers along the Broadview-to-Townsend line route were removed for repair by MPC linemen. The linemen were instructed not to touch any surfaces of the glass insulators. The strings were placed in clean containers and delivered to the Electrical Engineering Department at MSU where ESDD measurements were made on the top and bottom surface of each individual insulator. A description of the exact orientation of each string is provided in Table 16 in Appendix E, and the ESDD level of each surface is listed in Table 17 in Appendix E. Figure 21 summarizes the results by showing the mean and maximum ESDD levels measured at each tower.

Scattered rain showers occurred the week before the strings were removed, and very heavy rain occurred between Bozeman and Columbus a week before the strings were removed. The string from Tower 95-12, which had the highest average ESDD level, was noticeably more contaminated than the other two strings. Perhaps rain was more effective at washing the other two strings.

Although the strings were handled carefully, some contamination probably fell off the insulators during the transportation of the strings from the line to Bozeman. All future samples were taken on site immediately after removal.

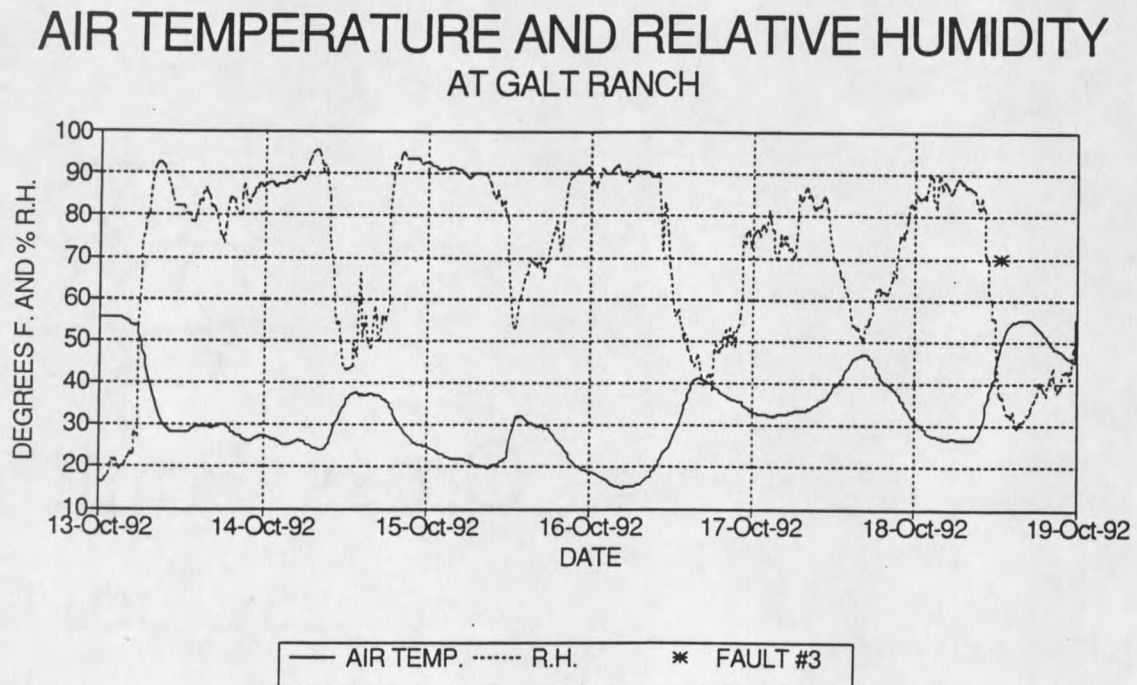
As shown by Figure 35 and Table 9, this fault occurred on a relatively warm and dry afternoon after the air temperature rapidly increased from 28°F to 55°F and the relative humidity dropped from 89% to 37%. Figures 36 and 37 indicate a light breeze averaging 3 m.p.h. at the time of the fault. Figure 38 indicates a trace (0.01") of

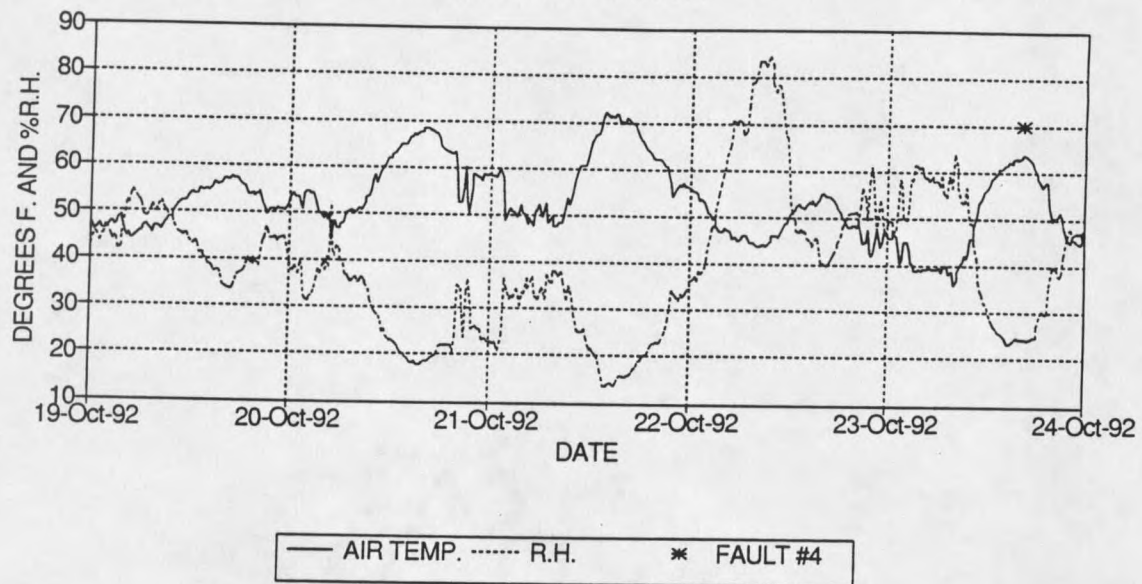
Figure 40

The test insulator thermocouple and dew sensors were operating at the time of this fault. This fault also occurred on a warm and dry afternoon after the air temperature increased from 38 °F to 64°F and the relative humidity dropped from 65% to 24%, as shown by Figure 40. Figures 41 and 42 indicate a moderate breeze up 13 m.p.h. was present the afternoon of the fault. A high pressure system had moved into the area as shown by Figure 43. The resistance of the dew sensors, shown in Figure 44, indicate that the test insulator was dry around the time of the fault (moisture on a dew sensors will cause its resistance to increase above 10kΩ). The surface temperature of the test insulator and the ambient air temperature is plotted in Figures 45 and 46. Figure 46 also includes the dew point temperature. As shown by Figure 46, there was little difference in the insulator and air temperatures around the time of the fault and the insulator did not fall to the dew point any time in a six hour period before the fault.

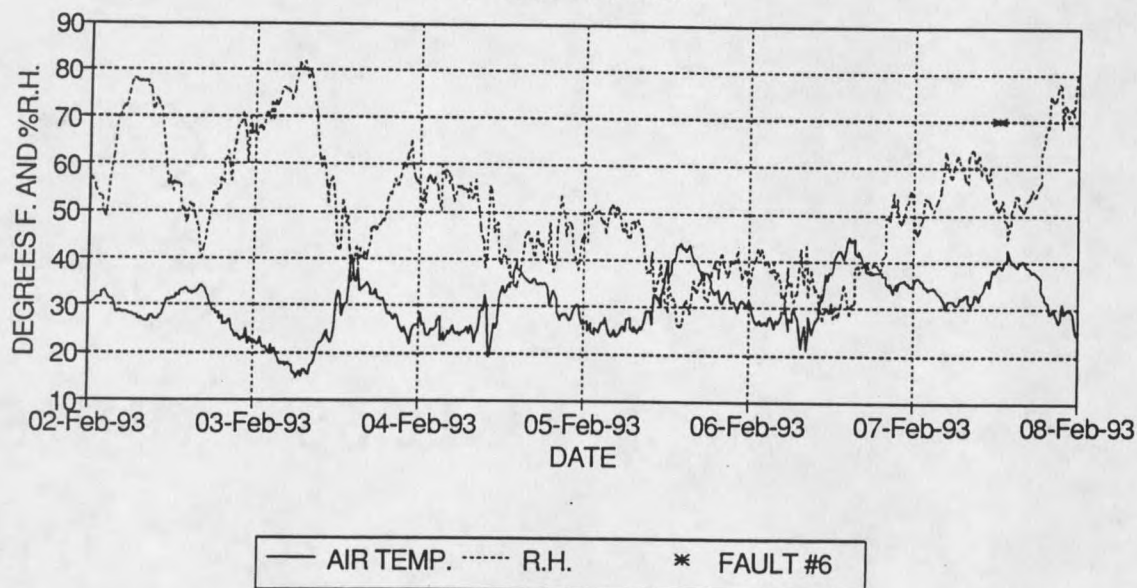
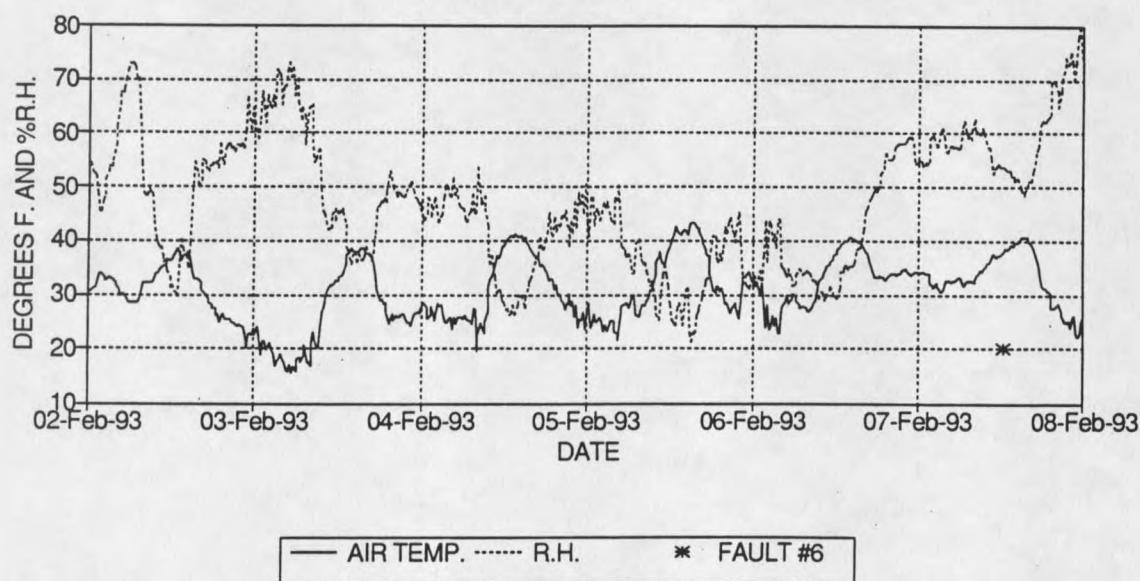
According to the MPC estimate, Fault #6 occurred midway between the Galt Ranch weather station and the Rostad Ranch weather station. Therefore, the meteorological data from both weather stations were analyzed. Figures 52 and 53 show that the relative humidity decreased from approximately 64% to 54% and the air temperature increased from approximately 30°F to 38°F before this fault. No precipitation plots are presented because no precipitation was recorded by either weather station for the week preceding this fault. Therefore, the dust accumulation criteria were satisfied. As shown by Figures 54 to 57, both weather stations recorded relatively low wind speeds (usually under 10 m.p.h.) for four days preceding the fault and a light breeze (8 m.p.h. to 12 m.p.h.) at the time of the fault. Figures 58 and 59 show that the barometric pressure was dropping gradually during the four-day period preceding and including the day of the fault. Figures 60 to 63 indicate that the test insulators were warmer than the ambient air during the fault and the test insulators were also at least 15°F above the dew point. The dew sensors (Figures 64 and 65) provide no evidence of moisture on the test insulators preceding or around the time of the fault.

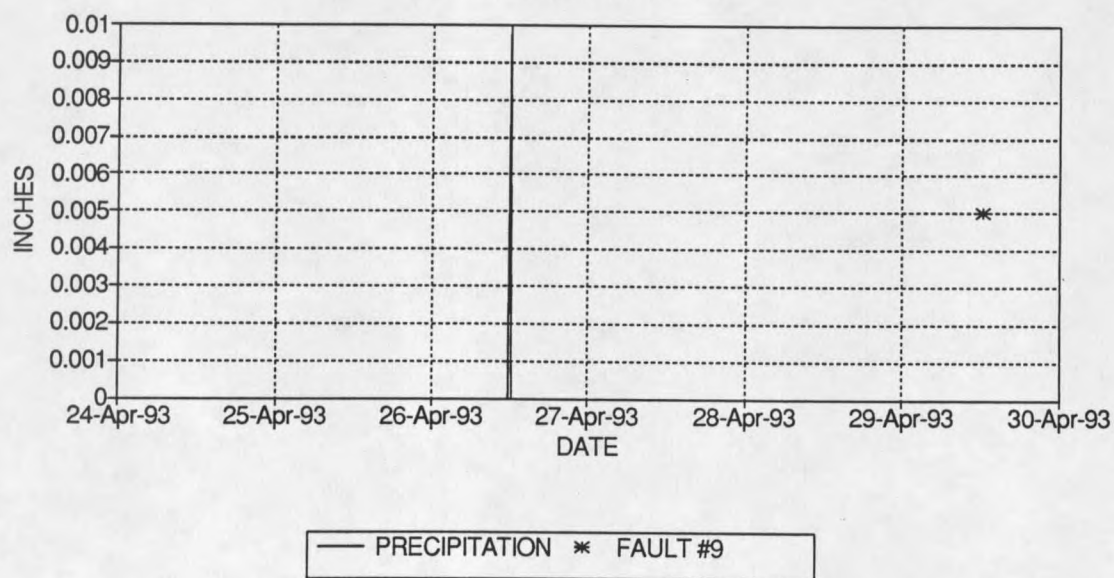
Figure 83 indicates a trace of precipitation (0.01") fell April 26, three days before the fault. Wind gusts of up to 38 m.p.h. were recorded during the week preceding the fault and 12 to 17 m.p.h. winds were present at the time of the fault (Figures 84 and 85). The barometric pressure, shown in Figure 86, was gradually dropping and was approximately 2 mbars below the April average. The dew sensor resistances, shown in Figure 87, indicate no moisture on the test insulator. The test insulator temperature was above the ambient air temperature during the fault and did not drop to the dew point prior to the fault, as illustrated by Figures 88 and 89.

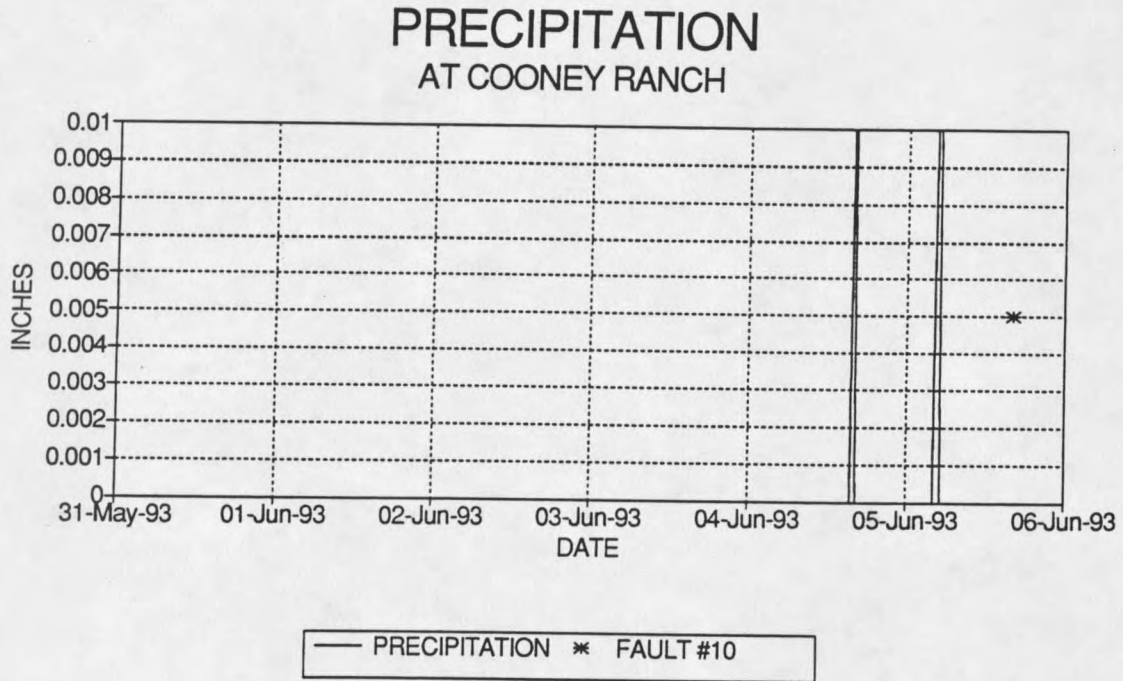
Figure 90 indicates this fault occurred 10 hours after light precipitation (0.03"). The relative humidity exceeded 90% during this precipitation. However, the air temperature increased from 47°F to 56°F and the relative humidity decreased to 66% before this fault (Figure 91). The dew sensors indicated moisture on the top and bottom of the test insulator during the 5:00 a.m. rain, and the top sensor indicated moisture again around noon, possibly in the form of very light drizzle (Figure 92). However, both surfaces of the test insulator became dry three hours before the fault. The area was probably cloud covered, since the test insulator remained within 1°F of the ambient air temperature for an eight-hour period preceding the fault (Figures 93 and 94). The wind

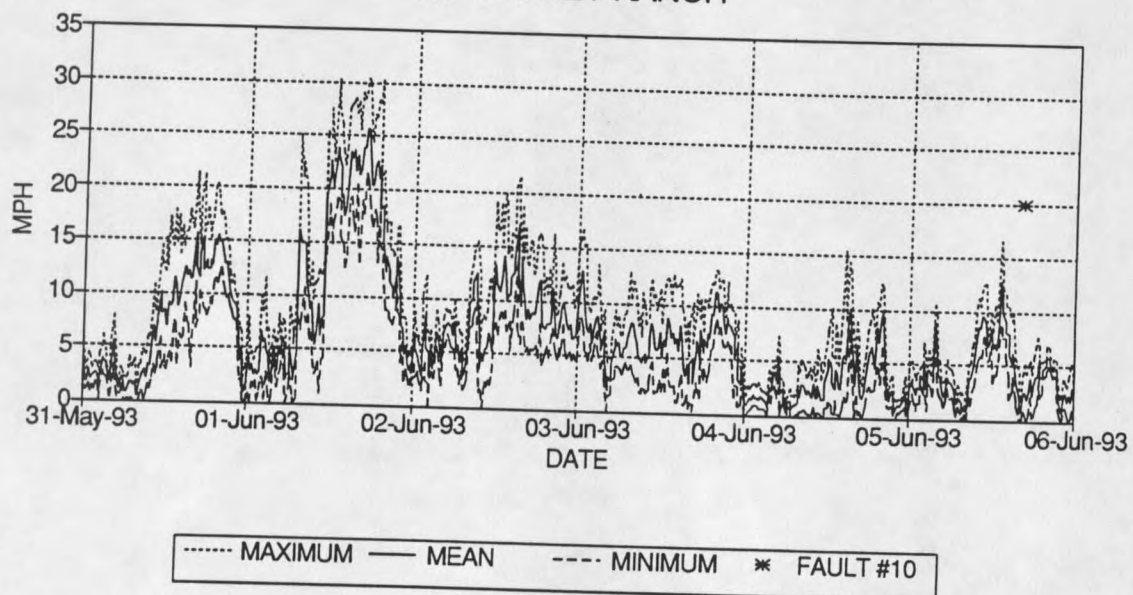
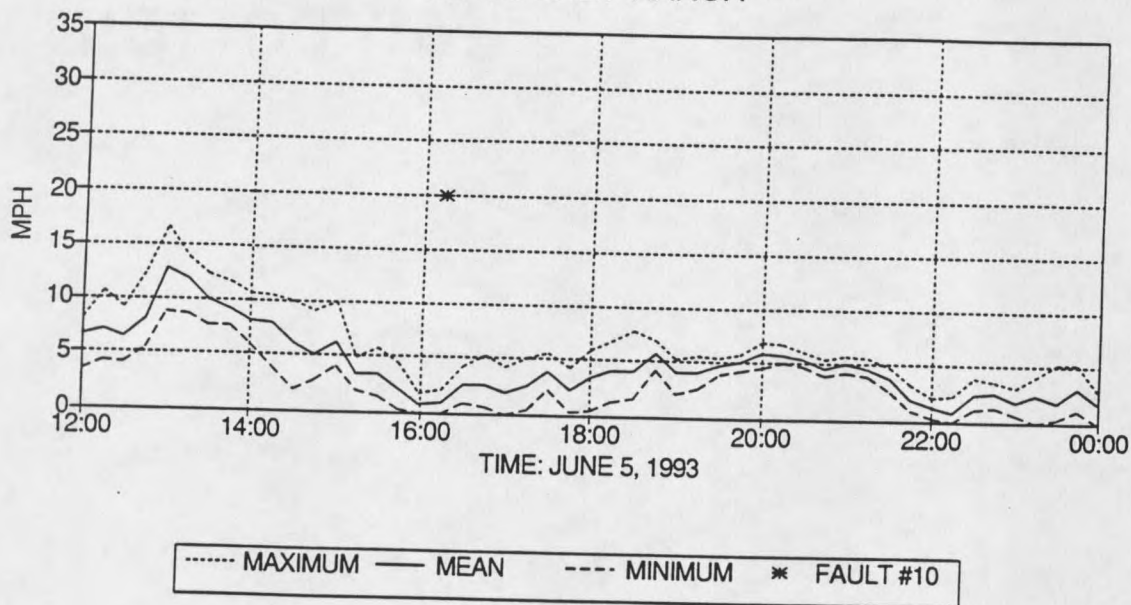
speed, plotted in Figures 95 and 96, had peaked at 15 m.p.h. before the fault, however, became calm (0 m.p.h. minimum) 15 minutes before the fault.

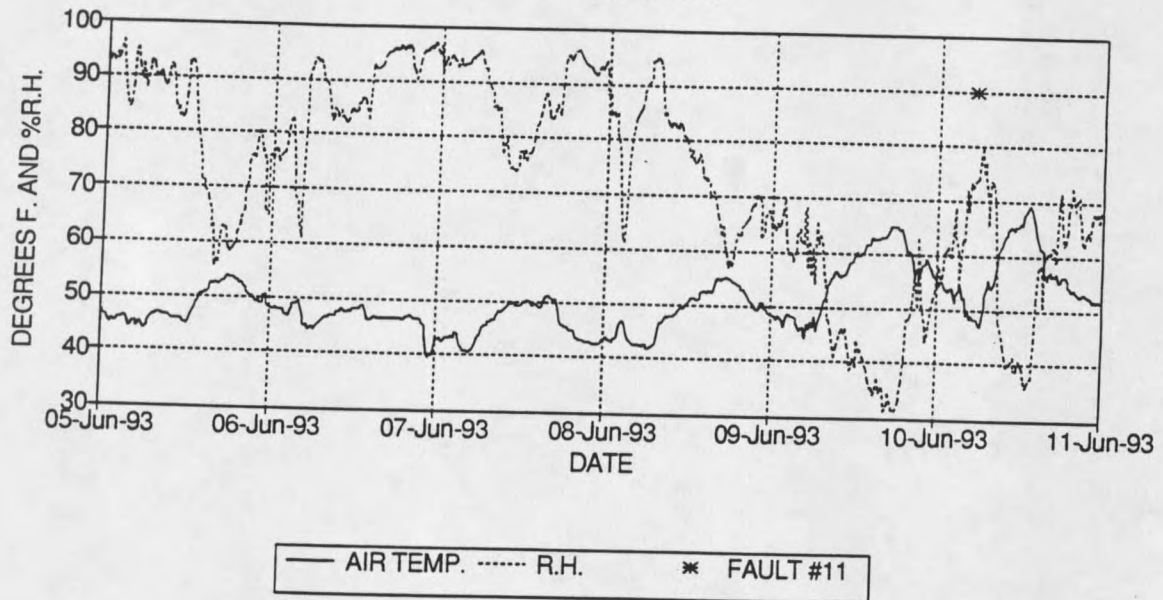
Figure 98

This fault occurred before sunrise on a morning in which the temperature was dropping and the relative humidity was rising as shown by Figure 98. Figures 99 and 100 show a gentle breeze was (0 m.p.h. to 12 m.p.h.) recorded from midnight to the time of the fault. A significant amount of precipitation (approximately 1") was recorded for June 6, 7, and 8 (Figure 101). The rate of precipitation exceeded 0.1" per hour on June 6 and 7, therefore, the dust criteria were not satisfied. The barometric pressure was low during the rain on June 6 and 7, however, it had risen 11 mbars and leveled off June 9 to approximately 839 mbars (Figure 102). The top dew sensor on the test insulator was defective; the bottom dew sensor, which was operating correctly, did not indicate any moisture the morning of the fault as seen in Figure 103. Figures 104 and 105 show that the test insulator did not warm to above the air temperature until about 9:00 a.m., four hours after the fault, suggesting the area was cloud covered. As shown in Figure 105, the test insulator did not cool to the dew point at any time during the night and early morning hours preceding the fault.

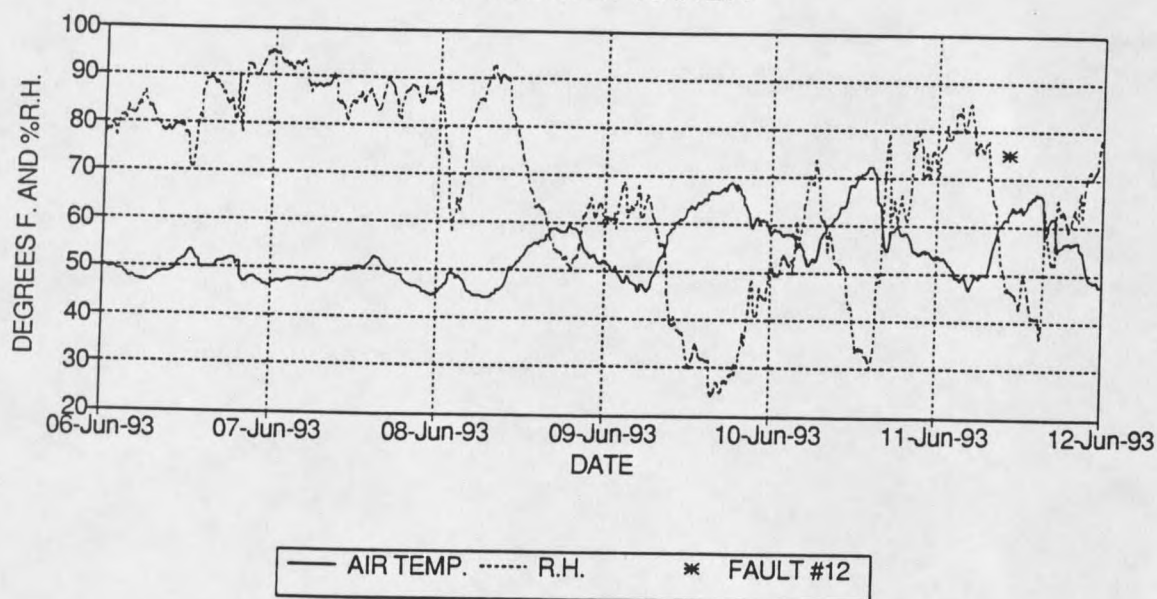
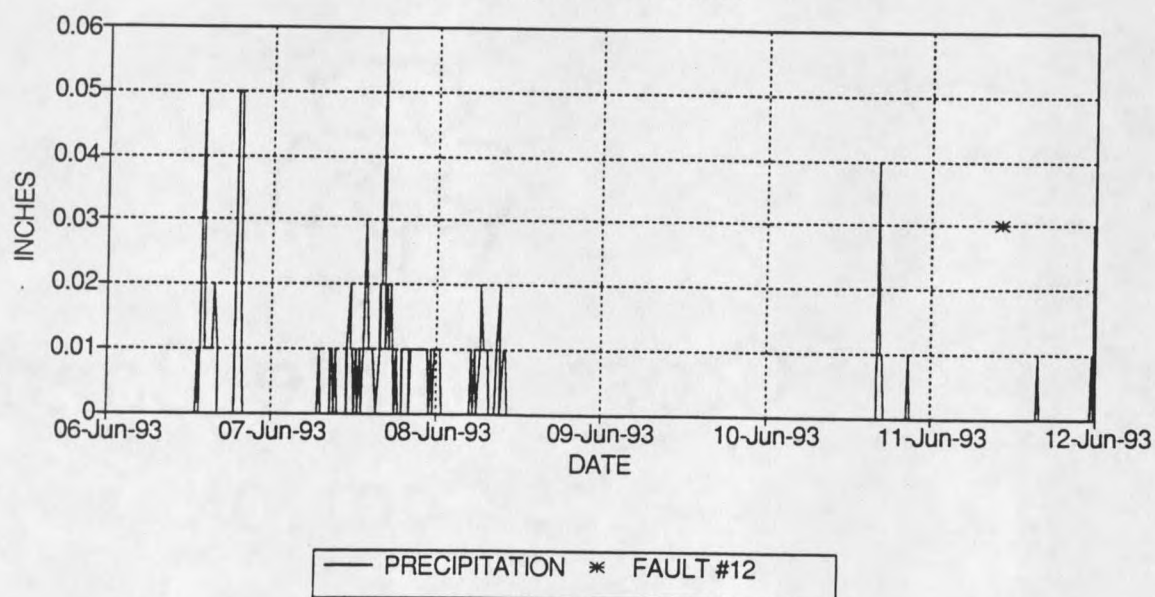
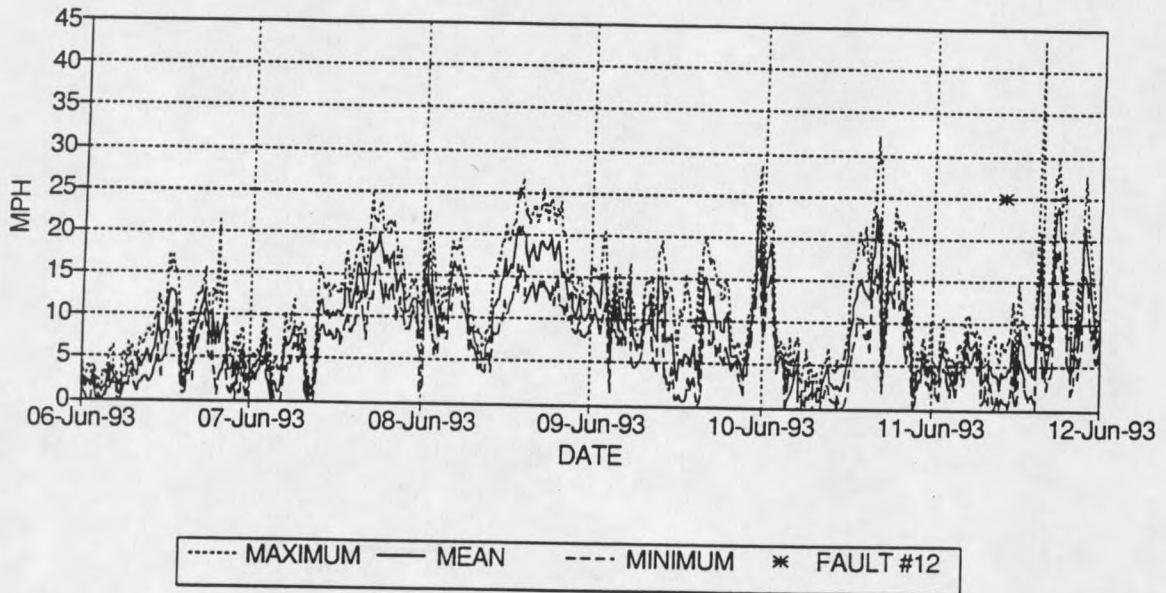
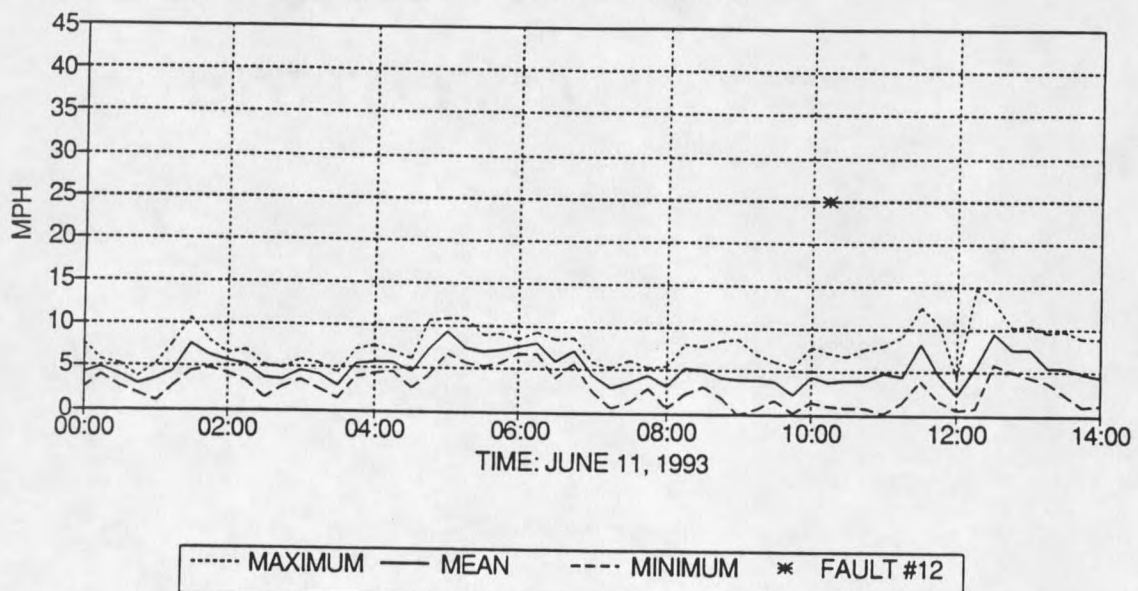
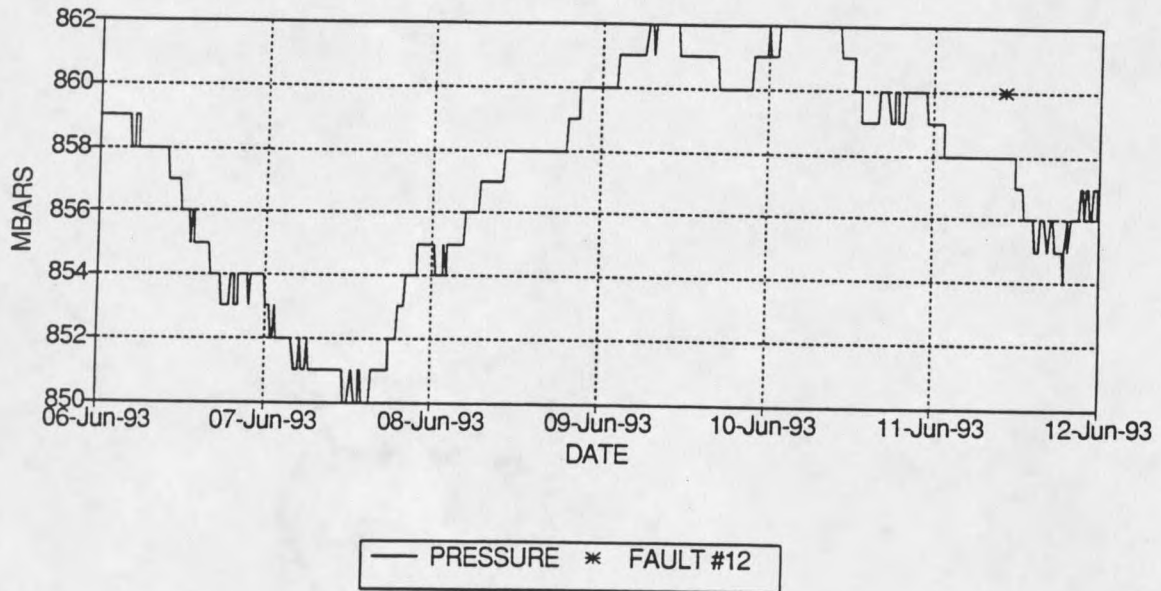
This fault occurred the day after and about 25 miles east of Fault 11. Many of the meteorological conditions which preceded Fault 11 were similar to those for Fault 12 (Figures 106-110). Fault 12 occurred mid-morning when the air temperature was rising (61°F at time of fault) and the relative humidity was rapidly dropping from 85% (around 4:00 a.m.) to 47% at the time of the fault (Figure 106). As in the case of Fault 11, significant precipitation was recorded on June 6 and 7 and the rate exceed 0.1" per hour (Figure 107). Therefore, the dust criteria were not satisfied. The dew sensors indicate the test insulator was dry the morning of this fault (Figure 111). Figures 112 and 113 show the test insulator was 9°F warmer than the ambient air temperature, suggesting the sun was shining on the insulators at the time of the fault. Furthermore, the test insulator temperature was approximately 30°F above the dew point.

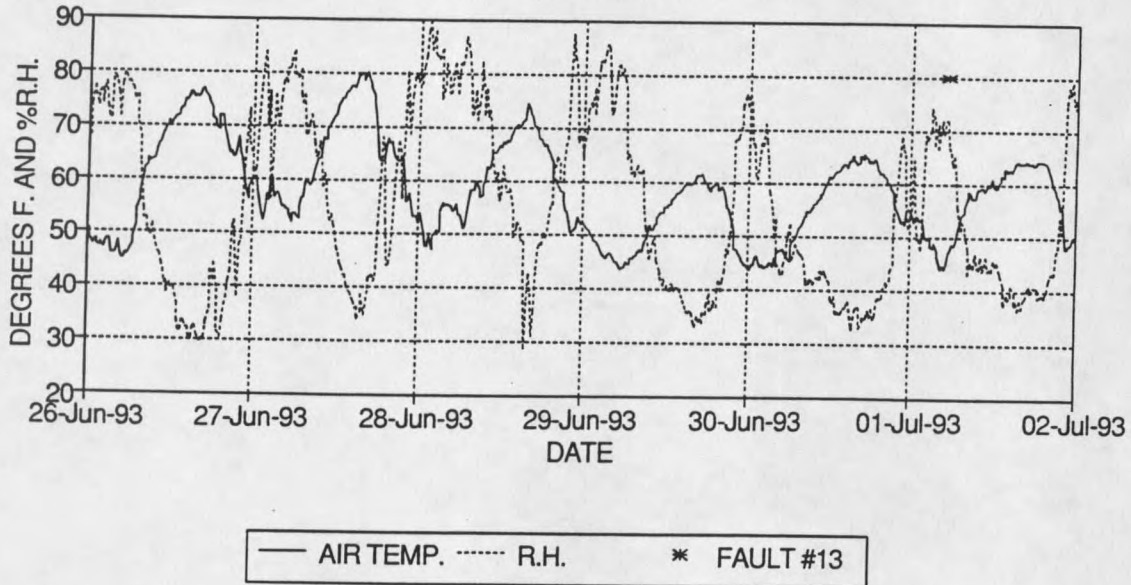
Figure 114 illustrates that Fault 13 occurred in the morning when the air temperature (45°F) was near a minimum and the relative humidity was near a maximum

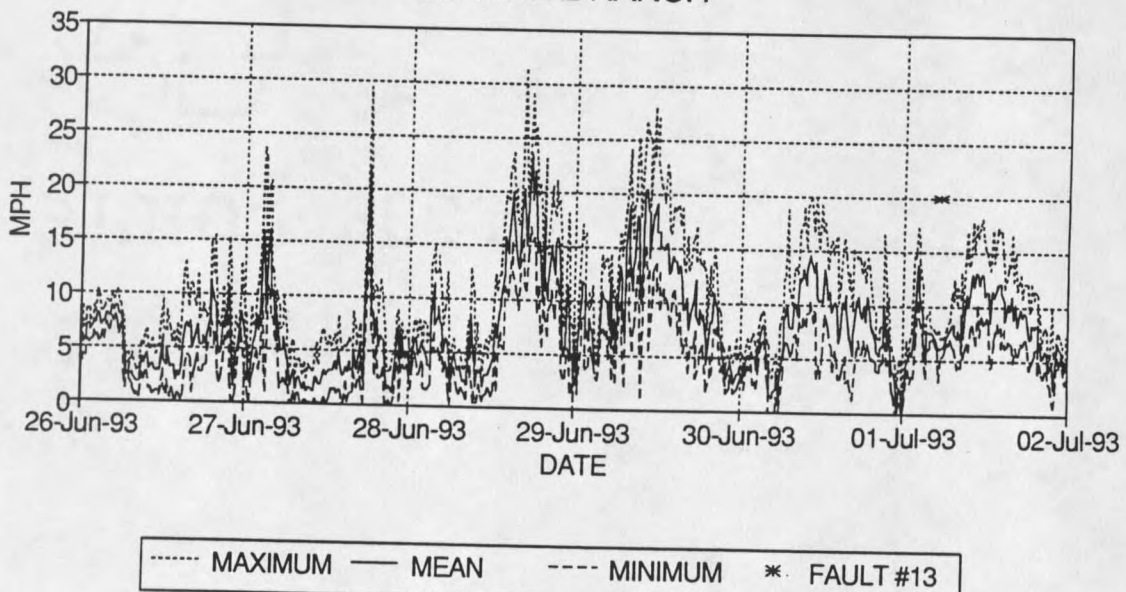
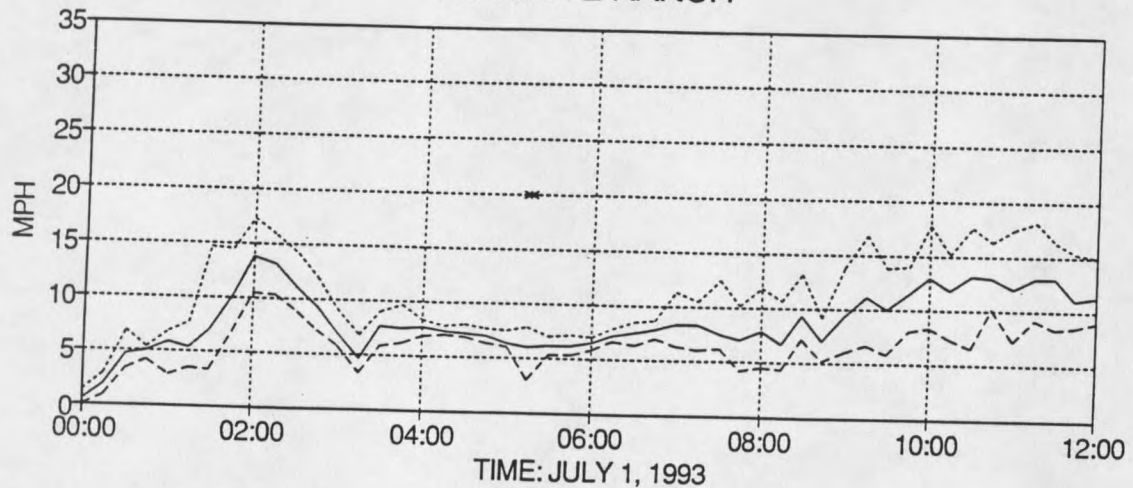
(above 70%). A light breeze, averaging 6 m.p.h., was present at the time of the fault (Figures 115 and 116). Figure 117 shows a significant amount of precipitation was recorded the evening of June 28 and early morning of June 29. The rate of precipitation the morning of June 29 exceeded 0.1" per hour, therefore, the dust accumulation criteria were not met. Figures 118 and 119 indicate the test insulator temperature remained close to the ambient air temperature (within 3°F) and did not cool to the dew point anytime in the early morning hours preceding the fault. The dew sensors indicate that the top surface of the test insulator was wet from approximately 10:00 p.m. the evening of June 30 and remained wet the entire day of July 1 (Figure 121). However, the bottom surface remained dry for the entire period. This suggests very light drizzle wetted only the top surface of the test insulator. Since the bottom surface of the test insulator remained dry, the fog or drizzle criteria were not satisfied.

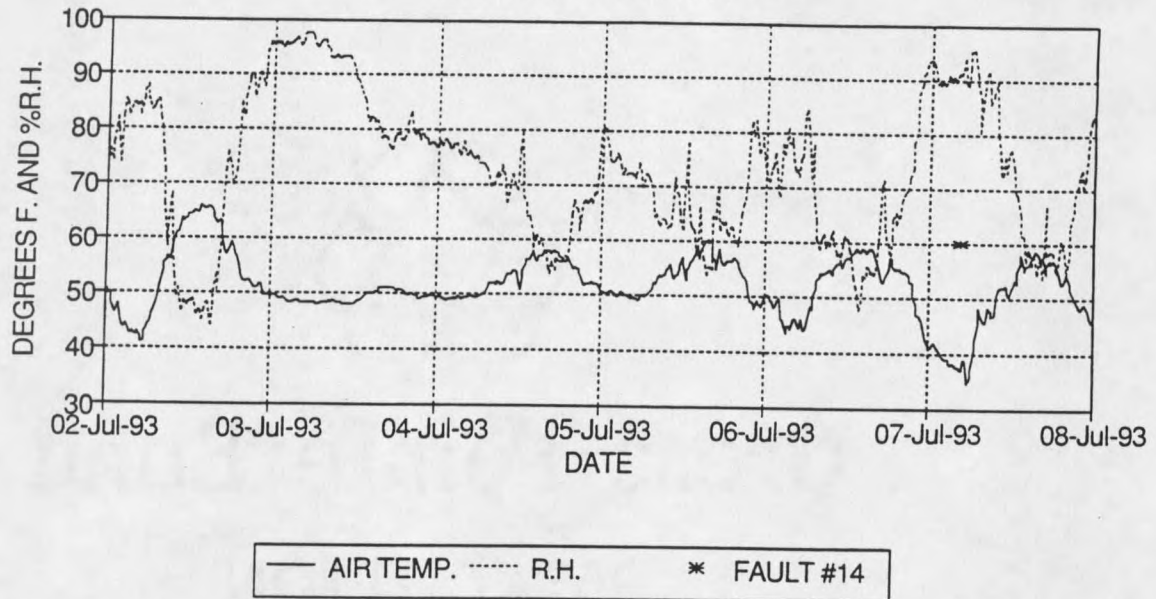
Figure 122

As shown in Figure 122, Fault 14 occurred during a period of very high humidity (above 90%), while the air temperature (37°F at time of fault) was gradually dropping. Figure 123 indicates heavy rain was recorded July 3, four days prior to this fault. The rate of precipitation exceeded 0.1" per hour, therefore, the dust accumulation criteria were not satisfied. Figure 123 also shows this fault occurred approximately three hours

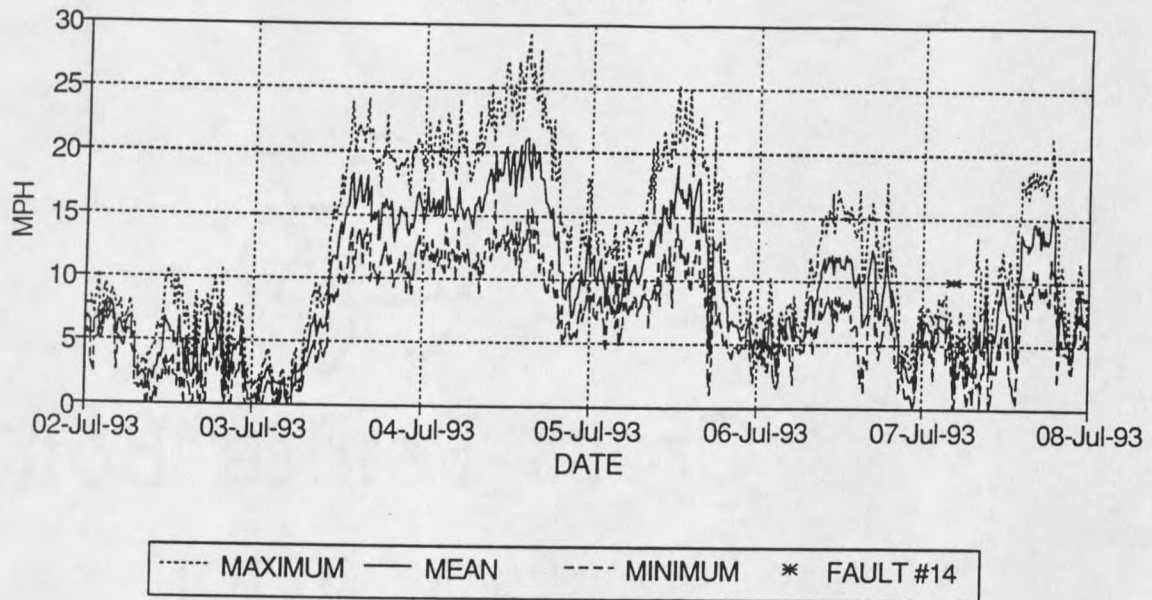
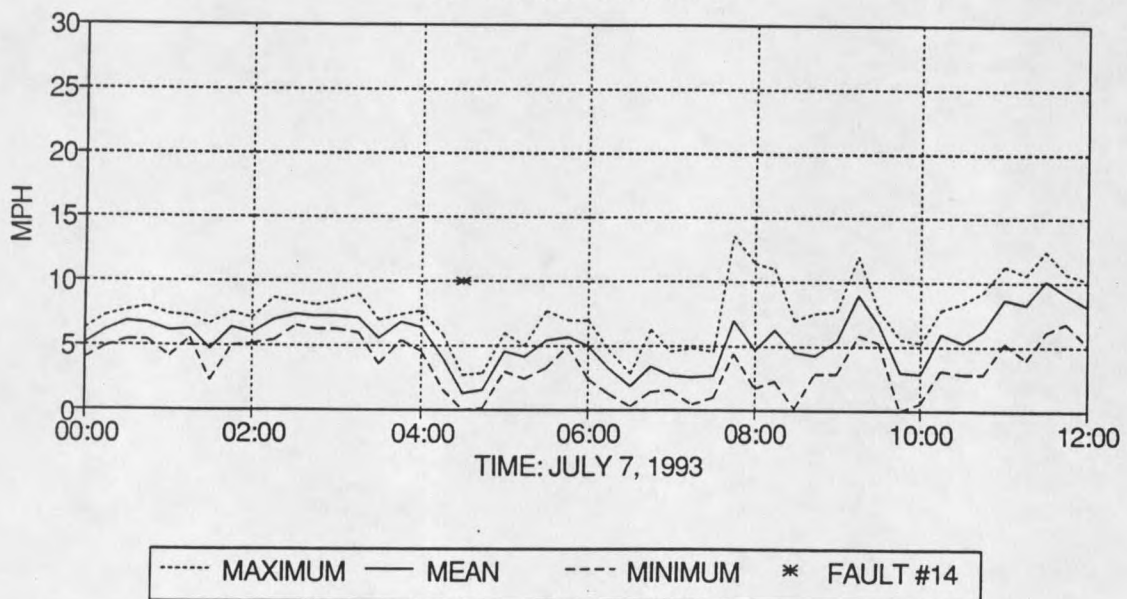
before a significant precipitation event. A light breeze was recorded during the early morning hours of July 7 and the wind speed suddenly dropped to 0 m.p.h. 15 minutes before the fault (Figures 124 and 125). The top dew sensor indicated moisture the entire morning of July 7 and, interestingly, the bottom dew sensor indicated a sudden rise in moisture moments before this fault, as illustrated by Figure 126. Figures 127 and 128 indicate that the test insulator temperature remained close to the ambient air temperature and did not drop to the dew point any time during the night and early morning hours leading up to this fault. This suggests that the moisture on the top and bottom surfaces of the test insulator was a result of fog or very light drizzle and not surface condensation (dew). The fog or drizzle criteria were satisfied.
