Investigation of contamination flashover as a possible cause for unexplained faults on the Montana Power Company 500kV transmission lines  
by Mark Grant Major

A thesis submitted in partial fulfillment of the requirements for the degree of Master of Science in Electrical Engineering  
Montana State University  
© Copyright by Mark Grant Major (1993)

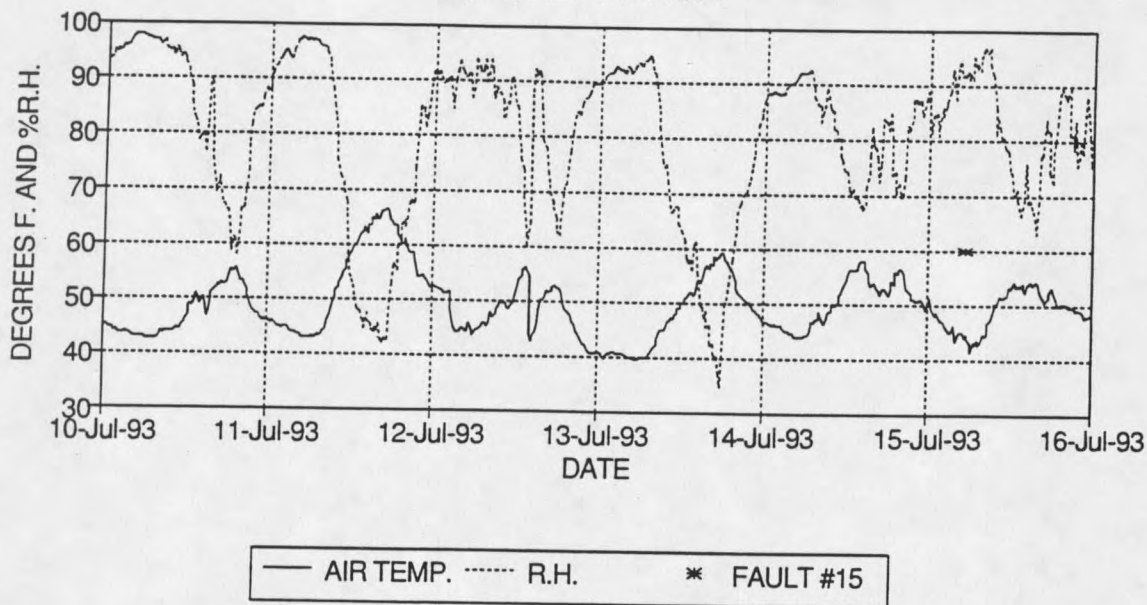
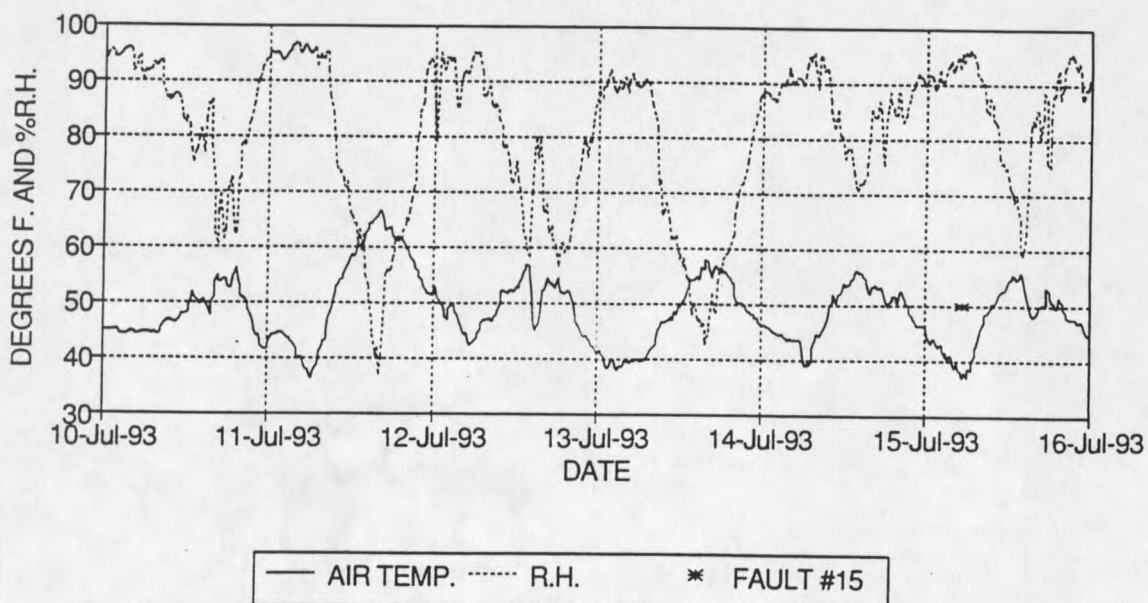
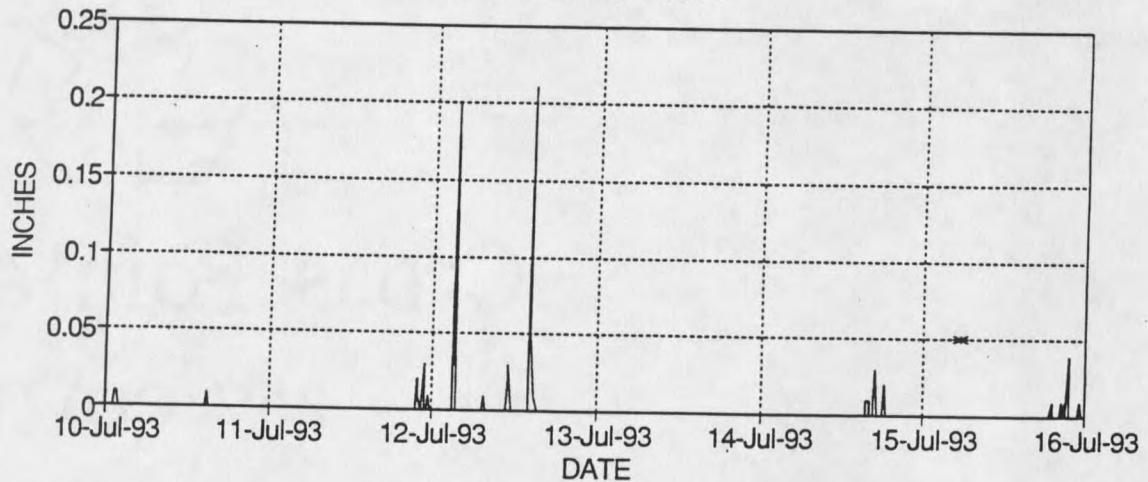
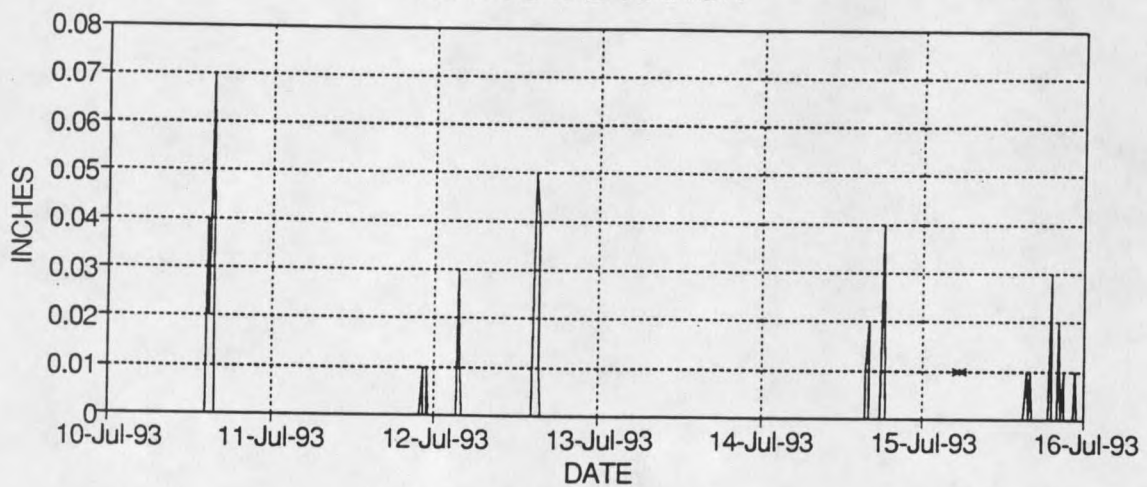
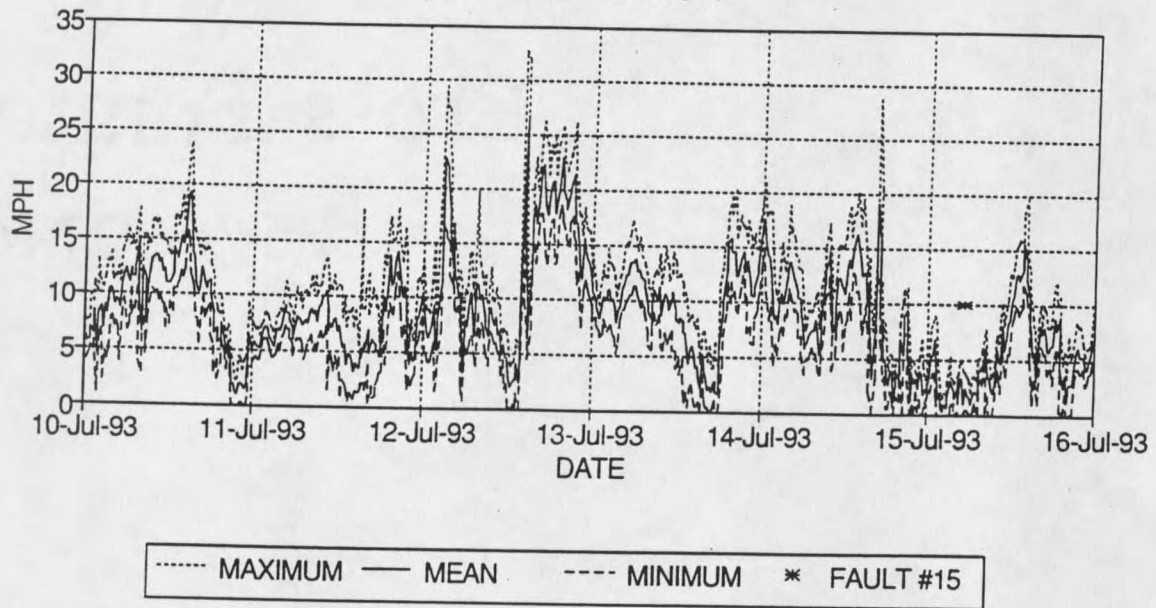
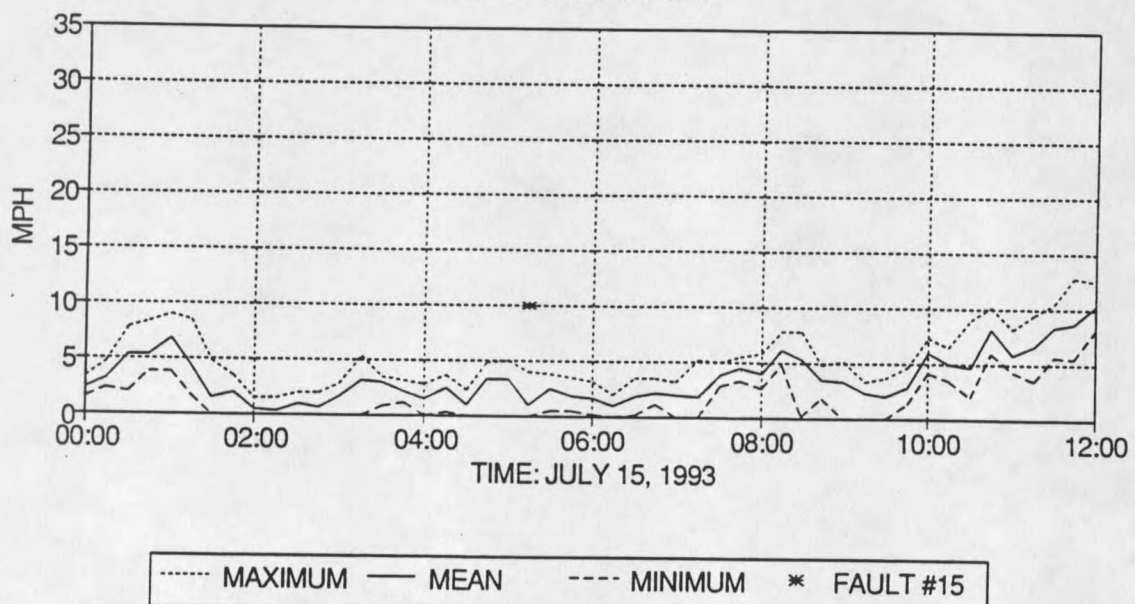
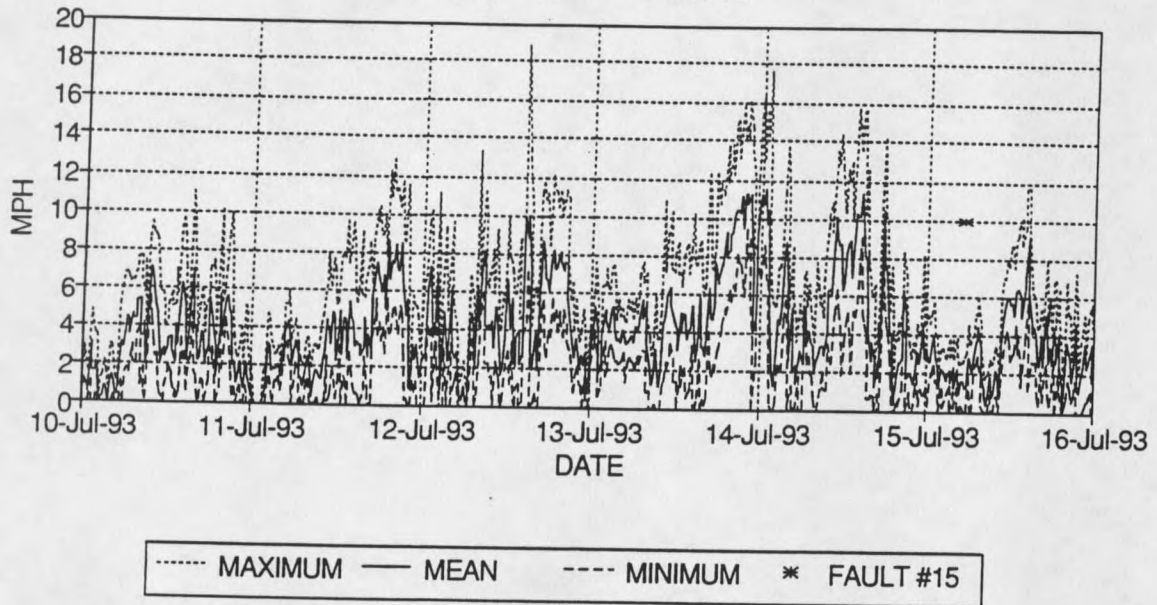
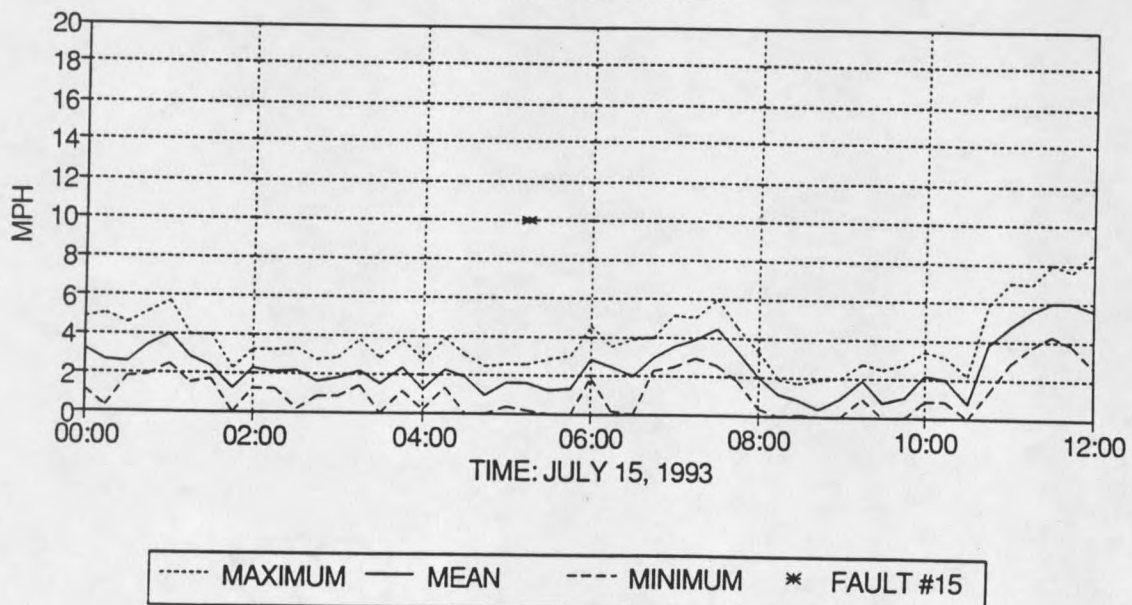
14 (Figures 130-137). This fault also occurred during the early morning hours when the air temperature was near a minimum and the relative humidity was very high. Heavy precipitation, in excess of 0.2" per hour, was recorded July 12, three days preceding this fault at both weather stations. The wind at both weather stations was very calm the morning of the fault and dropped to 0 m.p.h. for a one-hour period prior to the fault. The dew sensors indicate moisture on the top and bottom surfaces of the test insulators at both weather stations at the time of the fault (Figures 138 and 139). The test insulator temperature at each weather station did not drop to the dew point at any time during the night and early morning hours preceding this fault (Figures 140-143). These parameters suggest the insulator surfaces were wetted by fog or very light drizzle rather than dew. Although appropriate wetting conditions consistent with contamination flashover were also present for this fault, the dust accumulation criteria were not satisfied due to the rain recorded July 12. The consistency of the meteorological conditions surrounding this fault with contamination flashover are also deemed inconclusive.

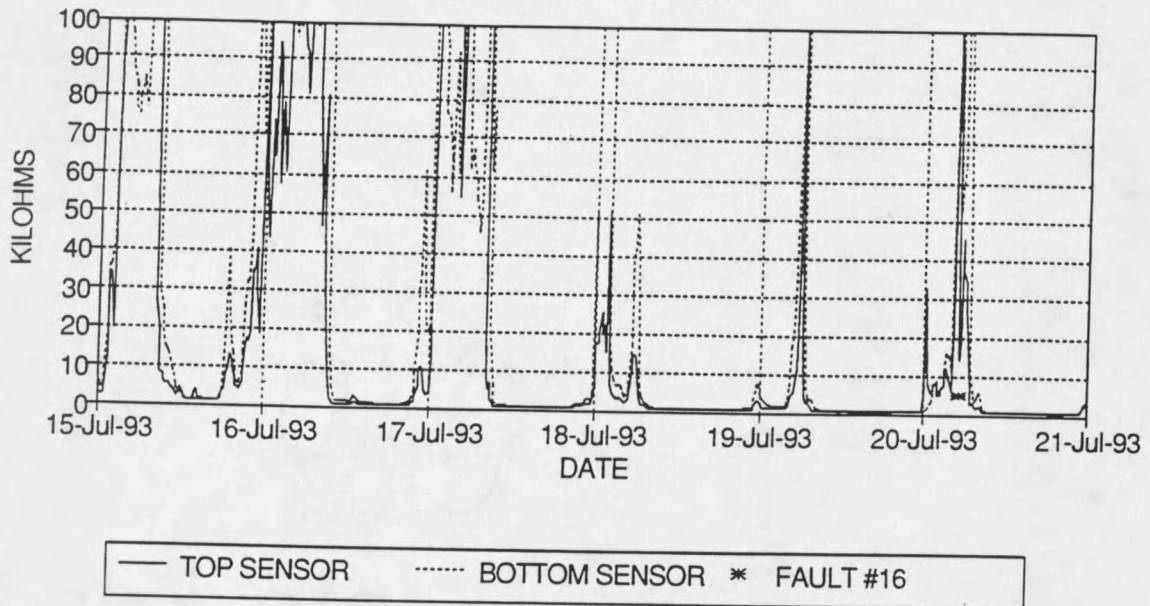
Figure 150

drizzle (0.02") was also recorded. The wind was very calm (usually under 5 m.p.h.) the entire morning of the fault. The dew sensors indicate moisture on the top and bottom surfaces of the test insulator at the time of the fault (Figure 150) and the test insulator temperature did not drop to the dew point at any time during the night and early morning hours preceding this fault (Figures 151 and 152). Again, these parameters suggest the insulator surfaces were wetted by fog or very light drizzle rather than dew.

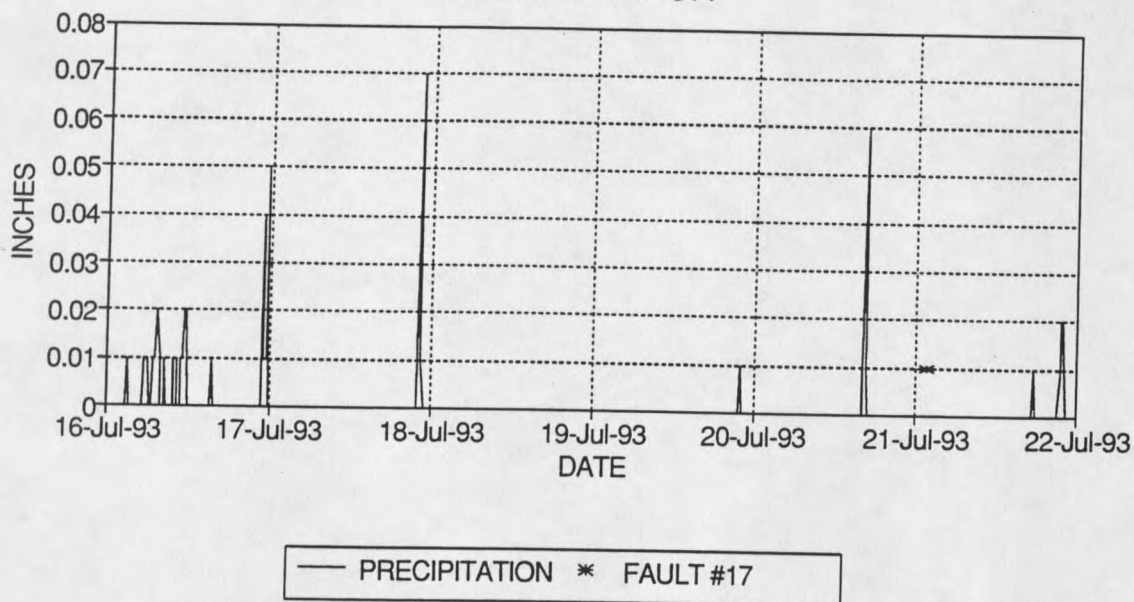
Figure 154  
**PRECIPITATION**  
AT GALT RANCH

Figure 154 shows that the relative humidity was above 70% the early morning hours from midnight to about 5:00 a.m. of July 21 and the temperature (50°F) was dropping at the time of the fault. The weather station recorded a precipitation event July 17, where the rate of precipitation exceeded 0.1" per hour and a light rain, accompanied by a drop in the barometric pressure, was recorded the afternoon before the fault (Figure 155). At the time of the fault, a 10 m.p.h. breeze was present, as shown in Figures 156 and 157, and, as Figure 158 illustrates, both dew sensors on the test insulator indicate the surfaces were dry. The test insulator temperature was close to the air temperature and did not drop to the dew point the evening preceding the fault (Figures 159 and 160).

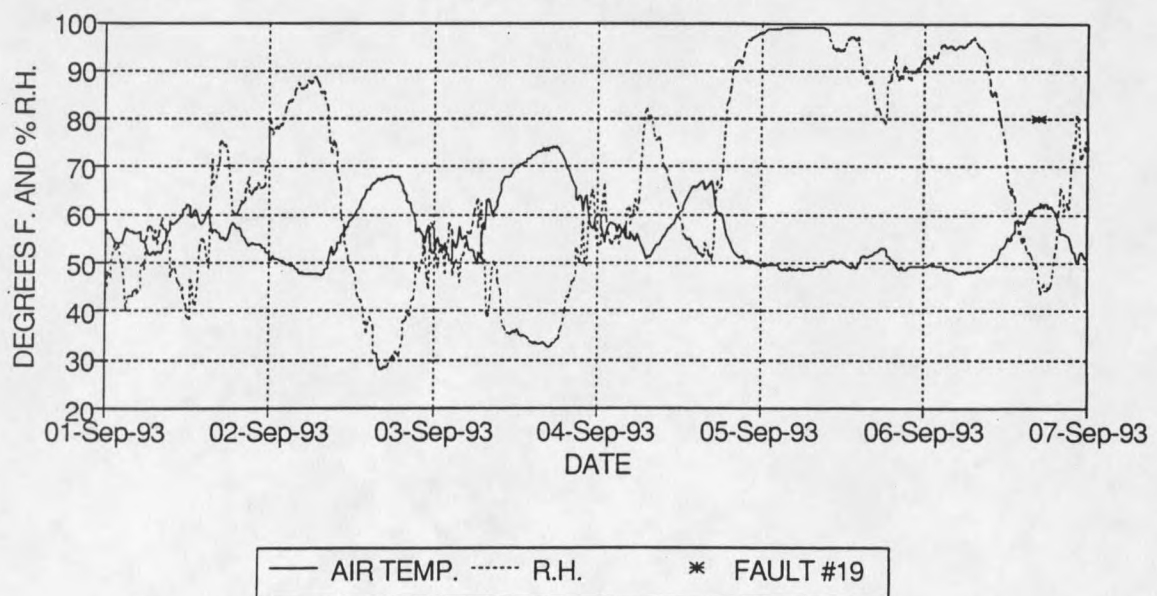
Figure 169

As shown in Figure 169, this fault occurred during a warm (62°F), relatively dry afternoon. The relative humidity dropped from 98% the morning of September 6 to 47% at the fault time. Significant precipitation was recorded during the early morning hours of September 5, the day before the fault. This precipitation exceeded 0.1" per hour (Figure 170), therefore the dust accumulation criteria were not satisfied. The dew sensors (Figure 173) indicate that the test insulator was dry for the entire afternoon in which the fault occurred. The test insulator temperature exceeded the ambient air temperature by 8°F (Figures 174 and 175) suggesting the sun was warming the insulators. A high barometric pressure system was present in the area (Figure 176).
