Investigation of bird induced outages on Montana Power Company's 500kV transmission lines  
by David Robert Maehl

A thesis submitted in partial fulfillment of the requirements for the degree of Master of Science in  
Electrical Engineering  
Montana State University  
© Copyright by David Robert Maehl (1996)

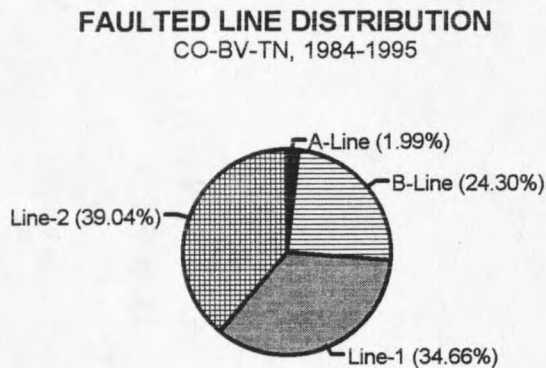
**Figure 5. MPC Line Fault Activity**

Figure 5 shows the fault activity on each MPC line and clearly, the A-Line is faulted less than all of the other lines. The BPA lines have experienced unexplained outage activity, although not as severe as MPC's B-Line and Lines 1 and 2.

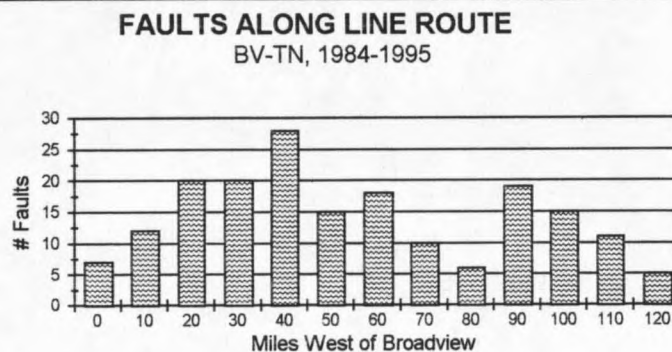
**Figure 7. Fault Location Distribution**

Figure 7 discloses where the faults tend to occur along the line route. The estimated fault locations used in the plots were categorized into 10 mile intervals, with 0 representing 0 to 10 miles west of Broadview. The distances were calculated using a fault current ratio method up until 1991 and after that, the FLR (Fault Location Relay) was used to determine the general location of the faults. FLR data are based on the time of arrival, to different substations, of transient waves associated with the faults, and have been shown to be more accurate than the current ratio method. The areas of the highest fault activity along the line route (20-30, 30-40, 40-50, and 90-100 miles west of Broadview) were all areas of flat rangeland. The least fault activity occurred where the transmission line passed through forest-land with trees nearby (80-90 and 120-130 miles west of Broadview).

All of the other faults appear to be randomly distributed along the line route.

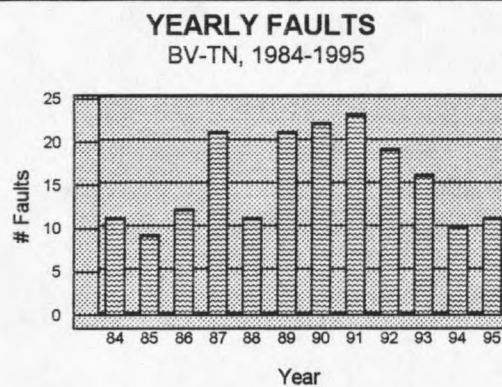
**Figure 9. Yearly Fault Distribution**

Figure 9 shows the number of faults that occurred each year, from 1984-1995,

between Broadview and Townsend. The transmission lines experienced an exceptionally high number of outages between 1987 and 1993, excluding 1988 when the fault activity dropped significantly. Several fires occurred during the summer of 1988, most significantly the Yellowstone National Park fire which was approximately 100 miles south of the 500kV lines. The number of unexplained outages have been declining since the peak in 1991.

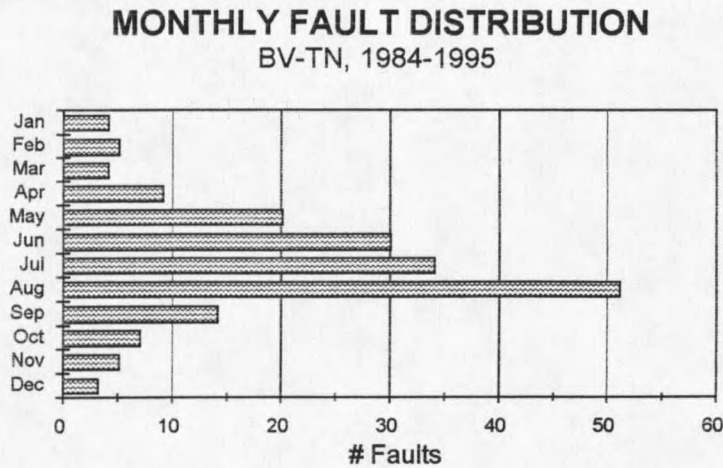
**Figure 10. Monthly Faults**

Figure 10, on the following page, depicts the Monthly Fault Distribution and illustrates the fact that more faults occurred during June, July, and August than the rest of the months combined. There was a steady increase in faults from March through August, then suddenly the fault activity dropped off in September. This was one of the most significant trends observed from the fault data.

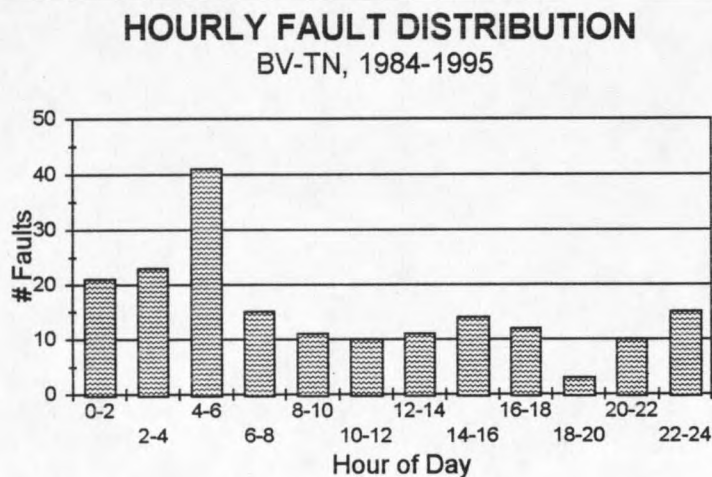
**Figure 11. Hourly Faults**

From Figure 11, it can be seen that more faults occurred between 04:00 and 06:00 than any other time of the day. The fault times were fairly scattered throughout the rest of the day, with the exception of 18:00 through 20:00 where very few outages occurred.

Raptors often will mute upon take-off from their perching location. Time of day and quantity of food consumed are both factors that may affect the volume of the mute. It has been suggested (Burnham 1995),[8] that birds, after roosting on the transmission line towers all night, will mute a large quantity around sunrise prior to commencing their daily activity. This may be an explanation for the large number of faults that occur between 04:00 and 06:00 (see Figure 11).

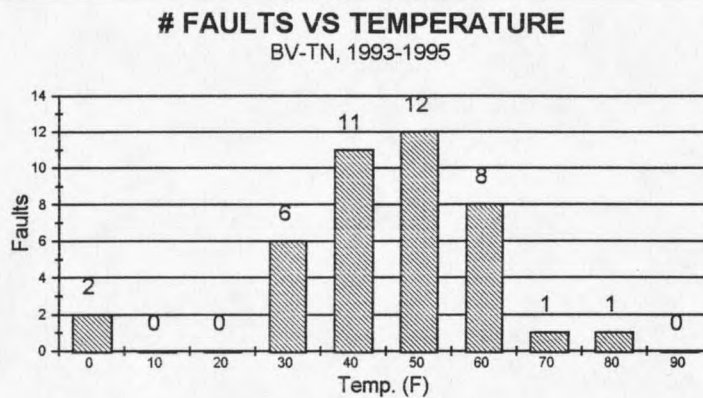
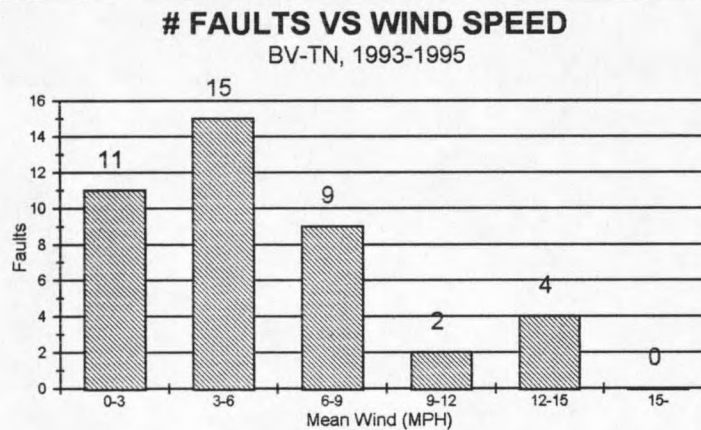
Other weather related faults such as high winds are also rare on MPC's lines because nearly all of the unexplained outages occur during moderate temperature periods and when the wind speeds are moderate. Figures 12 and 13 show the temperatures and wind speeds

during fault times for the last 41 faults. The weather data used in the plots were obtained from weather stations along the transmission line route that are spaced approximately 20 miles apart. Most of the faults occurred when the temperature was between 40 and 60 degrees Fahrenheit and when the wind speed was below 9 miles per hour.

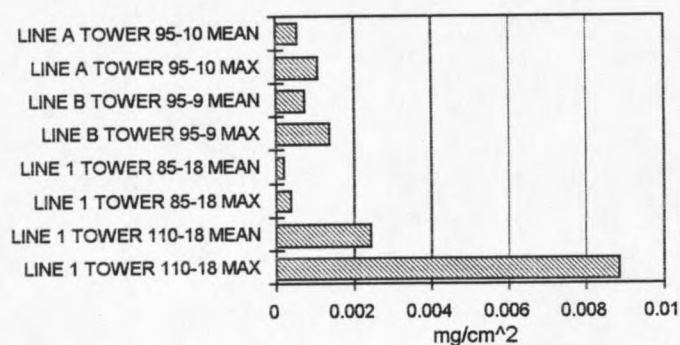
**Figure 14. ESDD Measurements****ESDD FOR STRINGS FROM 500KV LINE**

The values obtained from ESDD measurements on MPC's 500kV line insulators are illustrated in Figure 14. Notice that the highest value measured was .009 mg/cm<sup>2</sup>, which is three times less than a level considered to be light contamination.

Due to the fact that the meteorological conditions were not consistent with contamination flashover and the very light levels of contamination of the insulators, it was

concluded that insulator contamination flashovers were not a significant cause of unknown faults on MPC's 500kV transmission lines.

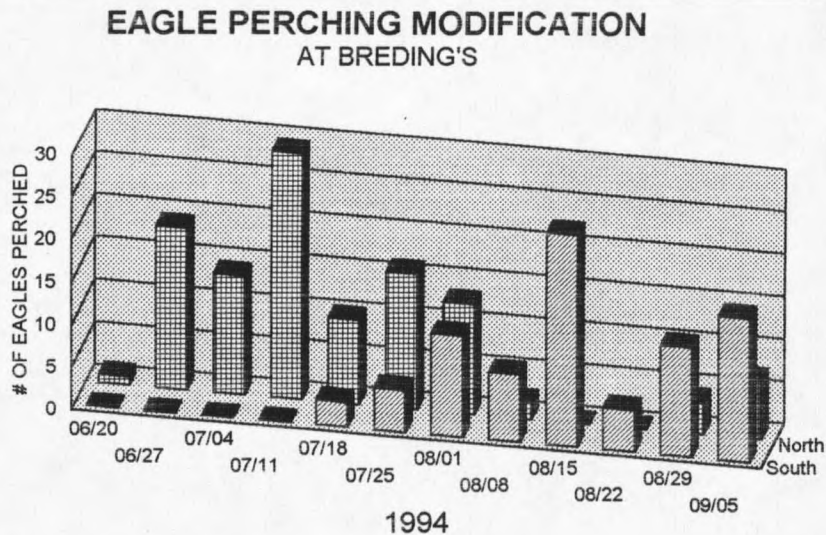
**Figure 19.** Eagle Behavior at Breeding's

Sufficient data were not available from observations of the Breeding Ranch perches to perform a statistical analysis. A surveillance camera installed in the area did provide some insight on the impact of the perches in changing the bird's behavior. Becky Charles,[21] analyzed the VCR tapes obtained from the surveillance camera site and noted some interesting observations. Figure 19 illustrates the use of the towers by the eagles in the area before and after the perch installation on July 21, 1994. The y-axis in the figure represents the number of birds landing on a tower corresponding to the particular date labeled on the x-axis. Note that the eagles used the north line to perch or hunt from before the installation of the perches on the south line, and then utilized the south line after the installation of the perches. Once again, it can be said that the raptors' behaviors were changed somewhat, due to the presence of perches, but it cannot be said that the changes were statistically significant because of the lack of data.

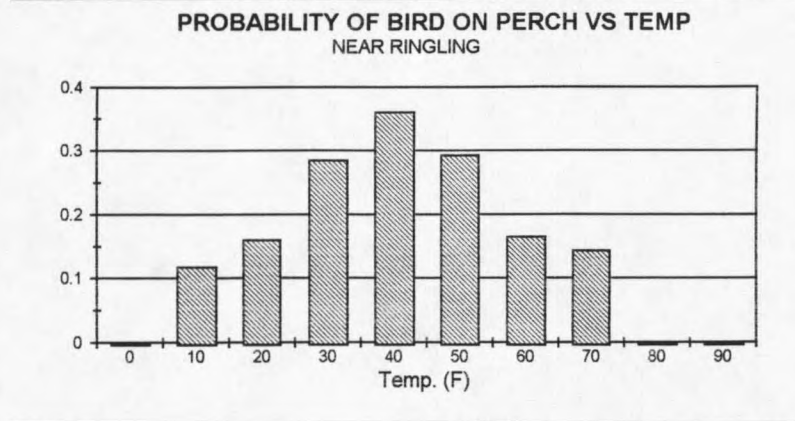
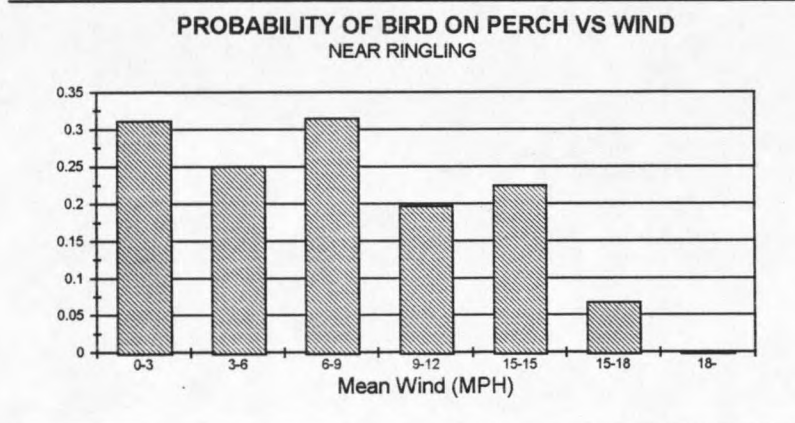
A weather station was installed north of Ringling at the base of a transmission line tower to help determine if any meteorological patterns correlated with the bird activity. Figures 20 and 21 show the Probability of a Bird on a Perch vs. Temperature and Wind Speed, respectively. The raptors tend to perch during moderate temperatures and wind

speeds, which matches the meteorological fault data shown in Figures 12 and 13 on page 16.

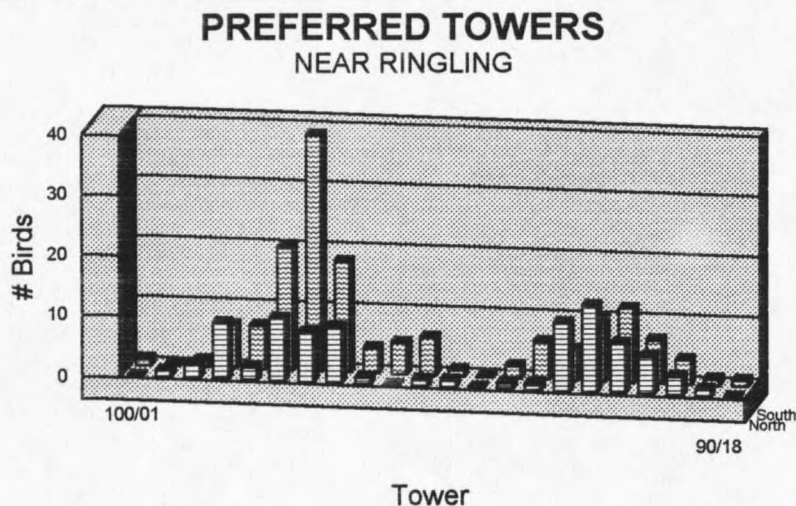
**Figure 22. Preferred Towers**

It was also observed that the birds tend to prefer certain towers to perch on or hunt from, most likely due to the food habitat nearby. Figure 22 illustrates the preferred towers near Ringling, and it appears likely that 90% of the raptors perch on 10% of the towers. The North and South legends used in the plot represent the #2 and #1 lines, respectively.
