Investigation of bird induced outages on Montana Power Company's 500kV transmission lines
by David Robert Maehl

A thesis submitted in partial fulfillment of the requirements for the degree of Master of Science in
Electrical Engineering
Montana State University
© Copyright by David Robert Maehl (1996)

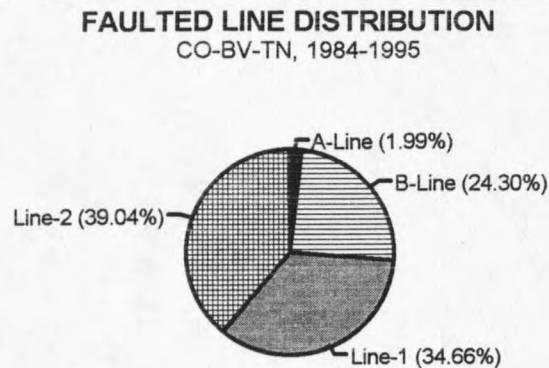
Figure 5. MPC Line Fault Activity

Figure 5 shows the fault activity on each MPC line and clearly, the A-Line is faulted less than all of the other lines. The BPA lines have experienced unexplained outage activity, although not as severe as MPC's B-Line and Lines 1 and 2.

relative to the different 500kV lines. Nests were documented from land observations as well as helicopter surveys. A complete listing of the towers with nests located in them can be seen in Appendix B. Notice the striking similarities that exist between Figure 16 and Figure 5, Faulted Line Distribution. The percentage of nests in towers on each line is almost exactly the same as the percentage of faults on each line.

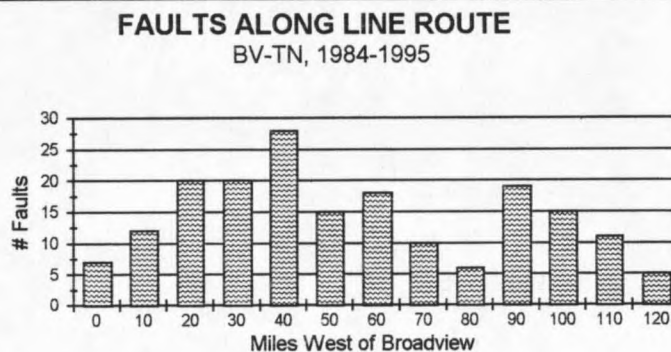
Figure 7. Fault Location Distribution

Figure 7 discloses where the faults tend to occur along the line route. The estimated fault locations used in the plots were categorized into 10 mile intervals, with 0 representing 0 to 10 miles west of Broadview. The distances were calculated using a fault current ratio method up until 1991 and after that, the FLR (Fault Location Relay) was used to determine the general location of the faults. FLR data are based on the time of arrival, to different substations, of transient waves associated with the faults, and have been shown to be more accurate than the current ratio method. The areas of the highest fault activity along the line route (20-30, 30-40, 40-50, and 90-100 miles west of Broadview) were all areas of flat rangeland. The least fault activity occurred where the transmission line passed through forest-land with trees nearby (80-90 and 120-130 miles west of Broadview).

All of the other faults appear to be randomly distributed along the line route.

All of the birds seen in the study area primarily eat the same foods; jackrabbits, ground squirrels, snakes, carrion, and some types of other birds. Most of these types of foods are found in the open prairies. Additionally, without the presence of trees, the transmission line towers present a commanding view of the open prairies. Referring back to Figure 7, Fault Location Distribution, it was noted that the areas of the highest fault activity along the line

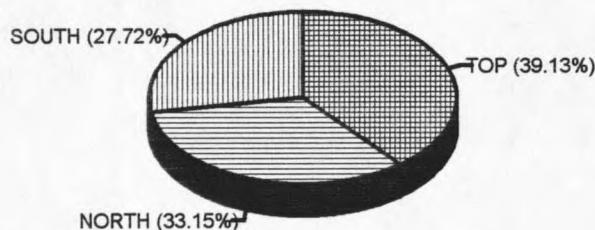
Figure 8. Phase Location Distribution

The top (window) phase was faulted slightly more than the two lower, north and south phases, although not by a significant amount. Other utilities with similar tower configurations have experienced significantly more outages on the window phase compared to the two lower phases (Sandhu et al. 1988),[3] however, Figure 8 shows that this was not the case with MPC's 500kV transmission lines.

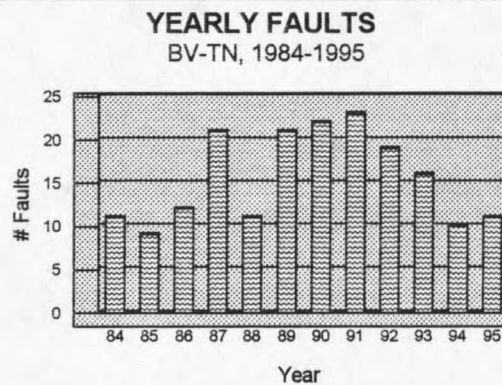
Figure 9. Yearly Fault Distribution

Figure 9 shows the number of faults that occurred each year, from 1984-1995,

between Broadview and Townsend. The transmission lines experienced an exceptionally high number of outages between 1987 and 1993, excluding 1988 when the fault activity dropped significantly. Several fires occurred during the summer of 1988, most significantly the Yellowstone National Park fire which was approximately 100 miles south of the 500kV lines. The number of unexplained outages have been declining since the peak in 1991.

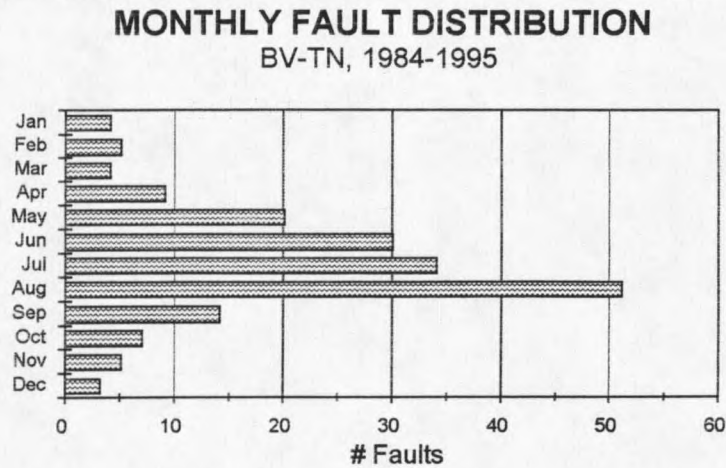
Figure 10. Monthly Faults

Figure 10, on the following page, depicts the Monthly Fault Distribution and illustrates the fact that more faults occurred during June, July, and August than the rest of the months combined. There was a steady increase in faults from March through August, then suddenly the fault activity dropped off in September. This was one of the most significant trends observed from the fault data.

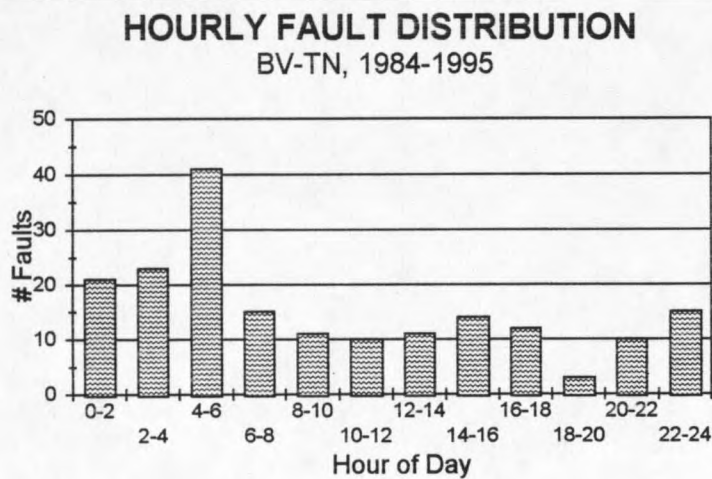
Figure 11. Hourly Faults

From Figure 11, it can be seen that more faults occurred between 04:00 and 06:00 than any other time of the day. The fault times were fairly scattered throughout the rest of the day, with the exception of 18:00 through 20:00 where very few outages occurred.

Raptors often will mute upon take-off from their perching location. Time of day and quantity of food consumed are both factors that may affect the volume of the mute. It has been suggested (Burnham 1995), [8] that birds, after roosting on the transmission line towers all night, will mute a large quantity around sunrise prior to commencing their daily activity. This may be an explanation for the large number of faults that occur between 04:00 and 06:00 (see Figure 11).

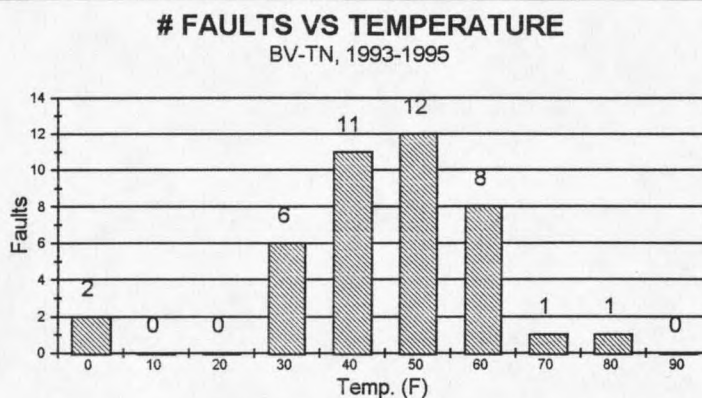
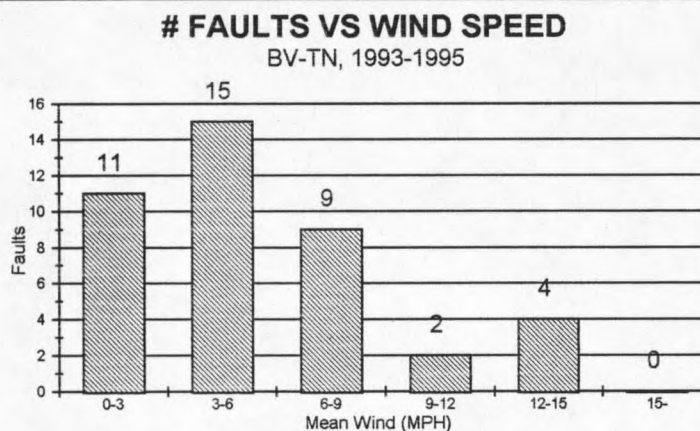
Other weather related faults such as high winds are also rare on MPC's lines because nearly all of the unexplained outages occur during moderate temperature periods and when the wind speeds are moderate. Figures 12 and 13 show the temperatures and wind speeds

during fault times for the last 41 faults. The weather data used in the plots were obtained from weather stations along the transmission line route that are spaced approximately 20 miles apart. Most of the faults occurred when the temperature was between 40 and 60 degrees Fahrenheit and when the wind speed was below 9 miles per hour.

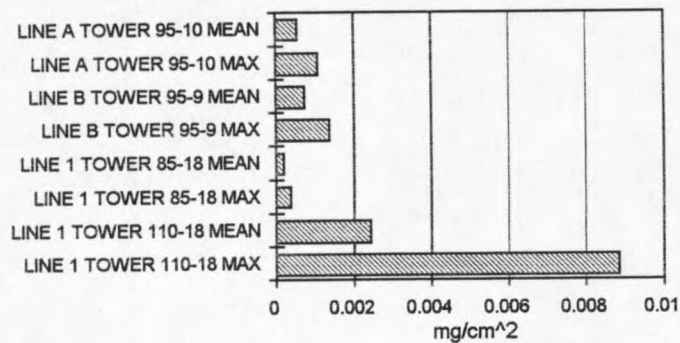
Figure 14. ESDD Measurements

The values obtained from ESDD measurements on MPC's 500kV line insulators are illustrated in Figure 14. Notice that the highest value measured was .009 mg/cm², which is three times less than a level considered to be light contamination.

Due to the fact that the meteorological conditions were not consistent with contamination flashover and the very light levels of contamination of the insulators, it was

concluded that insulator contamination flashovers were not a significant cause of unknown faults on MPC's 500kV transmission lines.

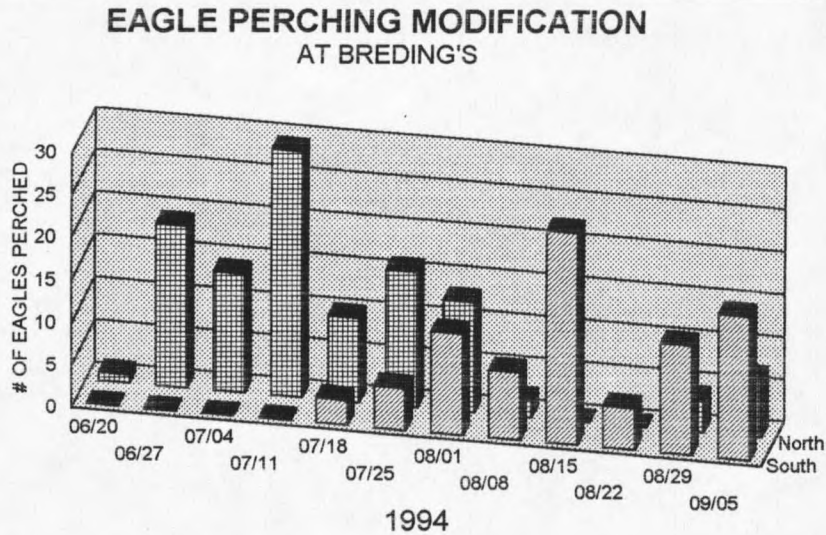
Figure 19. Eagle Behavior at Breeding's

Sufficient data were not available from observations of the Breeding Ranch perches to perform a statistical analysis. A surveillance camera installed in the area did provide some insight on the impact of the perches in changing the bird's behavior. Becky Charles,[21] analyzed the VCR tapes obtained from the surveillance camera site and noted some interesting observations. Figure 19 illustrates the use of the towers by the eagles in the area before and after the perch installation on July 21, 1994. The y-axis in the figure represents the number of birds landing on a tower corresponding to the particular date labeled on the x-axis. Note that the eagles used the north line to perch or hunt from before the installation of the perches on the south line, and then utilized the south line after the installation of the perches. Once again, it can be said that the raptors' behaviors were changed somewhat, due to the presence of perches, but it cannot be said that the changes were statistically significant because of the lack of data.

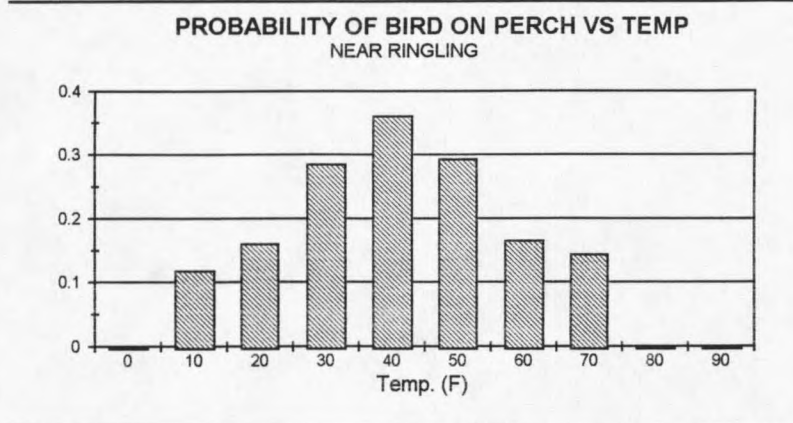
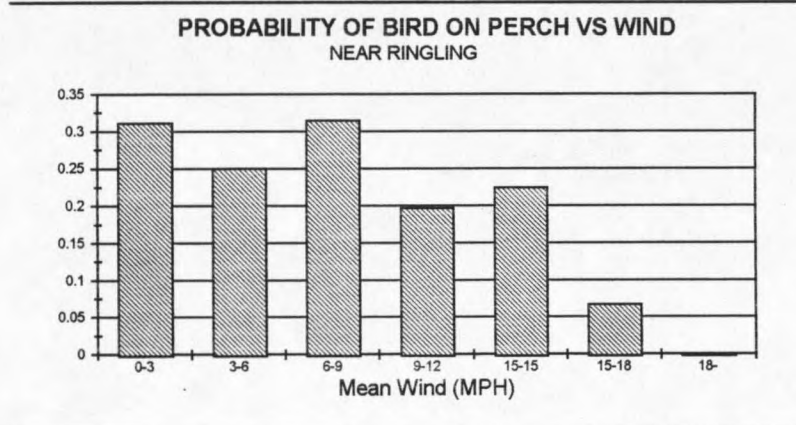
A weather station was installed north of Ringling at the base of a transmission line tower to help determine if any meteorological patterns correlated with the bird activity. Figures 20 and 21 show the Probability of a Bird on a Perch vs. Temperature and Wind Speed, respectively. The raptors tend to perch during moderate temperatures and wind

speeds, which matches the meteorological fault data shown in Figures 12 and 13 on page

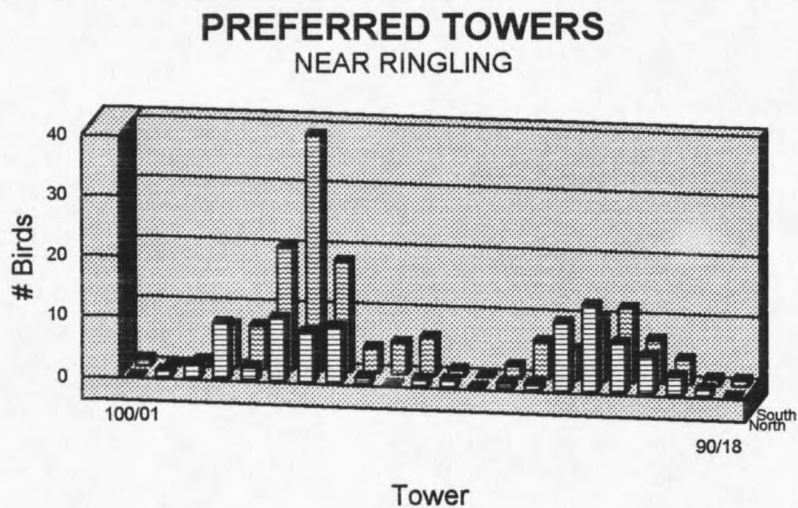
Figure 22. Preferred Towers

It was also observed that the birds tend to prefer certain towers to perch on or hunt from, most likely due to the food habitat nearby. Figure 22 illustrates the preferred towers near Ringling, and it appears likely that 90% of the raptors perch on 10% of the towers. The North and South legends used in the plot represent the #2 and #1 lines, respectively.
