Environmental geology of the southeast margin of the Gallatin Valley, Gallatin County, Montana  
by Earl Francis Griffith

A thesis submitted in partial fulfillment of the requirements for the degree of MASTER OF SCIENCE  
in Earth Science

Montana State University

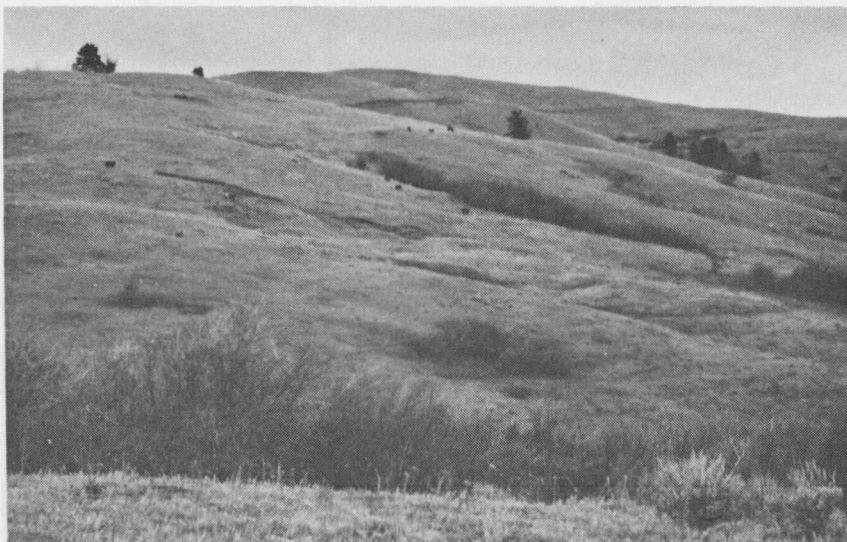
Figure 3. Small landslide on the dip slope of overturned Cretaceous bedrock in the Story Hills.

Holocene-Landslides (Hls). These geomorphic features have resulted from slope failure within the last 15 years. The small landslides are located in the eastern portion of the Story Hills and consist of unconsolidated surficial soil materials, Tertiary sedimentary rocks and the underlying fractured Cretaceous bedrock (Plates 4 and 5). A prominent headscarp, dip-slope attitude, large amount of available groundwater, hummocky topography and a lobate terminus characterize these small slides (Figures 3 and 4). Thickness is probably less than 25 feet.

A small two-acre slide approximately 300 feet east of the intersection of Big Gulch Drive and Carney Road in sec. 3, T.1 S., R.6 E. is a shallow soil failure on an overturned Cretaceous dip slope. Directly north of and adjacent to the slide, water is discharging from a small spring. This slope failure occurred in spite of the fact it has a southwest (climatically dry) aspect and an 18% slope (Figure 3).

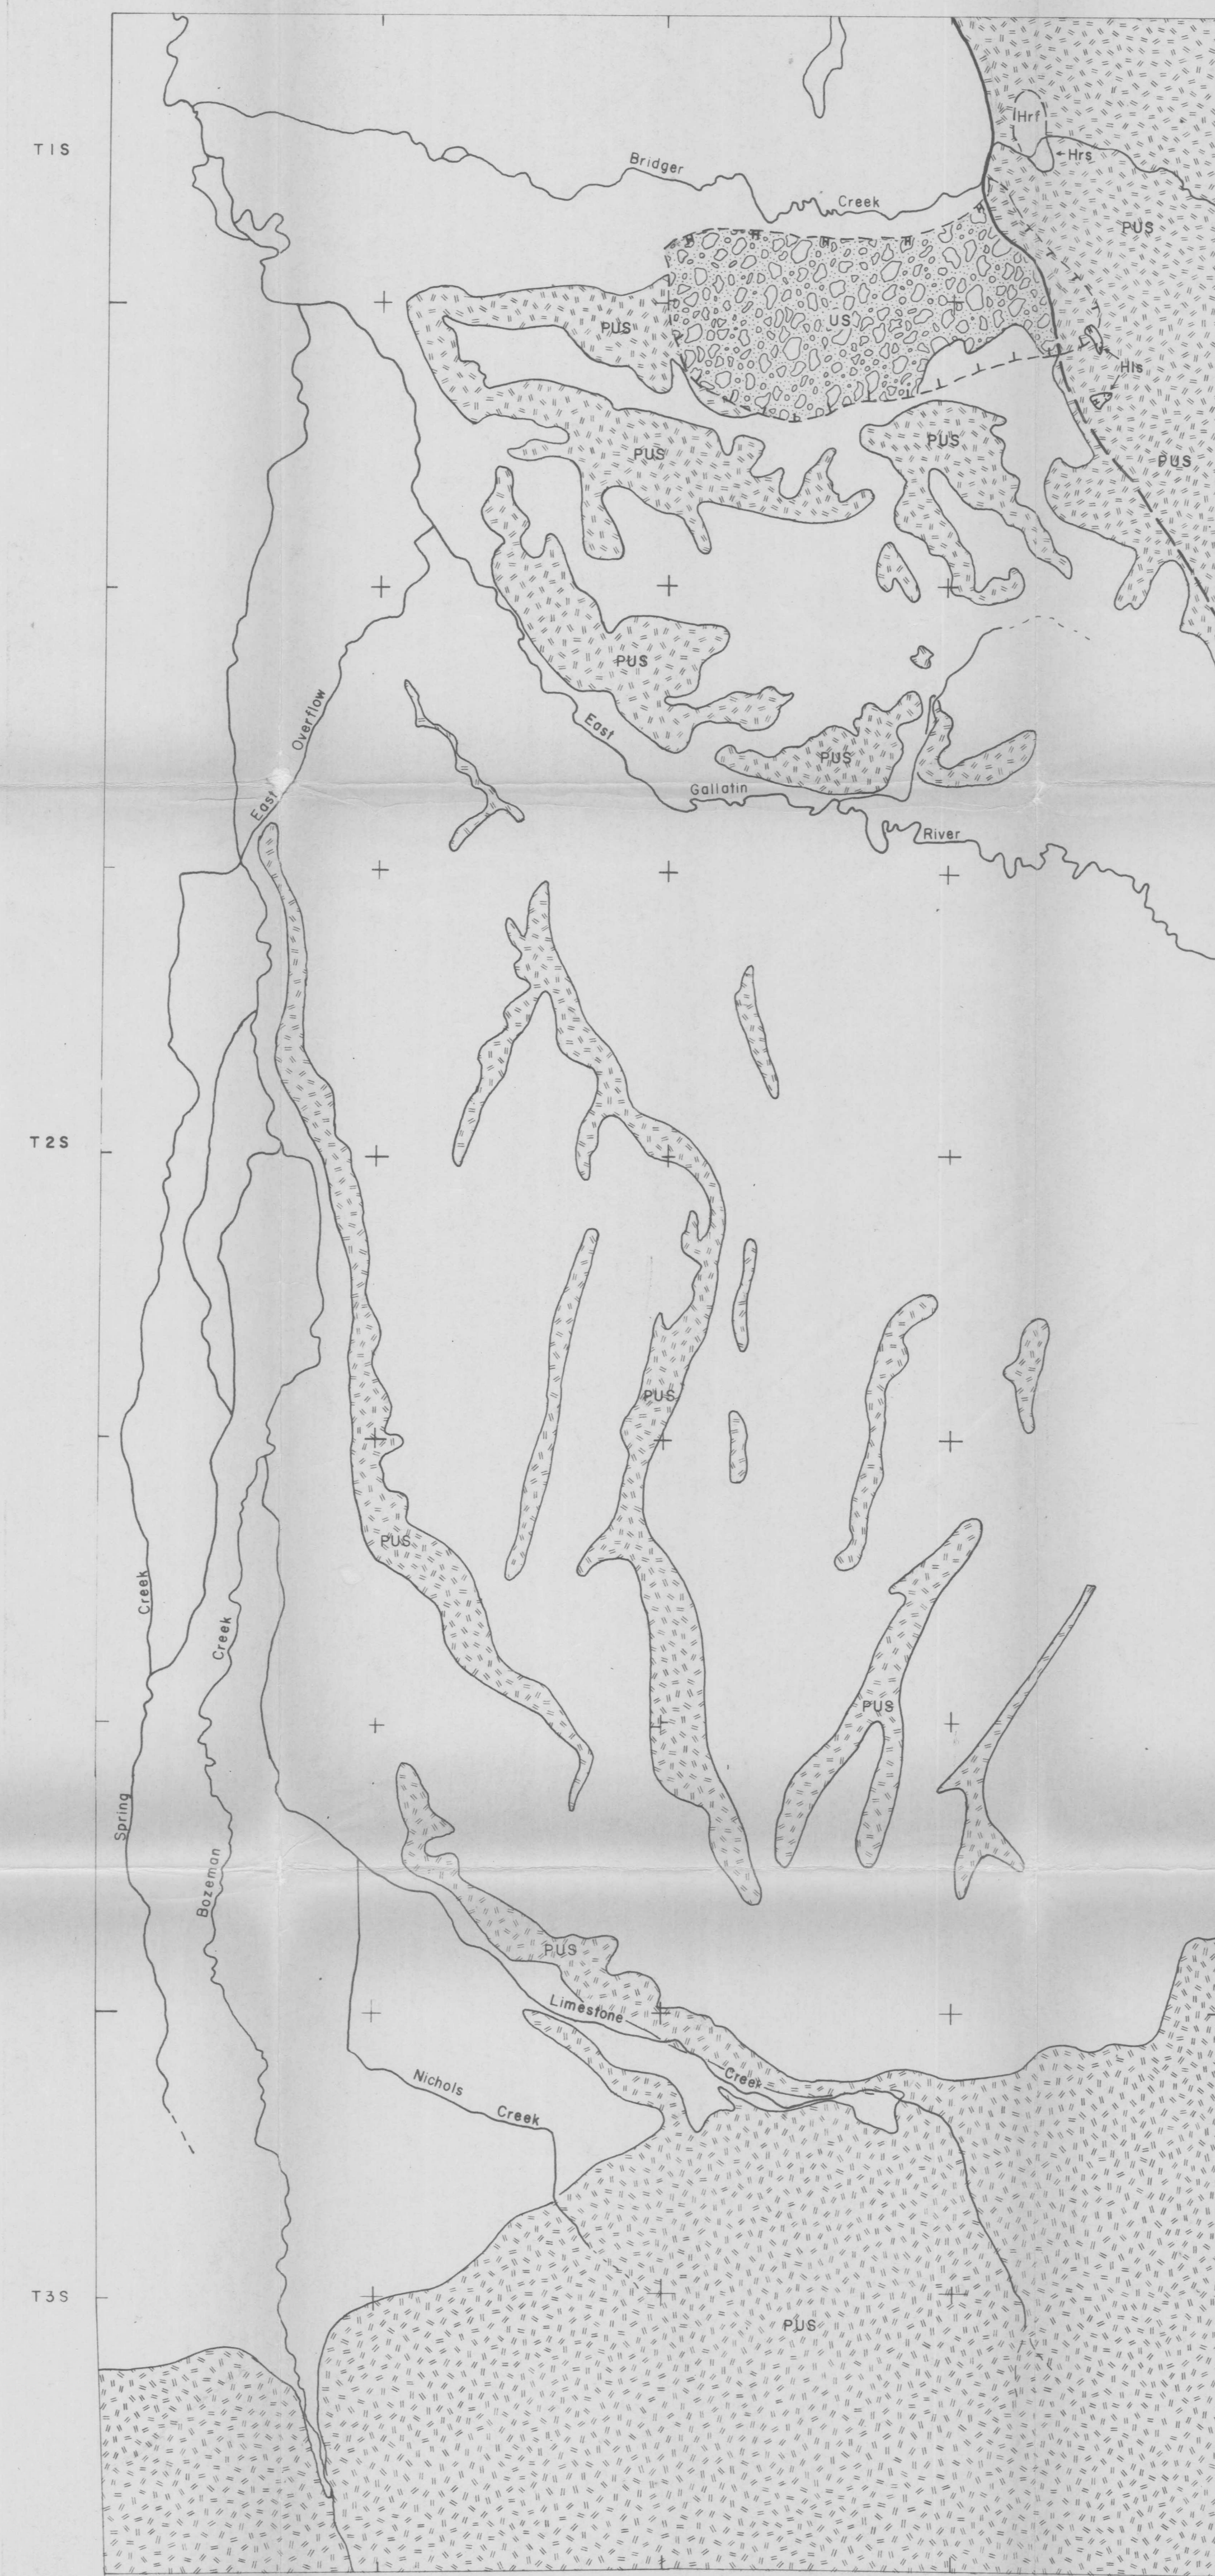
# PLATE 5 SLOPE STABILITY

**UNSTABLE SLOPE:** Slope with landslide physiography, but where signs of recent movement are non-existent or uncertain. The area has undergone slope movement in the recent geologic past (post-Pliocene). Some portions of the slide are presently stable due to climatic changes or other factors. Other places are metastable or show evidence of downslope creep in drainageways. Portions of this area are suitable for low or medium density housing, but access is limited, especially on the steeper north slopes. The hazard associated with this area is much less certain than on active landslides, and thus, human activity should be controlled accordingly. Any type of construction activity should be carefully monitored on a site specific basis, especially drainfield siting and roadway drainage measures.

Constraints addressed in this report include mass movement phenomena and the associated factors of slope steepness and aspect, creep, solifluction and unstable and potentially unstable slopes (Plate 5). Hydrologic con-

Bridger Canyon rockfall area. Directly across from the Bridger Canyon rockslide are cliffs of Madison Limestone (Plate 5). These jointed and fractured rocks present a very localized rockfall hazard. The competency of the limestones and their shallow dip away from the road preclude a large scale slide onto the roadway. However, the stresses of mechanical weathering and continued loss of support material in combination with the very steep slope allows rocks of

All of the area east of the Bridger Creek-Bear Canyon fault not considered as active landslides is considered potentially unstable (Plate 5). This includes the areas controlled by dip slopes in overturned Cretaceous units and the very steep side slopes of the Bridger Canyon exclusive of the rockslide areas. The high mountainous slopes of the Gallatin Range have thin soil profiles and exhibit active creep throughout. The additional effects of increased precipitation and north aspect further supports a classification as potentially unstable.
