USE OF PULTRUDED CARBON FIBER / EPOXY INSERTS AS  
REINFORCEMENT IN COMPOSITE STRUCTURES

A thesis submitted in partial fulfillment  
of the requirements for the degree

Mechanical Engineering

MONTANA STATE UNIVERSITY  
Bozeman, Montana

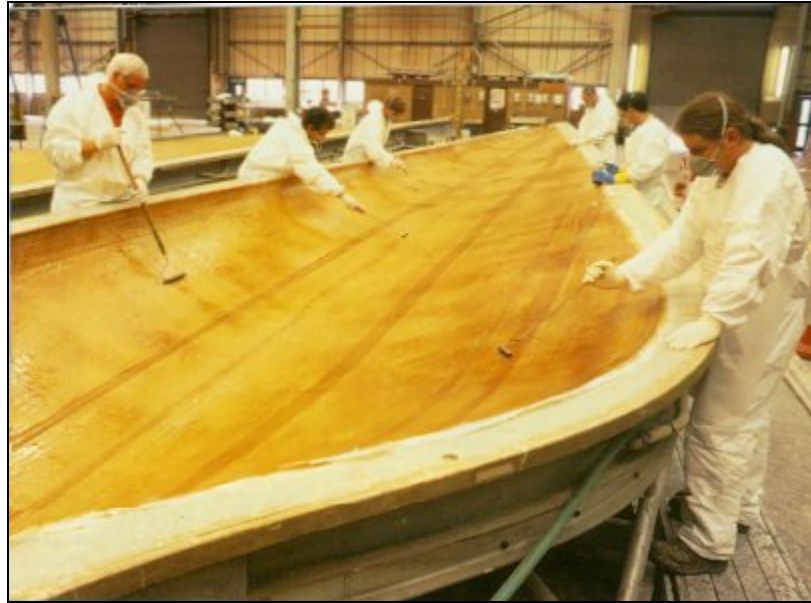
A photograph showing laborers physically laying up a wind turbine blade skin is shown in Figure 3 [5]. The fabric schedule is placed layer by layer until the desired thickness is reached; between layers polymer resin is poured over the new fabric. Wind turbine blade manufacturers primarily use thermosetting resins for their low viscosities in infusing into fabrics and relative mechanical property stability in higher temperatures and low cost [6]. The hand rollers used are to compact the fibers down, push any trapped air to the surface, and push away excess resin.

Figure 3: Physically laying up half a blade skin [5]

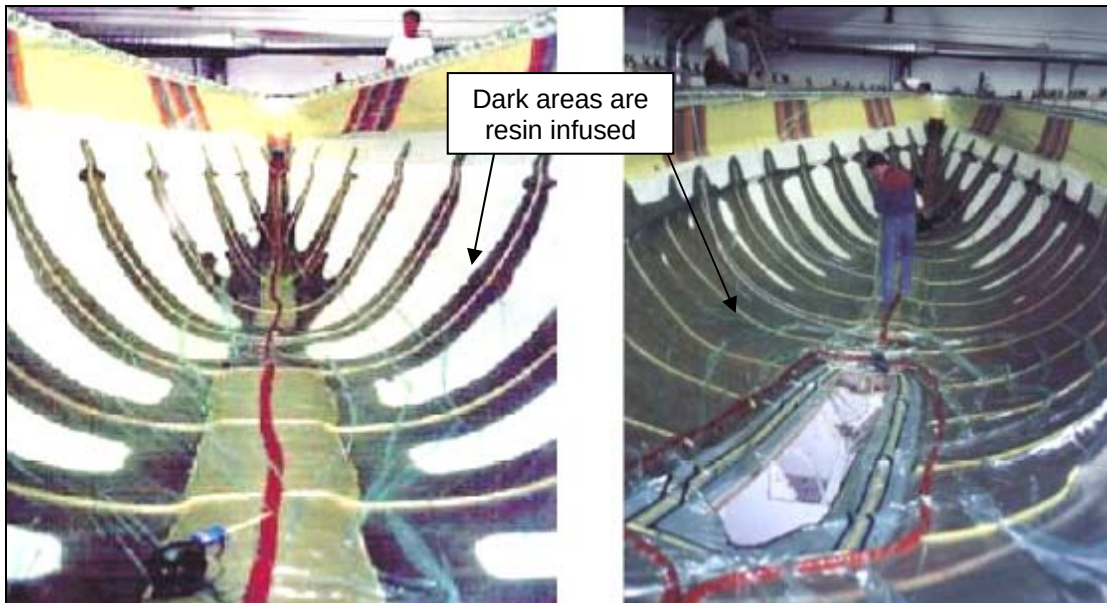
Figures 4 and 5 [8] show large structural skin members being infused with resin by use of vacuum pressure (vacuum assisted RTM) to pull resin through the fabric rather than push the resin. Figure 4 shows a 20 meter long rotor blade. Figures 5a and 5b show a 16.4 m long by 4.5 m wide by 2.5 m high fiberglass

boat hull being vacuum infused. The thicknesses of these parts were not given in the reference. Due to increasing understanding and successes of resin infusion processes in thicker laminates, manufacturing methods for wind turbine blades are turning away from hand lay-up methods and towards the various forms of resin infusion because of the advantages in production time, labor, and materials [1, 7, 9].

Figures 5a and 5b: 54 ft long fiberglass boat hull under vacuum resin injection [8]

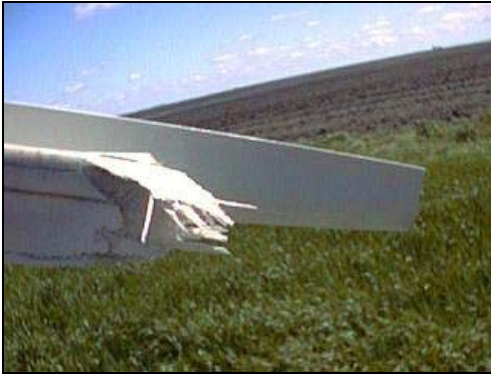
The resulting damage opens up the structure to environmental factors that could further compromise the performance of the local material or structure. An example of the damage sustained by a 7.5 ft long wind turbine blade after a tower strike is shown in Figures 7, 8, and 9 [12]. It appears from the preceding figures that damage from the strike to the blade weakened the local structure. The loads on the compromised blade tip caused delaminations around the damaged area. The damaged material then cracked too much and finally snapped off.

Figure 7: Damaged blade after tower strike compared to undamaged blade [12]

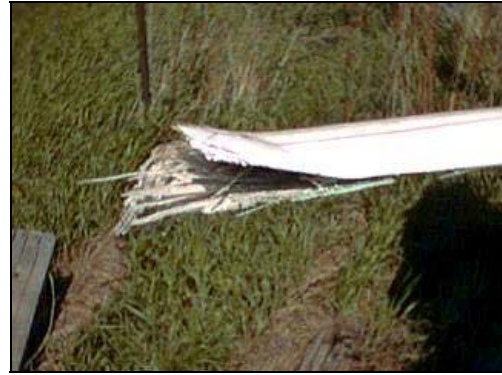
Figure 8: Same damage, view from trailing edge [12]

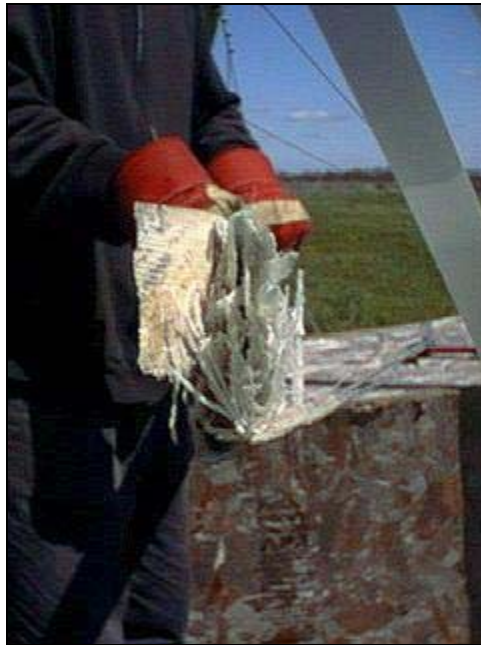
Figure 9: Straight on view of damaged blade [12]

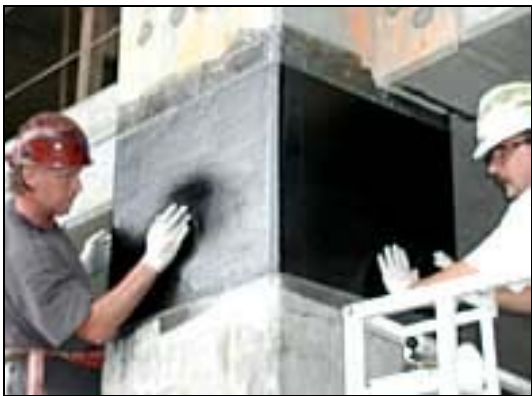
Exterior Strengthening - Pultruded strips, sheets, and shells can be applied externally to deteriorating bridge substructures such as the undersides of bridge decks or support columns. These composites can have their lifetimes extended by strengthening in flexure and shear at a fraction of the associated costs of classical rehabilitation concrete structures. The light weight of carbon PMC composites translates into easier handling, fewer laborers and lifting devices and fast executions needed as seen in Figures 20 and 21 [30, 31, 32]. Most joining is accomplished by high performance epoxy adhesives. The best bonding environment is accomplished by increasing the surface area of both adherends. Sandblasting the concrete and abraiding the surface of the composite is typically done. Mechanical fastening methods are also occasionally employed [32]. The high strength of the composite allows less material to be used compared to traditional steel plate rehabilitation and pultrusions do not corrode like steel.

Figure 20: Column Strengthening [33]

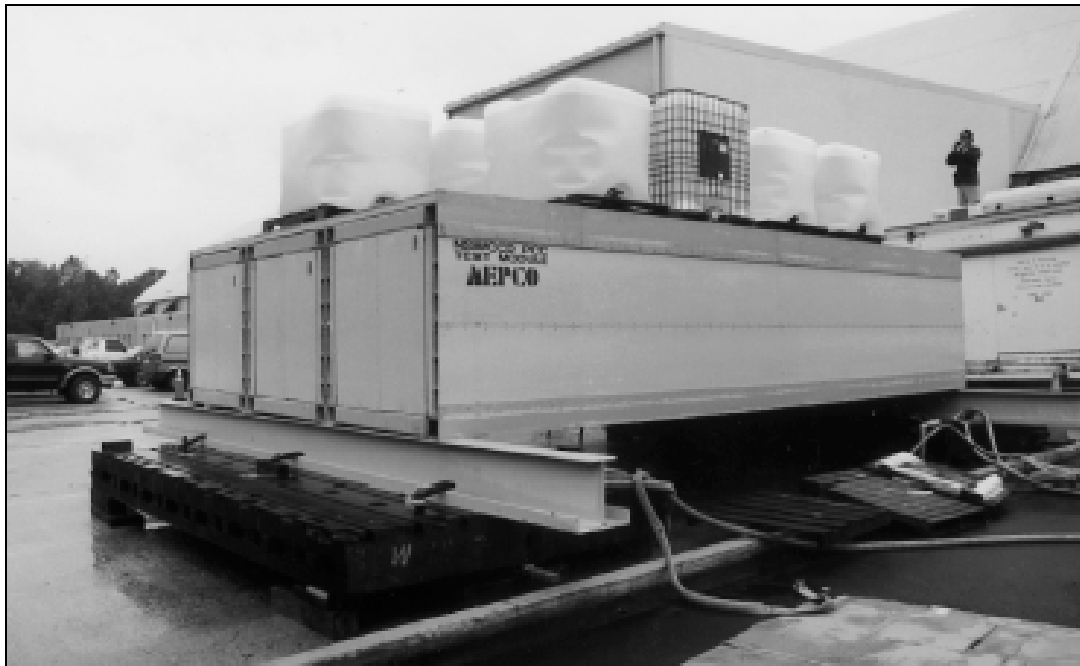
Figure 26: Completed causeway structure element under load [39]

assembled from several multi cell pultrusions as shown in Figure 27. The assembly was done by a couple of laborers and a light crane. Each square beam in Figure 27 was mechanically fastened at its corners to a girder along the top and a T-beam connection at the bottom. The completed structure in Figure 26 was loaded by 14 1-m<sup>3</sup> containers filled with water for a total of 132.7 kN for 7 days. The structure deflected 6 mm at the center and recovered half of that after unloading [37, 39].

An example of pultrusions assembled in a box girder for a marine environment causeway structure details how easy it is to assemble a pultrusion based structure. The composite structure shown below in Figure 26 was

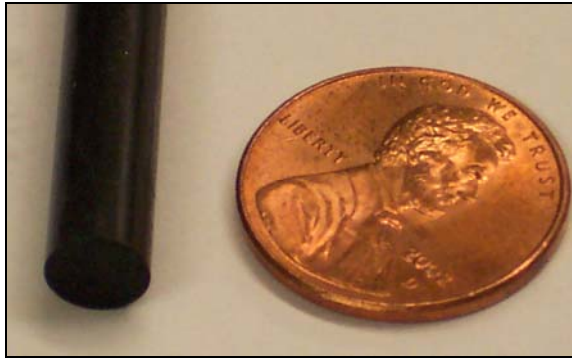
Figure 32: Scale of pultruded rods used in this study

The pultruded sections used in this study were primarily 5.91 mm diameter by 1.83 meter rods that employed Zoltek brand Panex® 35 intermediate modulus carbon fiber [54]. The matrix was Epon 826 Bisphenol-A based epoxy manufactured by Shell Chemical Corp. The curing agent used was LS-81K, made by Lindau Chemicals. This epoxy system is specially formulated for pultrusions [55]. The tip of one such rod is shown in Figure 32.

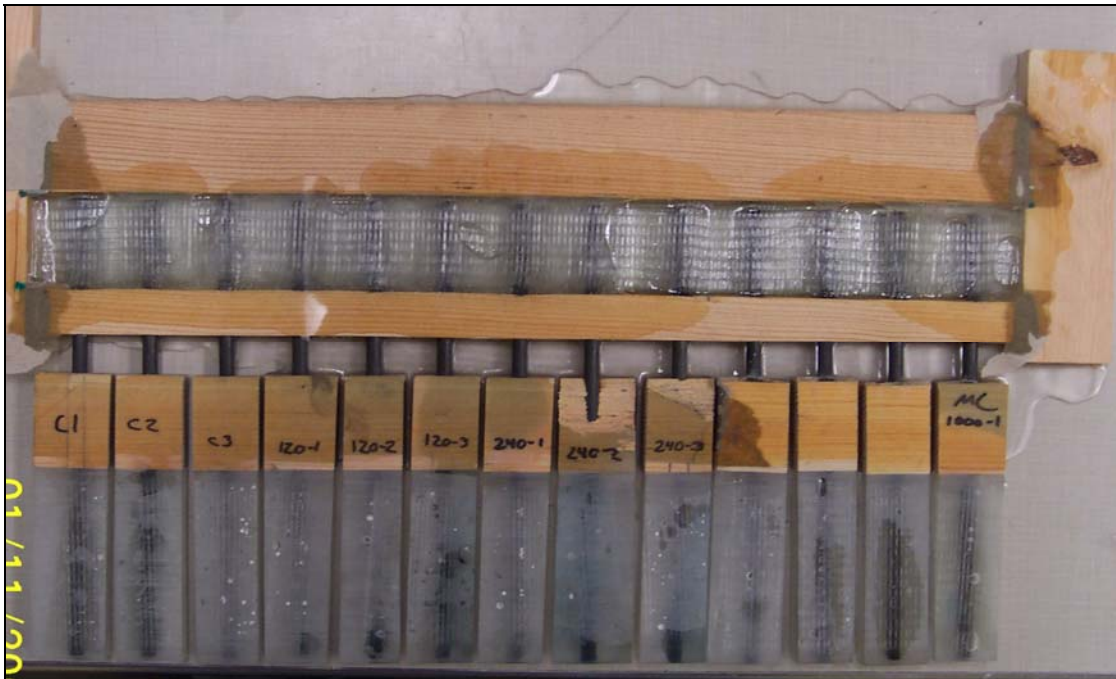
Figure 41: Top down view of the short end mold

Two rectangular molds were made to encase both ends of the rod in epoxy with the middle of the rod exposed. The length of epoxy on the longer end was 76.2 mm long with a depth of 9.525 mm and width of approximately 25.4 mm after cutting the coupons. The shorter end would be 38.1 long x 25.4 x 9.525 mm. Prior pullout tests with just one rod end in resin resulted in premature failure in the free end. Tempered glass was placed over the mold after applying the secondary resin. These molds are seen in Figures 41 and 42.

end mold was made separately to encase this end after the crushing problem could not be overcome by other means. The mold was made of 2x4 boards cut lengthwise with the thickness dimension vertical so the thickness of the wood was 9.525 mm. The overall length of the mold was as long as needed to create as many coupons as possible. The mold was held together with gray adhesive tape. This tape did not react with the resin and could be peeled away after infusion. The rod holes were drilled most of the way through with a 6.35 mm drill bit; the last 3.175 mm distance was drilled with a 5.9436 mm bit. This part of the hole fit snugly against the rod and would resist resin leaking through the hole. The wood parts of the mold were bonded to the secondary epoxy instead of the pultruded rod.

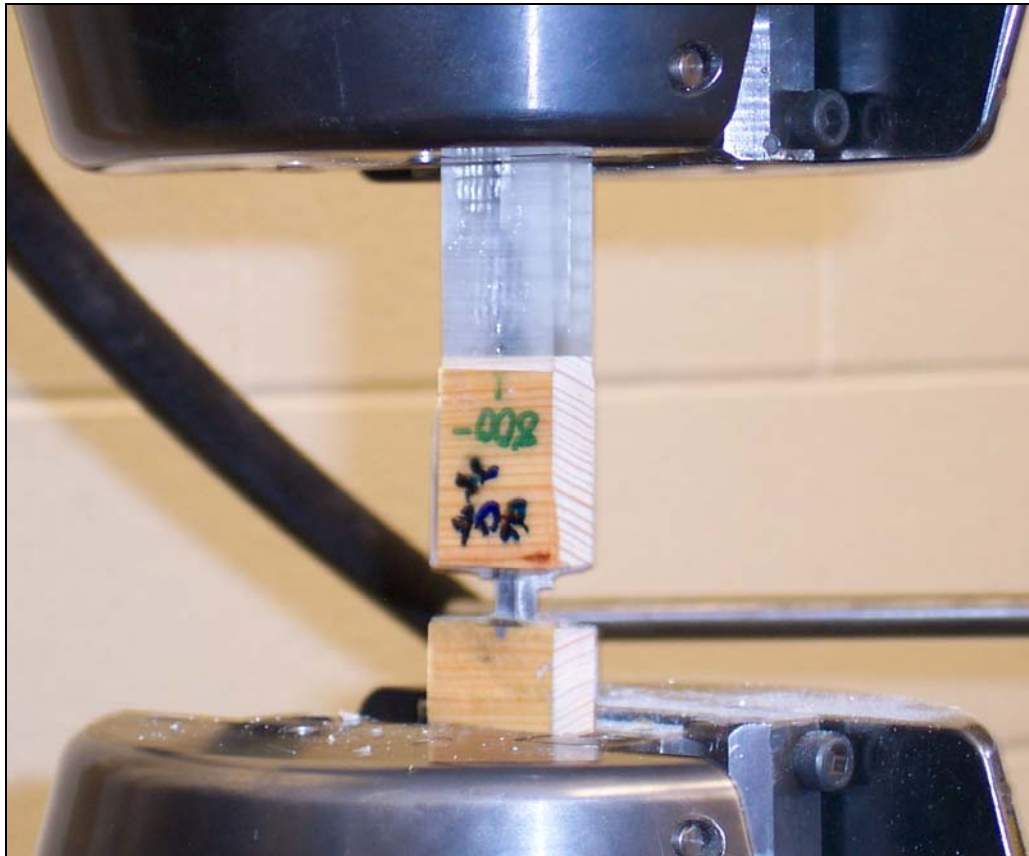
Figure 44: Pre-tested pullout coupon in grips

randomly. Figure 44 below is an example of a coupon in the grips for this test. The coupon was then pulled in tension under a displacement control of 1 mm per second. The test was concluded when the rod was visibly slipping as it was pulled out of the coupon. The gripping area did not include any of the wood mold parts attached to the coupon. The maximum load force was recorded from the Instron control panel display. A schematic of the pullout test is shown in Figure 45.

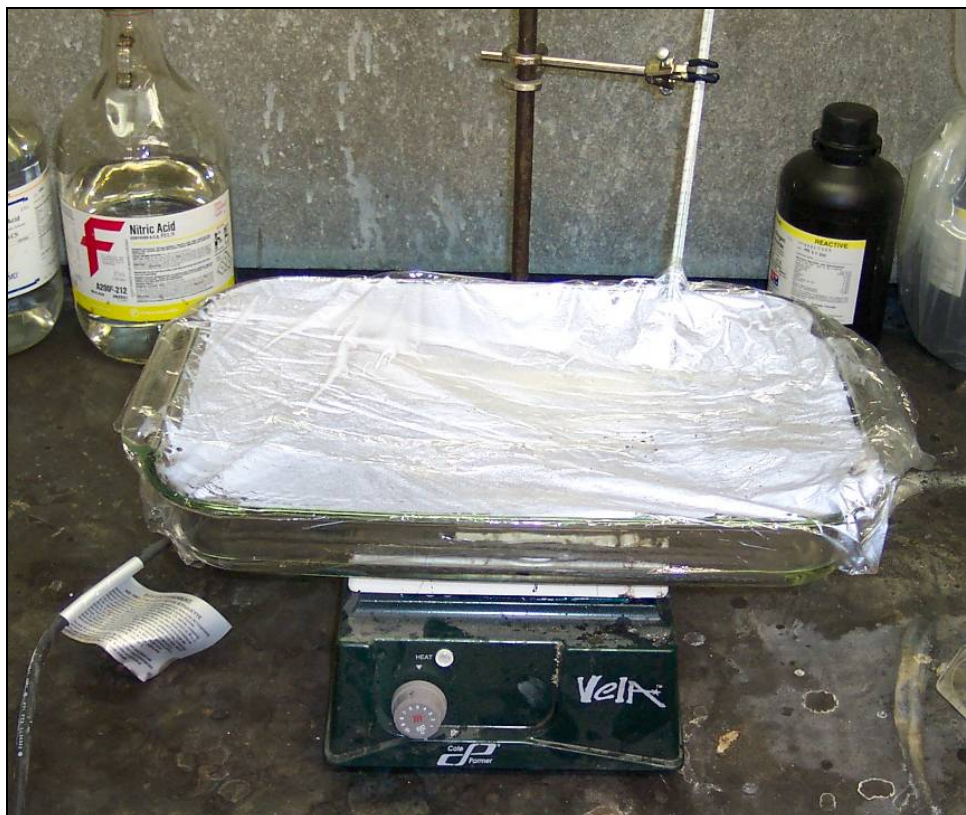
Figure 52: Heated nitric acid bath experimental setup

For chemical surface treatment, the rods were soaked in nitric acid ( $\text{HNO}_3$ ) at temperatures between 65-75 degrees Celsius for periods of 15, 30, and 60 minutes in the setup seen in Figure 52. Sixty minutes was determined as the point of maximum fiber oxidation; longer times begin to degrade the carbon fiber [70]. The shorter times were investigated with manufacturing process speeds in mind.

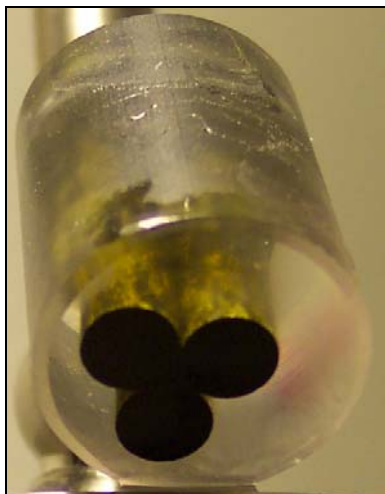
Figure 60: Washed 60 min  $\text{HNO}_3$  trial

Again, trials with short rod sections were tried to observe the effectiveness of each proposed solution. The distilled water soak took about five days to reach pH neutrality for the 15, 30, and 60 min  $\text{HNO}_3$  only treatments and five days to dry in atmospheric air conditions. When embedded in secondary resin, the porosity was almost eliminated but the yellow discolor remained and the color intensity increased as acid treatment time increased. The resin rich areas between the rods were also clear in all trials. The appearance of the 60 min  $\text{HNO}_3$  trial is seen in Figures 60 and 61. The 15 and 30 min trials were all similar in appearance to the Figures below. This distilled water approach, while probably not fit for production environments, was considered a success at neutralizing the leftover nitric acid.

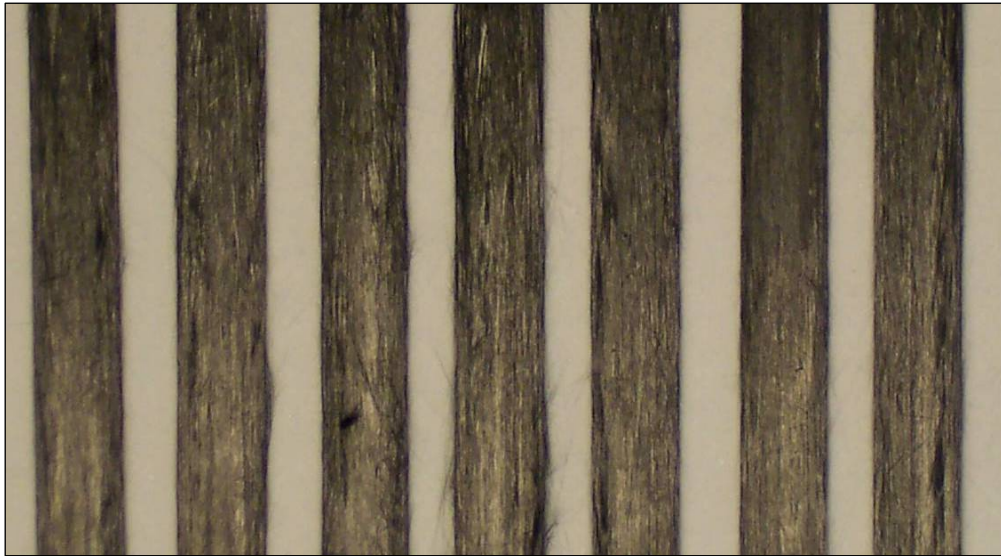
Figure 71: 60 min  $\text{HNO}_3$  / 20 sec 1M NaOH treated rod surfaces before secondary epoxy infusion

For the test coupon series of  $\text{HNO}_3$  plus  $\text{NaOH}$  exposed rods, the  $\text{NaOH}$  treatment time was limited to 15-20 seconds in each respective molar concentration. The  $\text{NaOH}$  exposure was performed in a 1000 mL graduated cylinder over a magnetic mixing plate. The magnetic stirring rod mixed the solution at a medium-high speed. This mixing was performed to allow the  $\text{NaOH}$  solution to interact with the entire surface of the rod quickly, rather than having an uneven exposure profile when the rod is dipped in. This mixing speed caused the loose fibers to leave the unidirectional orientation and entangle around the surface and freed the smaller loose fibers. This entanglement is seen in Figures 71 through 73 and was exacerbated by the handling of the rods throughout the procedure.

removed and dried in standing atmosphere for 15 days before bundling and infusion. The appearances of the treated rods after drying are shown in Figures 71 through 73.

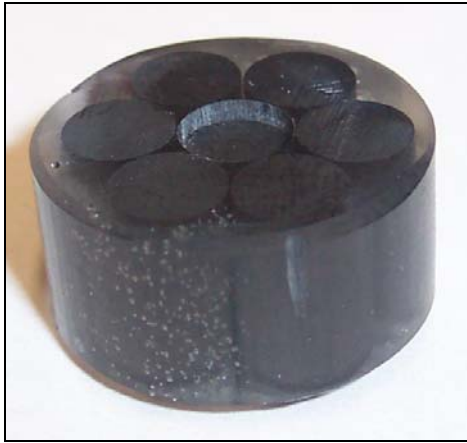
Figure 120: Typical pushout coupon interface failure appearance

This test is similar to the pullout test in that failure of the interface is initiated at the interface discontinuity where the pushrod contacts the center rod and the embedding epoxy. Once the interface debonds at this location, the interface crack grows around the pultrusion interface by some energy release rate until the crack grows suddenly to debond the final length of the interface. The average IFSS values calculated is based on the assumption described earlier; that the shear stress is constant along the interface after the debonding is initiated. A visual inspection of the failed pushout coupon is shown below in Figures 120 and 121.

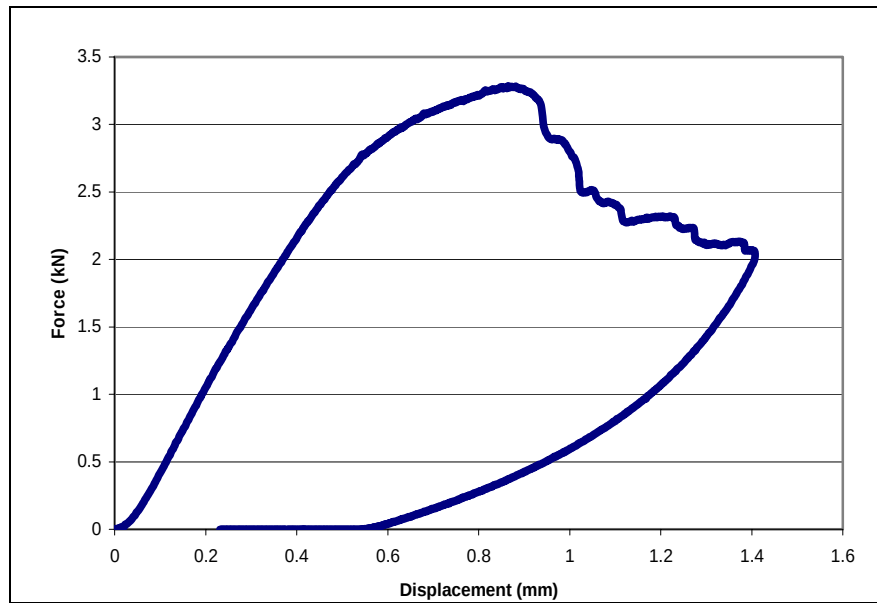
Figure 155: Typical force vs. displacement curve for a pultruded rod in short beam shear

The results are listed in Tables 9 and 10. Typical force vs. displacement curves for both coupon types are shown in Figures 155 and 156. The Panex 19 tow coupon had average short beam shear (SBS) strength about 4 MPa higher than the 20 tow counterpart at 65.91 MPa. The Toray fiber flats had an average SBS strength around 67.86 MPa. The failure mode of the flats was by delamination of the pultrusion at the mid-depth of the coupon under the loading nose as seen in Figure 157. The average SBS strength of the pultrusion was 78.94 MPa. Failure of the rods was initiated by kinking of the fibers under the

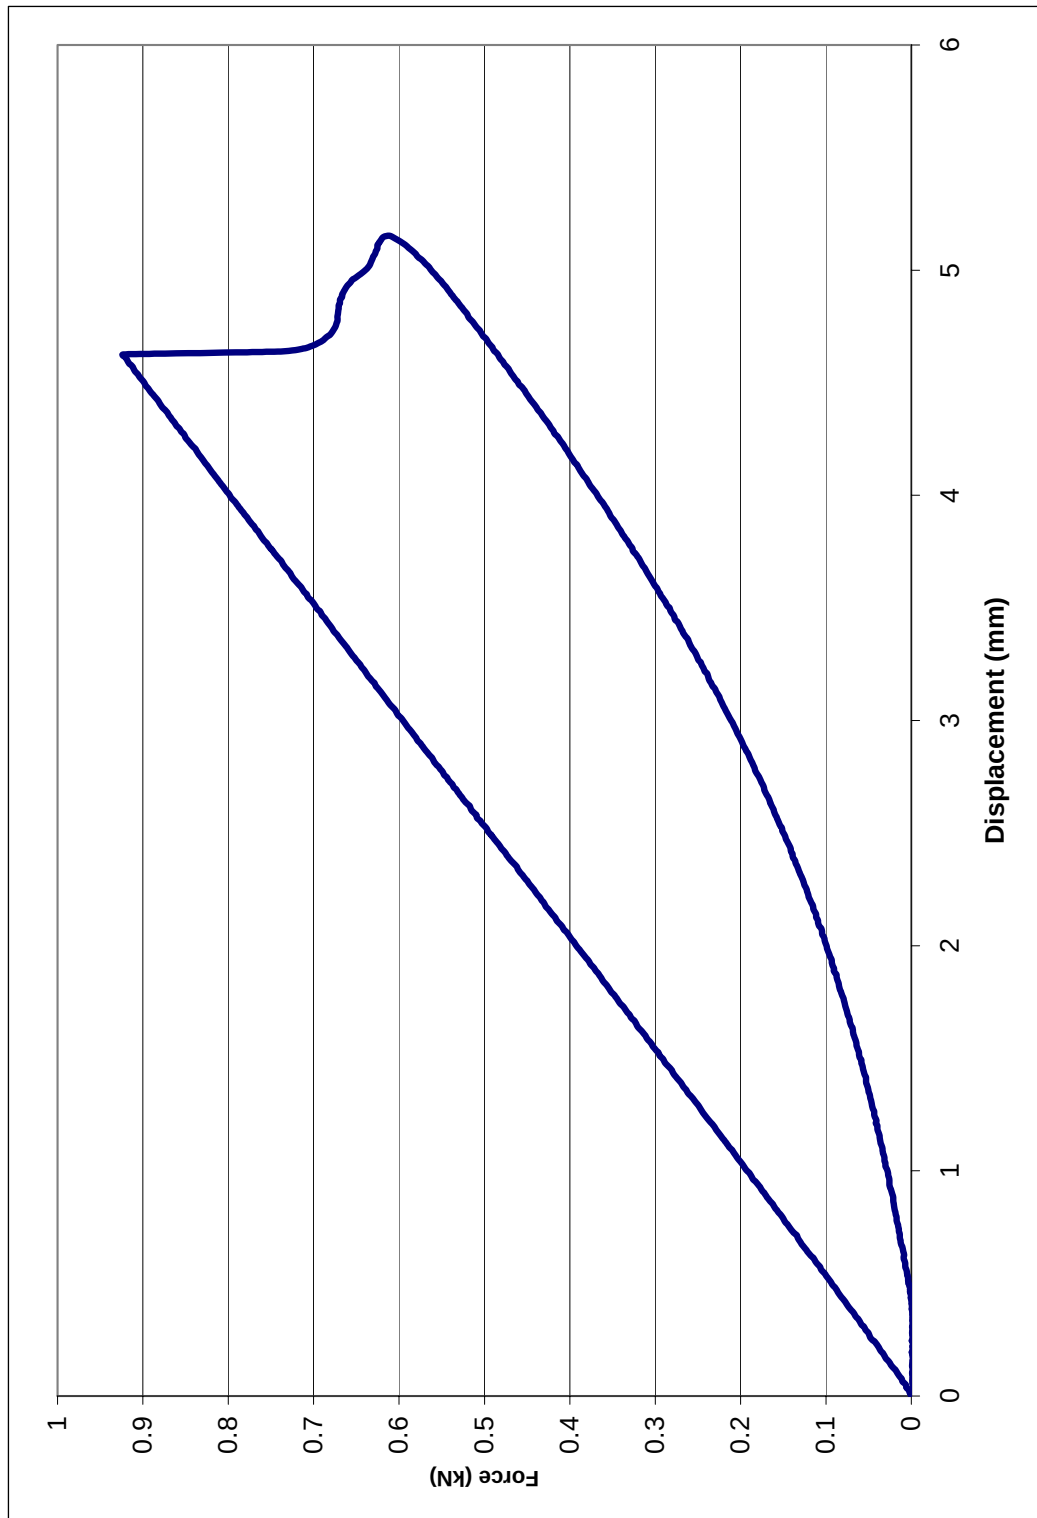
Figure D-2: Three-point bending force vs. displacement curve for coupon 7

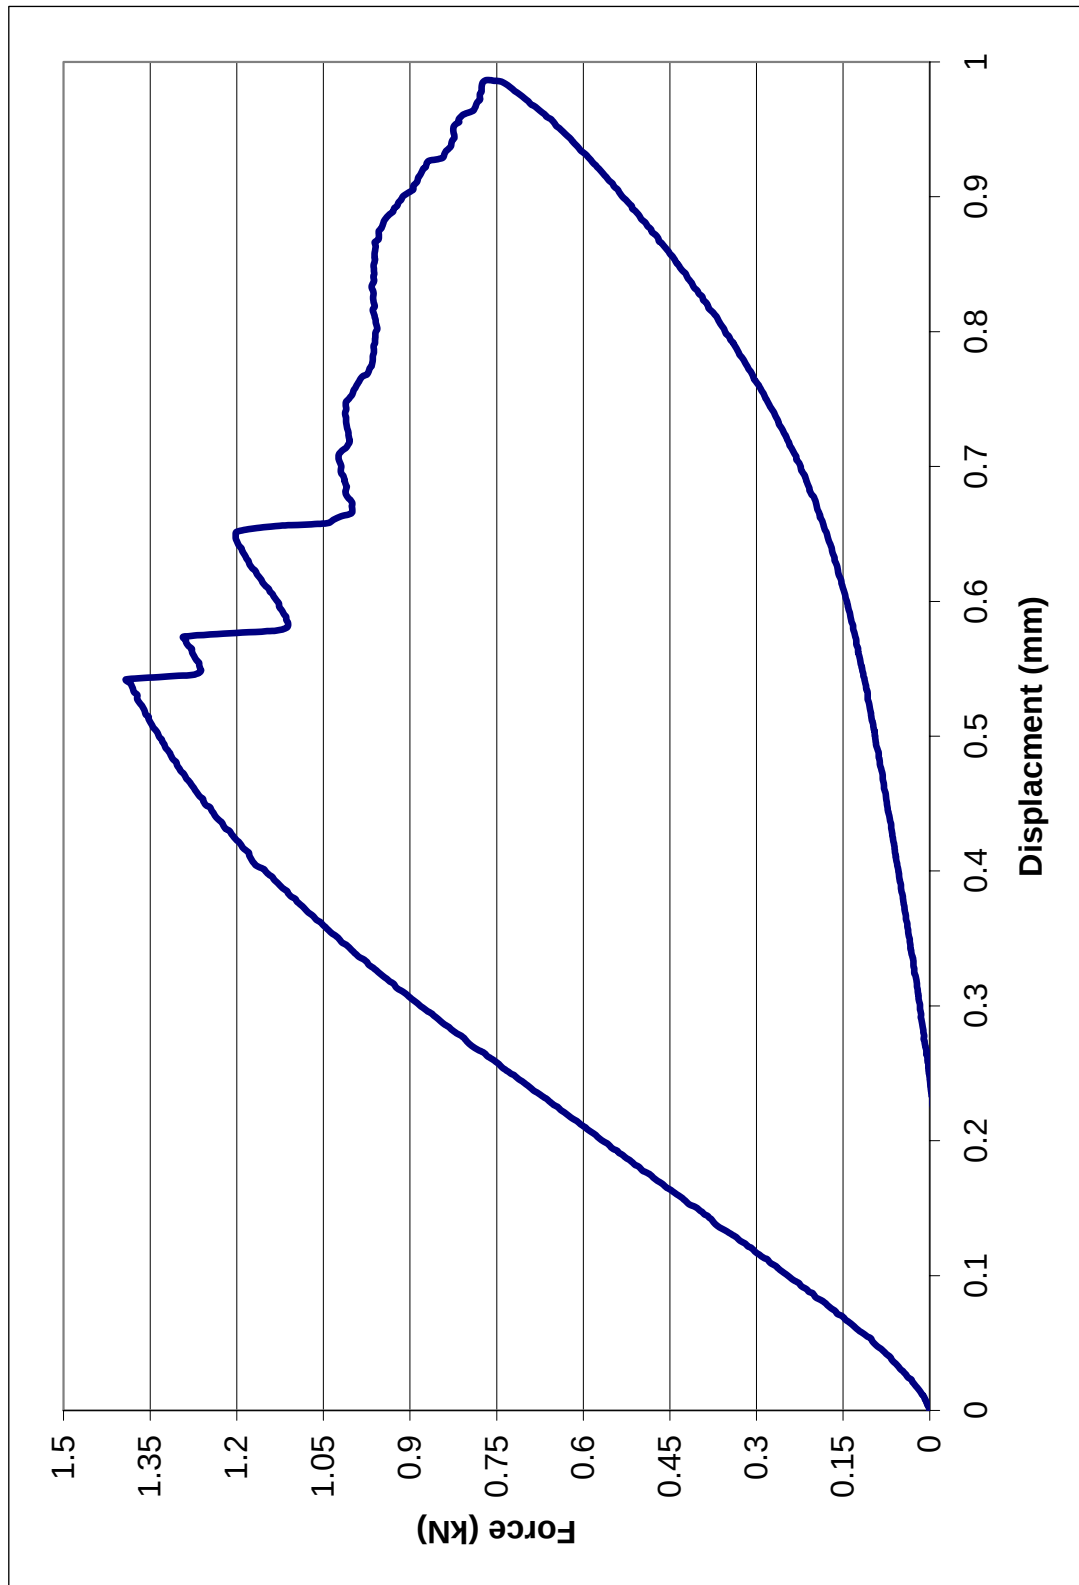
Figure E-1: SBS pultruded flat coupon Panex 19-1 force vs. displacement curve

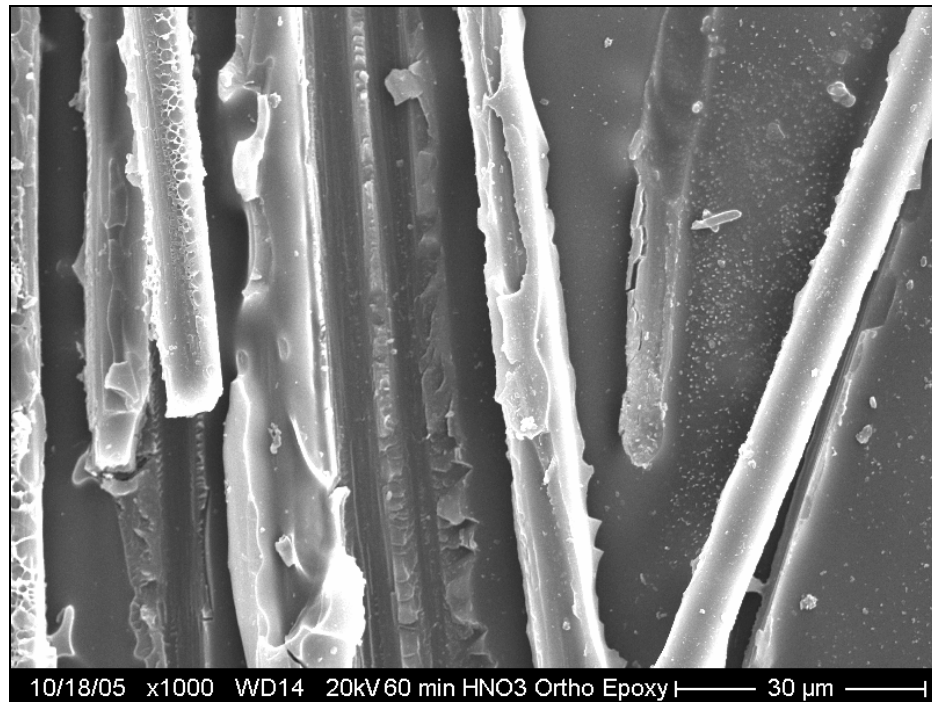
Figure H-32: Magnified view of post-tested 60 min unwashed rod surface with ortho spacing
