Environmental geology of the southeast margin of the Gallatin Valley, Gallatin County, Montana
by Earl Francis Griffith

A thesis submitted in partial fulfillment of the requirements for the degree of MASTER OF SCIENCE
in Earth Science

Montana State University

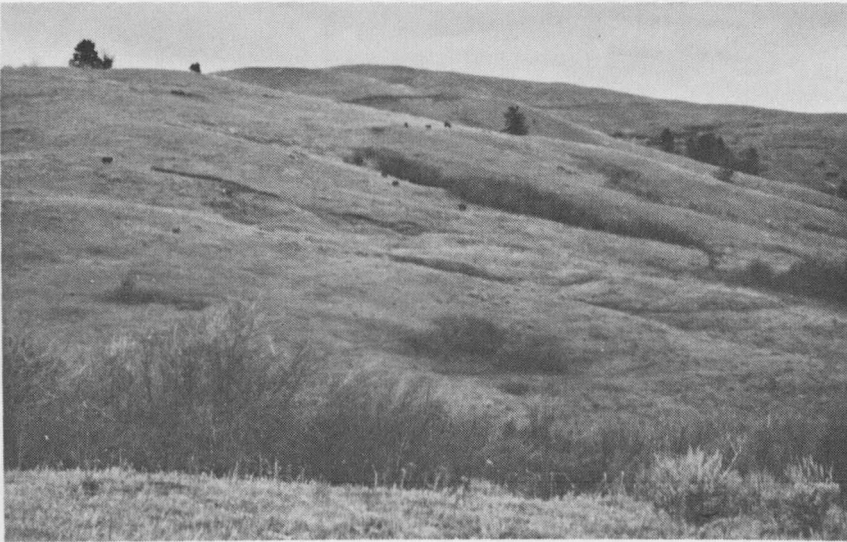
Figure 3. Small landslide on the dip slope of overturned Cretaceous bedrock in the Story Hills.

Holocene-Landslides (Hls). These geomorphic features have resulted from slope failure within the last 15 years. The small landslides are located in the eastern portion of the Story Hills and consist of unconsolidated surficial soil materials, Tertiary sedimentary rocks and the underlying fractured Cretaceous bedrock (Plates 4 and 5). A prominent headscarp, dip-slope attitude, large amount of available groundwater, hummocky topography and a lobate terminus characterize these small slides (Figures 3 and 4). Thickness is probably less than 25 feet.

A small two-acre slide approximately 300 feet east of the intersection of Big Gulch Drive and Carney Road in sec. 3, T.1 S., R.6 E. is a shallow soil failure on an overturned Cretaceous dip slope. Directly north of and adjacent to the slide, water is discharging from a small spring. This slope failure occurred in spite of the fact it has a southwest (climatically dry) aspect and an 18% slope (Figure 3).

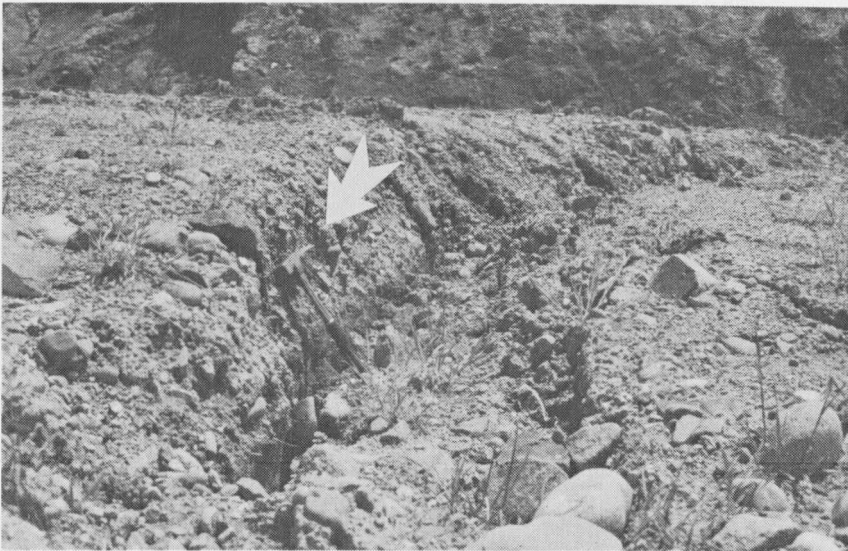
Figure 4. Headscarp displacement across existing roadway on reactivated landslide in the Story Hills. Rock hammer for scale.

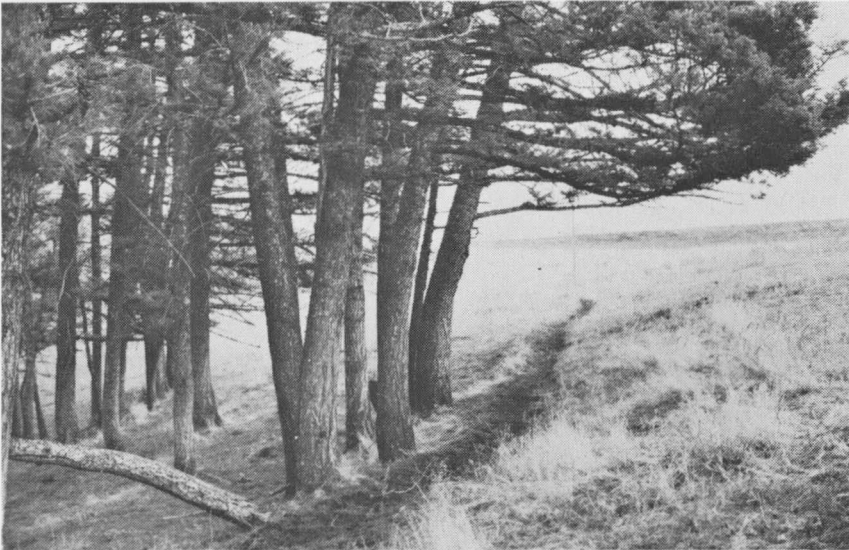
Figure 5. "Pistol butted" fir trees at the head of a coulee on a north slope in the Story Hills.

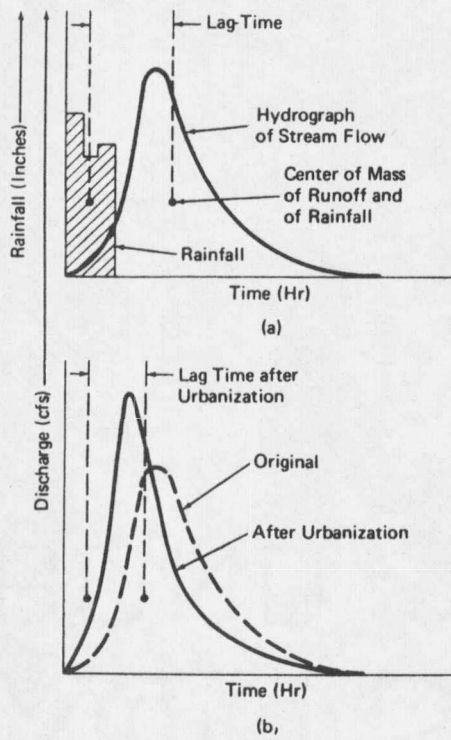
Figure 7. Generalized hydrographs. (L. B. Leopold, U.S. Geological Survey Circular 559, 1968; from Keller, 1976, p. 88).
