A thesis submitted in partial fulfillment of the requirements for the degree of Master of Science in Civil Engineering
Montana State University
© Copyright by Stephanie Ann Hallock (2003)

A baseline study was completed in the summer of 2003 on Cottonwood Creek along the portions that flow through the Bandy Ranch. This reach will likely be the host for studies of management practices and corresponding channel change in the future.

AN EXAMINATION OF CHANNEL GEOMORPHOLOGY, HYDRAULIC
CHARACTERISTICS, AND FISH HABITAT IN COTTONWOOD CREEK ON THE
MONTANA UNIVERSITY SYSTEM'S BANDY RANCH

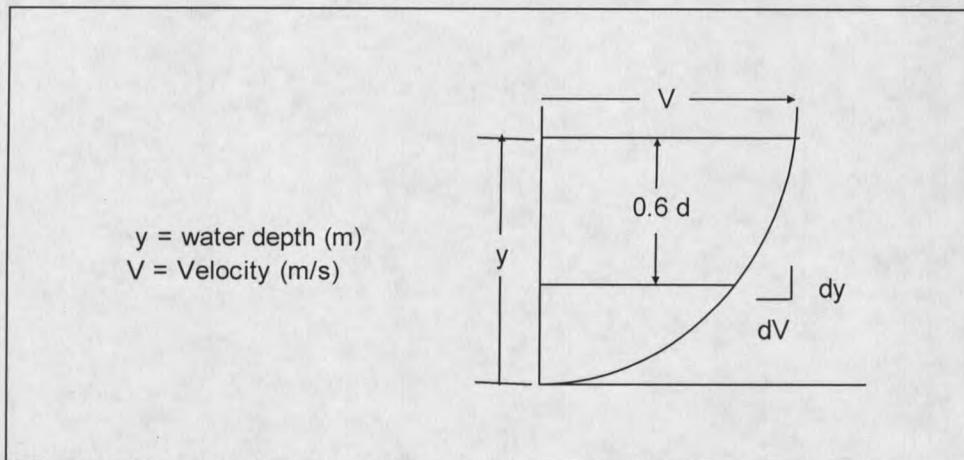
Prandtl-Von Karmen log velocity profile for turbulent flow (Julien, 1995). An example of an idealized velocity profile is shown in figure 2.1.

Figure 2.1. Idealized velocity profile for a natural channel.

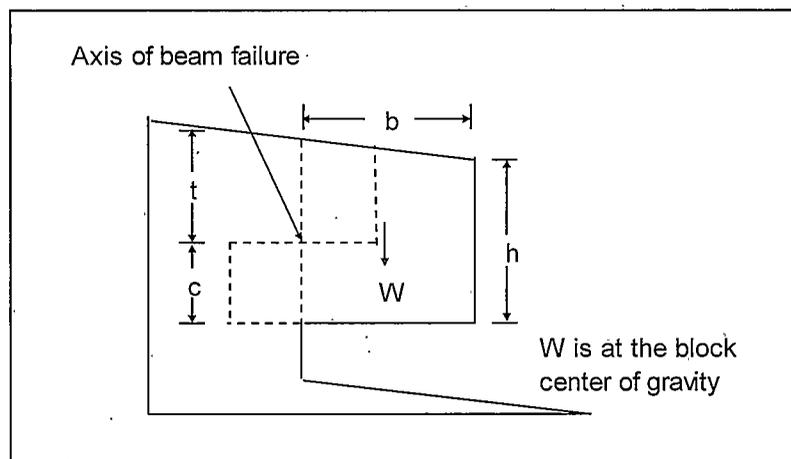
As soil depth increases, the strength of the roots decreases. Most of the reinforcement by plant roots are concentrated in the top 20 cm of the bank and a sharp boundary occurs below (Simon and Collison, 2002). Beyond the root zone failure planes are not reinforced. Knowing the distribution of strength with depth is important in predicting the effect of roots on stability. If the bank is taller than the root zone, reinforcement might not be effective since bank failure can occur underneath. This is often the case with cantilever banks. Riparian vegetation can strengthen cantilevered banks via root reinforcement. However, bank failure due to flow erosion and tensile failure occur below the root zone. These root strengthened cantilevers fail by beam or shear (ASCE, 1998). Thorne and Tovey (1981) developed an equation to predict stable widths for a cantilever bank (described in figure 2.2):

Figure 2.2. Failure of a cantilever bank.

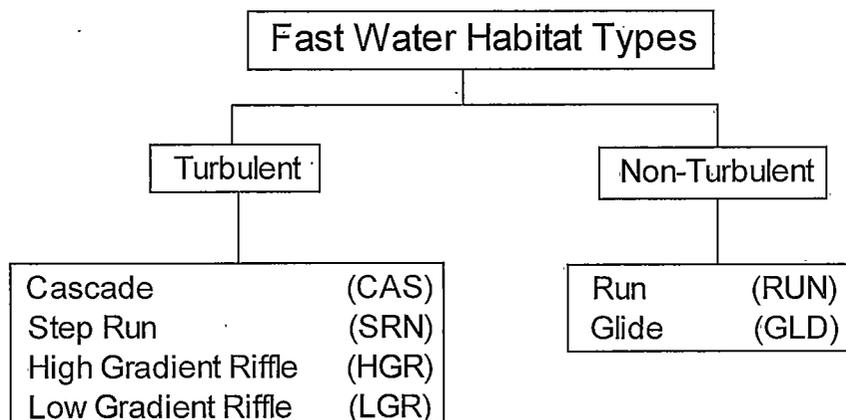
Figure 5.1. Fast water habitat types used in the stream surveys (Overton et al, 1993).

Habitats were delineated according to habitat type (see figures 5.1, 5.2). These habitat types were categorized according to average velocity, cause of formation, and location in channel. Once the habitat was identified, measurements were taken for length, mean width, and mean depth. The habitat length was measured along the thalweg. Bankfull height and width were estimated but not for all habitat units. Mean width was determined by taking multiple width measurements along the channel (approximately 2 for every 4.6 m). A tape was stretched across the channel at these points and depth measurements were taken at 20%, 40%, 60%, and 80%. Average width was found by averaging all of the width measurements taken for the habitat unit.

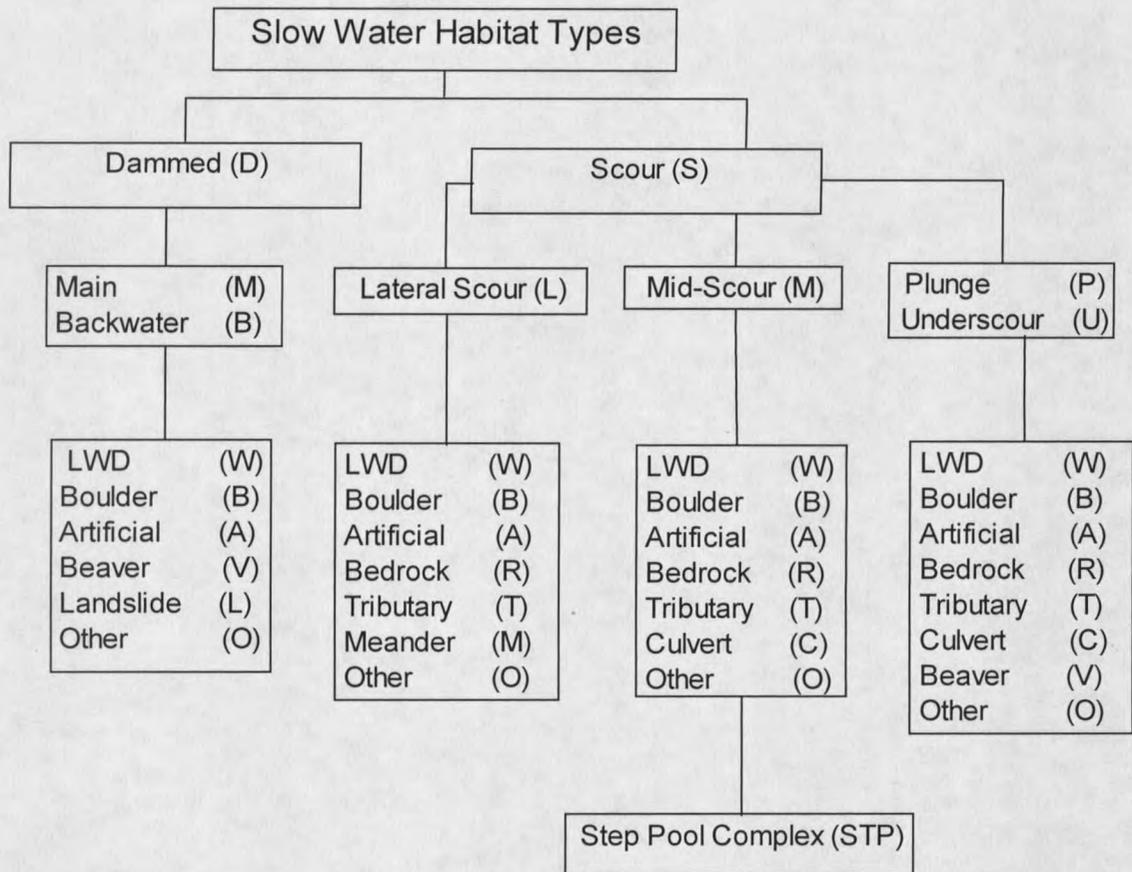
Figure 5.2. Slow water habitat types used in the stream surveys (Overton et al, 1993).

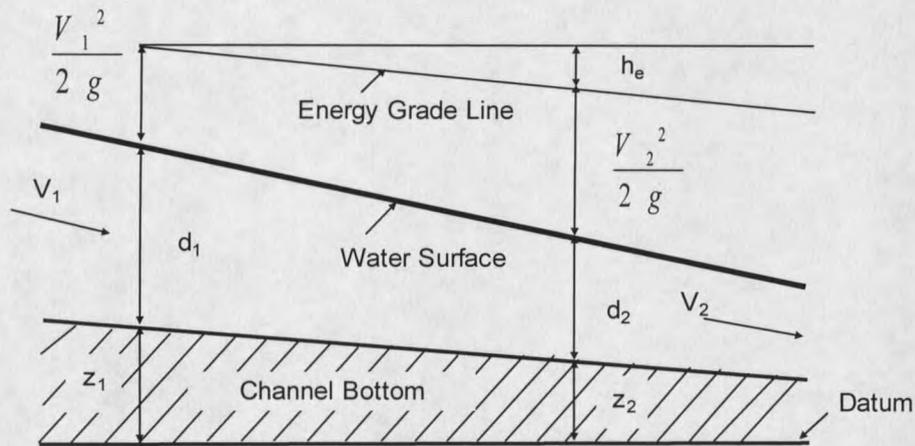
The Hydrologic Engineering Center's River Analysis System (HEC-RAS) was designed by the U.S. Army Corps of Engineers to allow the user to "perform one-dimensional hydraulic calculations for a full network of natural and constructed channels" (US Army Corps of Engineers, 1997). Water surface profiles for steady, gradually varied flow can be found using this software for subcritical, supercritical, and mixed flow regimes. The standard-step method is used to determine water surface profiles by utilizing the energy equation and the concept of gradually varied flow. Figure 5.3 shows the theory behind gradually varied flow. Head losses between two adjacent cross-sections result from friction losses or contraction/expansion losses. If flow is subcritical, the standard-step method works in the upstream direction starting from an initial known water surface elevation (Chow, 1959). If the initial water surface elevation is not known, an assumed elevation at a distant section may be used. The velocity is calculated from the desired flow rate and cross-sectional area. From this the velocity head is determined and the head losses are computed. The water surface profile is then

found by identifying the depth that makes the current total head minus the previous total head + head loss equal to zero.

Figure 5.3. Explanation of the theory behind gradually varied flow.

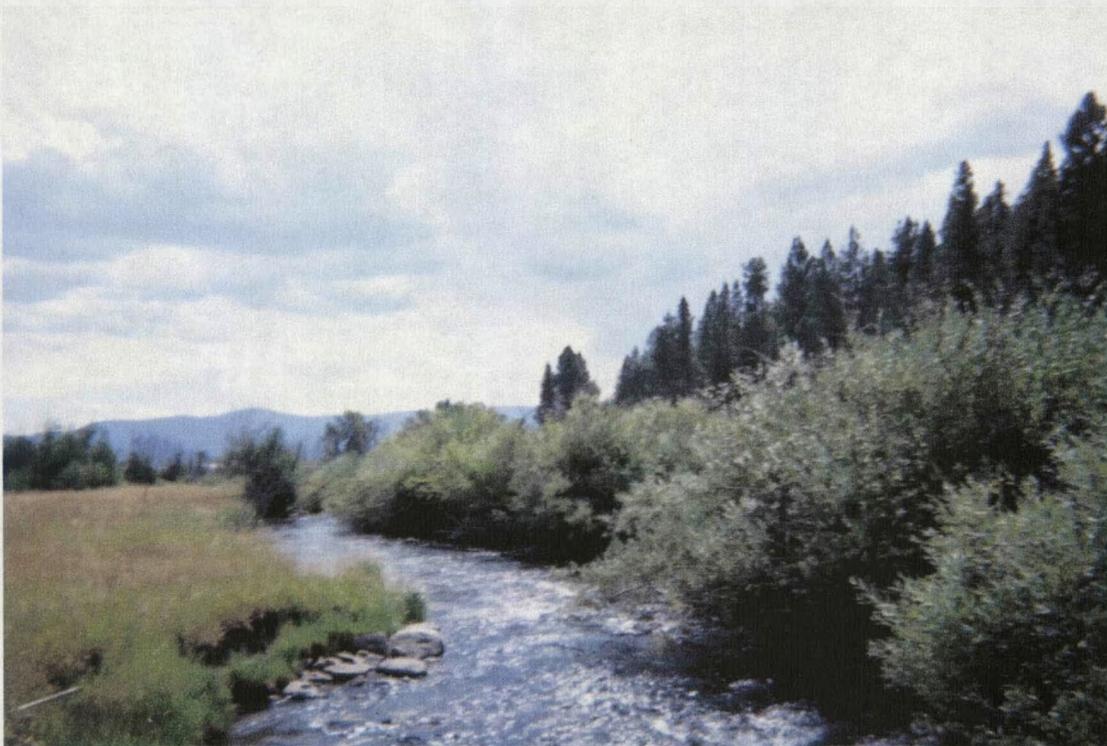
Reach A was located at 47.04.159° N and 113.15.930° W. This reach is directly upstream of the Boyd dam diversion structure. Willows dominate the left bank (facing upstream) while sedges and grasses dominate the right bank. Rock riprap has been placed along a meander in this reach to reduce erosion. This reach had the most habitat units, 9 total, of any of the surveyed reaches. Pools dominate the upper end while riffle habitat dominates the lower end (table 6.1). Eight pocket pools were counted for the entire reach. Figure 6.2 gives a general overview of reach A.

Figure 6.2. Looking downstream towards the beginning of reach A.

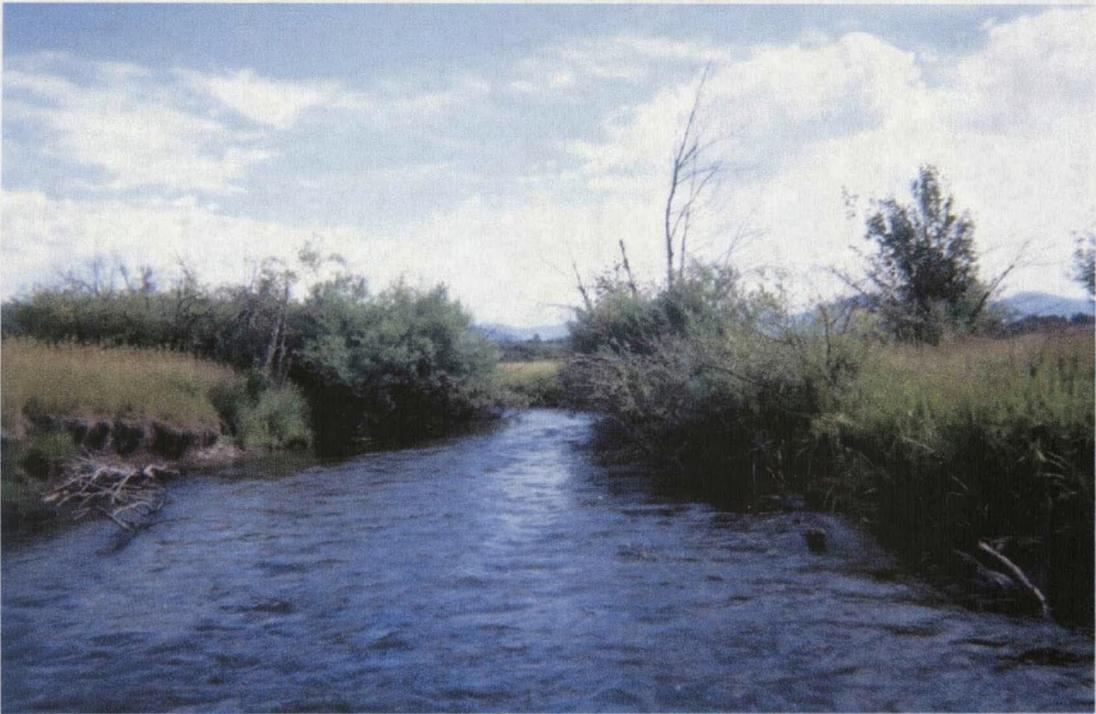
Reach B is a predominantly riffle reach located upstream of Reach A (47.04.266° N, 113.15.946° W). Figure 6.3 is a picture taken along this section of Cottonwood Creek. Along the left bank (facing upstream) at the start of reach B is a bare cut bank. There are two pool habitat units in reach B. One of the pool habitats actually consists of two small pools that are adjacent to one another. A beaver dam complex is responsible for creating these two pools along with scouring along the bank. The other pool habitat is at the upstream end of the reach. This pool is formed due to a confluence of two braided channels. The mean wetted width of this channel was 10.6 m and mean depth was 22.72 cm. This pool might not be representative of Cottonwood Creek above Reach B.

Figure 6.3. Looking upstream at the beginning of reach B.

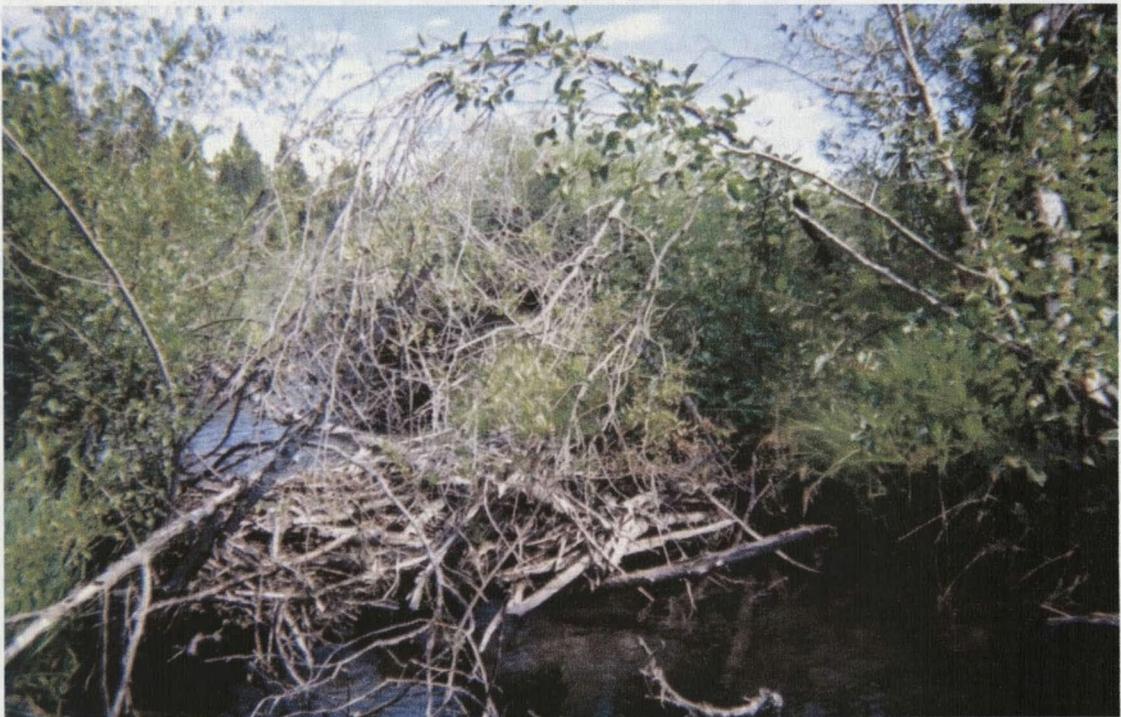
Figure 6.4. Beaver dam remains in reach B.

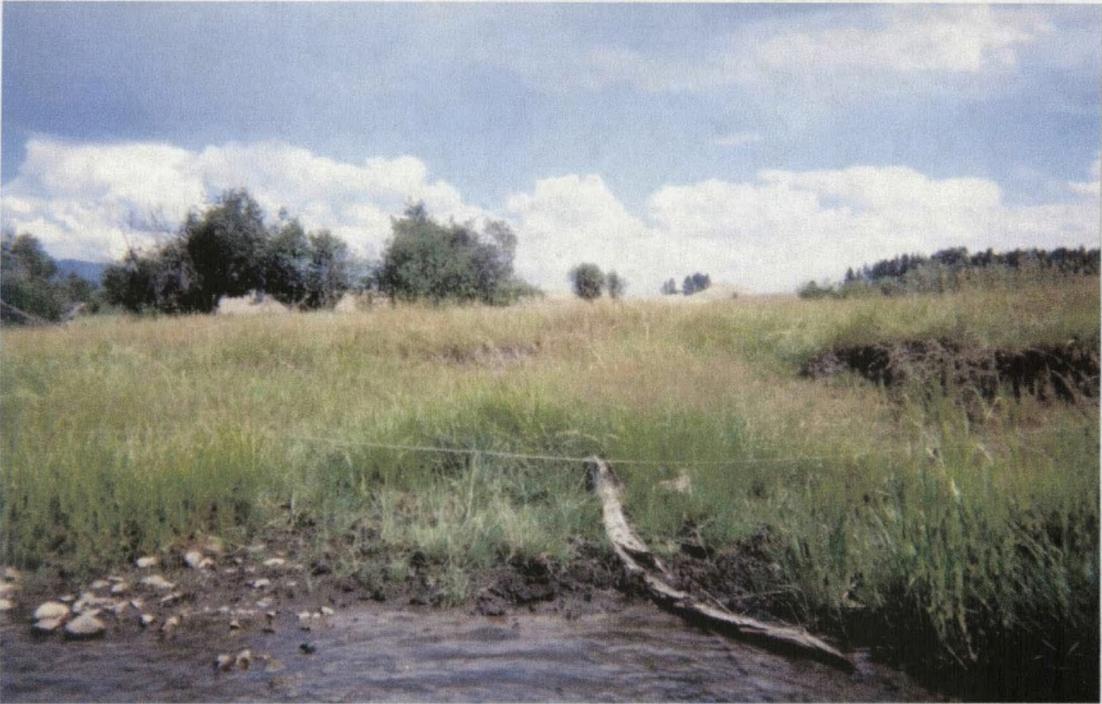
Figure 6.5. Crossing area in reach C (right bank facing upstream).

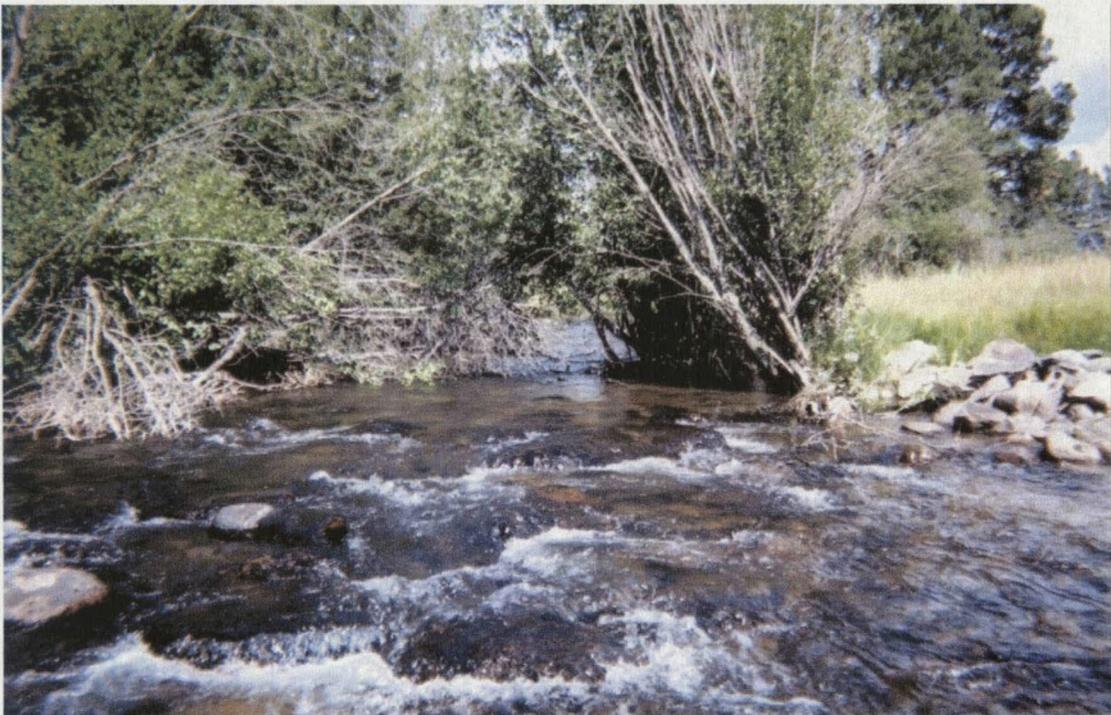
Figure 6.6. High-gradient riffle and pool in reach C. Note the rock riprap on the banks.

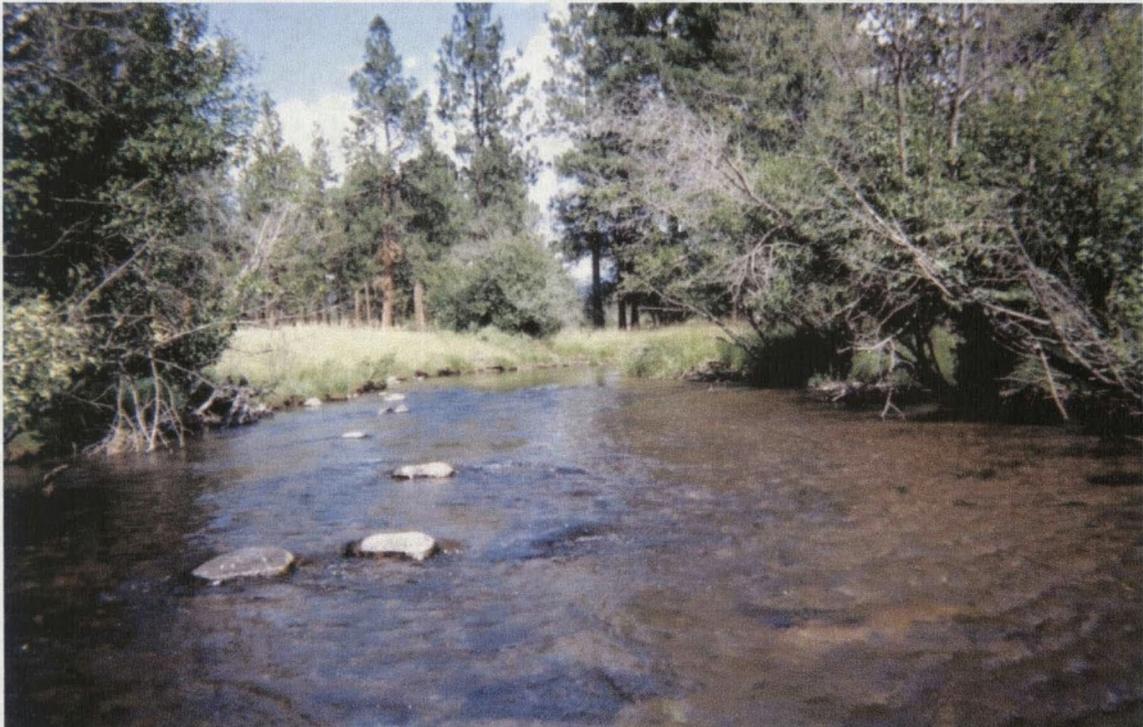
Reach D is the farthest upstream reach of the study at 47.04.525 °N, 113.15.760 °W. This reach is dominated by meander pools that average 36.26 cm deep (table 6.4). This reach also has some heavily rip-rapped banks (figure 6.8). The sinuosity in this reach is the highest of the reaches due to a sharp meander. Ponderosa pines are encroaching into the riparian zone on the right bank (see figure 6.7).

Figure 6.7. Reach C looking towards the beginning of reach D.

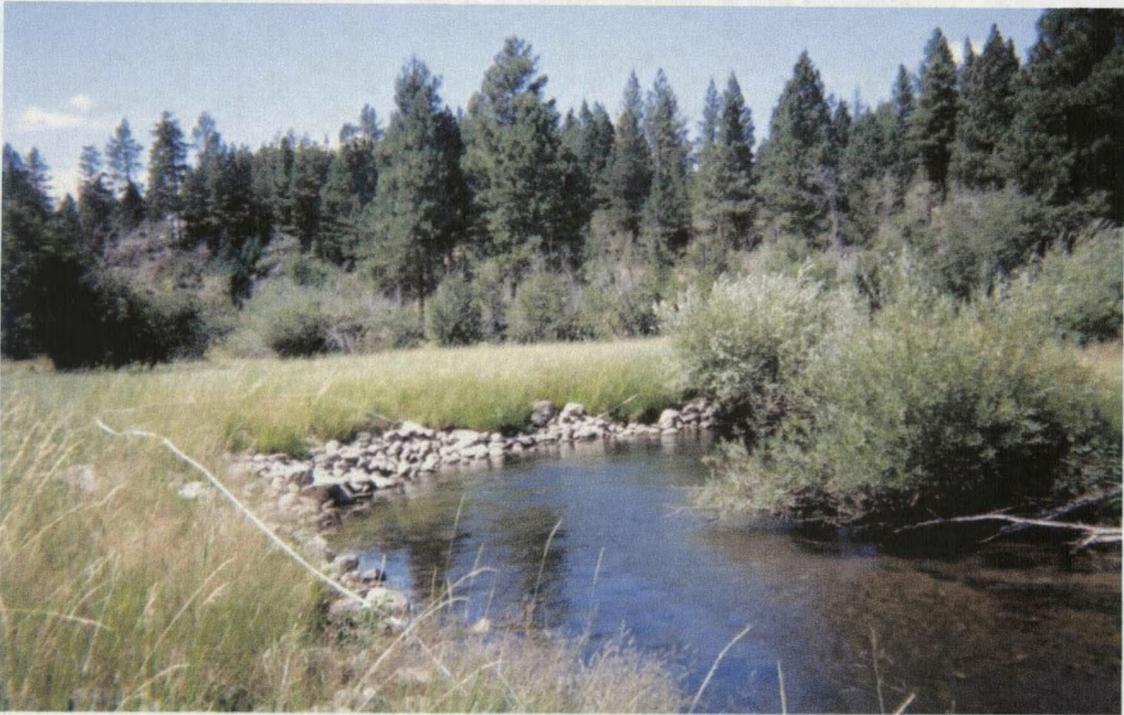
Figure 6.8. A meander pool in reach D. The left bank is heavily riprapped.

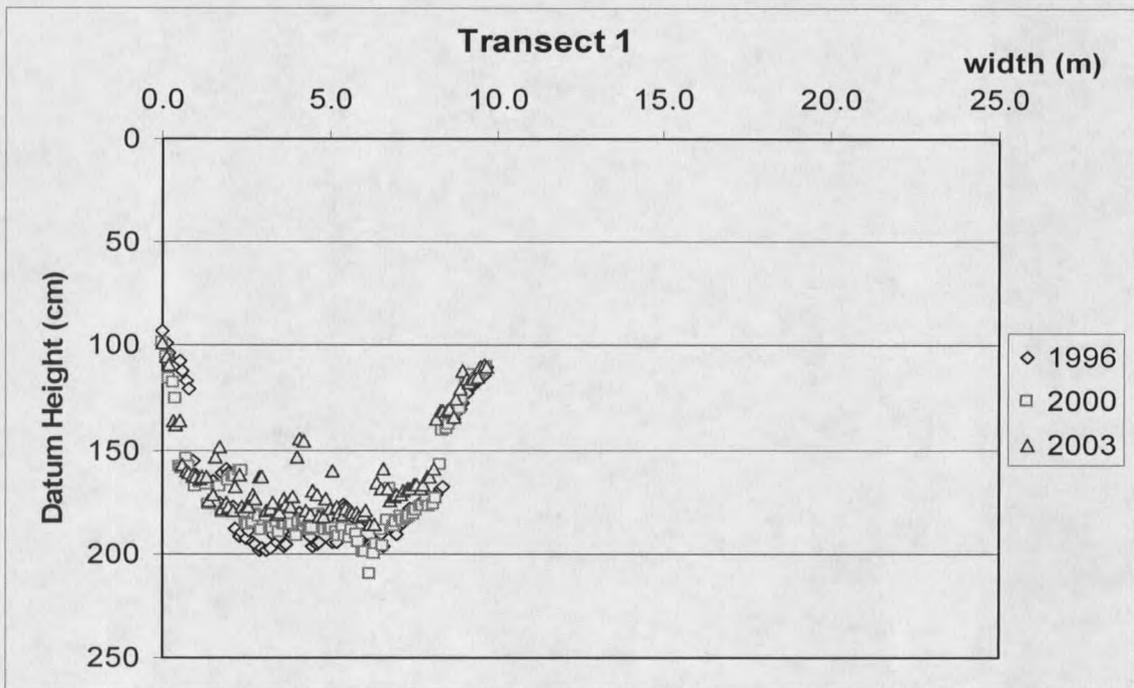
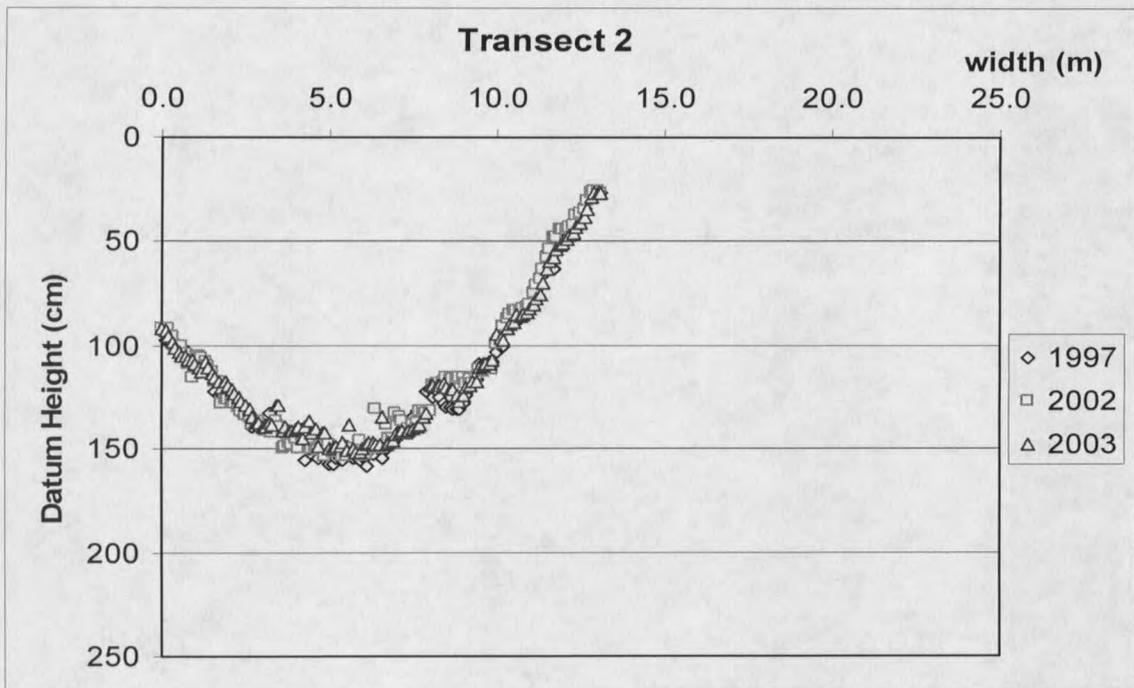
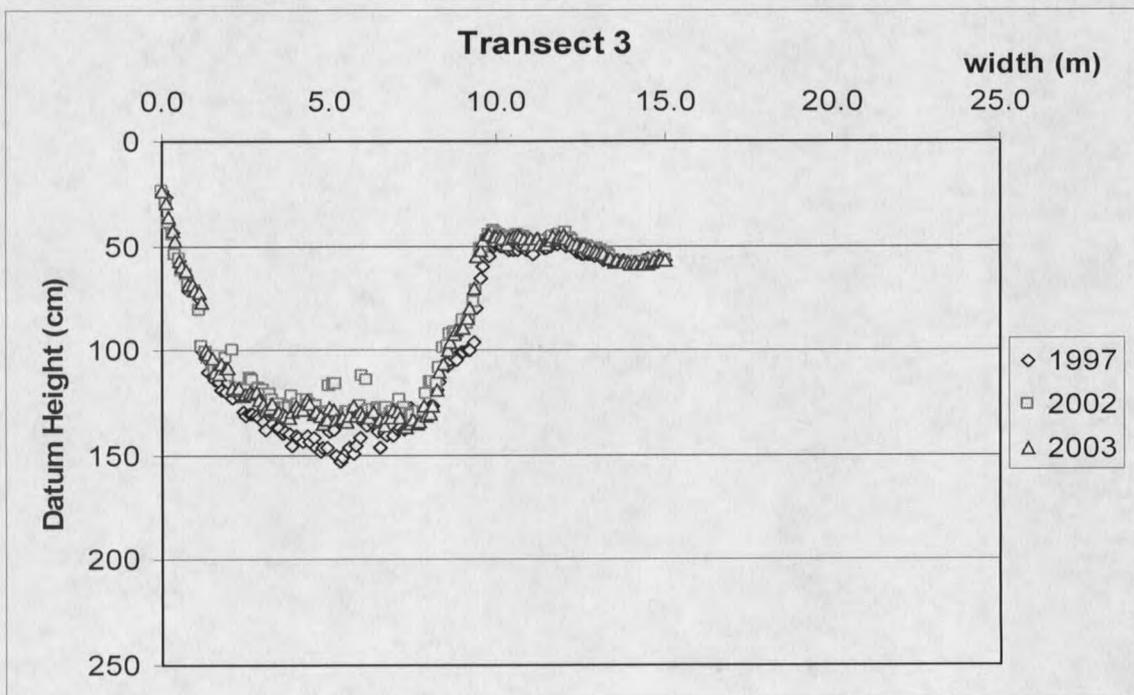
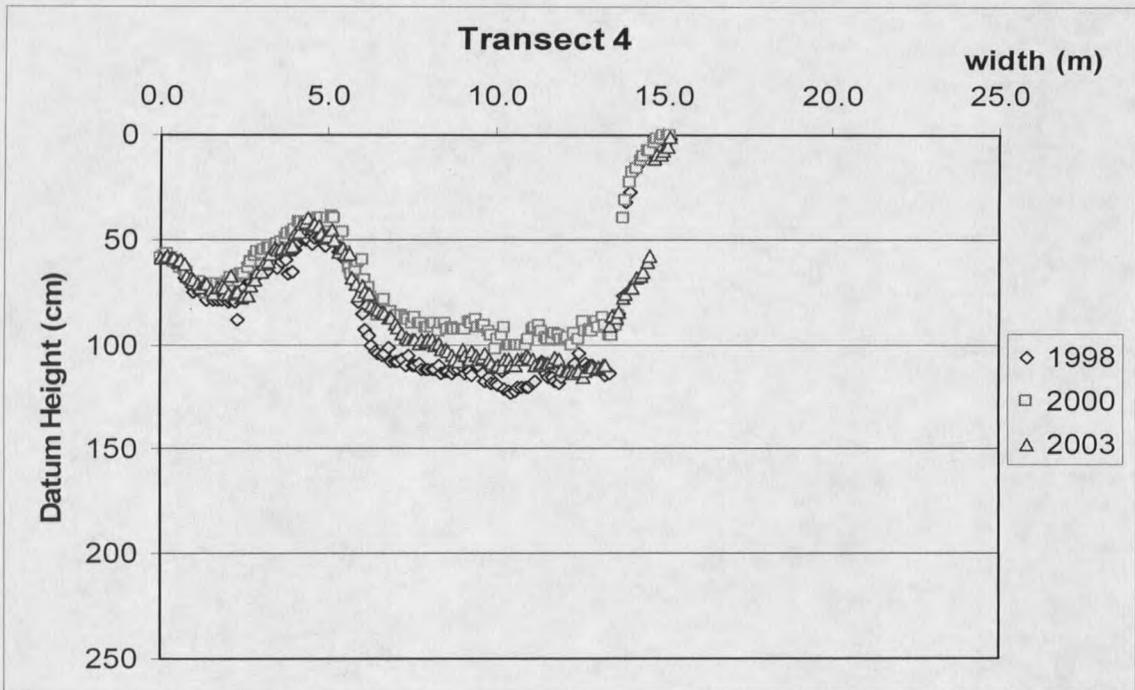
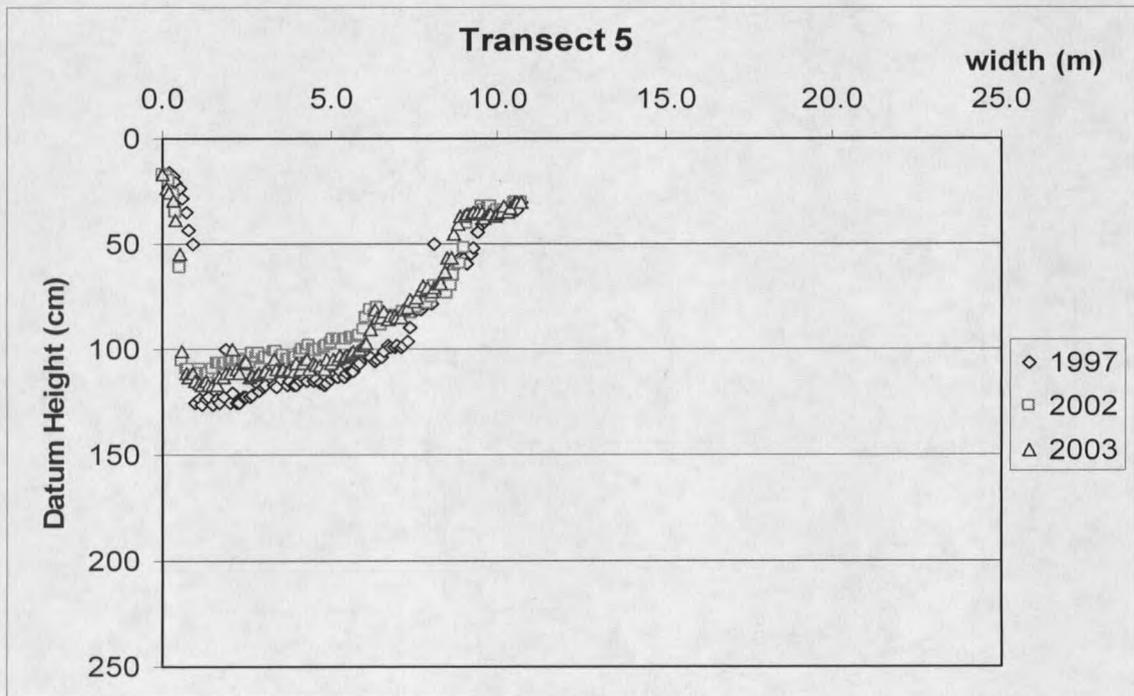
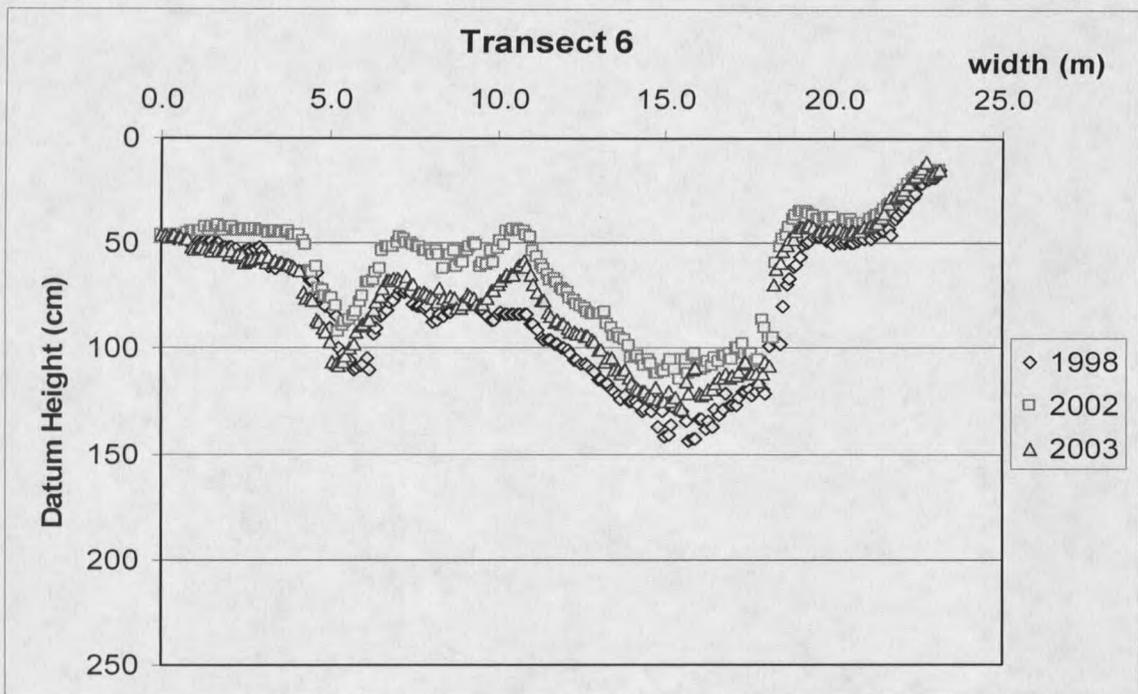
The cross-section data used for the Gini comparisons of each transect are shown in figures 6.10 through 6.15. Gini coefficients were calculated for each of the six transects. Two different year ranges were examined (3 years compared). The first year range was before the ditch was closed at the confluence of Cottonwood and Shanley

Figure 6.10. Cross-Section profiles for three different years for monumented transect #1.

Figure 6.11. Cross-Section profiles for three different years for monumented transect #2.

Figure 6.12. Cross-Section profiles for three different years for monumented transect #3.

Figure 6.13. Cross-Section profiles for three different years for monumented transect #4.

Figure 6.14. Cross-Section profiles for three different years for monumented transect #5.

Figure 6.15. Cross-Section profiles for three different years for monumented transect #6.

The Gini coefficient is independent of cross-sectional area and datum height (Olson-Rutz and Marlow, 1992). Table 6.19 shows the Gini coefficients found for each of the monumented transects. Transect 1 showed negative changes in Gini for both year ranges. The average Gini coefficient for the year 2003 for the Creek was 0.180. If transect 1 and 2 are ignored, the average gini value is 0.211. Reach 1 had Gini values ranging from 0.075 to 0.093. For the other transects, Gini values ranged from 0.16-0.228.

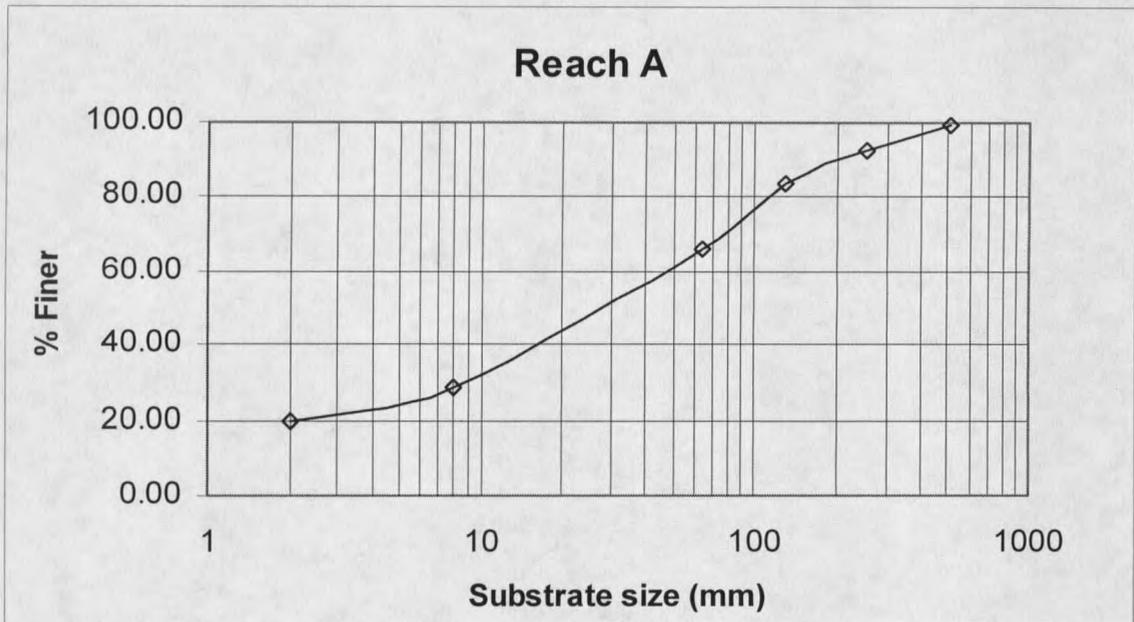
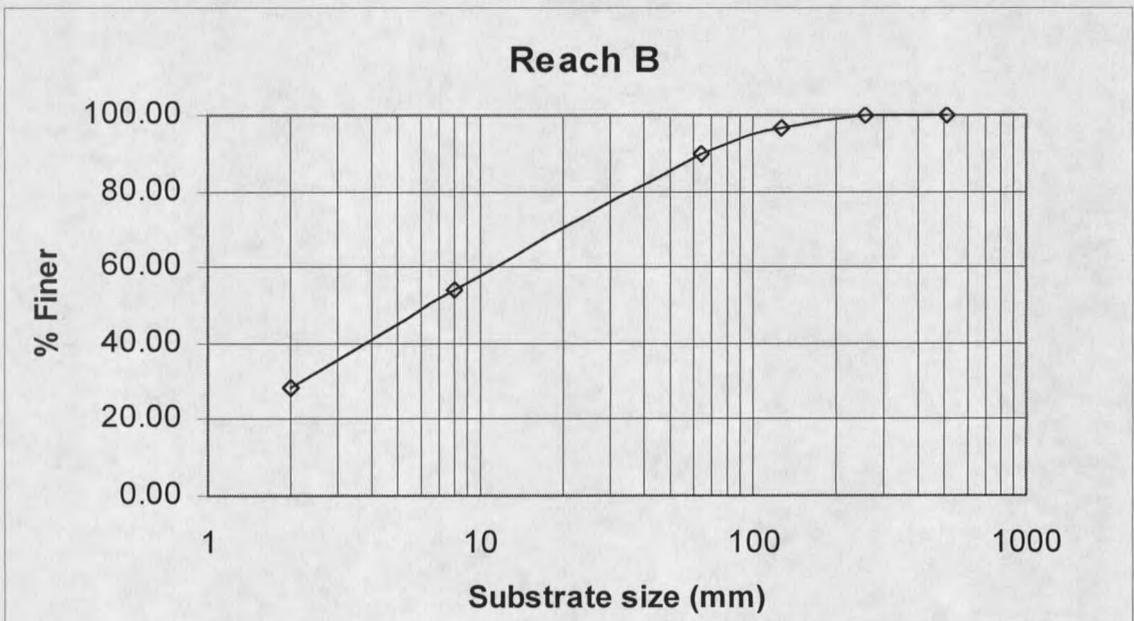
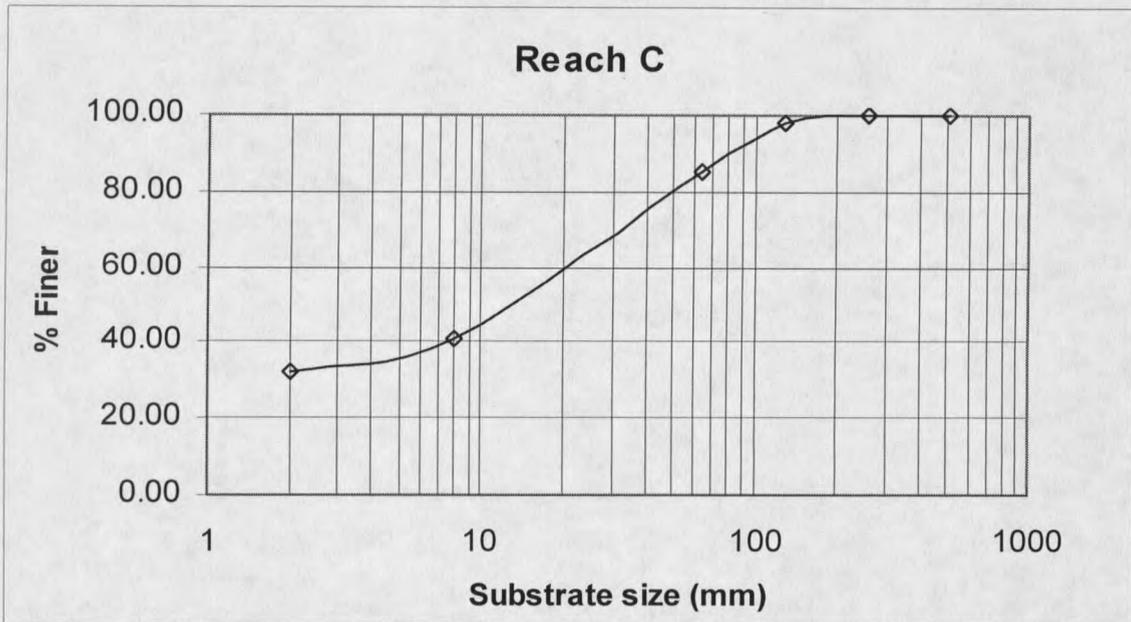
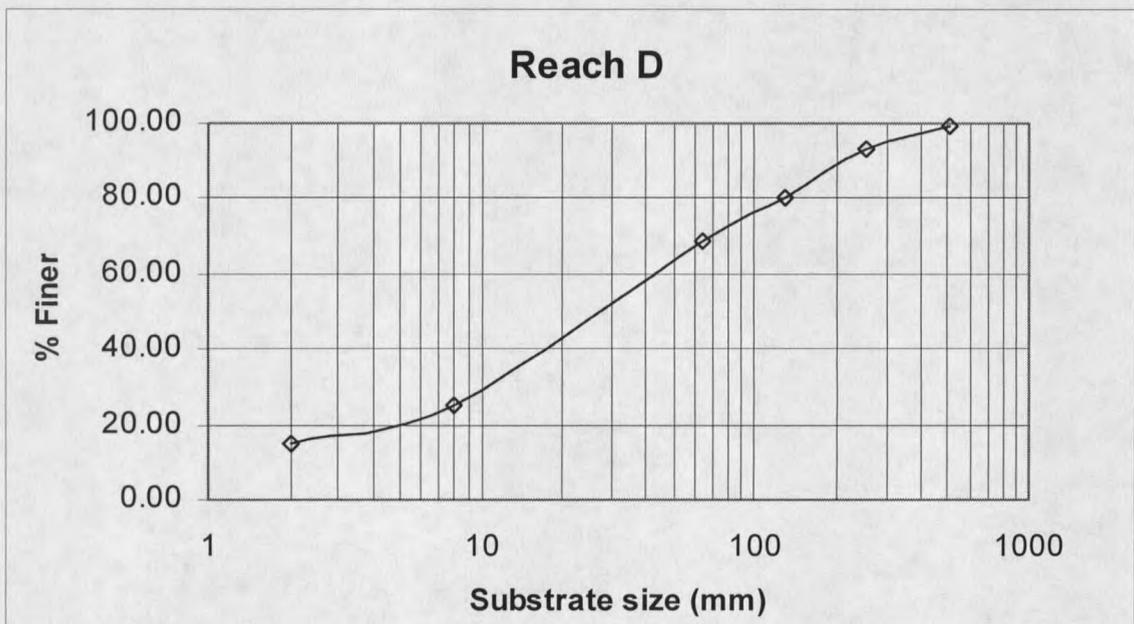
Figures 6.17 to 6.20 show the particle size distributions obtained from the Wolman Pebble Counts for the each monumented transect located within Reach A through Reach D (figure 6.16 shows the location of the reaches).

Figure 6.17. Particle size distribution for reach A.

Figure 6.18. Particle size distribution for reach B.

Figure 6.19. Particle size distribution for reach C.

Figure 6.20. Particle size distribution for reach D.

A summary of the d50 sediment size as well as the percentage of fines obtained from the Wolman pebble count is shown in Table 6.22. The results of the percent fines grid test (table 6.23) are similar to the percent fines found using the pebble count for reach A and D. The differences between the percent fines for the two tests in regards to the B and C reaches may be due to the fact there was more riffle habitat to sample from, in regards to the fines grid test, then for the other two reaches. The pebble count was located just downstream of the permanent cross-sections while the fines test was completed randomly in riffle habitats that were around 1 foot deep.

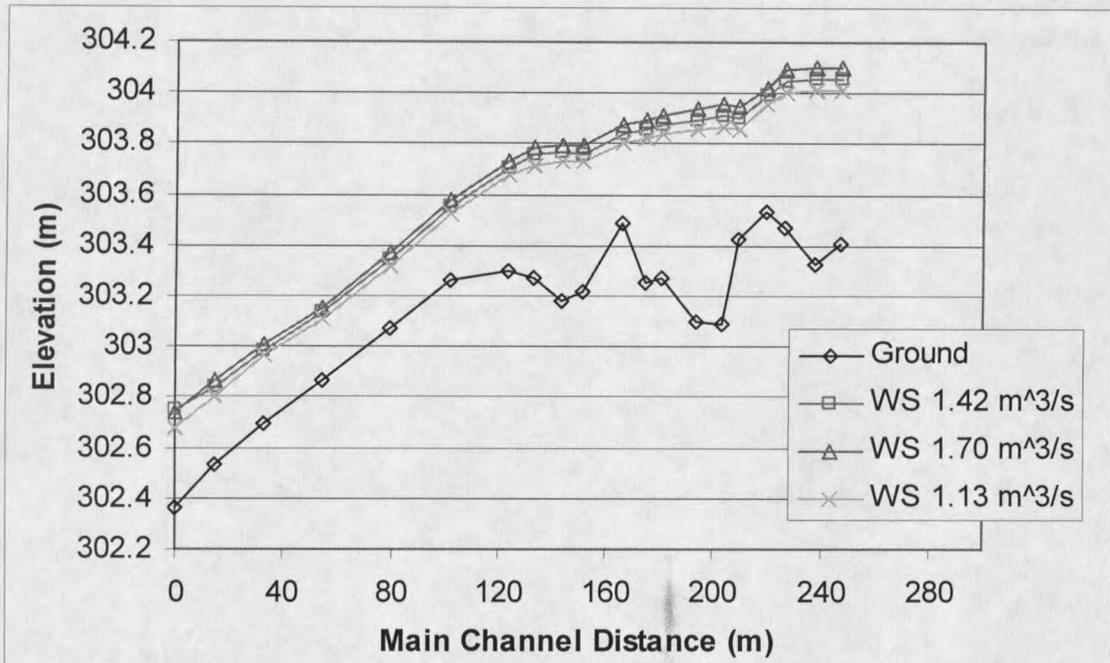
Twenty cross-sections were surveyed in reach C and D to get hydraulic data. Water surface levels were also recorded at each. The data was placed in HEC-RAS to gather steady flow hydraulic profile data. The flow rate at the day of surveying was calculated to be $1.41 \text{ m}^3/\text{s}$ (50 cfs). Figure 6.22 shows water surface profiles for $1.41 \text{ m}^3/\text{s}$ as well as for $1.13 \text{ m}^3/\text{sec}$ (40 cfs) and $1.7 \text{ m}^3/\text{s}$ (60 cfs). To develop the profiles for 1.13 and $1.7 \text{ m}^3/\text{s}$, the lower boundary condition was chosen to be the normal depth. While figure 6.22 shows the longitudinal profile of the reach, figure 6.23 shows a three-dimension representation at $1.42 \text{ m}^3/\text{s}$. From this, it can be seen how the upper portion of the study area has severe meandering, and thus deeper water depth, while the lower end has lower sinuosity and a wider, shallower flow area.

Figure 6.22. Water Surface Profiles at 1.13, 1.42, and 1.70 m³/s.

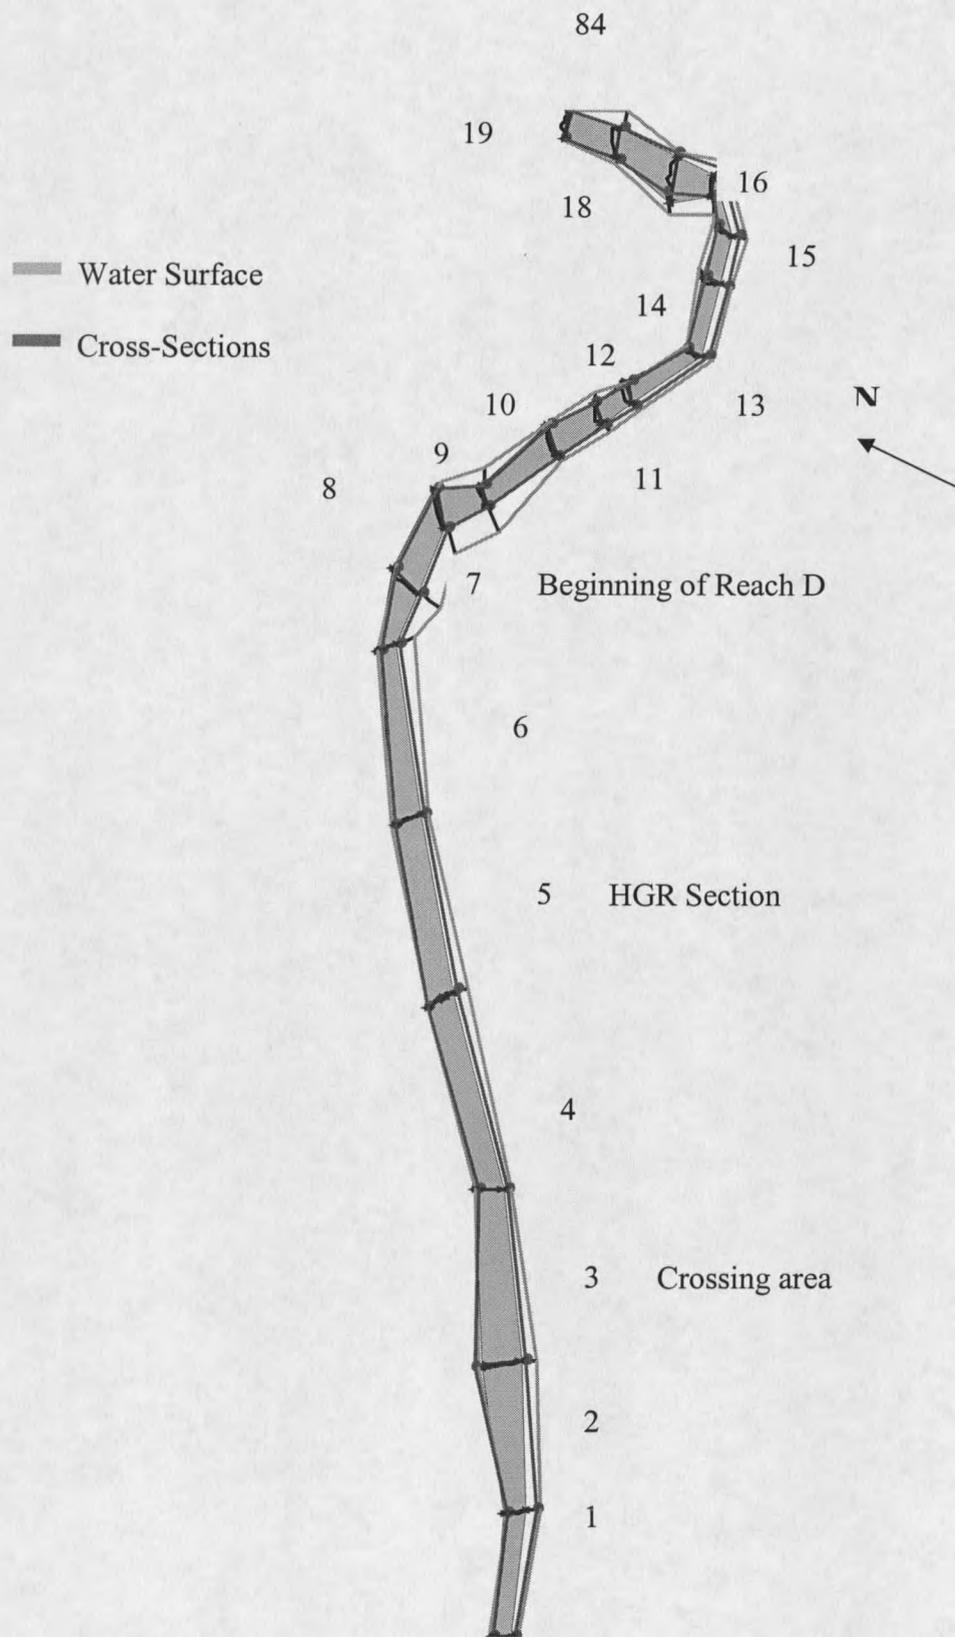
Figure 6.23. Three-dimensional profile of Cottonwood Creek at 50 cfs.

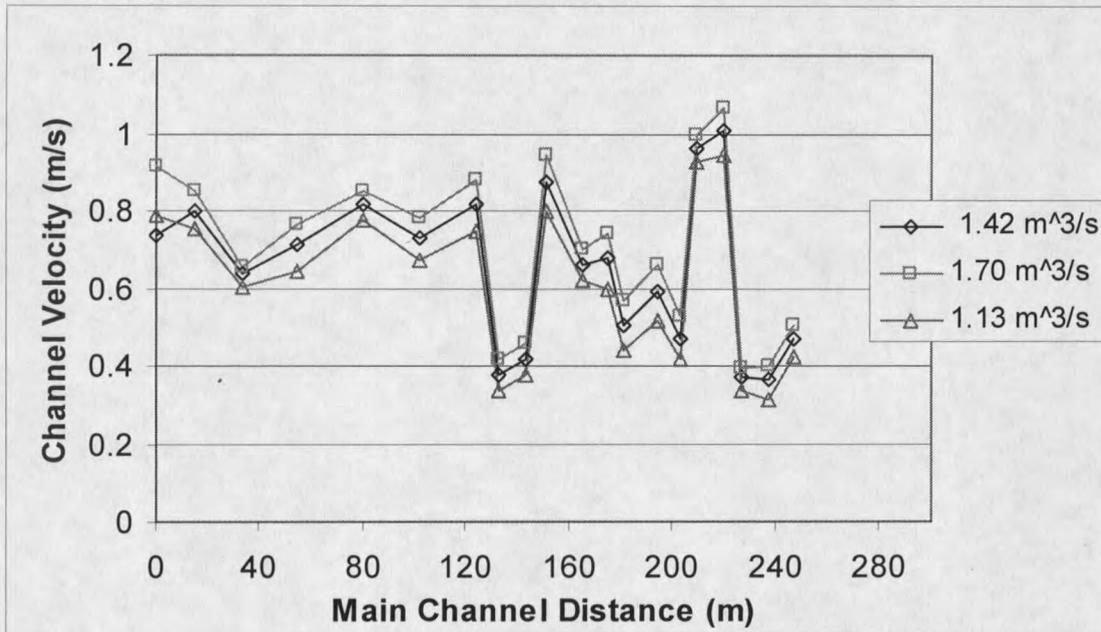
The velocity profile along the main channel is displayed in figure 6.24. As with the depth measurements, the velocities at the ends of the area are impacted by boundary conditions. Channel velocities were highest at 1.70 m³/s cfs and lowest at 1.13 m³/s. The crossing area was located at the third cross-section and this area had the slowest velocities of reach C. Cross-sections 8 and 9 had the slowest velocities, .381 m/s of

Reach D. These cross-sections corresponded to portions of a meander pool that was 12.2 m across. The 10th cross-section was only 10.36 m wide. This is why the velocity there is around .91 m/s instead.

Figure 6.24. Channel velocity longitudinal plot of Cottonwood Creek.

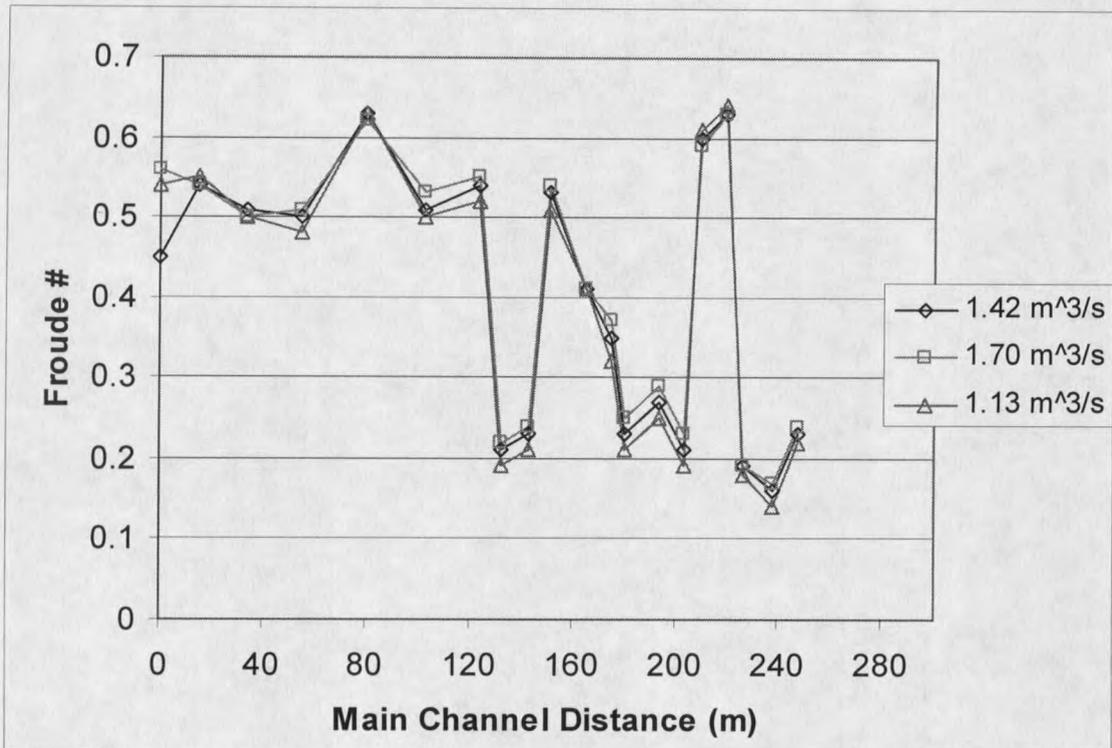
Froude numbers for the creek are shown in figure 6.25. The froude number corresponding to the only high-gradient riffle habitat (5th cross-section from 0 channel distance) in the study area was 0.63. Froude numbers follow the general trend as channel velocity.

Figure 6.25. Froude number variability along Cottonwood Creek
