A thesis submitted in partial fulfillment of the requirements for the degree of Master of Science in Civil Engineering
Montana State University
© Copyright by Stephanie Ann Hallock (2003)

A baseline study was completed in the summer of 2003 on Cottonwood Creek along the portions that flow through the Bandy Ranch. This reach will likely be the host for studies of management practices and corresponding channel change in the future.

AN EXAMINATION OF CHANNEL GEOMORPHOLOGY, HYDRAULIC
CHARACTERISTICS, AND FISH HABITAT IN COTTONWOOD CREEK ON THE
MONTANA UNIVERSITY SYSTEM'S BANDY RANCH

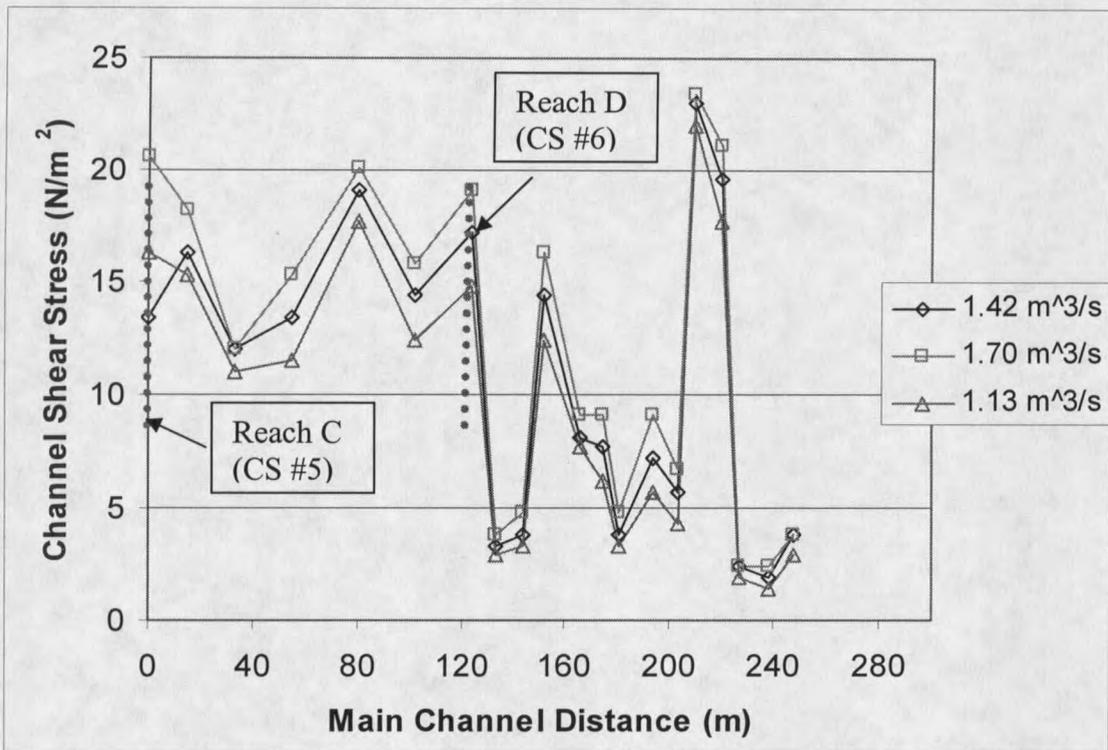
Figure 6.26 displays channel shear stress for each cross-section of Cottonwood Creek. Values range from 1.4 N/m^2 to 23.4 N/m^2 . Shear stress was lowest in the pools as is to be expected due to the lower velocities there. The locations of cross-section #5 and #6 are marked on the figure. The average shear stress for the three different discharges at for these two cross-sections is about 16.7 N/m^2 .

Figure 6.26. Shear stress variability along Cottonwood Creek.

The shear stress displayed in figure 6.26 was derived using the following equation:

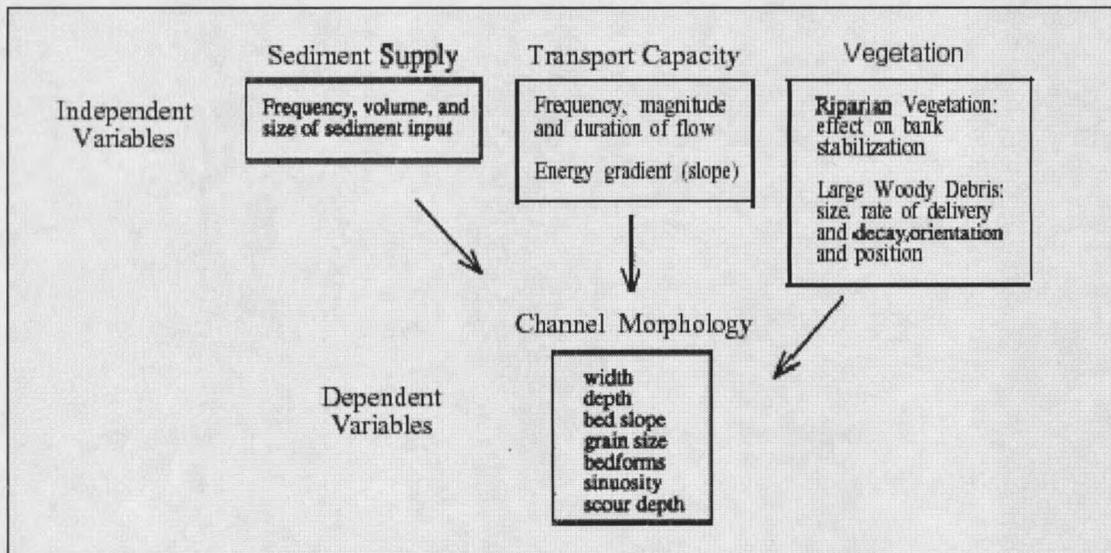
As mentioned previously, detecting and determining the causes for changes in channel morphology can be a difficult task. Channel morphology is a combination of local conditions and “the spatial context within the drainage network” (Montgomery et al, 1993). Figure 7.1 summarizes the different variables that combine to give a channel its shape.

Figure 7.1. Variables impacting channel morphology (taken from Montgomery et al, 1993)
